# Slope Instability Phenomenon in the Permafrost Region Along the Qinghai–Tibetan Highway, China

**Keywords** Slope stability · Permafrost · Tibetan Plateau · Failure mechanism · Embankment

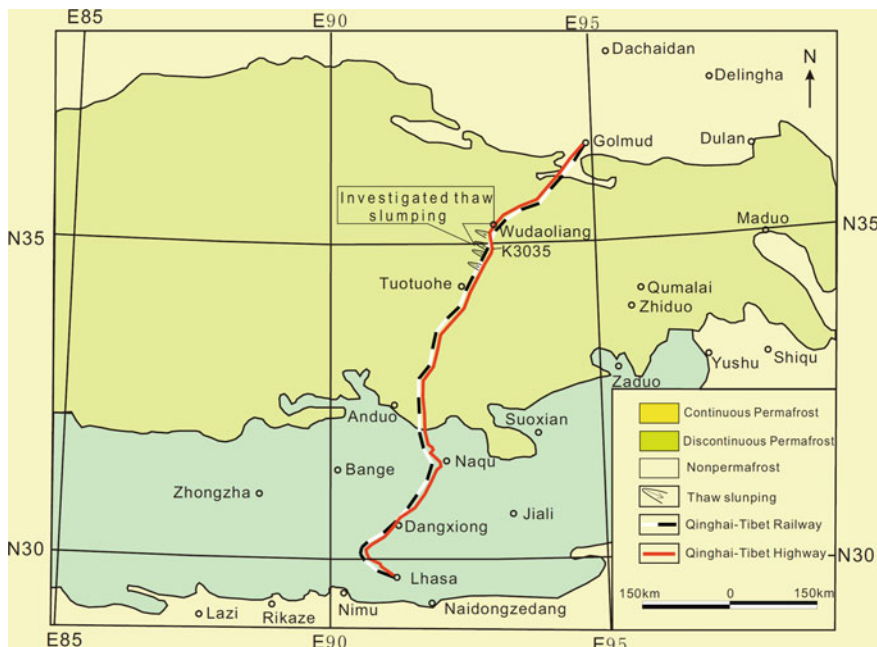
**Fig. 1** Distribution of the permafrost and the thaw slumping on QTP

The thaw slumping caused by construction of QTH mainly locate in the Hohxil hill region (K3014–3019), Beiluhe Basin (K3030–3060), and southern slope of the Fenghuoshan mountain (K3070–3080) (Fig. 1). The total length is about 45 km.

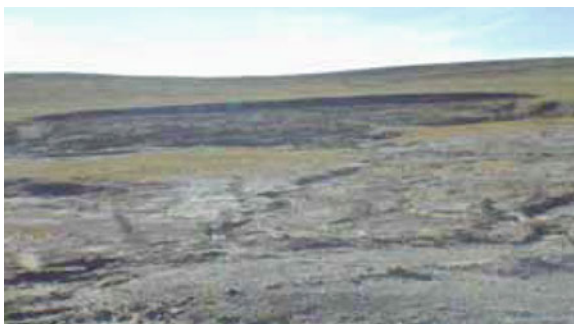
**Fig. 2** Thaw slumping near milepost K3035 of QTH

The thaw slumping near the milepost K3035 was caused by an accidental removal of soil during road reconstruction in the years between 1990 and 1992. Outcropped ground surface formed after earth borrowing. In summer, thawing of ground ice on the pit wall led to collapse of the upper part of the soil, which caused slumping of the soil for the first time. Afterward, it started to develop outward year by year and now formed a slumping with the length of 103 m East–Westward, the width of about 72 m North–Southward, the thickness of 1.5–2.0 m and the size of

about 10,000 m<sup>3</sup> (Fig. 2). The slumping is located between Wudaoliang and the Tuotuo River, 40 km north of Fenghuo Mountain and at the altitude of 4,578 m. The slumping occurred on a gentle slope with the gradient of about 7°. We will take this case for further analysis on thaw slumping.

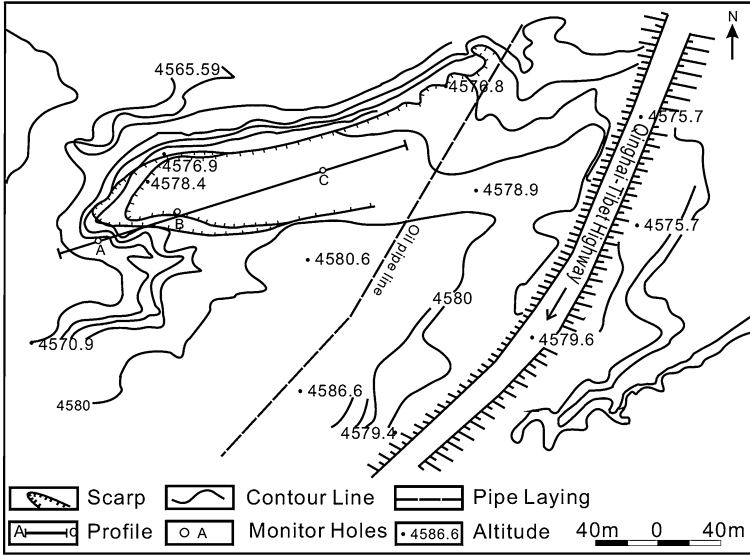
Fig. 3 Relief map and range of K3035 thaw slumping

Two thermometer boreholes, A and B, were drilled on the K3035 slumping. Hole A is located behind the head scarp of the slumping, in which 5 temperature probes were installed in the distance of 0.5 m each other; Hole B is located in the upper of the slumping mass, also 5 probes set as Hole A. Positions of monitoring boreholes in plane and profile were shown in Figs. 3 and 4. Monitoring data applied here are from 16 August 2002 to 2005, which lasts for three climatic years.

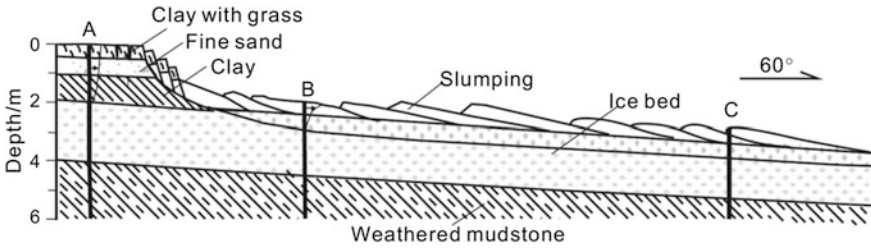
Fig. 4 Profile of the K3035 thaw slumping

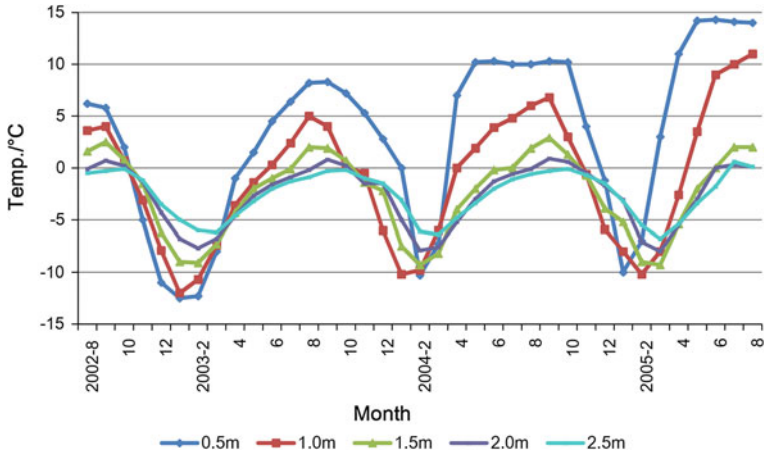
Fig. 5 Ground temperature changes at different depth versus time monitored in Hole A

Hole A represents the natural slope outside the K3035 slumping. Ground temperature at depth of 0.5, 1.0, 1.5, 2.0 and 2.5 m in the monitoring period is shown in Fig. 5 and the frozen depth in Fig. 6 respectively. First, it can be seen that soil temperature changes annually and there is a freezing period and a thawing period each year. The thawing period at the depth of 0.5 m lasts from early April to the beginning of December, and the freezing period lasts from early December to early April next year. With increase of the depth, the thawing period is shortened and delays in some extent. Figure 6 shows that the maximum thawing depth monitored is 2.2 m, generally appears in the mid-September and approximately the same in the three thawing periods. So, the upper boundary of the permafrost is 2.2 m.

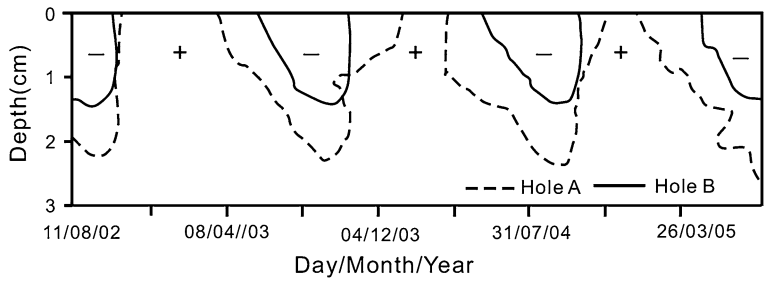
Fig. 6 The freezing depth monitored at Holes A and B

The ground temperature at the depth of 0.5, 1.0, 1.5, 2.0 and 2.5 m monitored in Hole B is shown in Fig. 7 and the frozen depth in Fig. 6. Similar to Hole A, the soil temperature changes annually and the thawing period at the depth of 0.5 m is almost the same as that of Hole A. The thawing period is shortened with the increase of depth and also delays clearly. It can be seen from Fig. 6 that maximum thawing depth is relatively shallow, which is 1.5 m, and also the same in the three

is thawing periods. It shows that thaw slumping has changed the hydrothermal condition, and the annual maximum thawing depth is shallower than that in Hole A, so the upper boundary of the permafrost has redistributed in the slumping area.

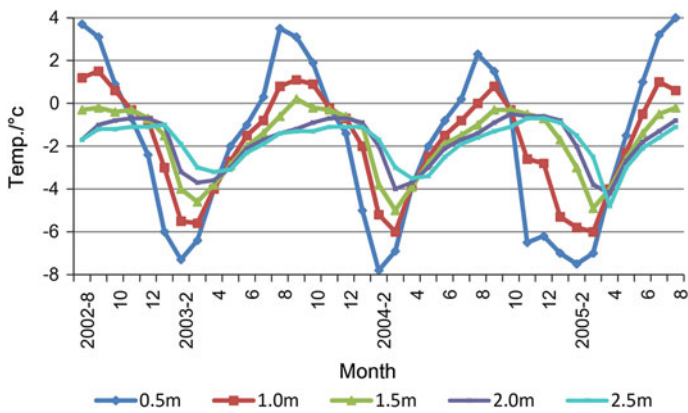
Fig. 7 Ground temperature changes at different depth versus time monitored in Hole B

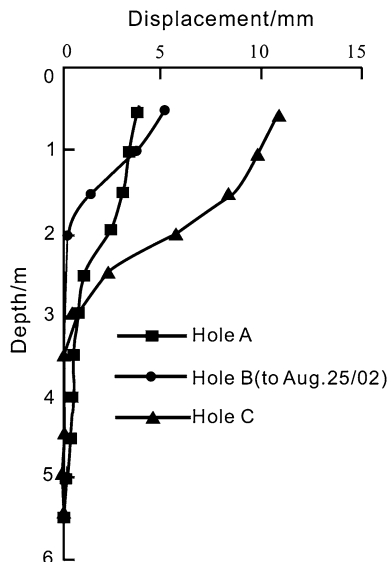
**Fig. 8** Displacements versus depth monitored in the Holes A, B and C (8 Aug 2002 to 16 Apr 2003)

In addition, Geokon-603 inclinometers were set in boreholes A, B and C. Of which, Hole C is located near the toe of the slumping mass as shown in Fig. 1. The monitoring started from 9 August 2002 to 16 April 2003, which had experienced a thawing period and a freezing one. Figure 8 shows the cumulative deformation of Holes A and C in the 250 days monitoring and that in Hole B in 15-day before 25 August, because the monitoring was stopped in Hole B at the date due to damage of the tube by extensive deformation. It can be seen that the maximum accumulative displacement at Hole A is 3.7 mm and that at Hole C is 10.9 mm. Even though Hole A is out of the boundary of the slumping, it still has slow displacement, but much smaller than that at Holes C, which indicates that the slumping

tends to develop backward. The maximum accumulative displacement at Hole B reached to 5 mm in 15 days reflects that displacement at the back of the slumping mass is larger than that in the front. Reclined fold and imbricate structure on the slope surface can also prove the movement feature.

Examining the displacement vertically, it is found that the deformation character of thaw slumping is different from that of general landslide. General landslide moves as blocks and has an obvious sliding surface. While the thaw slumping deforms transitionally, it means that, displacement changes from maximum to diminished from the surface to the bottom, which should be associated with the thermal gradient under the surface. With decreasing of temperature, viscous force of the sliding mass in plastic or flow state is enhanced and the strength of solid frozen bed is much higher, the displacement would be restricted in degrees with depth. There is no deformation under 2 m out of the slumping reflecting by the curve of Hole A, and the thickness of thawing soil observed at that point is 2.2 m, they basically agrees with each other. Obviously the deformation extended deeper on the slumping mass as seeing the curves of Holes B and C, but mainly concentrated in the depth of 0–2 m and diminished under 4.5 m. The ground temperature in Hole B shows that the thickness of the thawing soil is only 1.5 m, but the deformation zone extends below 1.5 m. It indicates that there is deformation in the frozen soil lying underneath the thawing layer. The curves of ground temperature at the depth of 1.5 m and 2.0 m in holes A and B are shown in Fig. 9. It can be seen that although the thickness of thawing soil at hole B is decreased, the ground temperature is increased. The lowest temperature of them has the difference over 4 °C. It indicates that the frozen soil in high temperature creeps too, so the effect on sliding mass has extended to the soil under the thawing layer. On the

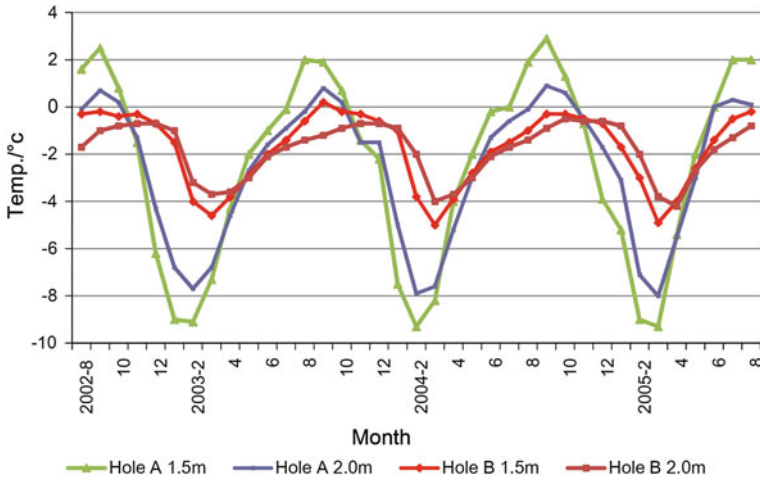
Fig. 9 Ground temperature versus month at depth of 1.5 and 2.0 m in Holes A and B

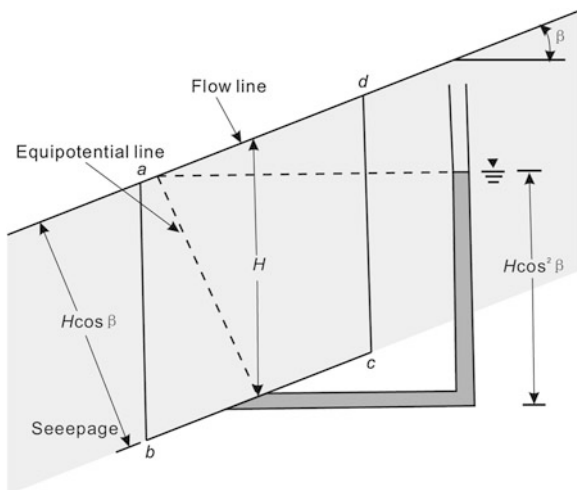
**Fig. 10** Analysis model of infinite slope

From the above analysis, thaw slumping has the features of thin thickness and broad area. The K3035 thaw slumping covers 7,200 m<sup>2</sup> of ground surface, but has the thickness of only 1.5–2.0 m, so the infinite slope model is suitable for its stability assessment as shown in Fig. 10. The model has the follow assumptions:

1. The sliding surface is a plane which parallels to the slope surface, so the thickness of the sliding mass is identical everywhere;
2. The thickness of the sliding mass is far more less than the length of the sliding mass;
3. The sides of the sliding mass extends infinitely, so the side effect is not considered;
4. The seepage flow direction is parallel downward to the sliding plane.

To determine the factor of safety against failure along the plane *AB*, consider the slope element *abcd*. The forces that act on the vertical faces *ab* and *cd* are equal and opposite. The total weight of the slope element of unit length is
