Chapter 6

Vibration Testing of a Floor During Multiple Phases of Construction

Brad Pridham

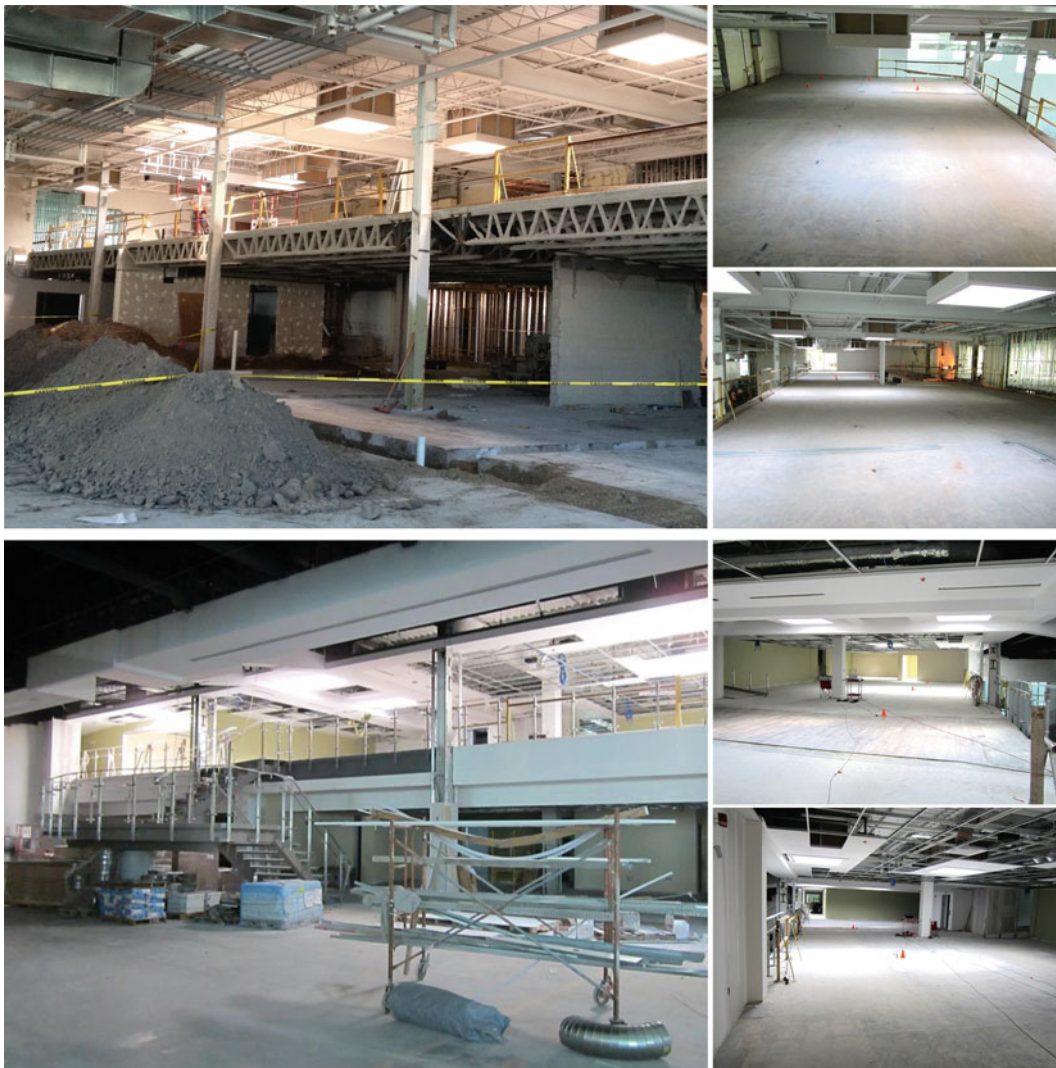
Fig. 6.1 Photos of the test floor during early renovation/demolition (*top*) and partial fit-out (*bottom*)

Photos of the test floor, taken during demolition and partial fit-out, are shown in Fig. 6.1. Figure 6.2 is the final layout of the office space, and ground floor area below. This particular area of the building houses executive office space, with the office's senior executive located at the northeast corner of the mezzanine floor. The space is favored architecturally due to the free edge along grid line B, which allows occupants of the offices to look out over the area below. The server room extends below the mezzanine area (as shown at right in Fig. 6.2), and due to its function must remain mostly open. The few wall partitions located at level one are mostly full-height (slab-to-slab) concrete masonry construction.

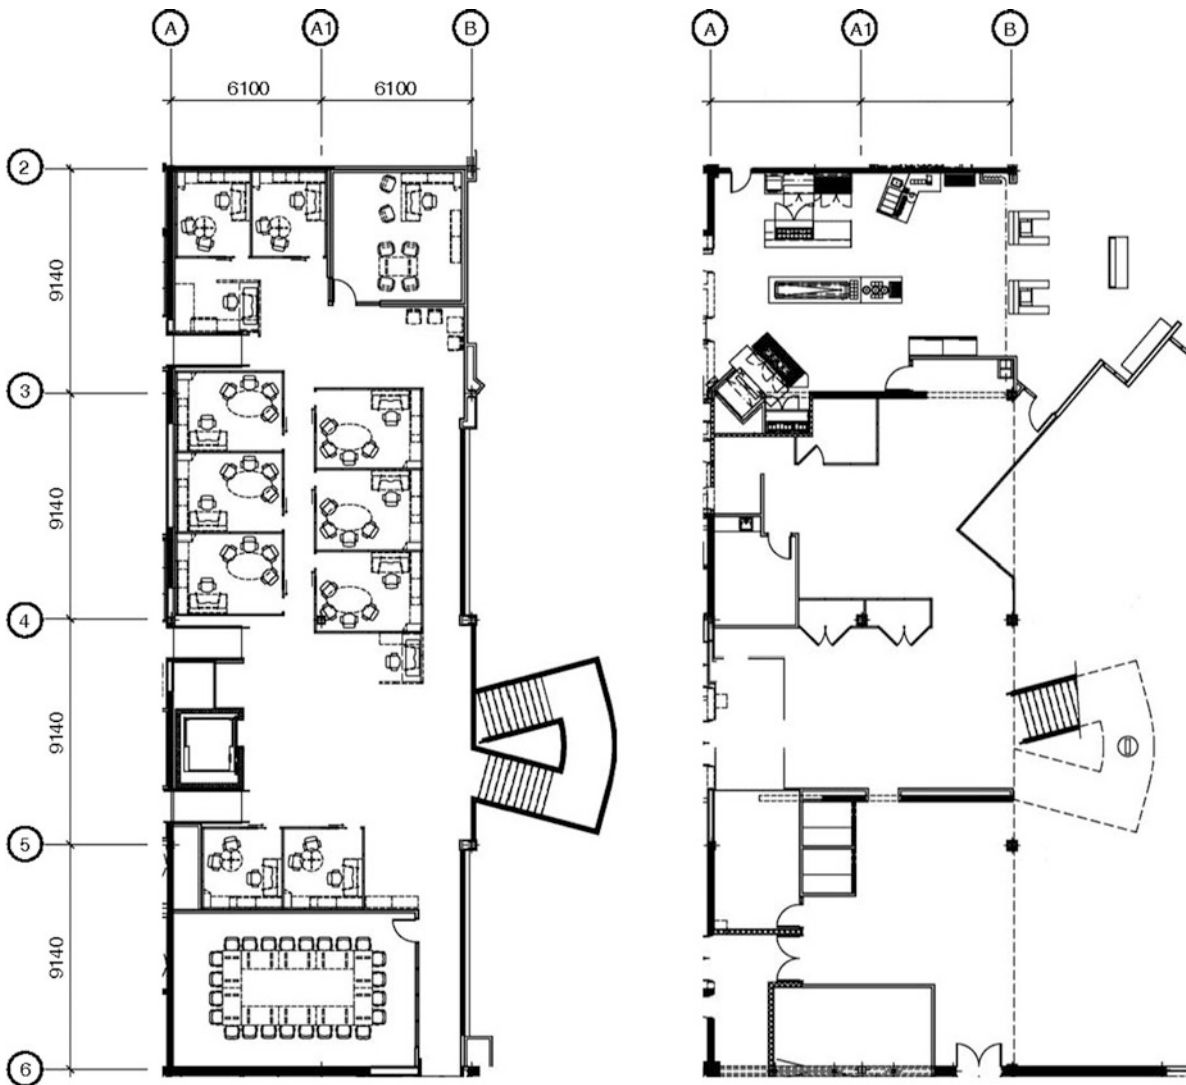
Fig. 6.2 Final floor layouts, mezzanine (*left*) and servery below (*right*)

The final floor layout, shown in Fig. 6.2, includes demountable (partial height) wall partitions across most of the floor. The only walls extending slab-to-roof above are those in the northeast office and the conference room at the south end.

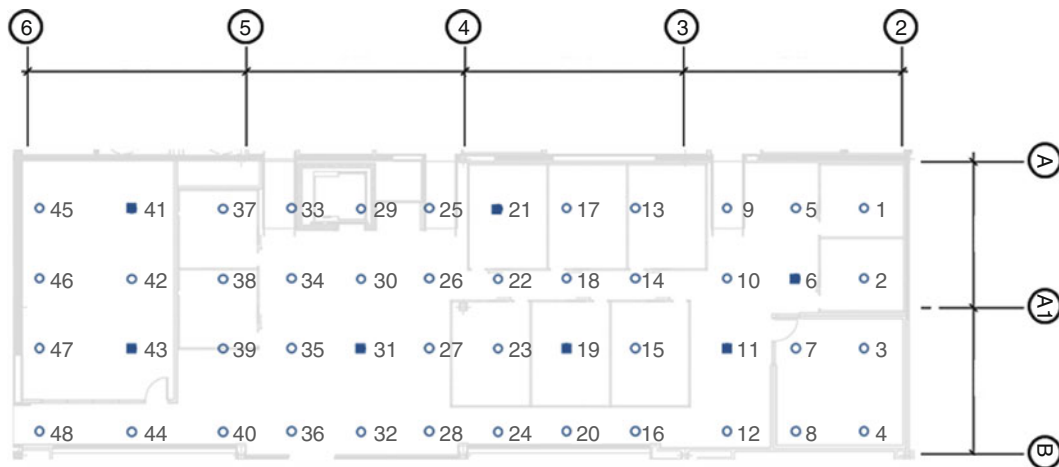
Fig. 6.3 Impact test grid layout (measurement points shown as *filled squares*)

Given the light weight and liveliness of the floor, impact testing was selected as a suitable methodology for the modal tests. A total of 48 test points were specified (4×12 grid), so that a high degree of spatial resolution could be achieved for mode shape visualization. An 8-channel acquisition system was employed for data collection. Channels 1–7 were used to record floor accelerations using a combination of three seismic accelerometers (10 V/g sensitivity), and four general purpose units (1 V/g). Channel 8 was dedicated to the modal hammer. The test grid layout is shown in Fig. 6.3. Additional sensors were employed for redundancy to ensure that multiple data sets could be analysed during Phase 1. Only four sensors were deployed for Phases 2 and 3 at grid points 11, 19, 31 and 43.

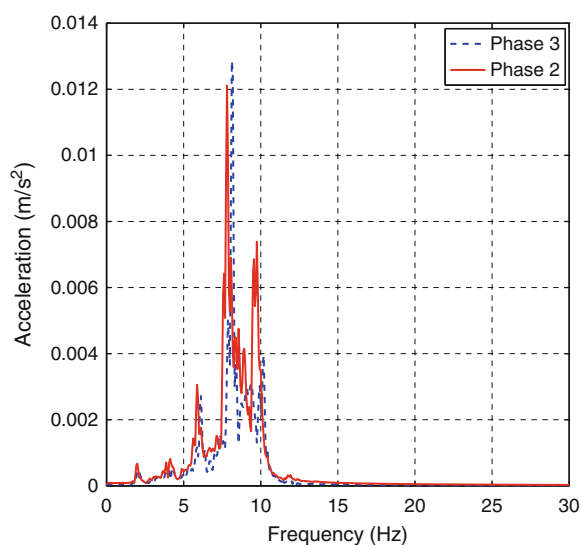
Fig. 6.7 Footfall responses at grid 5 measured during Phases 2 and 3
