# Laser Scanner Application in Monitoring Short-Term Slope Deformation

Kiminori Araiba and Naoki Sakai

In order to develop a method to estimate the risk of secondary disaster during rescue activities at a site suffering from slope failure, a method for using repeated surveying by means of laser scanner installed on the ground is proposed. Eight experiments of slope failure including one carried in a natural slope were done. To improve the accuracy in the deformation, spatial stacking of data was adopted. Availability and reliability of the method, characteristics of deformation measured are discussed.

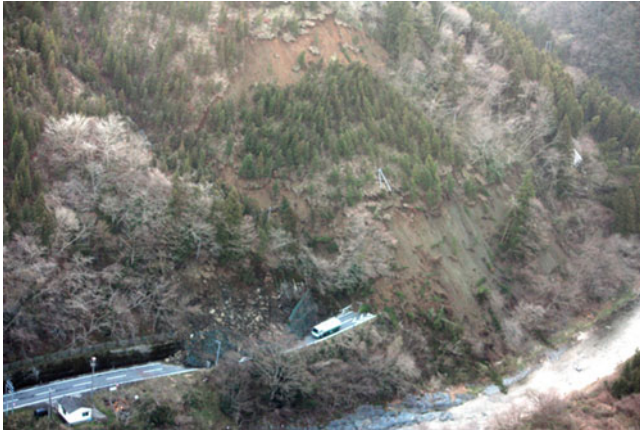
**Fig. 1** A S&R activity was done in the deposit of a landslide where mass of up-slope was still sliding during activity

Assessing and controlling the risk of a secondary disaster during a search and rescue (S&R) operation at a disaster site are difficult because both the quantity and quality of information regarding the disaster are usually inadequate due to the limited time and space available for investigation. As an example, 60 fire-fighting volunteers were killed during an S&R activity because of a secondary failure of a slope that occurred approximately 4 h after the initial slope failure, which had buried 1 person in Shigeto, Kochi prefecture, Japan, in 1972 (Nakagawa and Okunishi 1977). Figure 1 is a picture of a landslide caused by an earthquake in Fukushima Prefecture on 11 April, 2011. Fire fighters conducted S&R activity in the deposit. They recognized that the slope was still moving. The activity was finished on the next day, recovering a body.

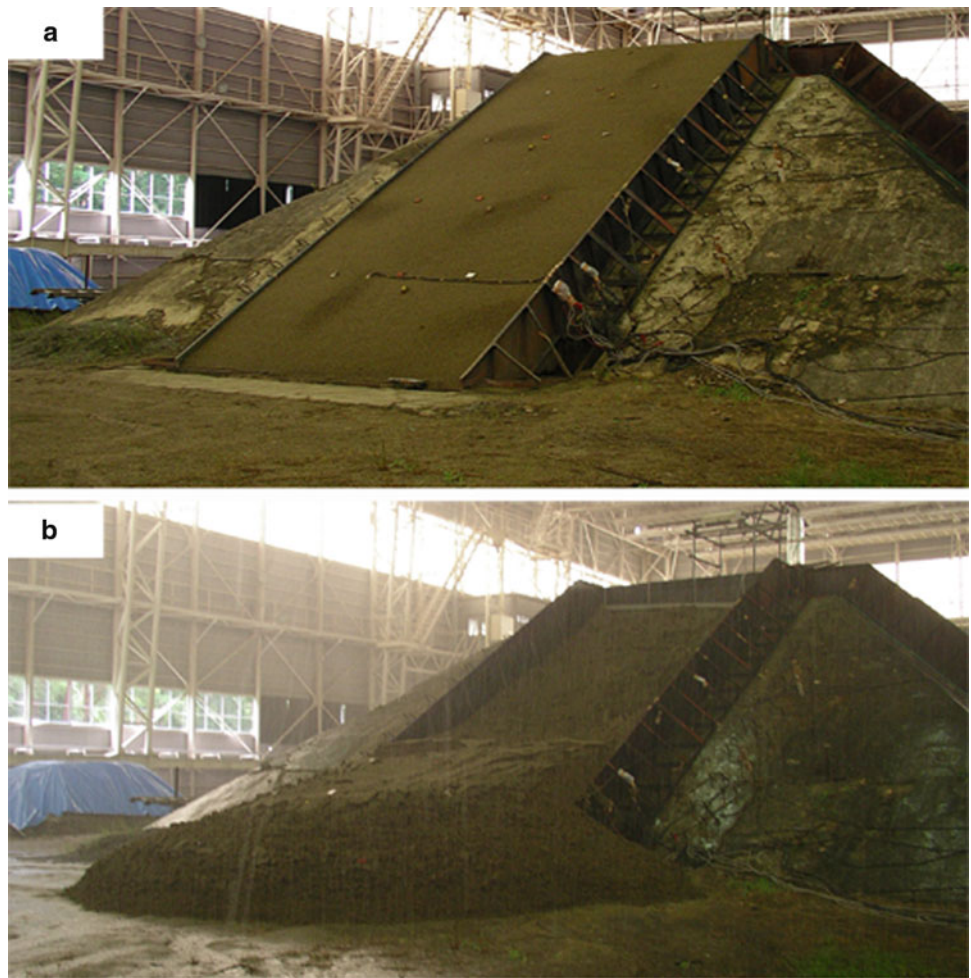
**Fig. 3** Model slope used in experiments No. 1–7. (a) Before failure; (b) after failure

A model slope covered by a soil layer with a height of 5 m, width of 4 m, depth of 1 m and an inclination of 30° was constructed using material listed in Table 2. Water was sprayed from nozzles that were set at a 6-m-high ceiling. A series of preparatory sprays were applied to the model slope for about 10 days. Each preparatory spray application was done for 8 h per day; its intensity was increased on a daily basis from 15 to 45 mm/h. On the final day, the intensity was increased to the value in Table 2, and water was sprayed until the model slope eventually failed. Figure 3 shows photographs of the model slope before and after the failure.

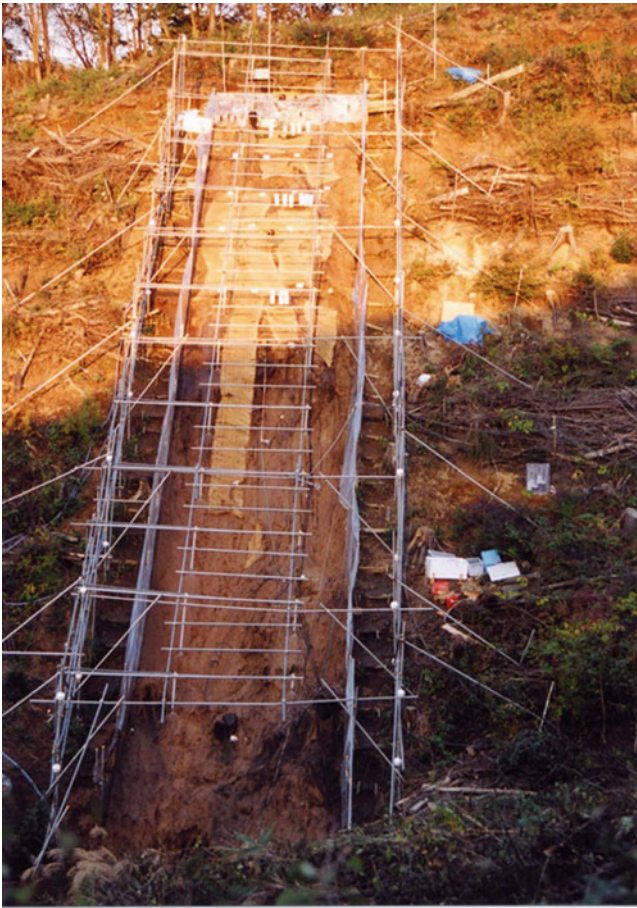
**Fig. 4** Slope after the experiment No. 8

Water was sprayed from nozzles attached to steel pipes at a height of 2 m above the ground. The intensity of the spray was 78 mm/h. The lower half of the segmented slope failed approximately 6 h after the start of spraying. The maximum depth of the failed mass was about 1.2 m. Figure 4 shows the photographs of the slope before and after failure. The pair of white arrows indicates the location of the head of the failure.

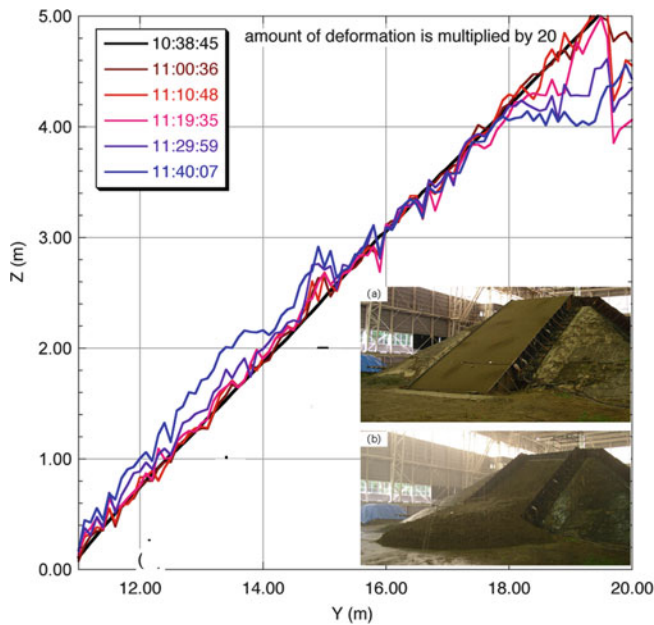
**Fig. 6** Change in the cross section of slope with time. The amount of deformation is multiplied by 20

Figure 6 shows changes in the cross section of model slope with time in experiment No. 2 where the amount of deformation is magnified by 20 times. The amount of retrogressive deformation in the upper region of slope has positive correlation with height and, on the other hand, that of progressive deformation in the lower part does not show correlation with position.

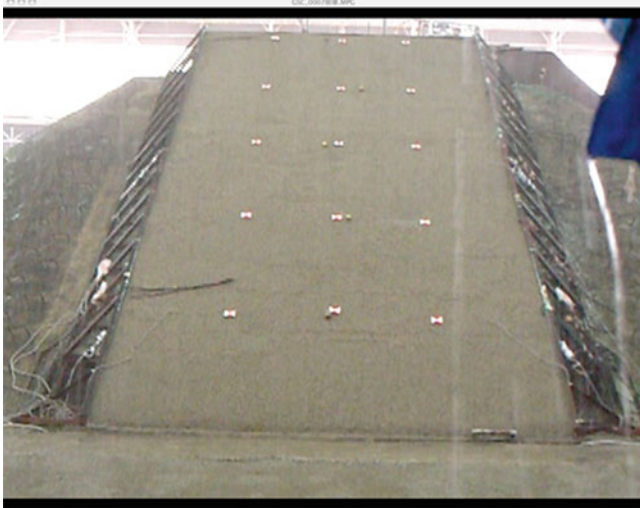
**Fig. 7** Picture of model slope about 1 min before failure in experiment No. 4

Figure 7 is a picture of slope about 1 min before failure, captured from video in experiment No. 4. Two clear lines

(compression cracks) can be seen in the lower part of slope and one tension crack can be seen on the top of the slope.

Retrogressive deformation was observed in the region below the tension crack and its amount has a positive correlation with height, which indicates that the deformation accompanied rotation. On the other hand, progressive deformation does not show such tendency. Slope seems to have dislocated at the compression cracks with slight changes in the angle of slope surface.

The dislocation at the compression is spatially sharp as shown in Fig. 7 and 10 cm mesh is larger than the area of dislocation, thus deformation values at meshes involving compression cracks must be smaller than values of dislocation. Furthermore, laser beam have a certain divergence therefore shape of laser-spot at the slope is in the shape of an ellipse. To measure more accurate value of dislocation, it is necessary to make the size of mesh smaller and area of laser-spot smaller. Further research in optimizing resolution of measurement, robustness of measurement, scan rate and scan position is necessary.

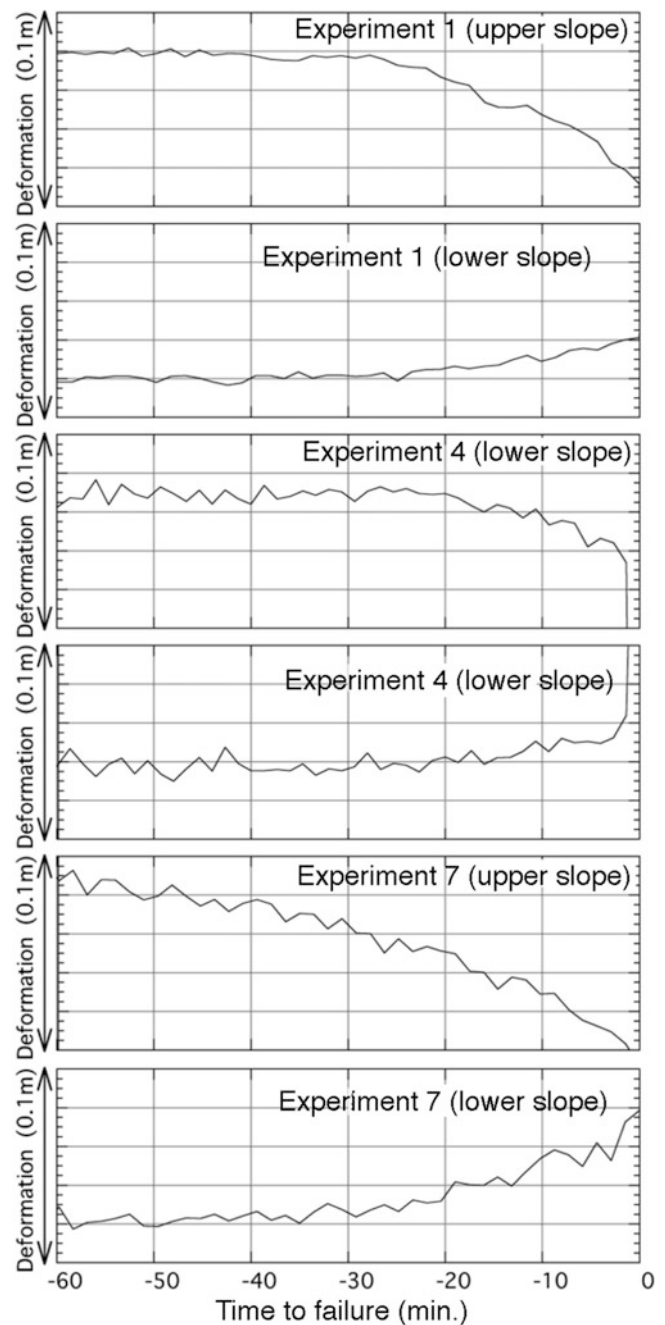
**Fig. 8** Time series of deformations

Figure 8 shows time series of specific meshes where large deformation was observed. Remarkable deformation was observed in all of tests. We can conclude that deformation prior to failure can be detected with high possibility in slopes that consists of the sandy material.

Retrogressive deformation shows acceleration with time; on the other hand, slight acceleration can be seen in progressive deformation.
