Creep Behavior of the Slip Zone of a Giant Slow-Moving Landslide in Northwest China: The Suoertou Landslide as an Example

Xiu-zi Jiang and Bao-ping Wen

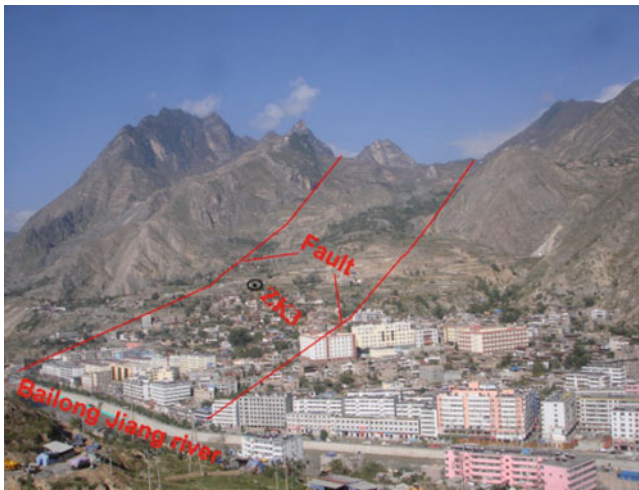
Fig. 1 View of the Suoertou landslide

The Suoertou landslide was located on the north bank of the Bailongjiang river, about 1 km upstream of Zhouqu County, Gansu province of China (Fig. 1). The landslide fully developed within a regional active fault zone, namely the

The test soil sample in the study was collected from borehole ZK3, in the middle portion of the landslide (Figs. 1 and 2). The sampling depth was 60–64 m. Basic physical properties of the sample were presented in Table 1. Grain size distribution and Atterberg limits of the sample were obtained in compliance with CNS GB/T50123-1999 (SAC 1999). Results showed that there was 10 % clay fraction with 52 % silt, 8 % sand and 30 % gravel. The liquid limit and plasticity indices were 35 and 19, respectively. X-ray diffraction analysis showed that the sample had primarily quartz, pyrophyllite and clay minerals, which primarily consisted of illite, kaolinite and pyrophyllite with some interlayered illite/smectite and chlorite (Table 2).

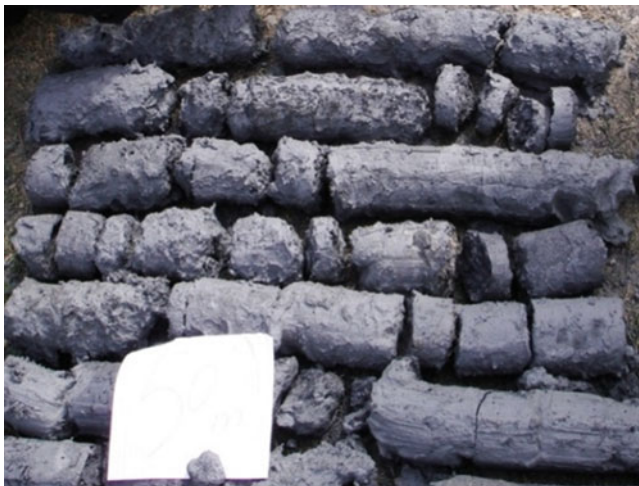
Fig. 2 Slip zone of Suoertou landslide from borehole ZK3
