## Study on the Microscopic Structure Characteristics of the Gray Matter Slate

## Overview of the Jiweishan Landslide

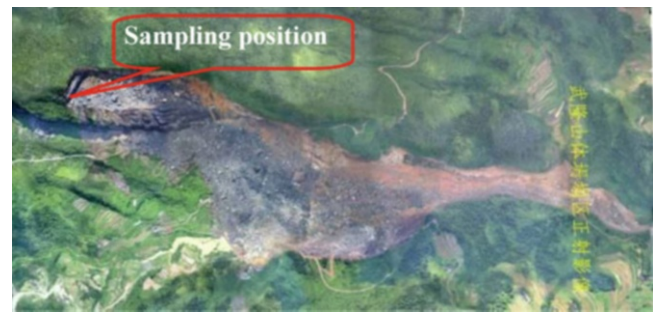
Fig. 1 Image of the Jiweishan landslide

At 3 pm on June 5, 2009, a tremendous landslide occurred at the Jiweishan in Tiekuang Township, Wulong County, Chongqing City. The thick limestone slipped down along a low angle dip inter-bedded shale plane from 1,300 m cliffs (the height difference of about 200 m). Blocked by the opposite steep creek wall, the sliding rock mass changed its direction and travelled further along the 22,000 m along Tiejiang ditch (Fig. 1). The landslide body was mainly constituted by the Permian off-white thick-bedded micritic limestone, dark gray medium to thick bedded asphaltene-containing limestone, argillaceous limestone and limy-slate mezzanine etc. The area was about 84,000 m<sup>2</sup>, and its volume was about  $5 \times 10^6$  m<sup>3</sup>.

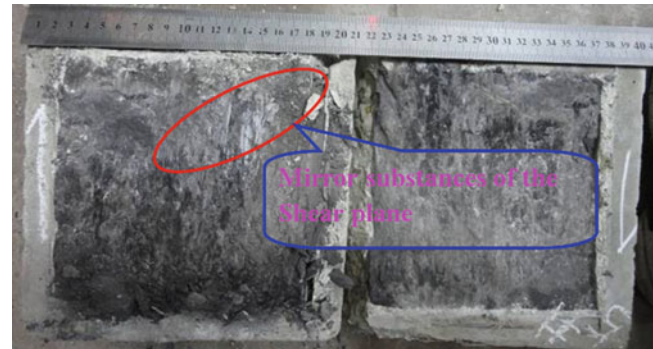
The slip zone generally developed along the rock strata, with the occurrence of  $30 \sim 355^\circ \angle 22 \sim 30^\circ$ . There are a large number of scratches on the slip surface along the sliding direction and a large number of white slickensides were developed on the slip surface, as can be seen in Fig. 2. The Jiweishan landslide with a dual structure in Wulong is a

Fig. 2 Destruction of the samples and the observed slickensides
