Vertical Root Fractures in Dentistry

Aviad Tamse • Igor Tsesis • Eyal Rosen
Editors

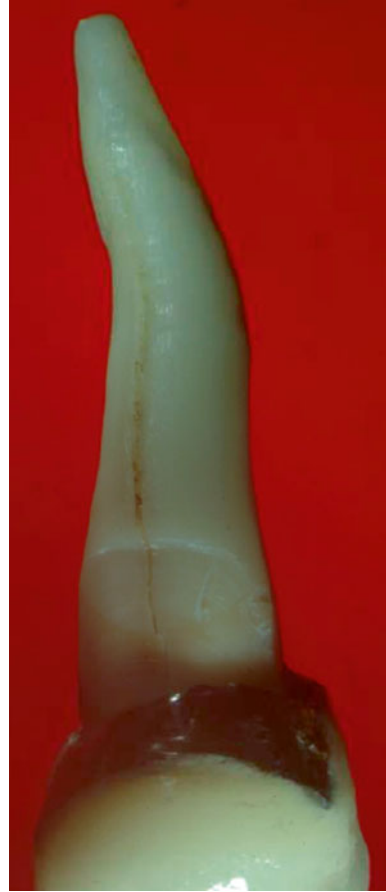
Fig. 1.1 A typical vertical root fracture in an endodontically treated, restored maxillary premolar

Vertical root fractures (VRFs) are root-originated fractures in endodontically treated teeth and are considered as the third most common cause for tooth extraction after dental caries and periodontal diseases [1–3] (Fig. 1.1). They often present diagnostic problems that challenge the expertise of even skilled and most experienced clinicians [1, 2]. This clinical entity may be difficult to diagnose because often the clinical signs, symptoms, and radiographic features can mimic signs and symptoms of failed endodontic treatment or a periodontal disease [1, 4, 5]. In addition, there are many aspects and a variety of issues regarding the root fracture etiology and risk factors, and VRFs may develop also in teeth with good-quality endodontic treatment and well-prepared coronal restoration [1, 4, 5]. Therefore, prevention of these fractures is all together difficult and frustrating.

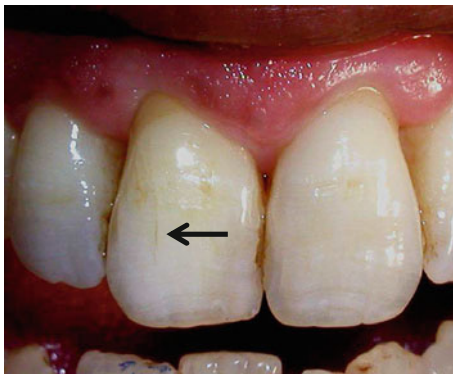
Fig. 2.3 (a, b) A mesiodistal fracture in a maxillary premolar crown. The crown was previously treated with an esthetic white restoration. The patient’s chief complaint was of “problems in brushing the teeth in this area.” (a) The pulp was diagnosed as necrotic with asymptomatic apical periodontitis. The fracture extends apically creating pockets of 6 mm in the proximal areas. Bone resorption due to the periodontal destruction can be seen mesially and distally (b) (Courtesy Dr N. Chivian)

Some crown-originating fractures (COFs) have been identified as *cracked teeth* [1]; they are found in maxillary and mandibular molars and maxillary premolars. These fractures occur mostly in teeth with vital pulps and have a mesiodistal pattern. They can be observed in intact crowns or may be seen next to a carious lesion or adjacent to a small restoration. The fracture in the crown can at times extend apically to eventually separate the tooth into two parts (*split tooth*) [3] (Figs. 2.3, 2.4, 2.5, 2.6, 2.7, 2.8, and 2.9).

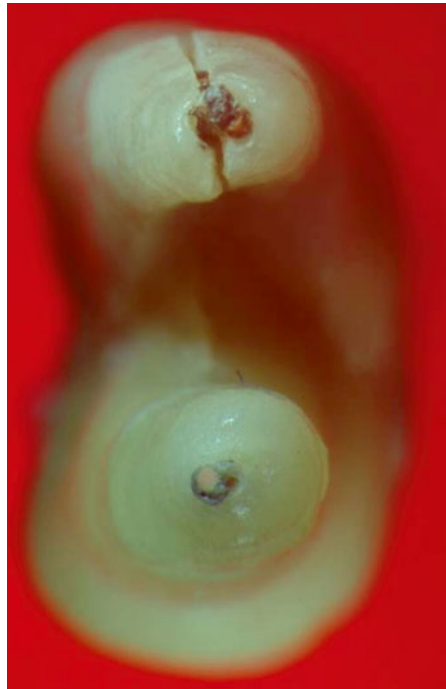
Fig. 2.13 A complete VRF in a buccal root of a bifurcated maxillary premolar

The teeth and roots most susceptible to VRF are those in which their mesiodistal diameter in cross section is narrow compared to the buccolingual dimension (oval, hourglass shaped, kidney shaped, ribbon shaped). Such teeth and roots are the maxillary and mandibular premolars (Figs. 2.12, 2.13, 2.14, and 2.15), the mesiobuccal root of mandibular molars (Figs. 2.16, 2.17, 2.18, and 2.19), the mandibular anterior teeth (Figs. 2.20 and 2.21a, b), and mesiobuccal roots of the maxillary molars (Fig. 2.17) (See also Chap. 3) [18].

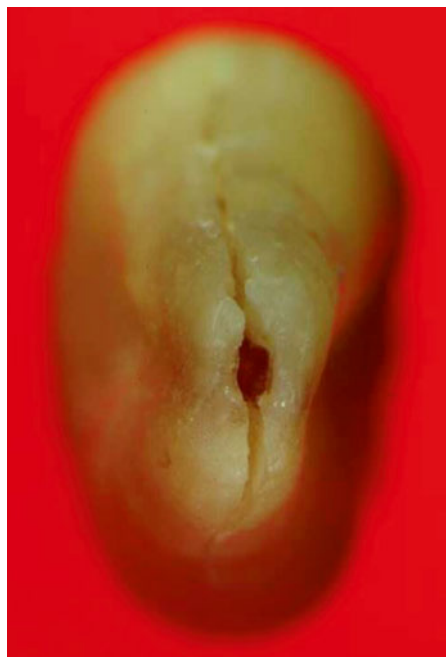
Fig. 2.14 An apical view in a complete VRF in a maxillary premolar. Note the typical “hourglass” morphology of these teeth in cross section and the typical mesial concavity in the trunk of the root

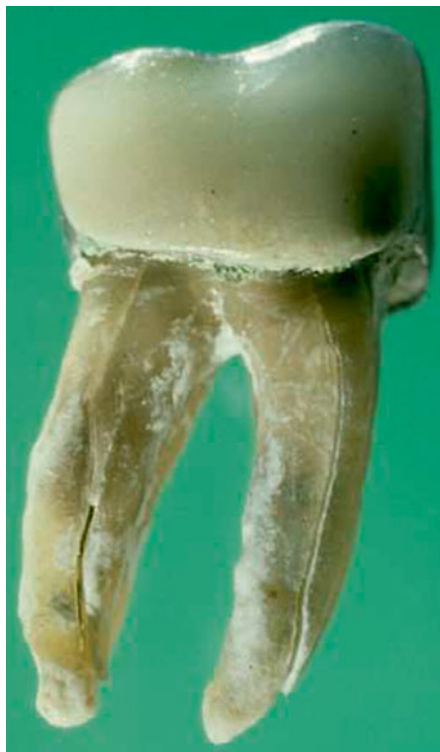
Fig. 2.19 Two VRFs in a mandibular molar. Note that in both roots the fractures in the apical parts are located few millimeters coronally to the root tip

In cases 2.16, 2.18 and 2.19 that where the teeth were extracted with their crowns, it is difficult to determine the origin of the fractures. It is possible that the fractures originated in the crowns and progressed apically (crown originating fracture—category 1) or originated in the roots and progressed to the cemento enamel junction.

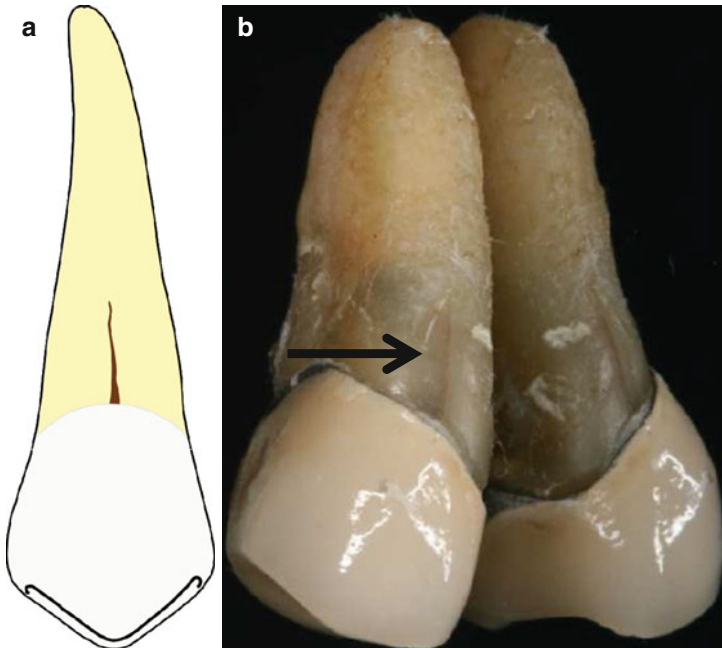
Fig. 2.23 Graphic view of a VRF in the coronal third of a maxillary premolar (a). In this case, the fracture originated either in the crown itself or in the coronal third of the root. (b) In an extracted single rooted maxillary premolar (Black arrow) (Courtesy Dr E. Venezia)

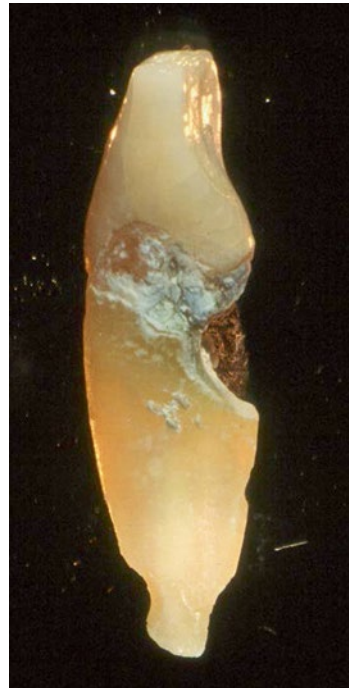
Fig. 3.1 Root caries and external apical root resorption in a mandibular anterior tooth

Although the predisposing factors for VRFs are beyond the control of the clinician, they should be considered carefully as part of the endodontic and restorative treatment planning [3]. These are the biochemical changes of root dentin of the endodontically treated tooth, preexisting cracks in the untreated tooth, and the specific anatomy of susceptible teeth with VRFs [3–5]. The amount of sound tooth structure in the crown and root as a result of caries and trauma is also a factor that increases the risk of crack formation in the dentin that could progress into a fracture (Fig. 3.1) [6].

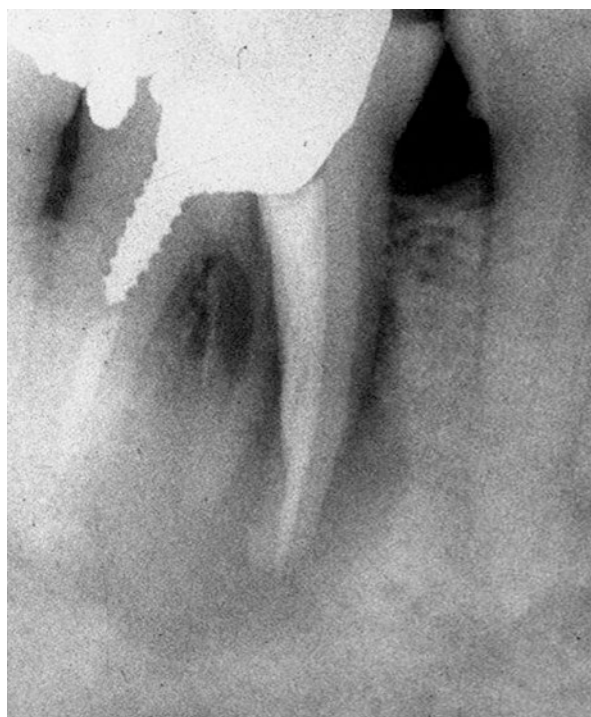
Fig. 3.2 Excessive removal of root dentin during root canal preparation in the mesial root of a mandibular molar caused a vertical root fracture. Separation of the root segments and large bone resorption can be seen in the radiograph

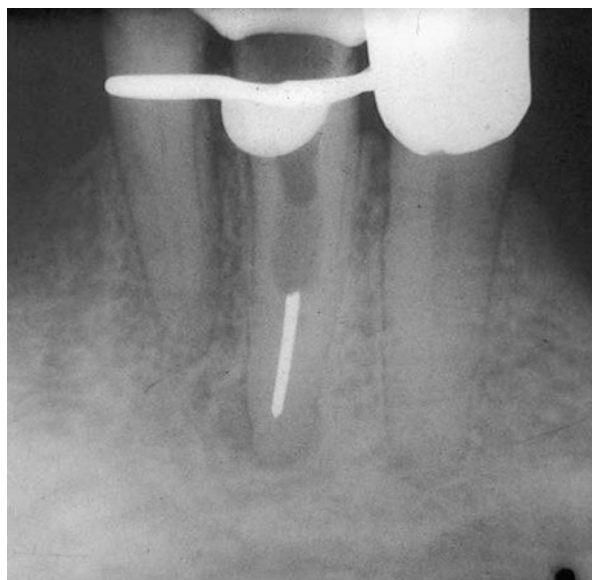
Fig. 3.8 Excessive removal of root dentin is shown in the two periapical radiographs (a, b). A bench periapical radiograph (c) is showing the large amount of dentin removed which was a major contributing etiology for the VRF in this tooth. (d) A black arrow is pointing at the fracture

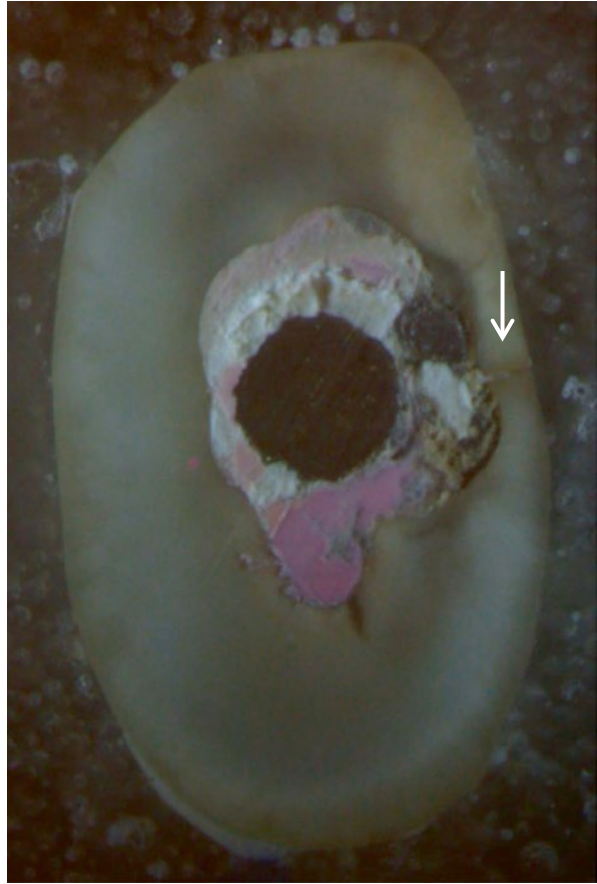
Fig. 3.10 A polished cross section of endodontically treated mesial root of a mandibular molar. Incomplete VRF is shown from the root canal to the lingual aspect, while a crack from the root canal is shown in the buccal part. Given enough time, this crack, shown by an *arrow*, will progress to the buccal aspect forming in this root a complete VRF from one aspect to the other

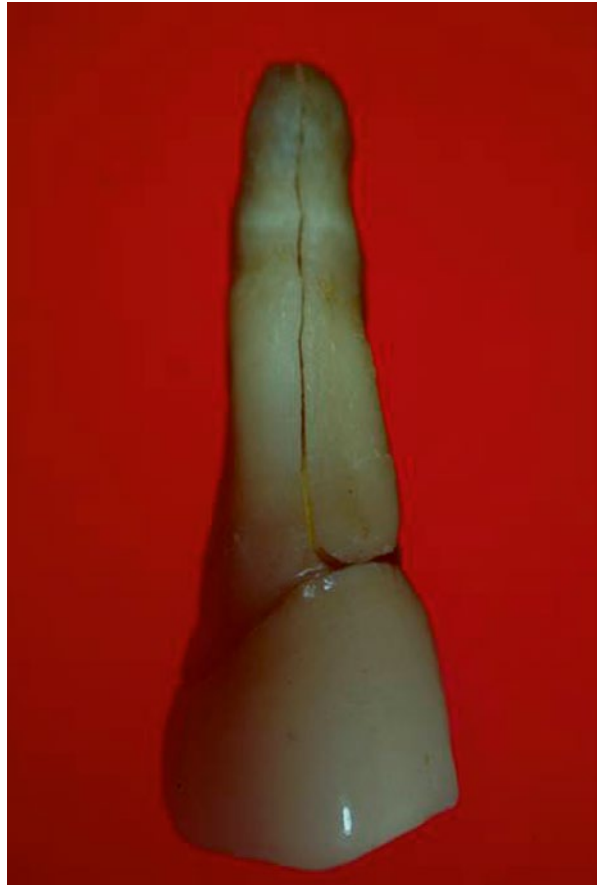
Fig. 3.11 Buccal view of endodontically treated mandibular premolar tooth extracted from a patient due to VRF in our laboratory

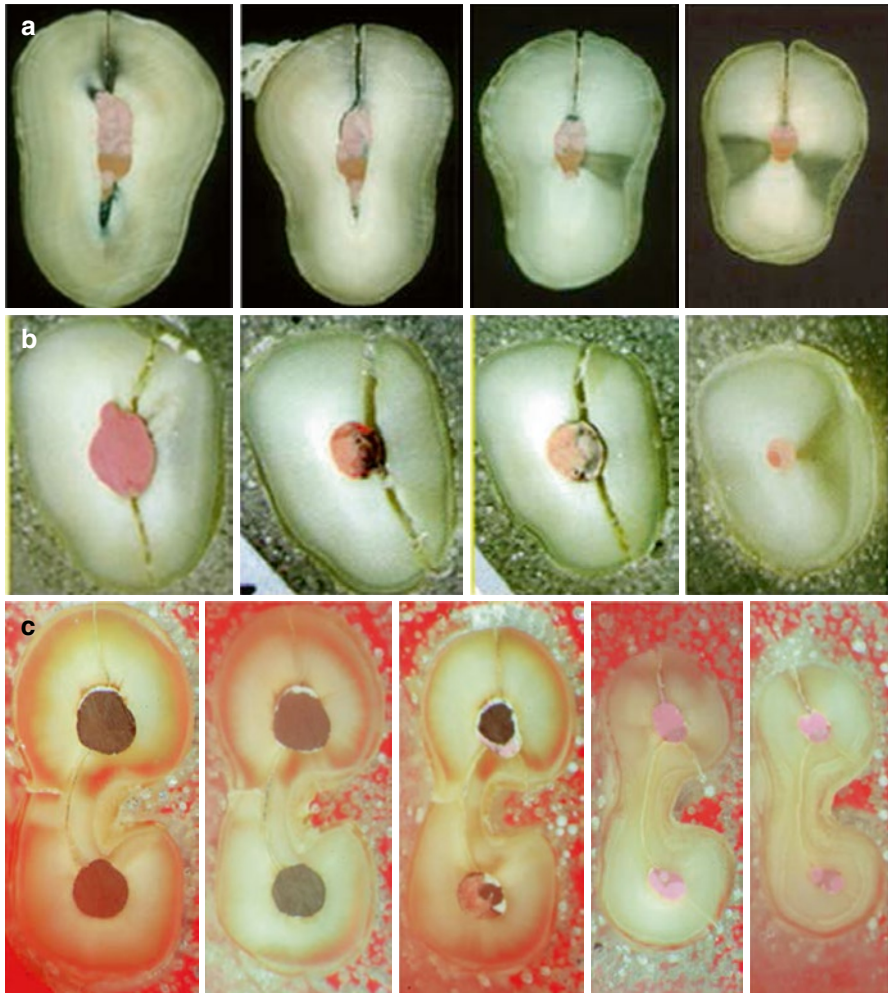
Fig. 3.12 Three micrograph sequences of horizontal cross sections for maxillary premolars extracted due to VRF in our laboratory: (a) Single-canal root showing incomplete VRF, (b) single-canal root showing complete VRF, (c) double-canal root with posts extending to the middle part of the root; a complete VRF occurs only in the apical part of the root. The fracture conclusively initiates at the root canal surface where the radius of curvature is the smallest (Courtesy Dr A. Raizman)

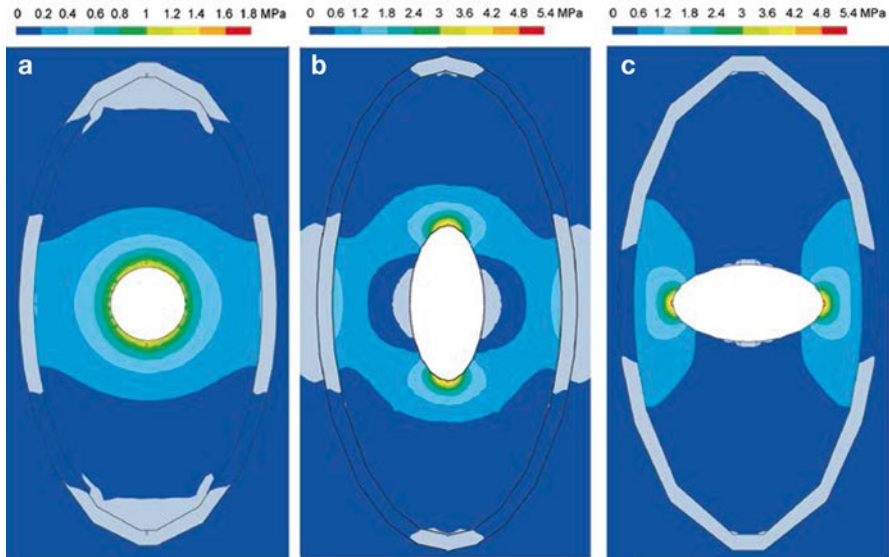
Fig. 3.14 FEM results showing contours of first principal (maximum) tensile stress for three canal cross sections corresponding to Fig. 3.13 with $c=0$, $q=1$ MPa, PDL thickness=0.2 mm, and major and minor axes of inner and outer root boundary equal 3 and 1.5 and 1 and 0.5 mm, in that order; (a) round canal, (b) major axis of inner and outer root boundaries coincide, (c) major axis of inner and outer root boundaries are perpendicular. Young’s modulus for (dentin, PDL, bone) is (18, 0.05, 1.4) GPa while Poisson’s ratio for this triplet is (0.31, 0.45, 0.3). Note the prints cover only part of the specimen

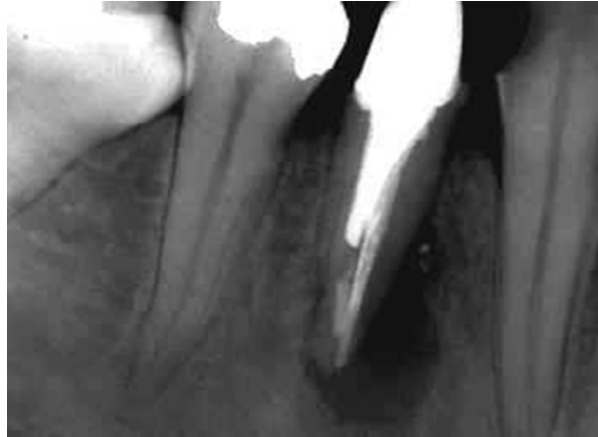
Fig. 4.5 A very large “halo”-shaped lesion in a mandibular premolar

A most frequent radiographic feature of VRF is the “halo” (“J shaped”) (Figs. 4.5 and 4.6) appearance. This is a combined periapical and lateral radiolucency along the side of the root or a lateral radiolucency on one or both sides of the root. It may also present as an angular radiolucency from the crestal bone terminating on the side of the root (Fig. 4.7).

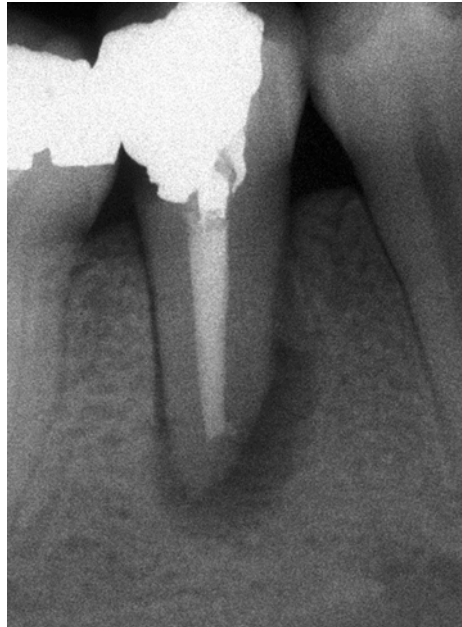
Fig. 4.6 A smaller-size “halo” radiolucent lesion in a mandibular premolar

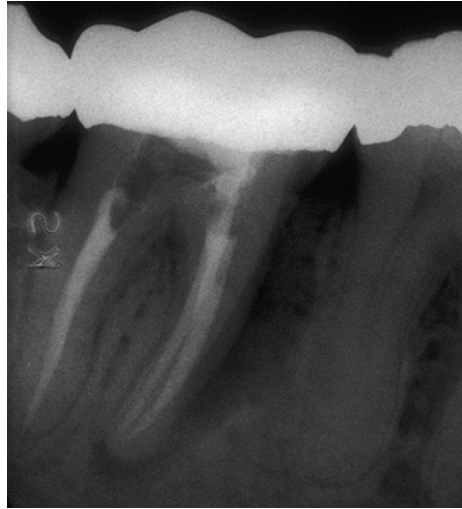
Fig. 4.7 Angular bony defect along the mesial root of a mandibular molar extending from the crestal bone to the apical part

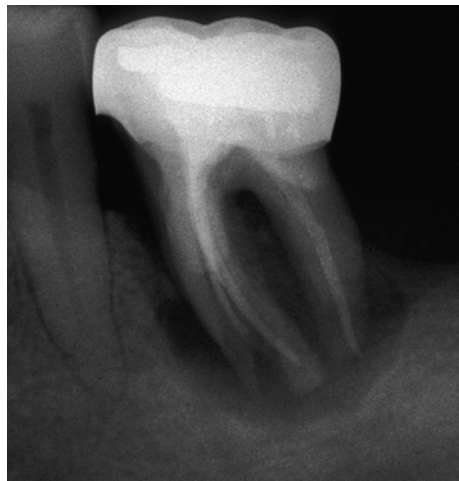
Fig. 4.10 Separated root fracture segments are an unusual finding and occur in long-standing inflammatory process in the area

Separated root segments are seldom visible on radiographs. If there is obvious separation, this is usually accompanied by a large radiolucency including and between the roots; this is inflammatory tissue separating the segments [17]. Obviously, when visible, these are absolutely diagnostic (Fig. 4.10). Segment separation with the large resorptive lesion indicates a long-standing event probably unnoticed by the patient. Lustig et al. [11] found that in most patients with other signs and symptoms (sinus tract, large osseous defect, mobility), or with acute exacerbations, greater interproximal bone loss was recorded than in patients in whom the VRF diagnosis was made at an early stage.

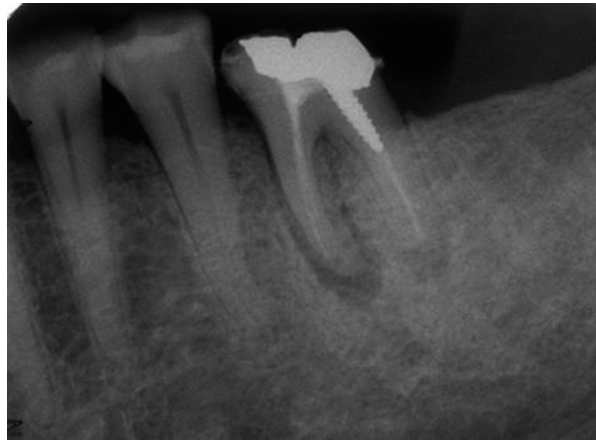
Fig. 5.15 Typical bony appearance of a “halo” radiolucency in a poorly filled mandibular molar, combined with radiolucency in the bifurcation. Other signs and symptoms typical to a VRF tooth led to the accurate diagnosis of VRF (Courtesy Dr. T. Blazer)

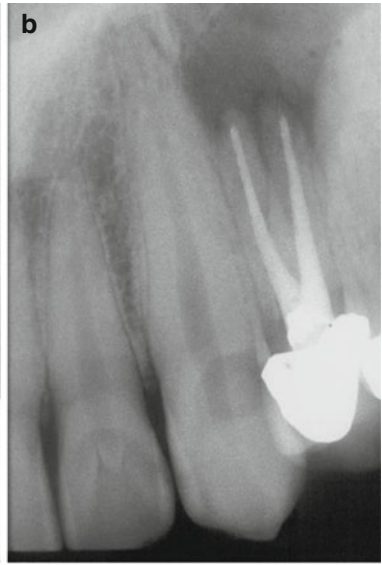
Fig. 5.21 (a–d) Patient history revealed that 5 years prior to arriving at the dental office, root canal therapy was performed on the maxillary first premolar with an amalgam dowel and PFM crown. The patient’s chief complaint was tenderness on biting and a “loose tooth.” The patient also experienced two episodes of swelling in the area over the past 3 years. Clinical examination revealed slight mobility, sensitivity to percussion, and a 7 mm probing defect on the midbuccal area. The first periapical radiograph revealed a well-obtured root canal and large “halo” radiolucency (**a**). An additional radiograph with a slight change in angulation showed (**b**) this tooth to be a bifurcated maxillary premolar. When a VRF is suspected it is highly recommended to take two periapical radiographs from different angulations. There was no sinus tract in the attached gingivae, and a definitive diagnosis of a VRF tooth could not be done. The patient declined a surgical flap procedure for final diagnosis and treatment. The tooth was extracted (**c**). The typical depression on the bifurcation aspect of the buccal root with the longitudinal fracture along the depression can be seen in this image following some shaving of the palatal root (*black arrow*). In one of the cross sections done (**d**), complete VRF from one side of the root to the other can be seen in both roots. The typical depression in the buccal root can also be seen

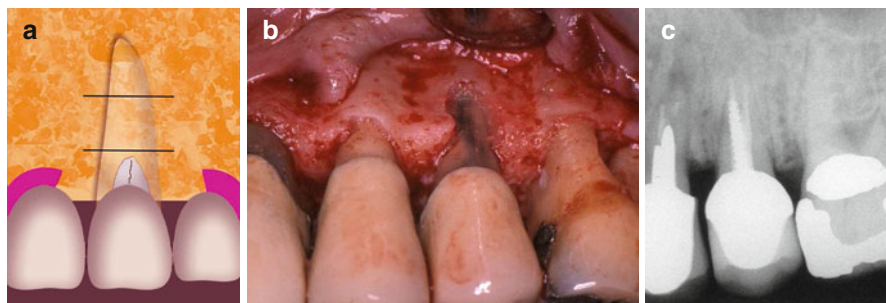
Fig. 8.1 (a–c) A patient was scheduled for periodontal surgery in the maxillary left quadrant. The periapical radiograph revealed endodontically treated bifurcated premolar with a dowel in the palatal root (b). A 5 mm probing defect was noted in midbuccal area and the probing was between normal limits in all the other aspects. Upon reflecting the periodontal flap (c), a typical dehiscence for a vertical root fracture in an endodontically treated tooth was seen. The dehiscence was limited to mainly the coronal area of the root which corresponds with the graphic illustration (a). The fracture and the dehiscence were noted early enough so there is still interproximal bone that will enhance the prognosis of the future implant

- Class Ia: affecting only the most coronal third of the alveolar bone surrounding the fractured root (Fig. 8.1a–c).
- Class Ib: including bony dehiscence in which the defect involves the coronal and middle third of the root without affecting the apical third (Fig. 8.2a–c)
- Subclasses (a-c) represent the evolution from an incomplete fracture affecting only the coronal portion of the root (Class Ia) to a fracture extending to the middle portion (Class Ib) and finally encompassing the apical third of the root (Class Ic) (Fig. 8.3a–c).

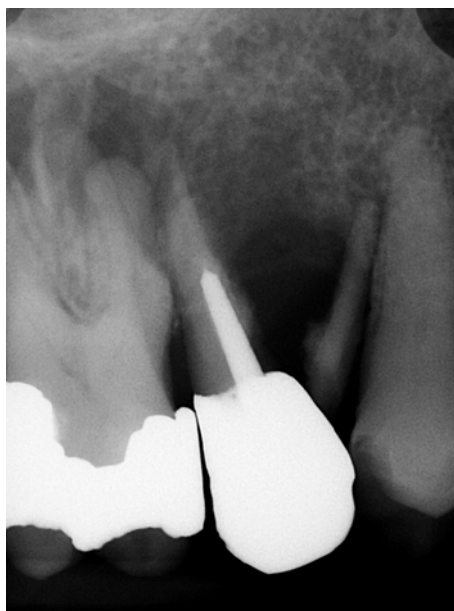
Fig. 9.1 An upper premolar with a vertical root fracture. The apical part of the root filling is not apparent. A potential medicolegal case will be based on the evaluation of the clinical procedures carried out (Courtesy DDS Vibe Rud)

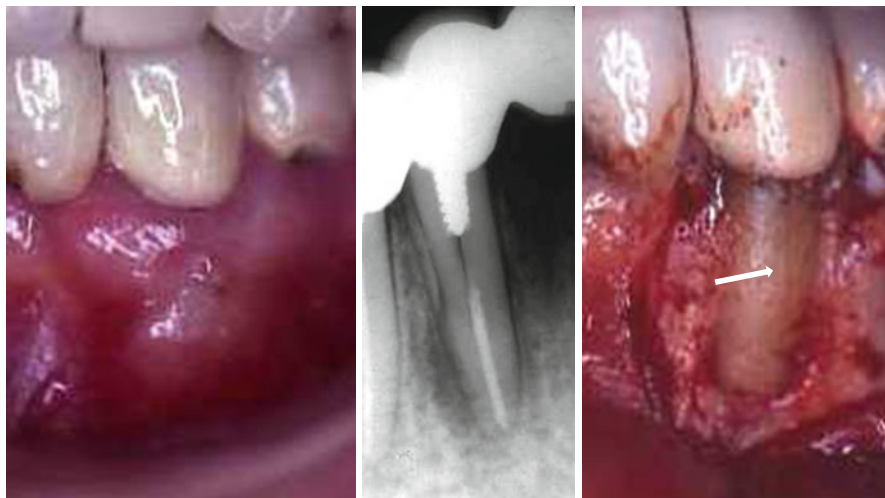
Fig. 9.2 An example of a VRF of a canine involved in a bridge construction. The pin of the post is too short and the post space preparation sub-optimal; consequently, this region has been deteriorated. It is not possible to reestablish the tooth by an endodontic retreatment. Along the buccal surface of the root, the VRF is apparent (*white arrow*). An injury as shown would in the Nordic model be categorized as a type 3 case. This is based on the expectation that another specialist would have prepared a sufficient post space in order to avoid a suboptimal load on the canine

Ad 3. For example, the injury is caused by an inadequate post space preparation (Fig. 9.2).
