Leif K. Bakland and Aviad Tamse

## Abstract

## Dental Fractures

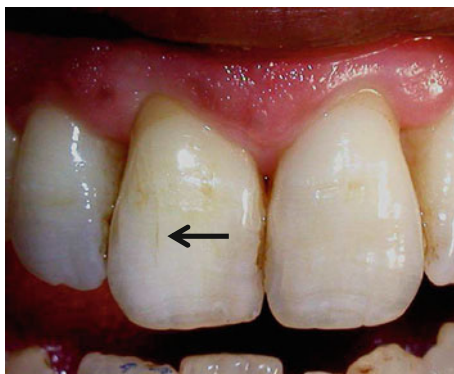
**Fig. 2.2** A *black arrow* pointing at a craze line in a maxillary incisor

Craze lines are fractures limited to the enamel only and may extend over the marginal ridges (Fig. 2.1) in molars and occur in the anterior segments as well (Fig. 2.2) [3]. They are considered benign and require no treatment except occasionally for esthetic reasons.

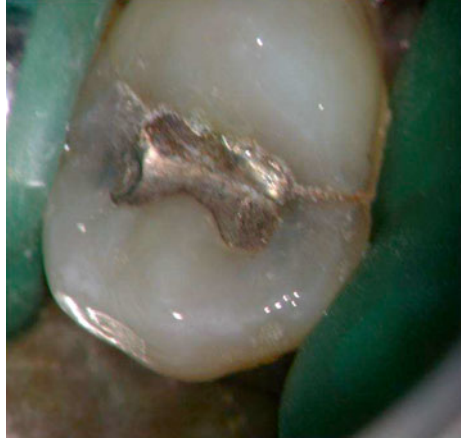
**Fig. 2.4** A diagnosis of symptomatic irreversible pulpitis was done in a patient with a class I amalgam restoration in a maxillary premolar. With the use of magnification and illumination, two fractures can be seen extending mesially and distally from the amalgam restoration

Some crown-originating fractures (COFs) have been identified as *cracked teeth* [1]; they are found in maxillary and mandibular molars and maxillary premolars. These fractures occur mostly in teeth with vital pulps and have a mesiodistal pattern. They can be observed in intact crowns or may be seen next to a carious lesion or adjacent to a small restoration. The fracture in the crown can at times extend apically to eventually separate the tooth into two parts (*split tooth*) [3] (Figs. 2.3, 2.4, 2.5, 2.6, 2.7, 2.8, and 2.9).

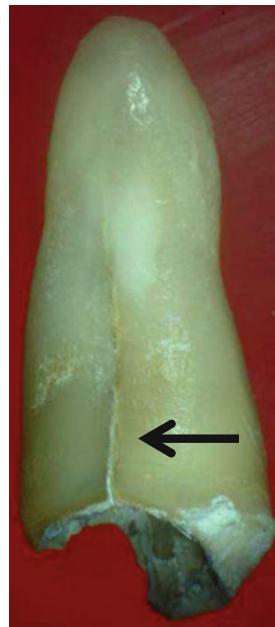
**Fig. 2.8** An extracted maxillary premolar showing a VRF that originated in the crown and propagated apically (*Black arrow*)

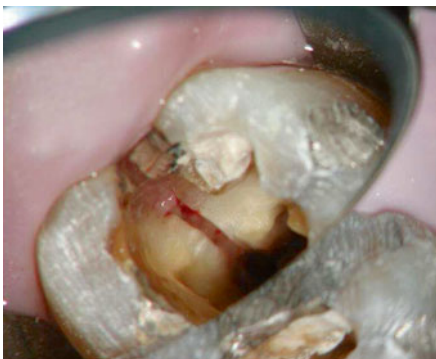
**Fig. 2.9** A fracture in the crown that extended apically to bifurcation area to separate a mandibular molar into two parts (Courtesy Dr. R. Paul)

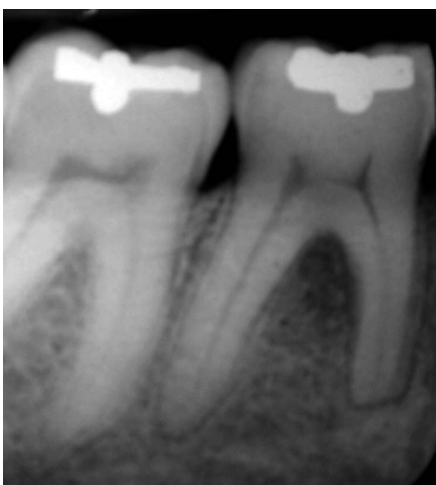
**Fig. 2.10** This radiograph was taken during routine patient examination. The tooth was asymptomatic. A shallow c I I intact amalgam restoration was noted in the crown. A small fracture was seen in the occlusal surface of the crown. The pulp tested nonvital. It caused necrosis of the pulp and as a result damage to the hard tissues. External apical resorption can be seen in the mesial root and bifurcation radiolucency (Fracture Necrosis) (Courtesy Dr R. Paul)

Some patients do present with existing pulp necrosis with or without periapical disease as a result of long-term COF. The term *fracture necrosis* has been suggested for such an entity [8] (Figs. 2.10 and 2.11).

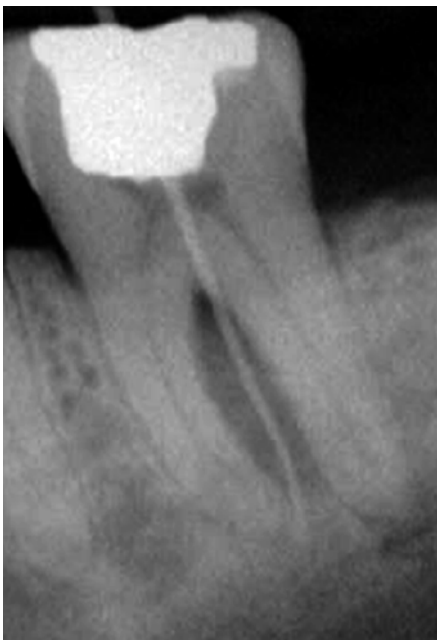
**Fig. 2.11** A patient presented to the dental office with a complaint of “suppuration of pus from the gum.” Clinical examination presented with a deep c1 1 amalgam restoration. The pulp tested nonvital, and a sinus tract was presented at the level of the apical part of the attached gingivae. A gutta-percha tracing can be seen in the radiograph all the way to the tip of the mesial root. Radiolucency between the roots can also be noted (Fracture Necrosis)

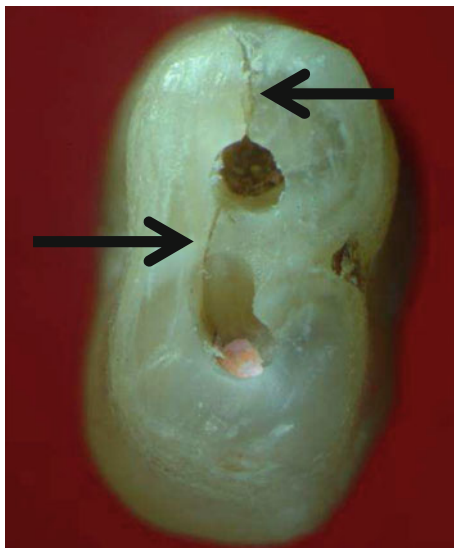
**Fig. 2.12** Two black arrows are pointing at an incomplete VRF in double-canal single-rooted maxillary premolar. The fracture is not extending to the other root surface

A VRF can originate at any level in the root [3] although it appears that they commonly begin in the apical part. If they originate away from the apex, such as in the middle of the root, they can propagate in either direction, either apical or coronal. From the horizontal aspect, the fractures originate in the root canal wall and extend to the root surface over time and may involve either one side—buccal or lingual (incomplete)—or both sides (complete fracture) (Figs. 2.12, 2.13, and 2.14).

The teeth and roots most susceptible to VRF are those in which their mesiodistal diameter in cross section is narrow compared to the buccolingual dimension (oval, hourglass shaped, kidney shaped, ribbon shaped). Such teeth and roots are the maxillary and mandibular premolars (Figs. 2.12, 2.13, 2.14, and 2.15), the mesiobuccal root of mandibular molars (Figs. 2.16, 2.17, 2.18, and 2.19), the mandibular anterior teeth (Figs. 2.20 and 2.21a, b), and mesiobuccal roots of the maxillary molars (Fig. 2.17) (See also Chap. 3) [18].

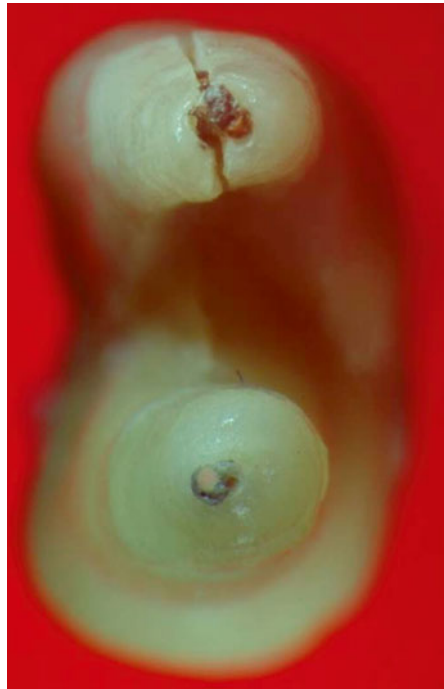
**Fig. 2.13** A complete VRF in a buccal root of a bifurcated maxillary premolar

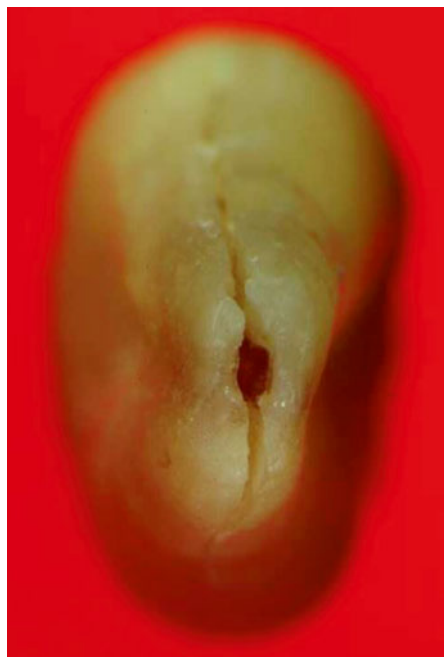
**Fig. 2.14** An apical view in a complete VRF in a maxillary premolar. Note the typical “hourglass” morphology of these teeth in cross section and the typical mesial concavity in the trunk of the root

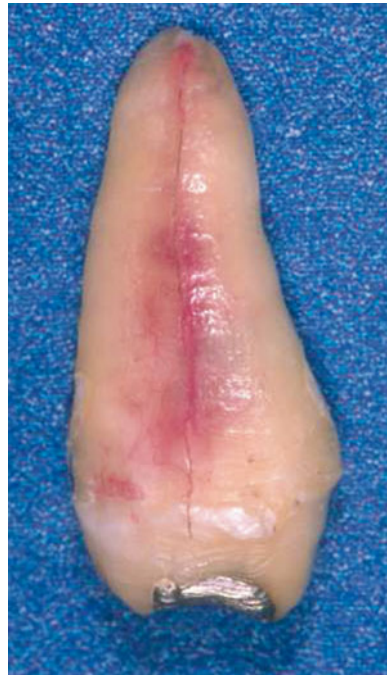
**Fig. 2.15** A rare mesiodistal oriented VRF from the tip of the root extending to the crown of a maxillary premolar. The coronal restoration was removed for better visualization

Both in the incomplete and complete fractures, for the most part the fractures have a buccolingual pattern. Very rarely does a VRF have a mesiodistal orientation (Fig. 2.15).

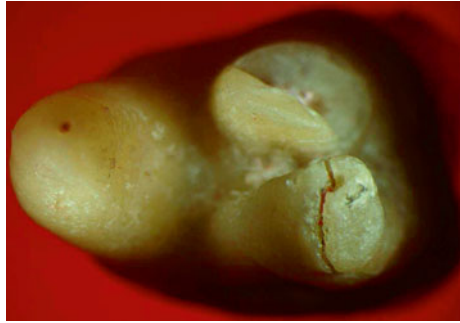
**Fig. 2.17** VRFs in the two buccal roots of a maxillary first molar

(Fig. 2.17) can also be seen. Although VRFs for the most part are longitudinal, they do not always follow the root axis but may progress differently based on the bulkiness of the root and the influence of occlusal forces (Figs. 2.16, 2.18 and 2.19).

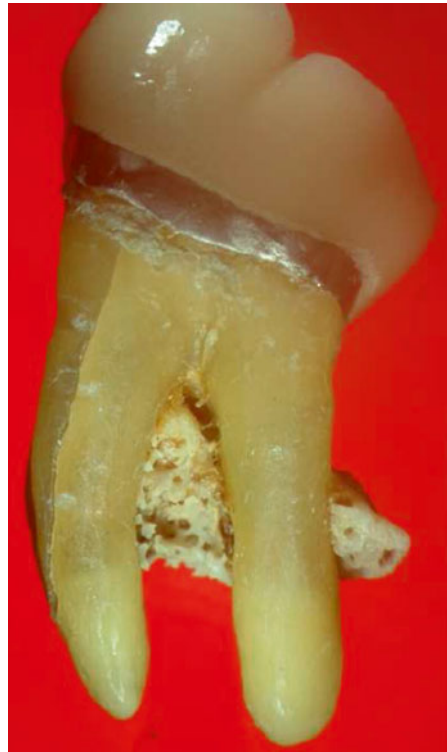
**Fig. 2.18** VRF in the mesial root is extending from the external lateral aspect of the root 5 mm coronally to the root tip to the coronal part of the root

In cases 2.16, 2.18 and 2.19 that where the teeth were extracted with their crowns, it is difficult to determine the origin of the fractures. It is possible that the fractures originated in the crowns and progressed apically (crown originating fracture—category 1) or originated in the roots and progressed to the cemento enamel junction.

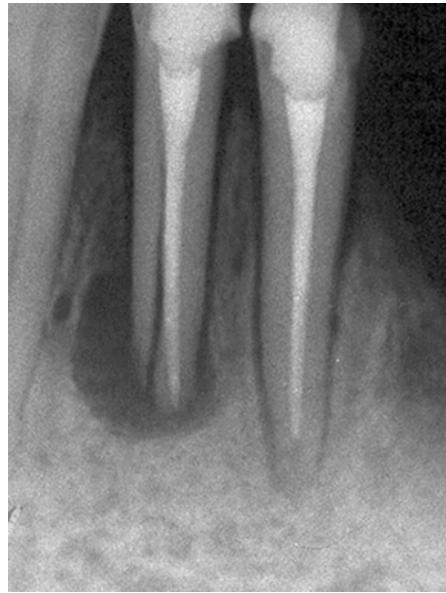
**Fig. 2.20** Vertical root fracture can be seen clearly as a radiolucent line parallel to the gutta-percha in an endodontically treated central incisor

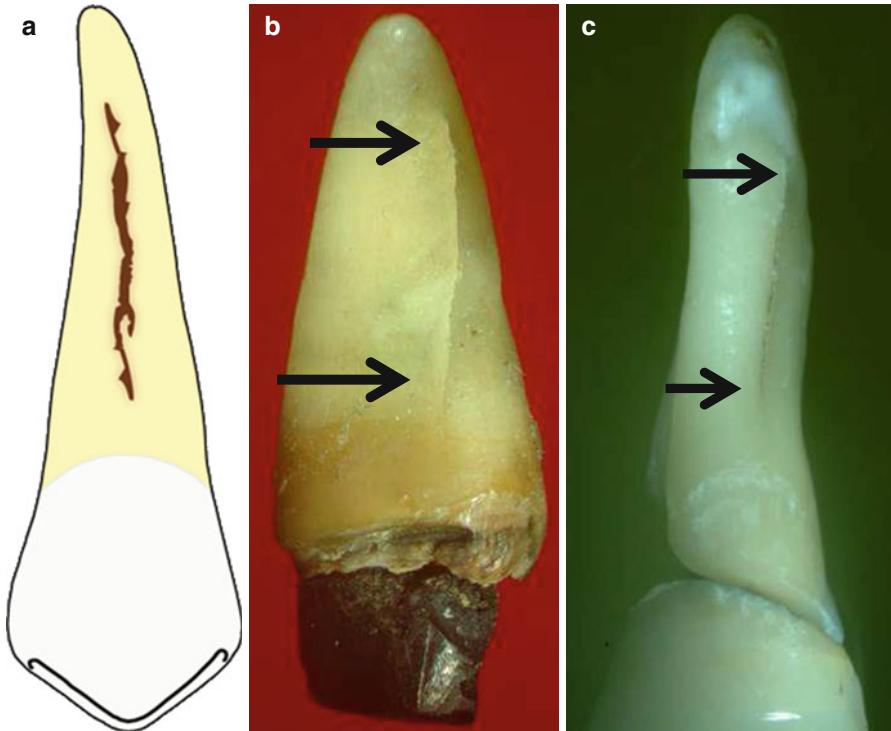
Fig. 2.25 (a–c) VRF in the middle part of the root of maxillary premolars which is not involving the coronal or apical parts (a) Graphic illustration, (b, c) examples in extracted maxillary premolars with VRFs (arrows)

From the apical–coronal aspect, the fracture can be limited to the apical area only (Fig. 2.22a, b), limited to the coronal part (Fig. 2.23a, b), both coronal and middle parts (Fig. 2.24a–g), limited only to the middle part of the root (Fig. 2.25a–c), or involving both the middle and apical parts (Fig. 2.26a, b). Often when a VRF diagnosis of an endodontically treated root is made, all the three thirds of the root are involved, i.e., from the tip of the root to the cervical part of the crown, and the fracture is complete from the buccal to the lingual sides. Examples are shown in the premolar teeth (Fig. 2.27a–d) and the mandibular molars (Figs. 2.28a–e and 2.29a, b).

Occasionally, a VRF is confined to the middle part of the root only and not involving the coronal or apical parts (Fig. 2.25). When a tooth with VRF is extracted and a full-length fracture is present, i.e., from the apex to the cementodentinal junction (Figs. 2.19, 2.27, 2.28 and 2.29), it is not possible to determine if the VRF originated in the coronal part of the root or even from the crown itself and progressed

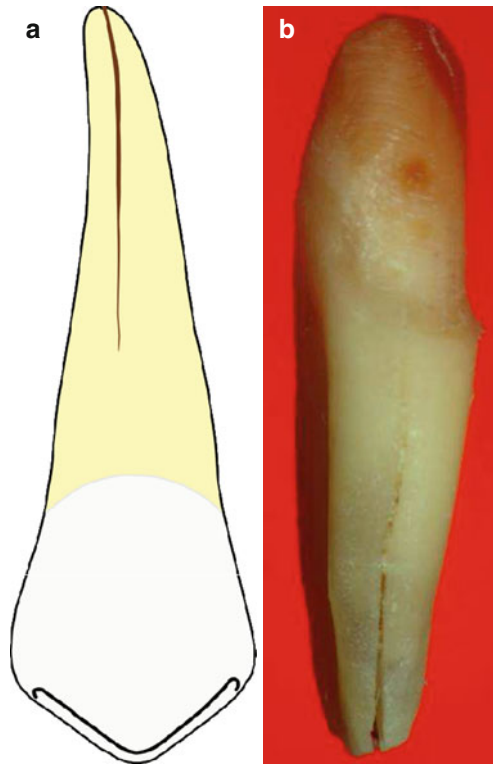
**Fig. 2.26** (a, b) Graphic illustration of a VRF limited to the apical and middle parts of the root not involving the coronal one. (a) Extracted bifurcated maxillary premolar in which the apical and middle parts are fractured leaving the coronal part intact (b)

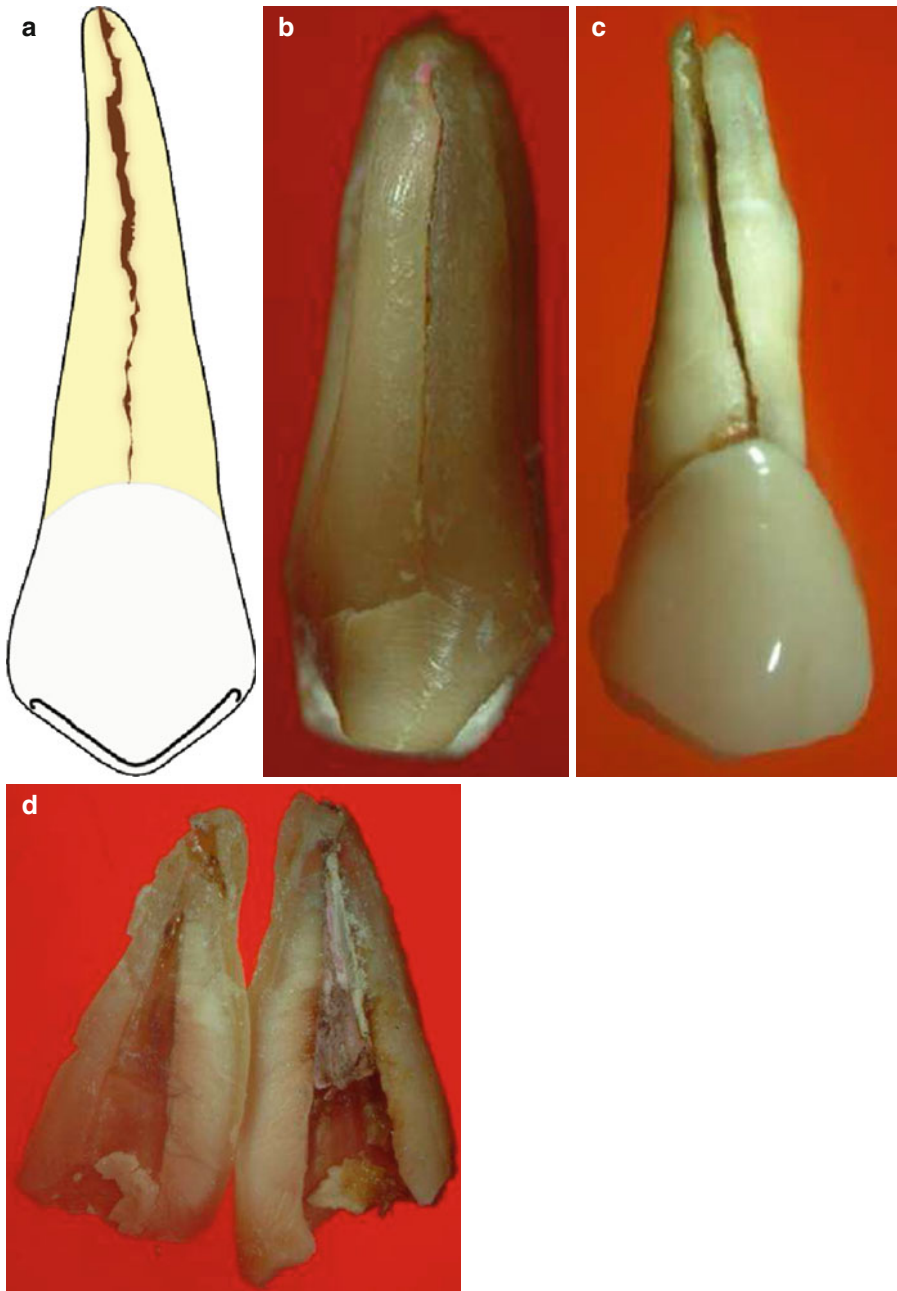
**Fig. 2.27** (a–d) Graphic illustration of VRF that involves the three parts of the root (a) VRF in all the three parts of an extracted maxillary premolar tooth (b) The two parts of the fracture were not separated when extracted. Another extracted maxillary premolar where the parts are separated (c) showing the very typical buccal–lingual fracture of the root (d)

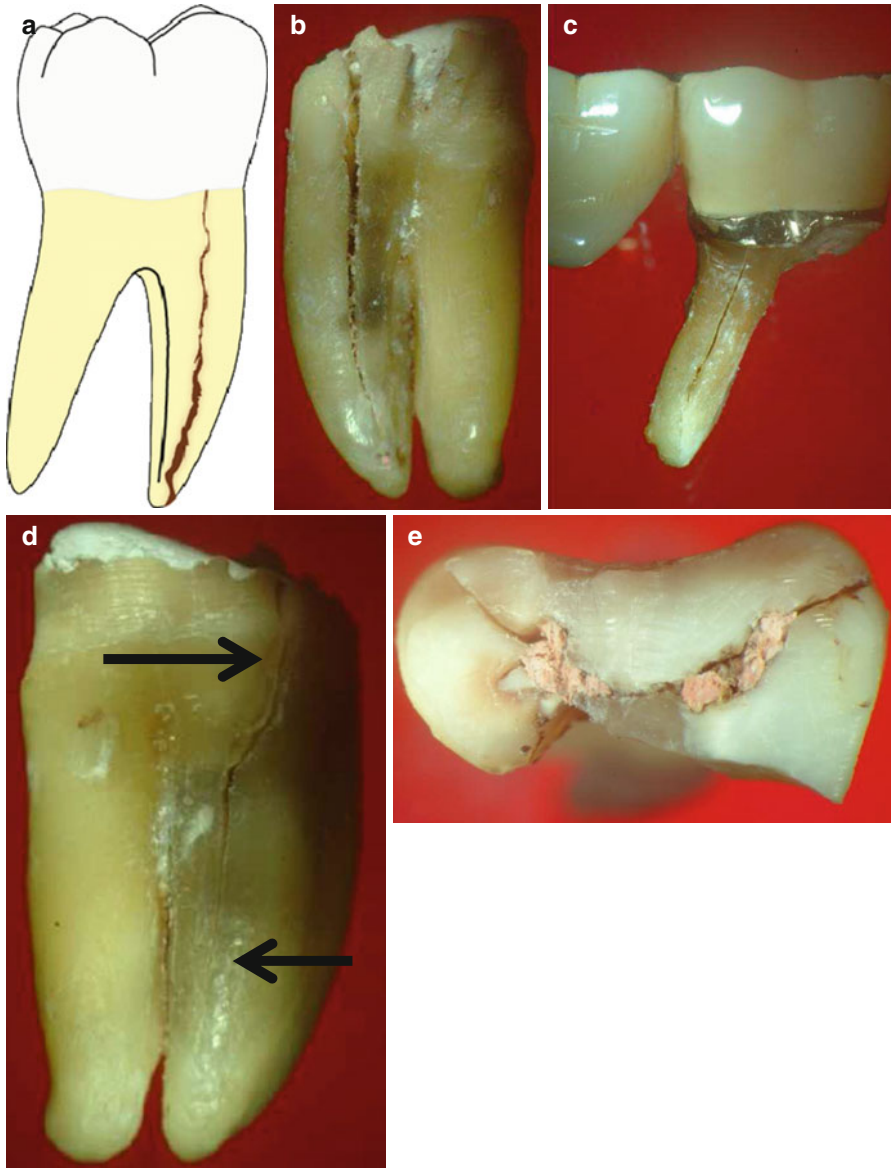
**Fig. 2.28** (a–d) Graphic illustration of a typical VRF involving the three thirds of an endodontically treated mesial root of a mandibular molar (a). A complete fracture in the mesial root of a mandibular molar that follows a straight axis from the tip of the root to the crown (b). A straight line VRF that involves the three parts of the root (c). Note that in figure (d) of another VRF case in a mandibular molar, most likely the fracture was initiated in the crown mesiodistally (crown-originated fracture—*top black arrow*) and propagated from the mesial aspect of the crown, turning diagonally and apically to form a buccal–lingual fracture which is typical for a VRF (*Bottom Black arrow*). A complete VRF in a cross section (e) of endodontically treated mesial root of a mandibular molar. The complete fracture involved the two root canals in the root and most likely through the isthmus between the canals

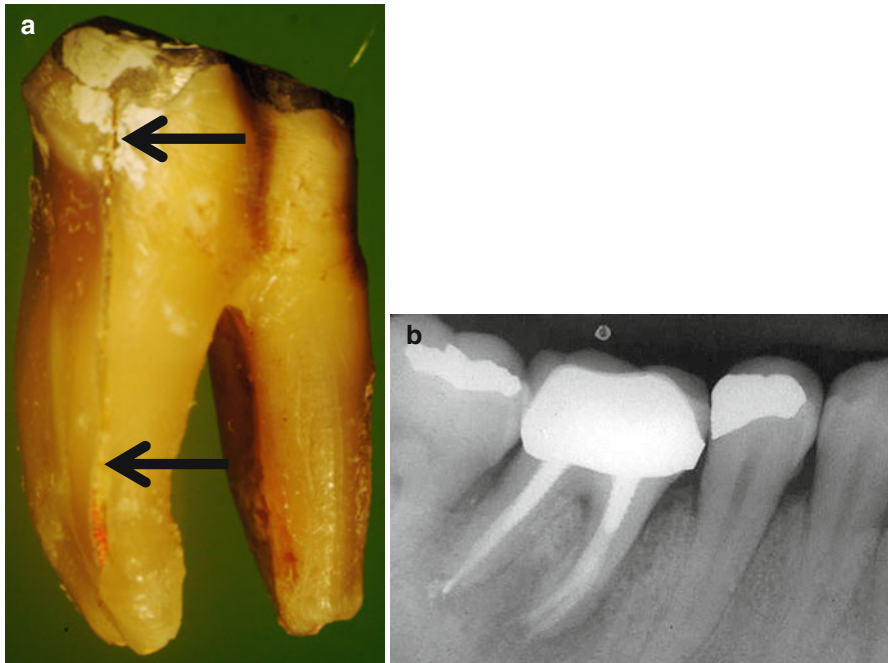
**Fig. 2.29** (a, b) The patient presented to the dental office with a history of acute exacerbation in the right side of the mandible. Three years earlier, the root canal treatment was retreated and a new PFM crown placed. On clinical examination, there was redness at the attached mucosa adjacent to the mandibular first molar, sensitivity to percussion, and 8 mm probing defect at the MB site. The periapical radiograph (b) revealed well-obtimated root canals and two dowels in the mesial and distal roots. Large “halo”-type radiolucency combined with a lateral one on the mesial aspect of the mesial root can be seen in the radiograph. Although the radiographic appearance and the probing hinted that there may be a VRF in this case, the diagnosis that was done was symptomatic apical periodontitis. The tooth was extracted because the prognosis for a new retreatment was poor. The extracted tooth (a) shows a VRF in the mesial root (arrows) that extends from the coronal area to the apical third of the root and a vertical root fracture in the bifurcation aspect (mesial) in the distal root as well. Most likely, this is a case of crown-originated fracture that progressed to the two roots as well

pressure during occlusion. Indeed, many of the VRFs occur in root canal treated teeth [20] where extensive amounts of dentin are removed from the root canal wall. These contributing factors will be discussed in detail in Chap. 3 on VRF Etiology. An example of a crown-originated fracture that progressed to the roots to create vertical fractures in the roots as well is demonstrated in Fig. 2.29.
