Aviad Tamse

### Abstract

A variety of clinical cases of vertical root fractures (VRFs) in endodontically treated teeth will be presented in this chapter. The importance in achieving accurate VRF diagnosis will be emphasized with figures and legends, and the clinical difficulties will be highlighted. The more typical cases will be presented, together with those in which the accurate VRF diagnosis was difficult to achieve. The importance of accumulating the most relevant information from the history of the involved tooth with meticulous clinical examination is shown in these clinical VRF cases.

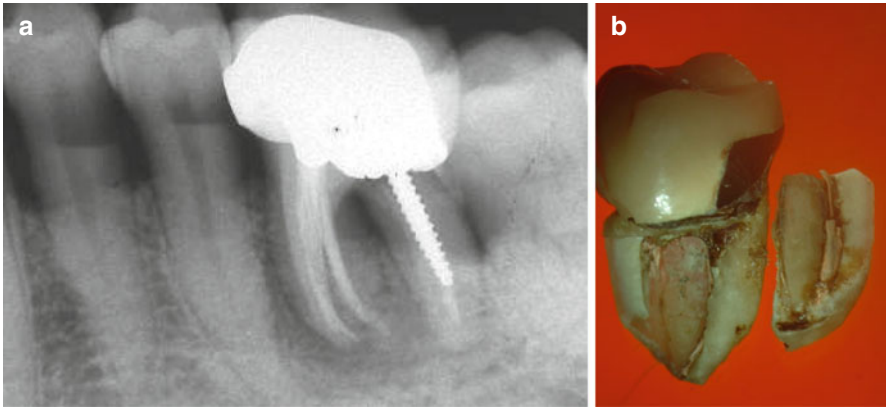
**Fig. 5.1** (a, b) The patient arrived at the dental office with a chief complaint of recurrent abscesses in the past year. The left mandibular molar was tender to percussion and palpation, and cl II mobility was also noted. An 8 mm probing defect was recorded in the mesiobuccal area and 5 mm in the midbuccal. The periapical radiograph (a) showed a previously treated mandibular molar, gutta-percha-filled root canals, a Dentatus dowel in the distal root, an amalgam dowel in the mesial, and full coverage with a crown. There was bone loss in the bifurcation and at the coronal half of the distal root. The mesial root was surrounded by a radiolucent lesion. A VRF was suspected and the tooth extracted. The typical buccolingual fracture can be seen in Fig. 5.1b

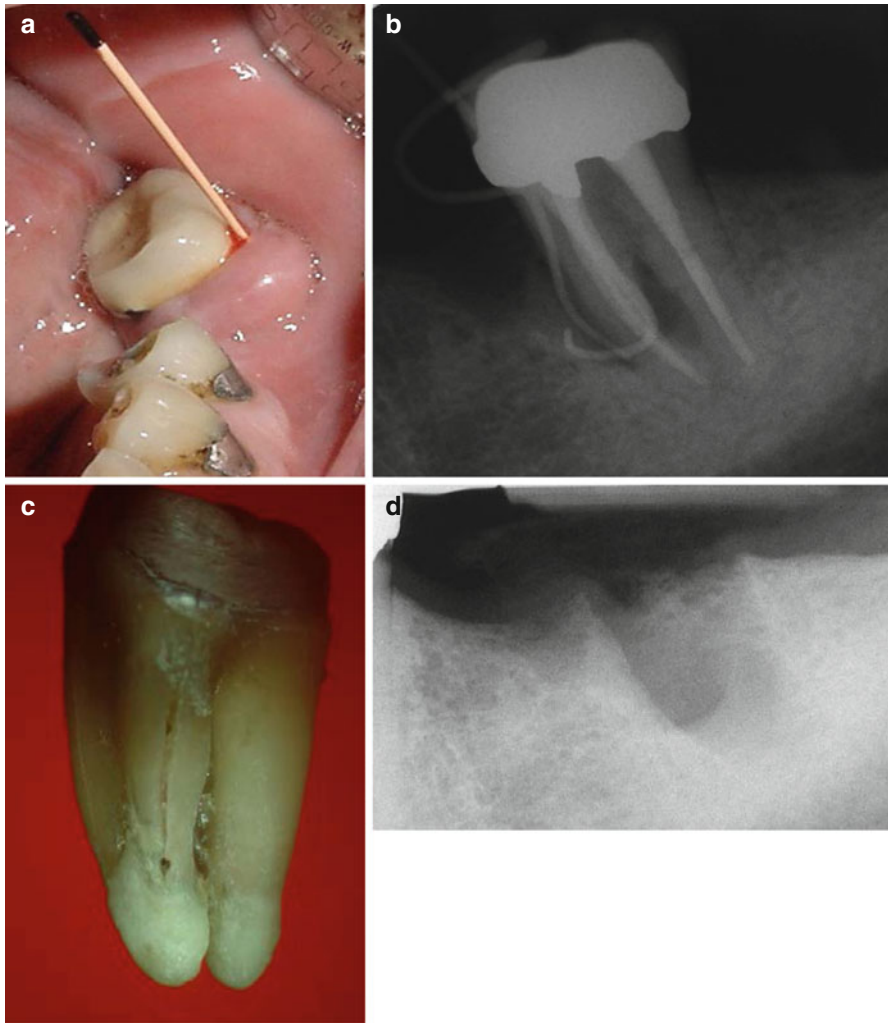
**Fig. 5.2** (a–d) The patient arrived at the dental office with “soreness on biting for the last couple of months and a swelling in the area about a year ago.” The first mandibular molar was extracted 5 years earlier but only the second molar endodontically treated, restored with amalgam dowels in the coronal 3 mm of the two roots and a crown (a). Clinical examination revealed sensitivity to percussion and two 8 mm probing defects both in the buccal and lingual aspects. The periapical radiograph (b) shows two gutta-percha tracing cones at the bone resorption area in the coronal two-thirds of the mesial root. A VRF diagnosis was made and the tooth extracted. In the extracted tooth (c), the fracture in the coronal two-thirds of the mesial root can be seen. A periapical radiograph of the extracted site (d) shows the amount of bone loss in the bone as a result of the continuous inflammatory process in the area (Courtesy Prof. J. Nissan)

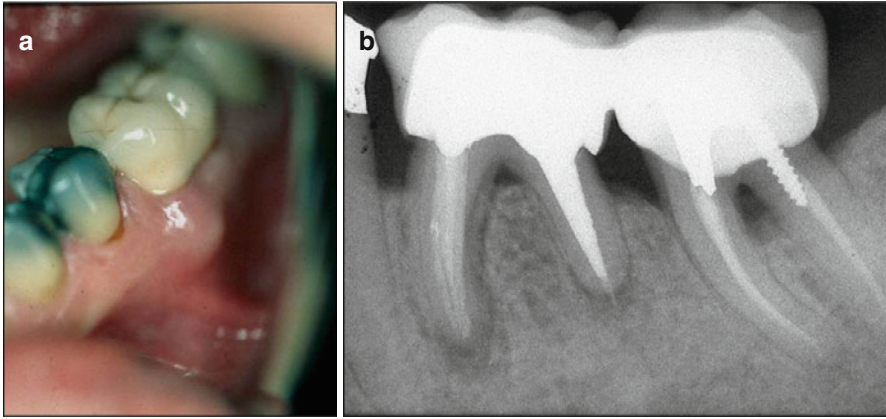
**Fig. 5.3** (a, b) A patient with severe periodontal problems who was evaluated for periodontal surgery arrived at the office with a small swelling adjacent to the mesial root area (a). The mandibular left first molar was endodontically treated 7 years previously and restored afterward. Probing depth around the tooth was 5 mm in the midbuccal and 4 mm in the mesiobuccal area. The radiographic appearance of the radiolucency around the mesial root which most likely was of an endodontic origin (b) and swelling in the gingivae adjacent to the mesial root pointed to a VRF. However, in this periodontally involved patient, the final diagnosis was an acute apical abscess (Courtesy Dr. J Halpern)

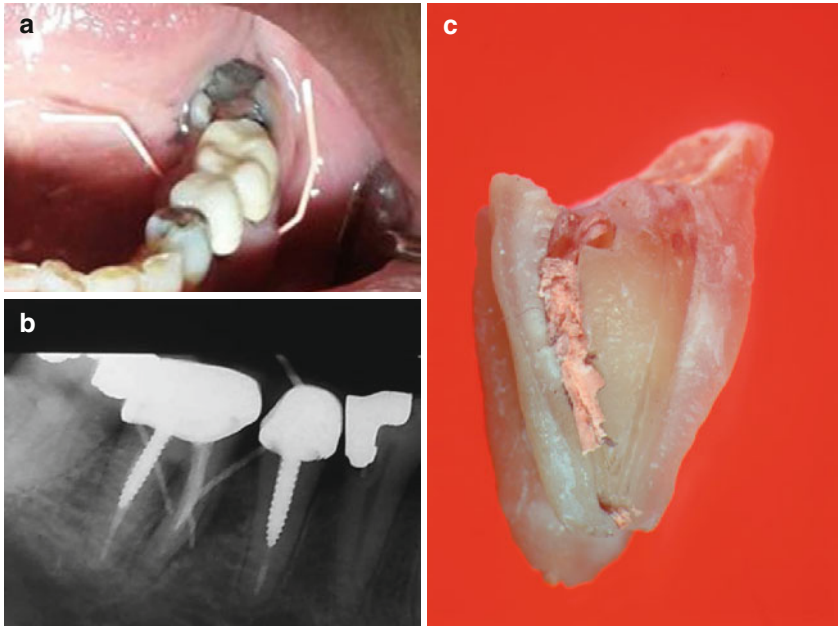
**Fig. 5.5** (a–c) The mesial root of the mandibular molar showing two gutta-percha tracings from the buccal and lingual sinus tracts (a). Radiograph (b) shows the wide lateral radiolucency on the mesial root aspect. Also, there is radiolucency in the bifurcation. After VRF diagnosis and extraction, the crown was removed, and one part of the mesial root can be seen with some of the gutta-percha filling (c) (Courtesy Dr. A. Aronovich)

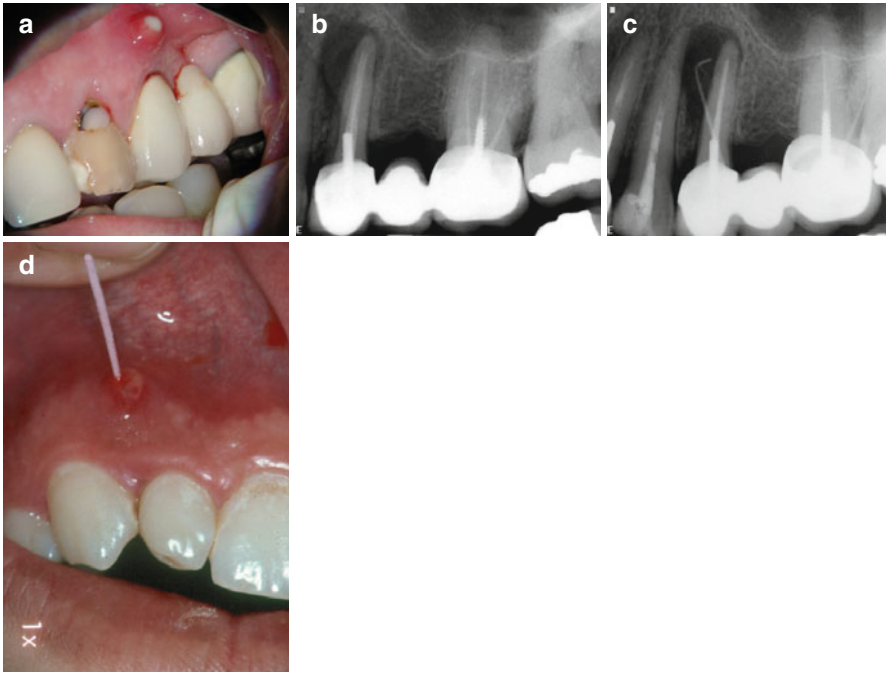
**Fig. 5.7 (a–d)** The patient arrived at the dental office with a chief complaint of “a lump in the gum that comes and goes.” Upon examination, a highly located sinus tract was noticed in the second premolar attached gingivae (a) with some pus extruding on slight pressure. A narrow 9 mm probing defect was noted in the buccal aspect and no probing noted in the palatal side. The periapical radiograph revealed that the tooth was used as a mesial abutment for a three-unit bridge and that both the second premolar and first molar were endodontically treated (b). A large “halo”-type radiolucency can be seen in the mesial root aspect extending from the root tip of the root laterally to the coronal part. A gutta-percha tracing through the sinus tract extends to this area (c). In patients with chronic apical abscess in non-VRF cases, the sinus tract is located in the gingivae much closer to the apical area (d). The patient had clinical signs and symptoms that are pathognomonic for the diagnosis of VRF (a–c) (Courtesy Dr. R. Paul)

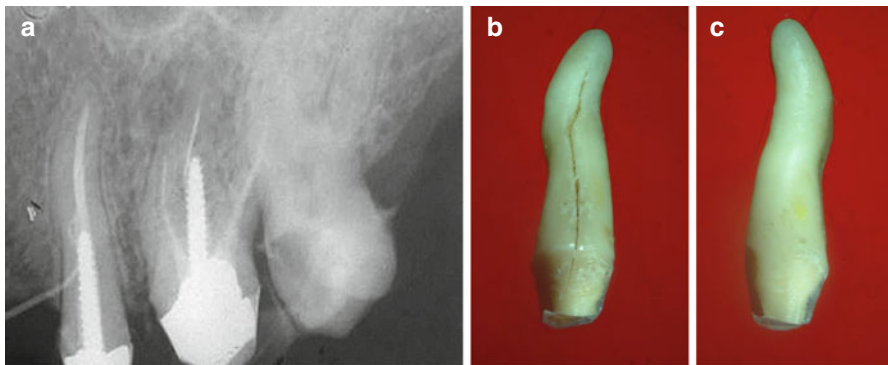
**Fig. 5.9** (a–c) The patient arrived at the dental office for a re-examination to replace two temporary crowns with permanent ones. Root canal treatment was performed 16 months earlier in a maxillary premolar, restored with a dowel and a temporary crown as well as in the maxillary molar. No radiolucencies in the bone surrounding the tooth could be detected in the radiograph (a). The patient initially declined to return to continue the restorative procedures. However, when he did return, there was a 9 mm probing defect in the midbuccal root and a highly located sinus tract. The gutta-percha tracing cone can be seen in the radiograph. The tooth was extracted. The incomplete VRF was found in the buccal side (b) but not in the lingual side (c)

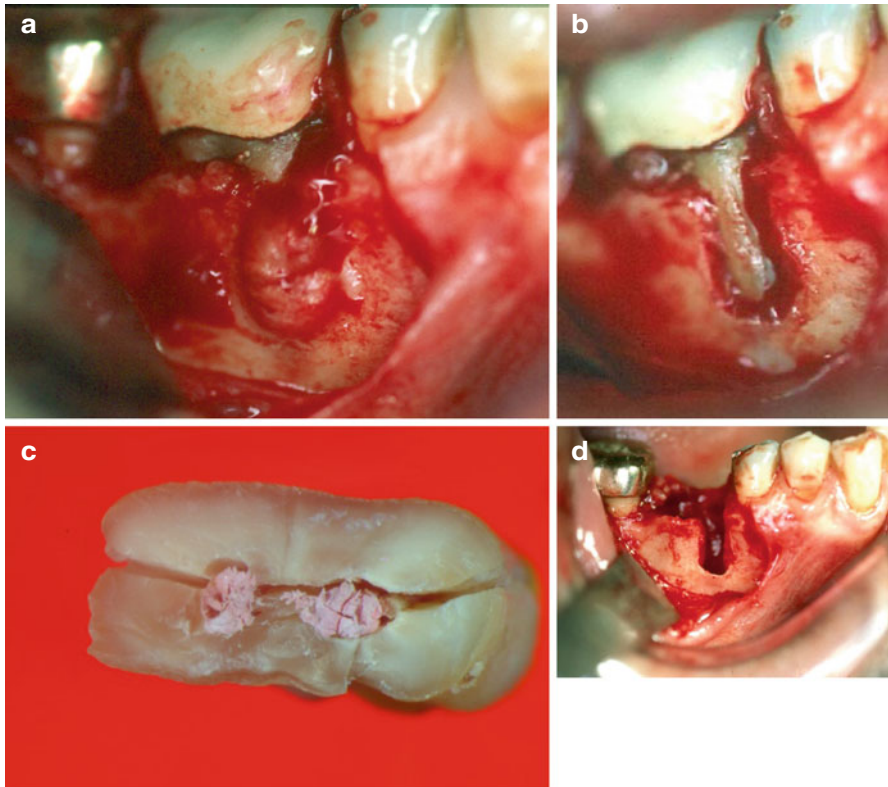
**Fig. 5.10 (a–d)** A large granulation tissue was seen when an exploratory flap procedure was performed to confirm a tentative diagnosis of a VRF in a mandibular first molar (a). After the granulation tissue was removed, a large dehiscence was seen in the buccal plate (b). Although the VRF was complete (all the way from buccal to lingual) (c), the large dehiscence was in the buccal plate as it was originally thinner than the lingual one (d)

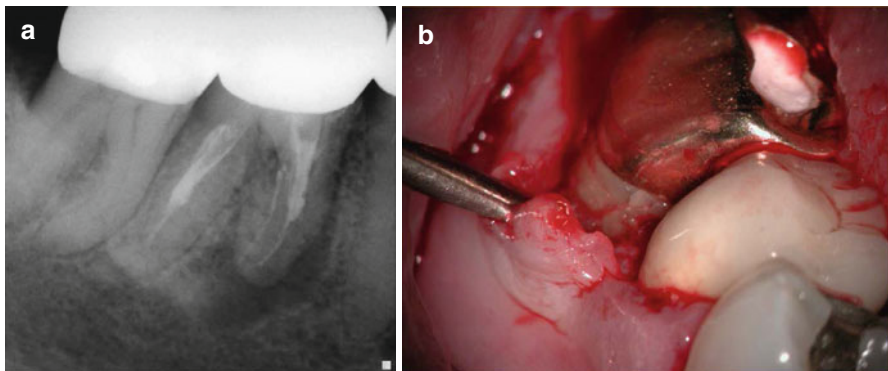
**Fig. 5.11 (a, b)** Mandibular first molar during retreatment. Following removal of the gutta-percha, calcium hydroxide was placed in the root canal. There was no probing; however, the “halo” radiolucency around the mesial root was suggestive for VRF (a). Upon probable flap reflection (b), the fracture can be seen in the mesial root (Courtesy Dr. R. Paul)

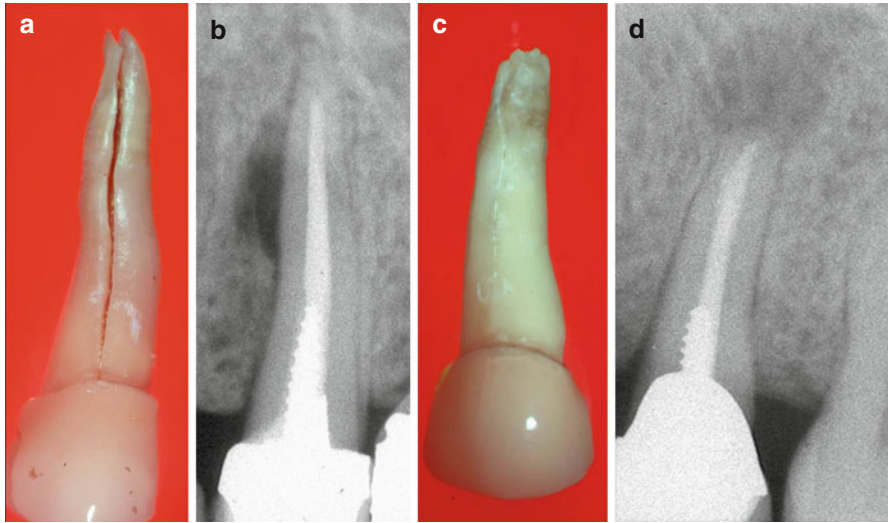
**Fig. 5.12** (a–d) Two longitudinal VRFs are presented. The segments are separated as in Fig. 5.12a, and the parts are still attached to each other in the other extracted tooth as in Fig. 5.12c. Although both VRFs are to the full length of the root, the radiolucency in the bone in case (a) is limited to the lateral part of the middle third of the root (b), and in the tooth (c), the radiolucency is limited to the periapical area (d), which is not typical to a vertically fractured tooth but rather to the failure of root canal treatment

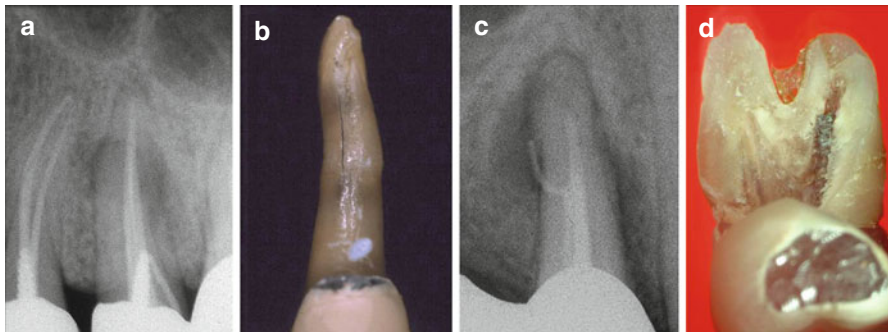
**Fig. 5.13** (a–d) Bony radiolucencies are seen in the mesial and distal lateral aspects of the middle third of the roots in two maxillary premolars (a, c). However, the types of fractures are different. In Fig. 5.13b, the fracture is limited to the middle third of the root, whereas in (d), the fracture is completely buccolingual

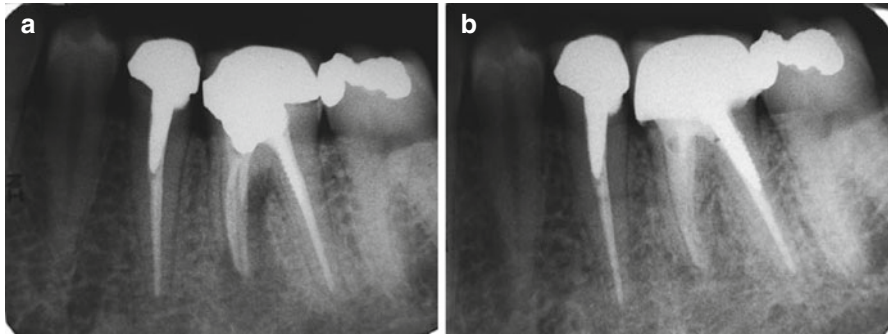
**Fig. 5.14** (a, b) The need for meticulous clinical examination to achieve accurate VRF diagnosis is emphasized in Figs. 5.14, 5.15, and 5.16. A periapical radiograph shows well-condensed gutta-percha filling in the mesial root of a mandibular molar, an amalgam dowel, and typical “halo” radiolucency around the mesial root combined with radiolucency in the bifurcation. Since there were no other signs or symptoms to make a VRF diagnosis, a diagnosis of asymptomatic apical periodontitis was made and the patient scheduled for retreatment (a). Complete healing of the radiolucency can be seen 1 year after retreatment (b) and a new restoration (Courtesy Dr. Z. Elkes)

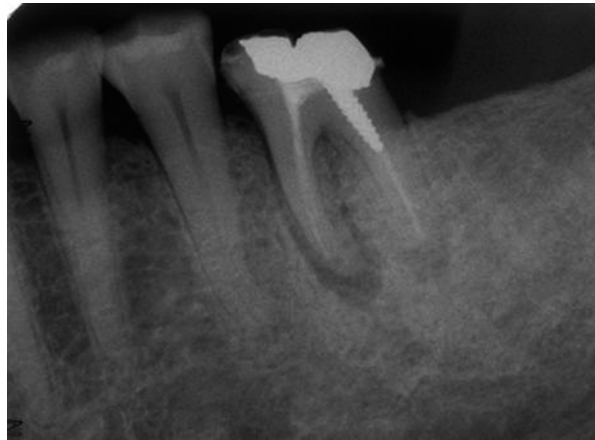
**Fig. 5.15** Typical bony appearance of a “halo” radiolucency in a poorly filled mandibular molar, combined with radiolucency in the bifurcation. Other signs and symptoms typical to a VRF tooth led to the accurate diagnosis of VRF (Courtesy Dr. T. Blazer)

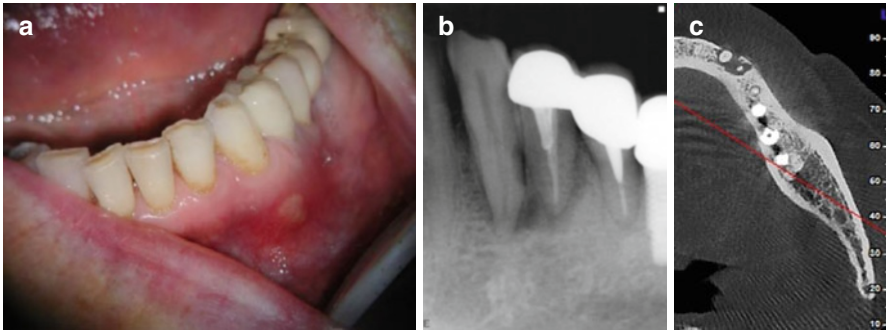
**Fig. 5.16 (a–c)** The patient arrived at the dental office for evaluation regarding tenderness on “touching the gum in the lower jaw.” Clinical examination (a) revealed two connected crowns in the first and second premolars next to implants in the posterior region. A highly located sinus tract was seen in the attached gingivae adjacent to the first premolar. The area was sensitive to palpation but no probing defect noted. The periapical radiograph (b) revealed a diffuse radiolucent bony lesion on the mesial and distal aspect of the root that was suspicious to be more typical to a VRF than of failure of root canal treatment. The canine tested vital. The large bony defect seen in the axial slices of the CBCT Scan (c) (this slice in the apical 2 mm) resulted in a diagnosis of chronic apical abscess, and the tooth was extracted. The extracted tooth did not reveal any fracture (Courtesy Dr. R. Paul)

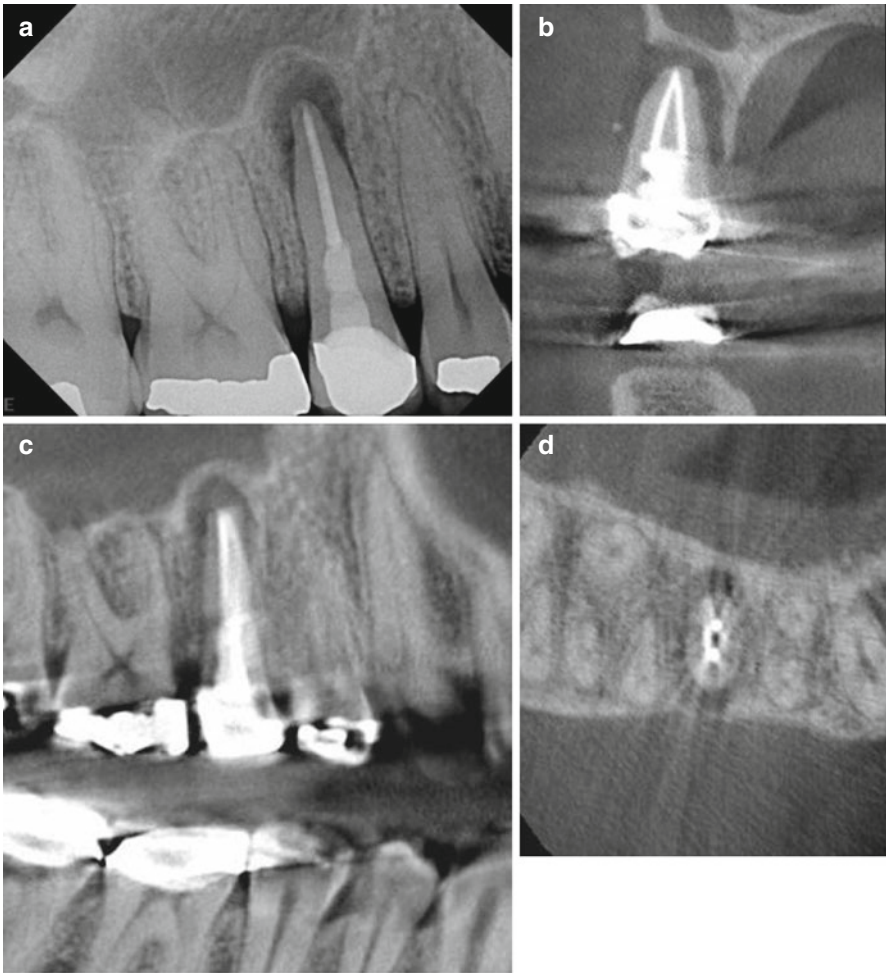
**Fig. 5.17** (a–d) A periapical radiograph of a VRF tooth in a maxillary second premolar (a). Note the typical “halo” radiolucency around the root. With CBCT imaging, the radiolucency around the root can be seen in the coronal (b), sagittal (c), and axial (d) images. What can be observed is the bone loss around the root but not the fracture itself (Courtesy Dr. R. Ganik)

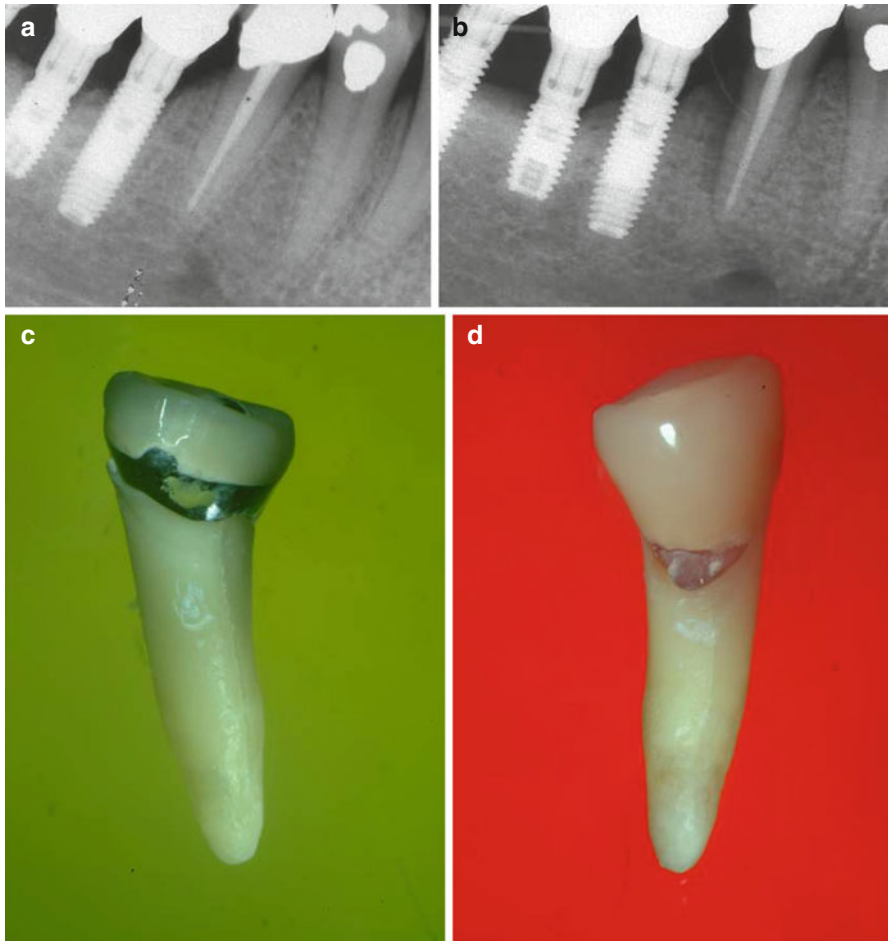
**Fig. 5.18** (a–d) Five years following root canal treatment as a result of symptomatic irreversible pulpitis in a mandibular premolar (a), signs and symptoms of a VRF in this tooth were diagnosed (b). A lateral radiolucency along the distal aspect of the root can be seen, together with a No. 20 gutta-percha tracer via a highly located sinus tract. The utmost importance of urgent tooth extraction was explained to the patient to prevent bone loss adjacent to the tooth, especially in such proximity to the implants (b). The extracted tooth shows a complete narrow fracture both at the lingual (c) and buccal (d) aspects of the tooth

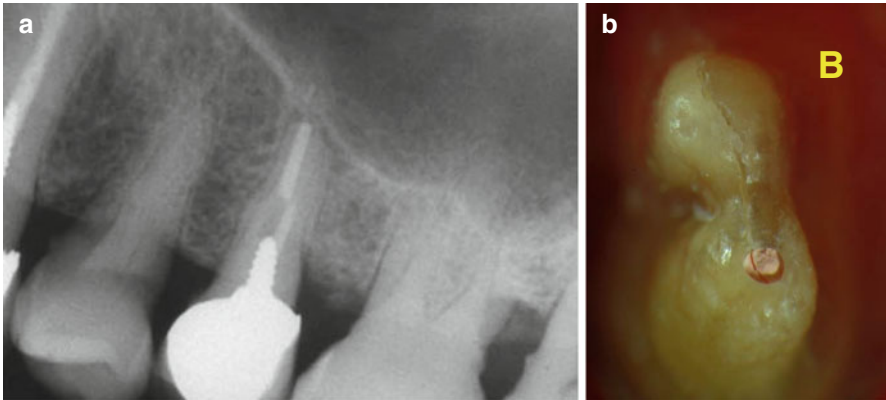
**Fig. 5.19** (a, b) The patient arrived at the dental office with a complaint about discomfort in “touching the tooth and when biting” and pointed to the maxillary second premolar. The tooth had been endodontically treated 4 years previously with gutta-percha, passive cementing of a serrated dowel in the palatal canal, and full coverage to the crown. Examination of the tooth revealed sensitivity to percussion and a 6 mm probing depth in the midbuccal area. The radiograph revealed two obturated canals and the dowel most likely placed in the palatal canal (a). A diagnosis of acute apical periodontitis was made. Since the endodontic prognosis for retreatment was poor, endodontic surgery procedure was suggested. The patient declined any surgery, and the tooth was extracted. Examination of the extracted tooth from the apices (b) shows the deep mesial concavity in the root trunk and the incomplete VRF from the buccal aspect toward the palatal area of the root

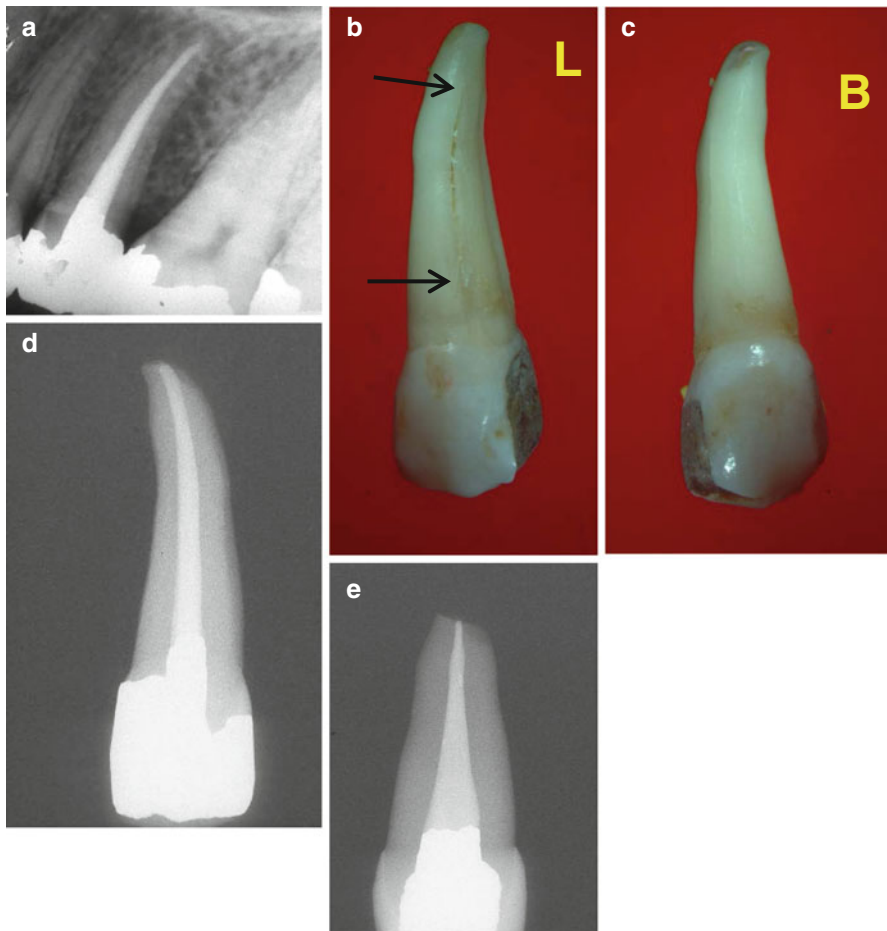
**Fig. 5.20** (a–e) Root canal therapy was performed on a maxillary second premolar as a result of chronic irreversible pulpitis. The root canal was obturated with laterally condensed gutta-percha (a). Shortly afterward and for several months, the patient complained of tenderness on biting. On clinical examination, the only sign noted was sensitivity to percussion. No probing, mobility, or bony radiolucency was noted even when the patient was examined 4 months post-op. The patient declined any further treatment, such as endodontic surgery. The tooth was extracted and cleaned. A VRF was found in the middle third of the palatal aspect of the root (*Arrows*) (b) but not in the buccal aspect (c). The well-obtained premolar can be seen in the bench periapical radiographs (d, e). This partial midroot palatal VRF could not be clinically diagnosed. This expresses the difficulties clinicians encounter in making accurate and timely VRF diagnosis (Courtesy Dr. Z. Elkes)

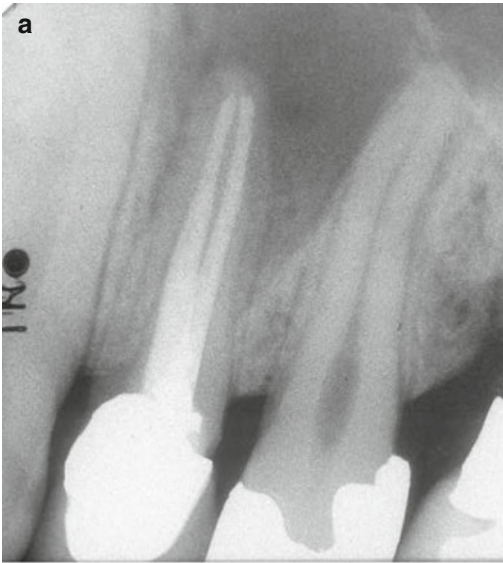
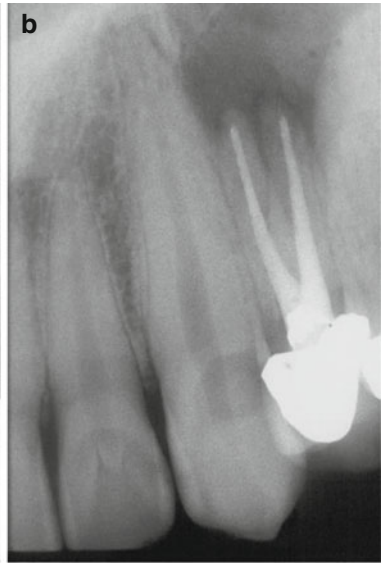
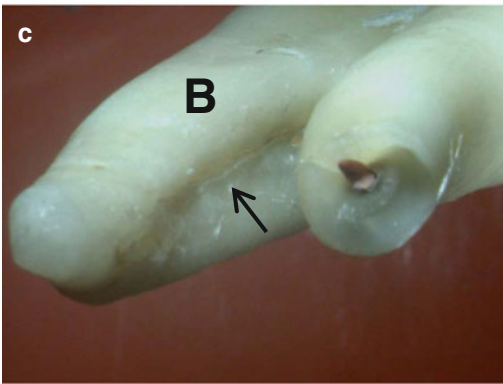
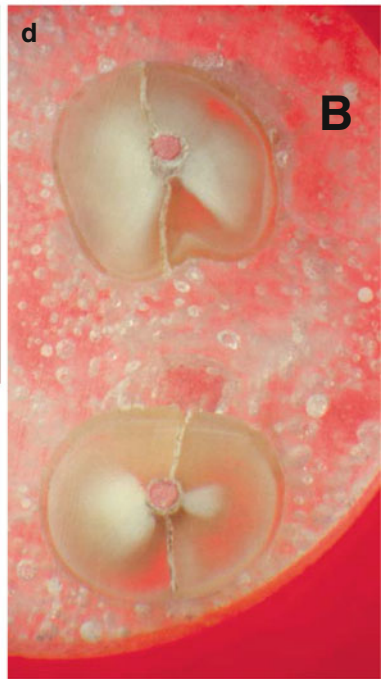
**Fig. 5.21 (a–d)** Patient history revealed that 5 years prior to arriving at the dental office, root canal therapy was performed on the maxillary first premolar with an amalgam dowel and PFM crown. The patient’s chief complaint was tenderness on biting and a “loose tooth.” The patient also experienced two episodes of swelling in the area over the past 3 years. Clinical examination revealed slight mobility, sensitivity to percussion, and a 7 mm probing defect on the midbuccal area. The first periapical radiograph revealed a well-obturator root canal and large “halo” radiolucency (**a**). An additional radiograph with a slight change in angulation showed (**b**) this tooth to be a bifurcated maxillary premolar. When a VRF is suspected it is highly recommended to take two periapical radiographs from different angulations. There was no sinus tract in the attached gingivae, and a definitive diagnosis of a VRF tooth could not be done. The patient declined a surgical flap procedure for final diagnosis and treatment. The tooth was extracted (**c**). The typical depression on the bifurcation aspect of the buccal root with the longitudinal fracture along the depression can be seen in this image following some shaving of the palatal root (*black arrow*). In one of the cross sections done (**d**), complete VRF from one side of the root to the other can be seen in both roots. The typical depression in the buccal root can also be seen
