How to Refurbish ‘80s *Brutalist Architecture*, Turning It into NZEB: The Case Study of the High School “Enrico Fermi” in Muro Lucano (Potenza, Italy)

Francesco Paolo R. Marino and Filiberto Lembo

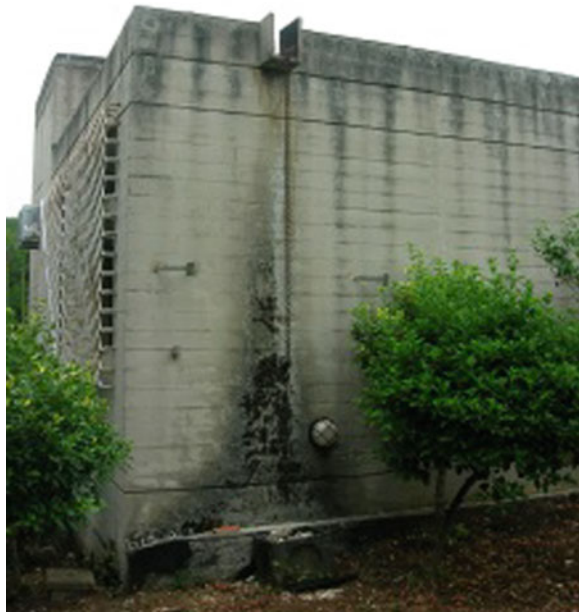
Photo 7 The dripping of water from the rainspouts

laboratory and in the classrooms IB, IIA and IIB; 1.07 in drawing laboratory; 1.48 in the computer lab and science-Great Hall, but, conversely, $\eta = 7.63$ in the atrium, 6.56 in the hallway, 5.27 in the living room of the guardian, 3.47 in the deposits of the gym and 4.03 in the classrooms on the first floor). In each device, such as covers, downspouts, window sills, the correct “rules of art” have been neglected. So, for example, it depends on not following correct “rules of art” the fact of forgetting to put a vapor barrier under slabs of the slopes in coverage ($U = 0.74 \text{ W/m}^2 \text{ K}$), so that those that appear as stains moisture from rain water in some places are also stains moisture from condensation; ensuring that, to the North, the building is black, becoming covered in mold corresponding to the areas where the water is concentrated and drip free from the rainspouts placed several meters in height (see Photo 7); making sure that the flat coverings become “lagoons” for the failure of the slopes or occlusion of the rainspouts

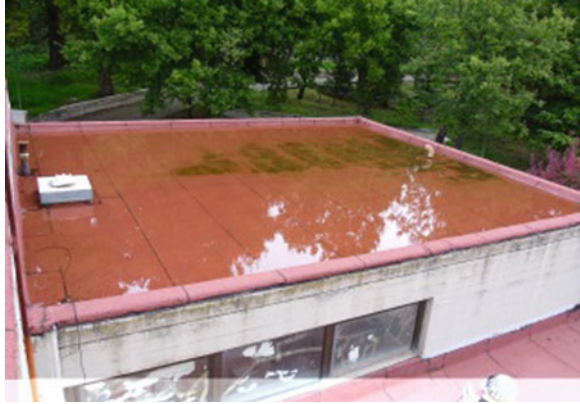
Photo 8 Water-logging on the caretaker's apartment

(see Photo 8); ensuring that the insufficient reinforcement concrete cover of the not-visible structures (bottom intrados of the floor, to the basement not used) compromises their stability so as to make it necessary for them to shoring (see Photo 9).

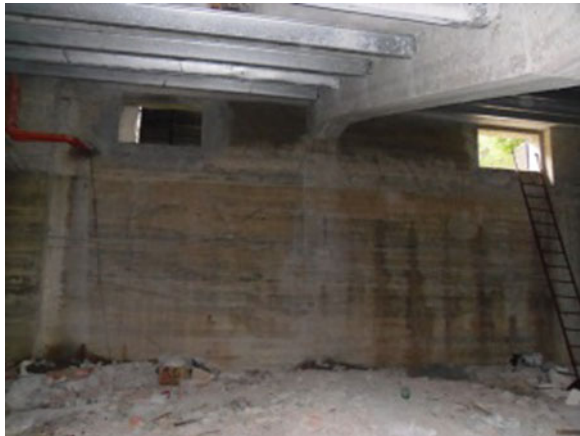
Photo 9 Slab propped up with steel beams

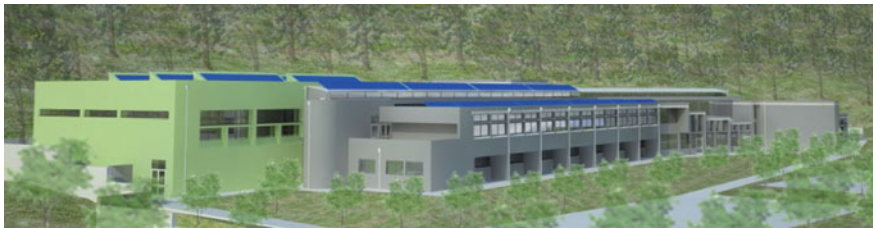
Fig. 4 Overall external view South-East side shows the different color finishes of the main building envelope and Gym, and the placement of photovoltaic panels on the roof of the sheds

exposed concrete deteriorated for carbonation, through the application of a comprehensive care cycle *Sto Cretec* type. The use of parts of the ground excavated, but not used, on the front of the North, was then expected: the places were lit and, for the purposes of fire safety, made accessible through the implementation of an overdraft basement corridor, 2.60 m wide and with two emergency staircases. The destination of these spaces is of Chemistry and Physics laboratories, with its stores, changing rooms and toilets. Their natural lighting, and that of many other parts of the building, including the Great Hall, has been optimized through the provision of *solar tubes*, starting from the coverage of the floor above (see Figs. 2 and 3). The Gym and drawing and computer laboratories located above those already mentioned, were instead provided with sheds, and arranged with openings windows facing north and with the roof surface covered with photovoltaic panels (see Fig. 4).

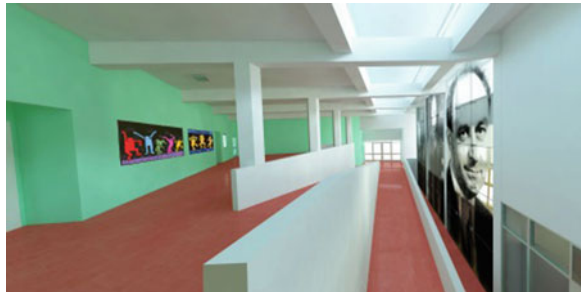
Fig. 5 Overall internal view of the atrium with acoustic panels steel coated

The problem of noise and excessive reverberation time in the hall/library/hallway is solved through the division of the space of the library from the atrium and the corridor through a structural glass, screen-printed with photos of Enrico Fermi, which enables to maintain the visual unity of space, intervening only on the propagation of noise. This solution is here laid on the ceiling and on the walls: on the first, placing a new false ceiling in mineral wool panels 1.5 cm thick; on the latter, through counter-walls containing mineral wool panels 27 mm thick,

consisting of granulated recycled glass panels with surface coating of aluminium. In some places, the attachment of additional sound-absorbing panels is provided with screen prints of works by Keith Haring (see Fig. 5). A careful study of the colours makes the surfaces lively and interesting and better defines the geometry (see Fig. 6).

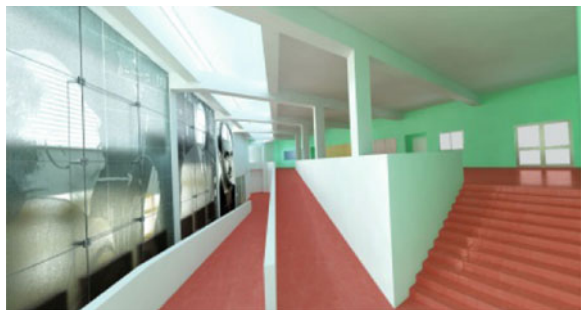
Fig. 6 Overall internal view of the atrium: it is evident the careful study of color which makes the surfaces lively and interesting and better defines the geometry
