Case 34: Spatial Frame Correction of an Infected Distal Metaphyseal Tibial Nonunion/Malunion

Daniel Schlatterer

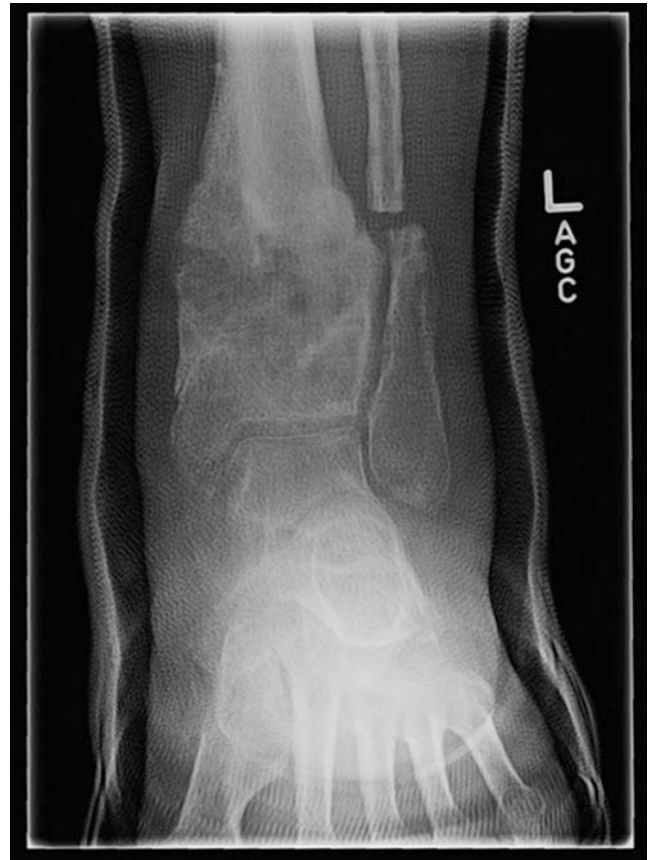
Fig. 5 Radiograph after 2 weeks of the frame off and patient in a short leg cast

The goal was to correct his deformity and avoid hardware placement after correction (Fig. 6a, b). In the office this patient tolerated removal of his frame at the 10 week mark (Fig. 4). He was placed into a short leg cast and obtained new radiographs to confirm no loss of correction. Repeat radiographs 2 weeks later revealed no loss of correction (Fig. 5). That same day in the office, the cast was changed to a walking boot. Further follow-up shows a negligible amount a correction loss. Deformity correction requires frequent office visits and radiographs to confirm the correction is progressing according to plan. This patient required a short course of antibiotics early on for pin site

erythema. Further pin care consisted of soaking the entire leg in a kitchen garbage can filled with warm water and two capfuls each of Clorox bleach and Epsom salt. Soakings lasted 20 min 2–3 times per week. Daily showering was encouraged. Taking measurements on follow-up radiographs in the office can be difficult due to fixator parts overlapping the deformity. This can be circumvented by adding a temporary method of fixation with a strut or threaded rod and removing a strut or two for imaging purposes. In this particular case the fibular osteotomy was always easily visible. The height or space of this osteotomy was routinely measured and offered an indirect indication of deformity correction. In fact, comparison of this space between images 3a, 5, and 6a shows the shortening of this height with the frame (Figs. 3a, 4, and 5) and then slight loss of the correction in the final radiograph (Fig. 6a).

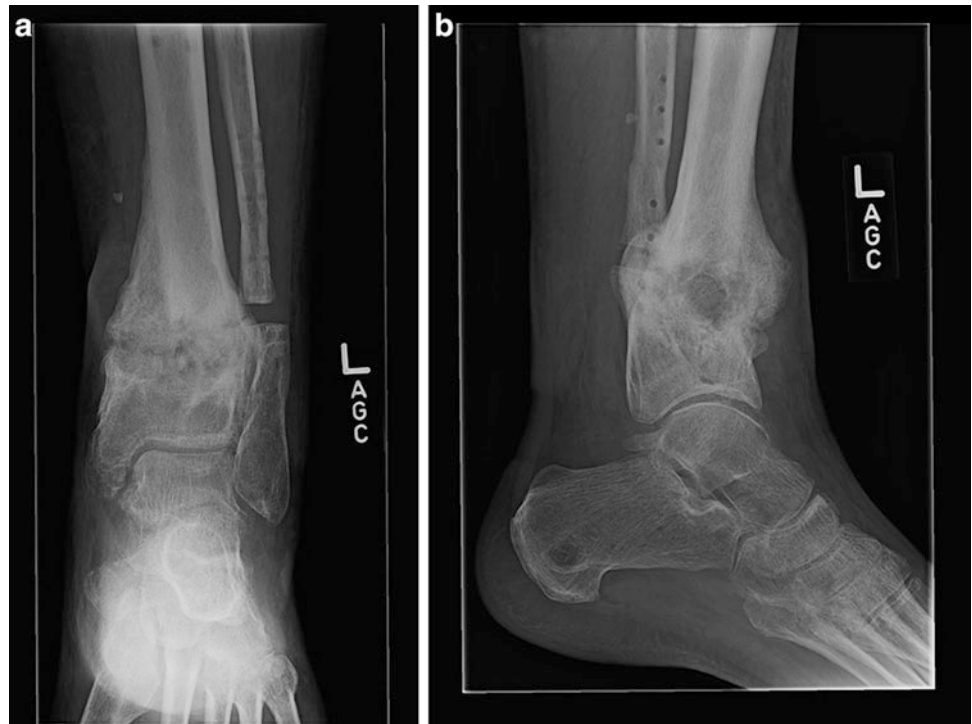
Fig. 6 (a, b) Final radiographs. Patient is back to full activities. The fibular osteotomy space has increased slightly from Figs. 4 and 5. A slight loss of correction occurred
