Comparative Study of Maintenance Vehicles Using Vibration Analysis

Abstract This article justifies the importance of vehicles maintenance throughout their entire running. According to this purpose, we have done a comparative study of vibrational behavior of two vehicles of the same type but different manufacturing years. For both cars, there were made experimental measurements of vibrations on the stand for three significant measurement points: the screw at the cover cleats, the bodywork, and the seat. The results are justified by the history of repairs and maintenance operations.

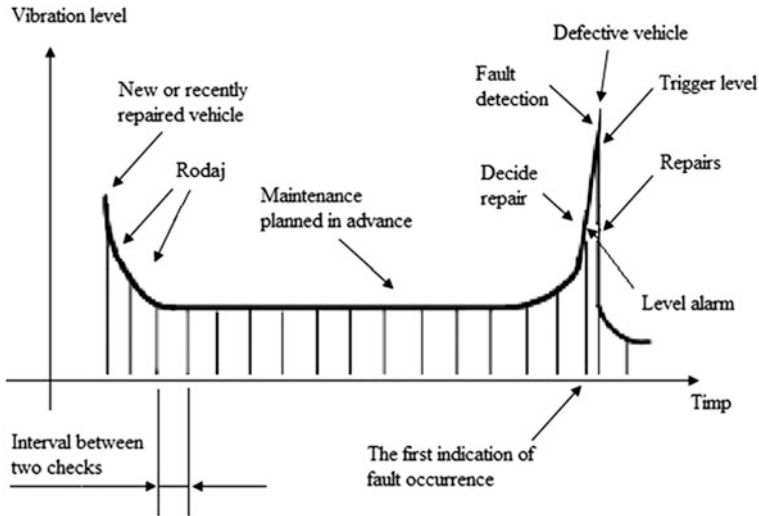
Fig. 1 Operating regime curve of a vehicles [2]

The maintenance of the transport means, especially motor vehicles, is represented by means of the operating regime curve (Fig. 1).

According to the curve shown in Fig. 1, maintenance actions are carried out at certain times and at certain values of vibration levels. It is observed that when the vehicle is new, it is normal to have high levels of vibration. During the period of running, this level decreases to a value that will remain approximately constant during the exploitation period. Significant increase in vibration parameters indicate a fault and there will be needed a remedial intervention. There is a vibration level value that indicates the vehicle is out of order and the repair is mandatory [2].

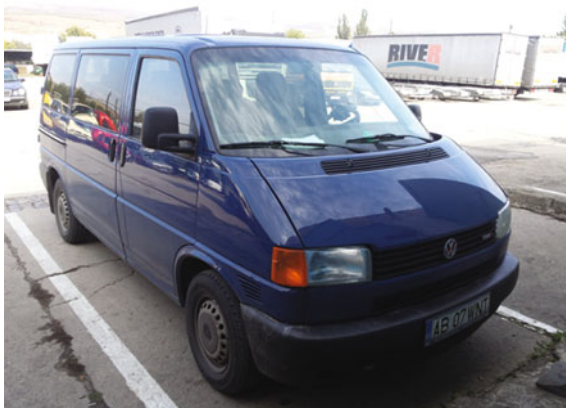
Fig. 2 Vehicle with AB 07 WNT registration number

To highlight the vibrator response of a transport means, it was determined that vibration sources are elements of two cars Volkswagen Caravelle with identical characteristics, in the normal state, but with different years of manufacture. The first vehicle, the Volkswagen brand, shown in Fig. 2, for which measurements were made, has the following technical characteristics (as per registration certificate):

- manufacturing year: 2002;
- registration number: AB 07 WNT;
- number of seats: 8 + 1;
- power source: Diesel;
- maximum mass: 2800 kg;

- power: 75 kW;
- engine capacity: 2461 cm³;
- total running: 428,988 km.

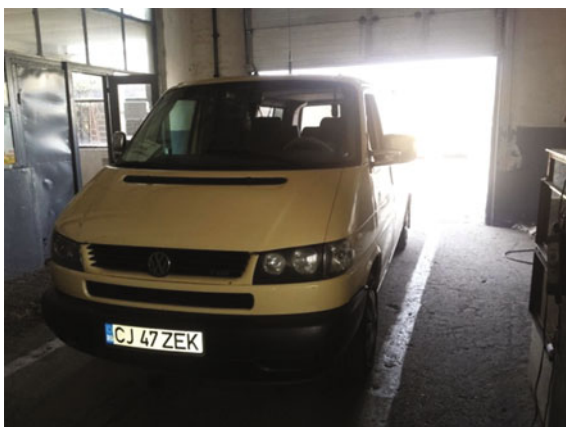
Fig. 3 Vehicle with CJ 47 ZEK registration number

The second vehicle, the Volkswagen brand, for which measurements were made, is shown in Fig. 3.

Technical characteristics (according to the registration certificate) of the vehicle from Fig. 3 are:

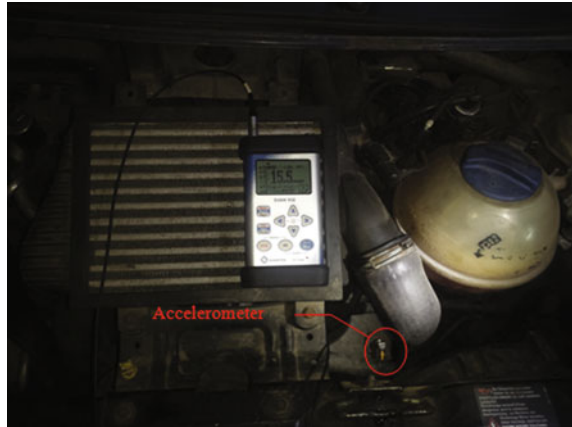
Fig. 4 Location vibration measuring system for P1 measurement point

Vibration measurement mode, in the P1 first measurement point is illustrated in Fig. 4.

According to Fig. 4, the measurement axes of vibrations have the following correspondence with accelerometer measuring channels:

- Oz axis measurement for channel 1 is Ch1;
- Oy axis measurement for channel 2 is Ch2;
- Ox axis measurement for channel 3 is Ch3.

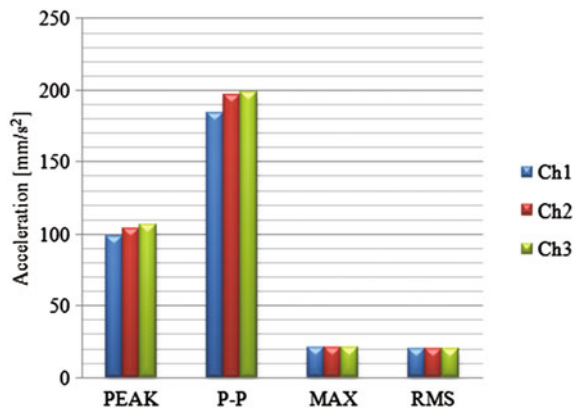
Fig. 5 Chart of effective vibration acceleration measured on the three channels, from the P1 measuring point

The numerical values in Table 1 are presented by graphical form in Fig. 5. From Table 1 and Fig. 5, it is observed that the highest values of vibration acceleration are along the Ox horizontal direction.

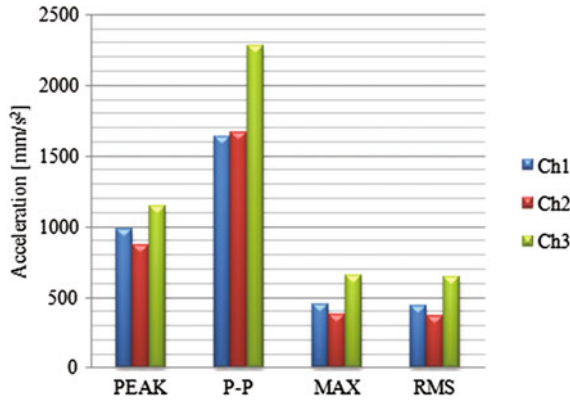
Fig. 11 Chart of effective vibration acceleration measured on the three channels from the P3 measuring point

Table 3 contains the effective values of vibration acceleration, type Peak, Peak-to-Peak (P-P), Maximum and RMS (Root Mean Square), obtained in P3 measuring point, determined experimentally on the three coordinate axes. The numerical values in Table 3 are presented in graphical form in Fig. 11.

From Table 3 and Fig. 11, it is observed that the highest values of vibration acceleration are along the Oz vertical direction.

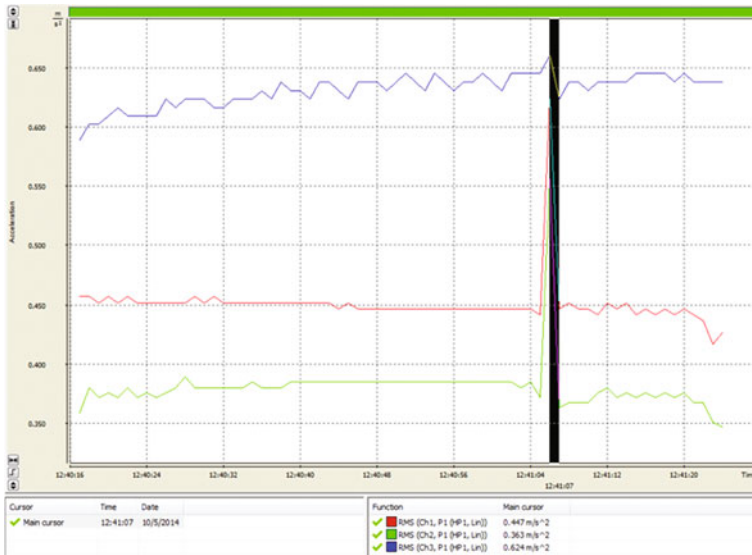
Fig. 12 Oscillogram of RMS acceleration from the P3 measuring point

For example, the maximum RMS acceleration along the Oz vertical direction is 641.95 mm/s². This is confirmed by the oscillogram given in Fig. 12.

Analyzing the results of vibration obtained in the three measuring points of the first vehicle, it follows that the acceleration is greatest at the P3 point, i.e., the front seat, along the vertical direction. Also acceleration values obtained for the first two measurement points are very close.

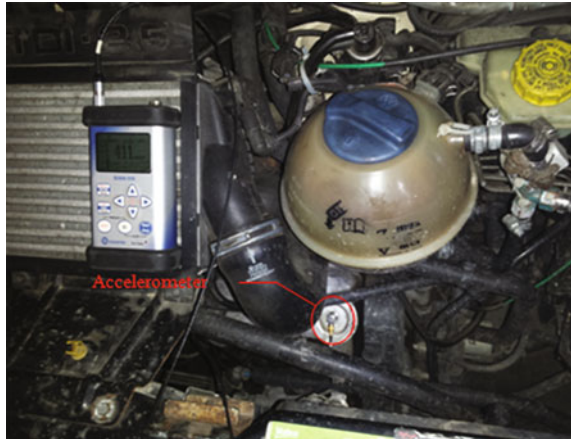
Fig. 13 Location vibration measuring system for the P1 measurement point

Vibration measurement mode, in the first measurement point P1, is illustrated in Fig. 13.

According to Fig. 13, the measurement axes of vibrations have the following correspondence with accelerometer measuring channels:

- Oz axis measurement for channel 1 is Ch1;
- Oy axis measurement for channel 2 is Ch2;
- Ox axis measurement for channel 3 is Ch3.

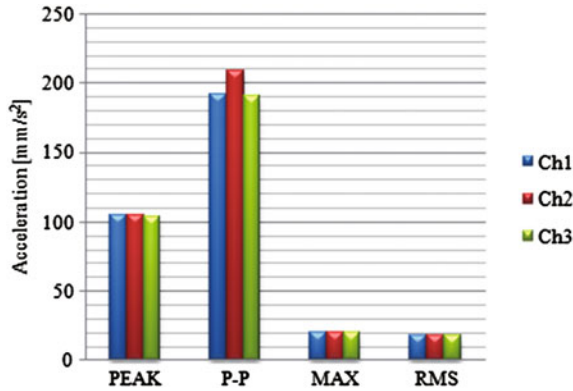
Fig. 14 Chart of effective vibration acceleration from the P1 measuring point

The numerical values in Table 4 are presented in graphical form in Fig. 14.

From Table 4 and Fig. 15, it is observed that the highest values of Peak-to-Peak and Max vibration accelerations are along the Oy transversal direction, 209.4 and 19.8 mm/s², respectively. RMS acceleration is higher along the Ox horizontal direction, valued at 18.5 mm/s². This is confirmed by the oscillogram given in Fig. 15.

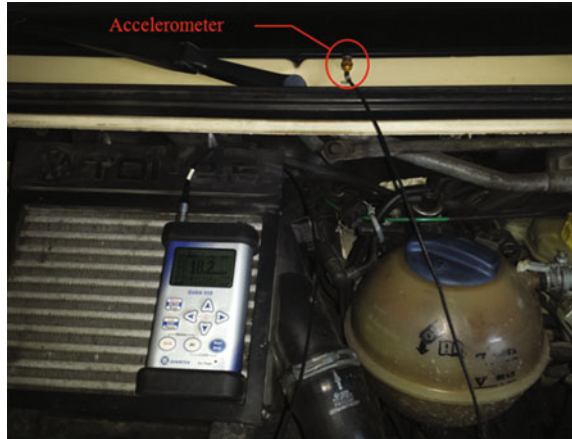
Fig. 16 Location vibration measuring system for the P2 measurement point

Vibration measurement mode, in the second measurement point is illustrated in Fig. 16. According to Fig. 16, the measurement axes of vibrations have the following correspondence with accelerometer measuring channels:

- Ox axis measurement for channel 1 is Ch1;
- Oy axis measurement for channel 2 is Ch2;
- Oz axis measurement for channel 3 is Ch3.

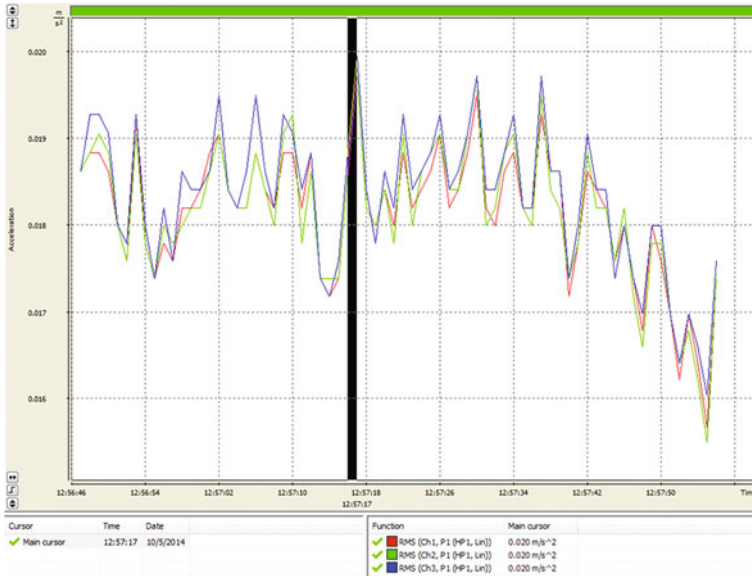
Fig. 18 Oscillogram of RMS acceleration from the P2 measuring point

acceleration along the Oz vertical direction is 17 mm/s². This is confirmed by the oscillogram given in Fig. 18.

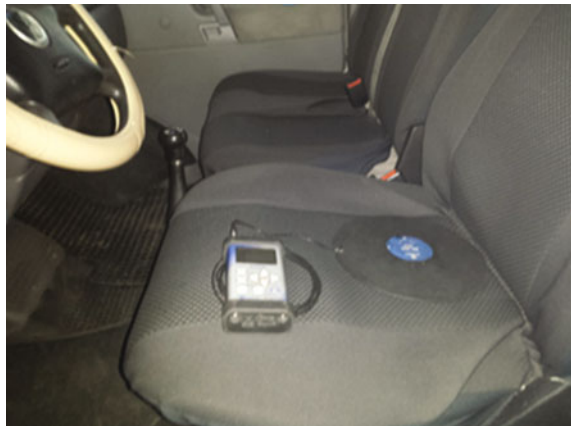
Fig. 19 Location vibration measuring system for the P3 measurement point

Vibration measurement mode, in P3 measurement point is illustrated in Fig. 19.

According to Fig. 19, the measurement axes of vibrations have the following correspondence with accelerometer measuring channels:

- Ox axis measurement for channel 1 is Ch1;
- Oy axis measurement for channel 2 is Ch2;
- Oz axis measurement for channel 3 is Ch3.
