# Chapter 14

## Wood-Frame Residential Buildings in Windstorms: Past Performance and New Directions

John W. van de Lindt and Thang N. Dao

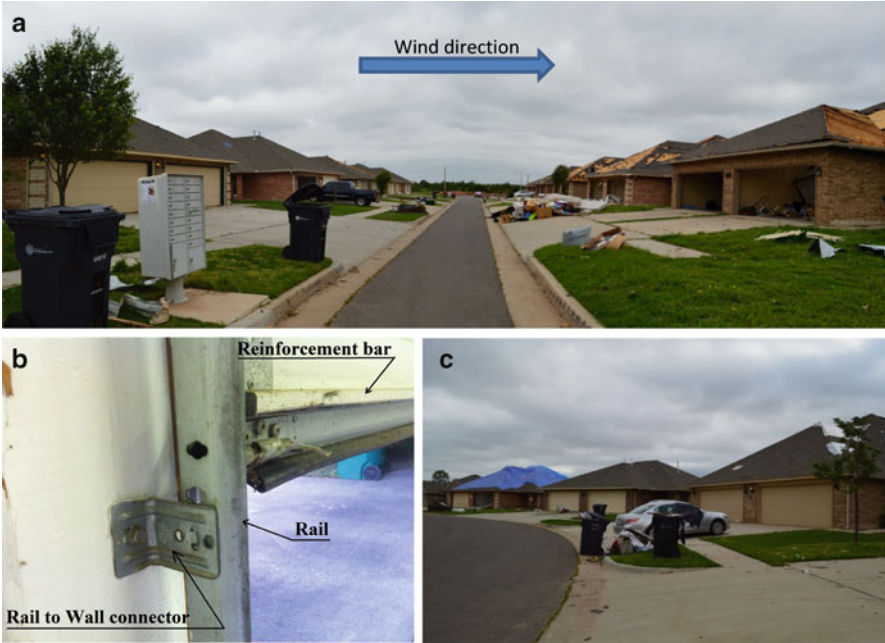
**Fig. 14.3** Different garage door damage levels on the same street. (a) Leeward (*left*) and windward (*right*) sides of SW 151st Street. (b) Garage door supports and configuration. (c) Change of garage door damage level when home orientation changes from leeward to windward direction

Figure 14.3a shows the damage to residential structures on SW 151st Street looking west. This figure shows houses on both sides of the street, and one can see that all homes on the left side still have garage doors and sustained little or no damage, while homes on the right side of the street lost garage doors that blew inward. Since all the garage doors had similar design and were installed on rails inside the door opening, the lateral reinforcement bars were placed inside the door (Fig. 14.3b), and these garage doors had higher capacity when experiencing negative pressure (outward load) as compared to lower capacity with positive pressure (inward load). This is because in the outward load case the load is transferred to the wall and rails through compression, while in the inward load case, the rails failed by bending into the garage (see Fig. 14.3b). With this reasoning, it can be seen from Fig. 14.3a that the residential houses in this picture experienced mainly one wind direction as the tornado passed this street, and the garage doors on the left were on the leeward walls (negative wind pressure), while those on the right side of the street were on the windward walls (positive pressure). This behavior can also be seen on streets where the direction of the street changes, and the garage doors change from leeward to windward as shown in Fig. 14.3c. This means that when the tornado passed this area, these houses mainly experienced horizontal winds (the failure pattern was similar to straight line winds seen during hurricanes). For those houses having garage doors on the windward side in straight wind, the garage doors often fail before roof sheathing panels.

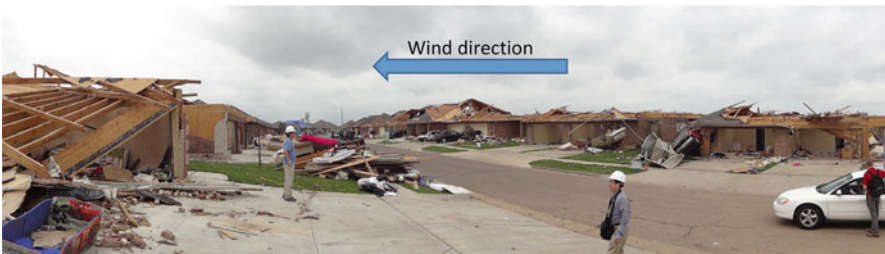
**Fig. 14.4** Damage pattern on Kyle Dr., Moore, Oklahoma (camera pointed to the south)

Homes on Kyle Dr., a north-south street shown in the circled area on Fig. 14.1, indicated an increase in damage when located closer to the centerline of the tornado track. This damage pattern is similar to what was observed in the aftermath of the Tuscaloosa and Joplin tornadoes. Figure 14.4 shows the damage pattern of houses on Kyle Dr., in which the camera was pointed to the south looking away from the centerline of the tornado. It should be noted that the tornado vortex was counterclockwise, and this neighborhood was on the south side of the tornado centerline. Therefore, the houses on the south edge of the damage area experienced west-to-east winds, which is right to left in Fig. 14.4. In Fig. 14.4, the houses on the right (west) side near the middle of the street had the roof fail before the garage door failed. Failure of the roof happened on the leeward side, and the roof was intact on the windward side. The garage doors, on the leeward side, were not damaged on these homes. Similar damage was observed on the roofs of the houses on the left

(east) side of the street (failure happened on the leeward roof, but the windward roof was intact), while the garage doors on the left side of the street all failed. This is because roof sheathing panels are weaker in uplift and stronger in compression due to nail withdrawal capacity. This failure pattern indicates that these houses experienced higher wind speed than at the edge of the damage area, and mainly in one direction of horizontal wind. It can also be seen in Fig. 14.4 that garage doors and roofs failed on both sides of Kyle Dr. to the north, where the photo was taken, and several walls were collapsed in the house on the northeast end of Kyle Dr. (far left in Fig. 14.4).

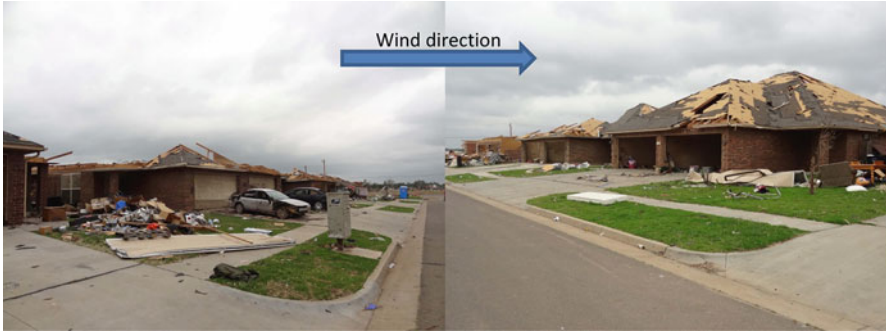
**Fig. 14.5** Failure of roofs and garage doors on different sides of Kyle Dr. (camera pointed to the north)

A closer inspection near the northern segment of Kyle Dr. indicated that the homes in this area experienced wind in one direction, as shown in Fig. 14.5. Again, the house on the left had roof failure and the garage door survived, while the house on the right had the garage door blown in, and only a minimal amount of sheathing panels failed.

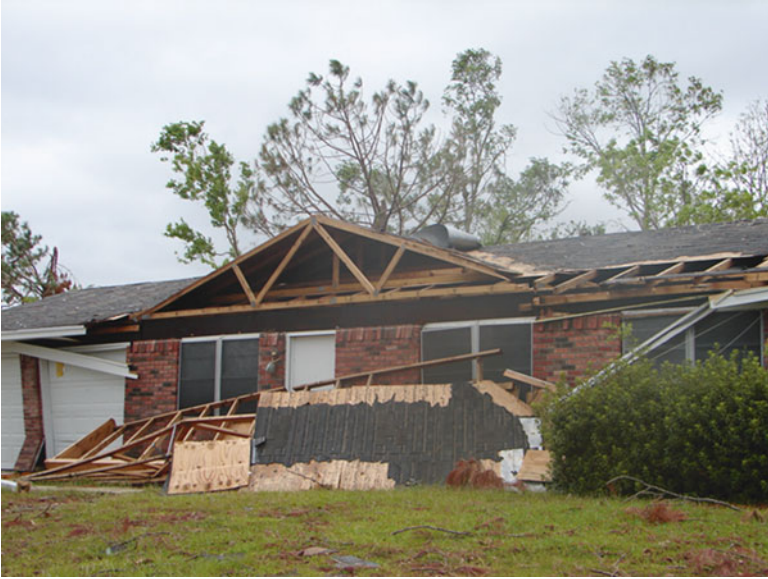
**Fig. 14.7** Loss of a porch overhang due to lack of support post anchorage

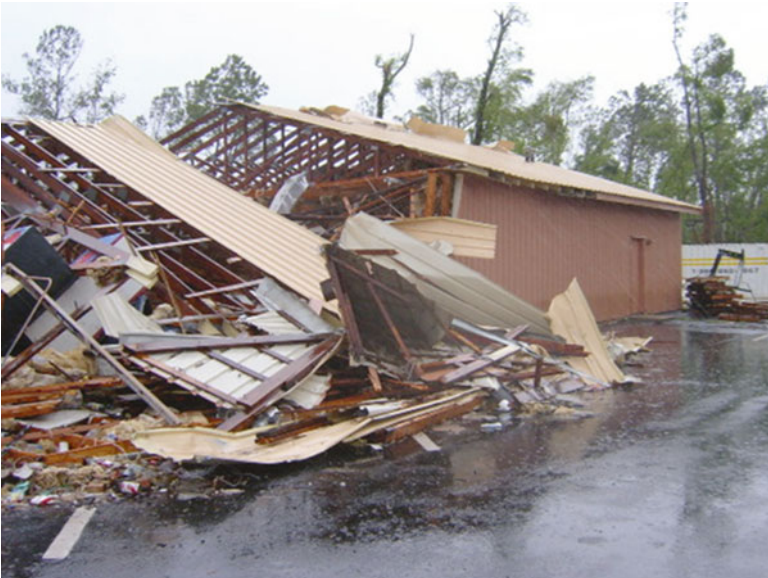
**Fig. 14.8** Collapse of a wood-frame (metal clad) building

Two additional performance expectations that have not been explicitly addressed to date are as follows. Structural integrity, which can be summarized as the state at which the structure shows significant signs of distress, may include the collapse of the roof or the loss of lateral capacity either locally or globally. Although the general consensus is that complete loss of lateral capacity from wind load is rare, it is possible as evidenced by Fig. 14.8. This is a convenience store in

Mississippi that was literally blown over in Hurricane Katrina. van de Lindt et al. (2007) describe this failure with the following sequence: The roof uplifted and there was a loss of roof sheathing. The front glass window “blew out” and the roof trusses collapsed. The trusses were tied to the walls with hurricane clips, but without roof sheathing they did not provide lateral stability for the trusses alone. The structural instability performance expectation includes life safety, meaning none of the performance expectations are necessarily mutually exclusive. For example, if the structure collapses, i.e., does not meet the expectation of structural integrity, clearly all of the other expectations were not met, albeit they may be tied to different hazard intensities. The performance expectation of life safety may not be met even when there is no local or global collapse.

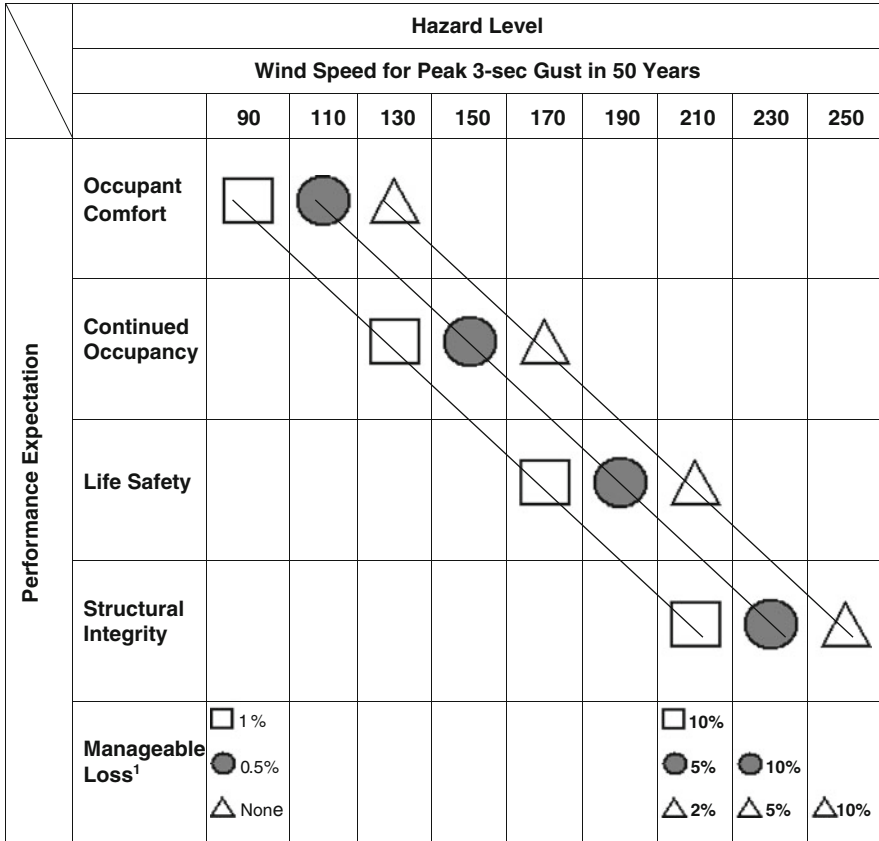
1. Manageable loss is defined as a % of the replacement cost of the building.

**Fig. 14.9** Example of various levels of building performance as a function of hazard level. <sup>1</sup>Manageable loss is defined as a percentage of the replacement cost of the building

Consider Fig. 14.9 whose concept is adopted from performance-based seismic design. Current force-based design utilizes a single peak 3-second gust and designs with some level of safety or with both a load and resistance factor (e.g., ASCE 16 1996). In Fig. 14.9 the leftmost line corresponds most closely to current force-based design values. However, it is important to note that simply by defining multiple performance objectives the design philosophy is no longer the same. For this leftmost line, returning to the performance expectations and damage parameters in Table 14.1, and for a peak gust of 90 mph (145 km/h), an owner would expect no damage and no water intrusion. For a well-designed and well-constructed residential structure, this is typically the case provided wood is in a non-decaying state and fasteners are spaced appropriately. For the same leftmost line (squares in Fig. 14.9), one would expect to provide life safety at 170 mph (270 km/h) meaning no loss of truss-to-wall connections or supporting post failures. Although this is the performance expectation described here, the method described below is probabilistic, and thus there is always some probability of exceeding such an expectation, as examined by Ellingwood et al (2004). Therefore some level of exceedance probability must be selected, which for the present study is set at 50% for illustrative purposes.

The concept of PBWE can be further explained by again returning to Fig. 14.9. Now, focusing on the rightmost line with triangles, one can see that no water intrusion or damage would be expected at 130 mph (210 km/h), life safety expected at 210 mph (335 km/h), and structural integrity expected at 250 mph (400 km/h).

to estimated losses during high-wind events. For example, in Fig. 14.9 how would one ensure that at 210 mph the performance expectation level for the leftmost line (indicated by squares) only has losses not to exceed 10 % of the replacement value of the structure? Further, for the “triangle” performance level, these would not be expected to exceed 5 % at 210 mph. As mentioned earlier, this is not quantitatively addressed in this chapter. To accurately assess the damage in terms of dollars would require the full inclusion of damage due to wind-borne debris and a mechanism to assess volume and affect of rainwater entry. This would likely include an approach such as assembly-based vulnerability (Porter et al. 2001; Pei and van de Lindt 2009; Dao and van de Lindt 2012; van de Lindt and Dao 2012).

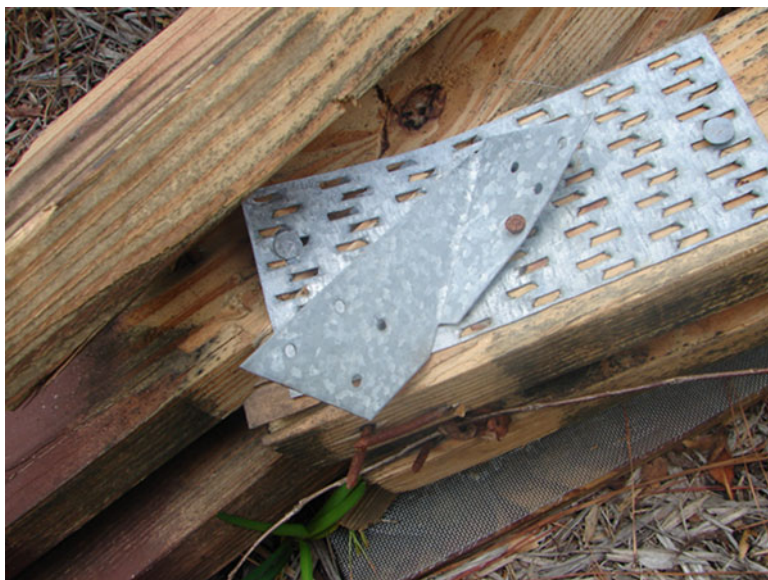
**Fig. 14.10** Photo of missing fasteners in a hurricane clip. The roof lifted off after several hours of uplift pressures
