Shigeko Haruyama · Toshihiko Sugai  
*Editors*

# Natural Disaster and Coastal Geomorphology

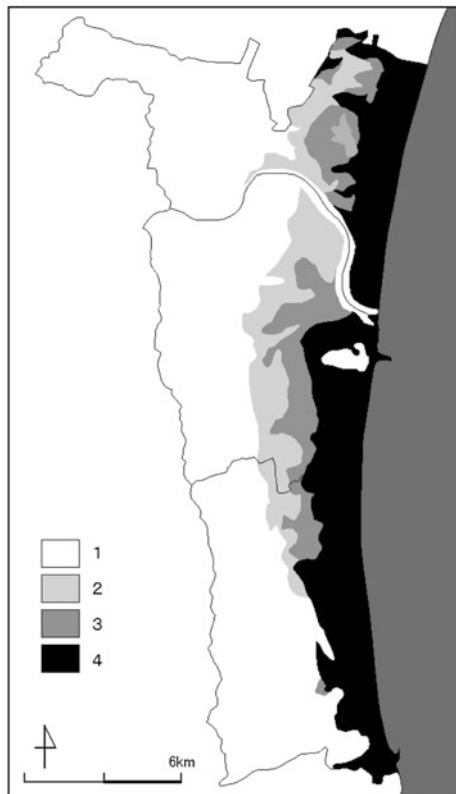
**Fig. 1.3** Classification map of deceased by 3.11 tsunami along the coastal area in southern part of the mouth of the Abumuma in each local administration (damaged level was calculated in each local administration and tied up in damaged levels) *Explanatory note: 1. 0 % damage, 2. below 1 % damage, 3. 1–2.5 % damage, 4. 2.5–5 % damage, 5. 5–10 % damage, 6. over 10 % damage*

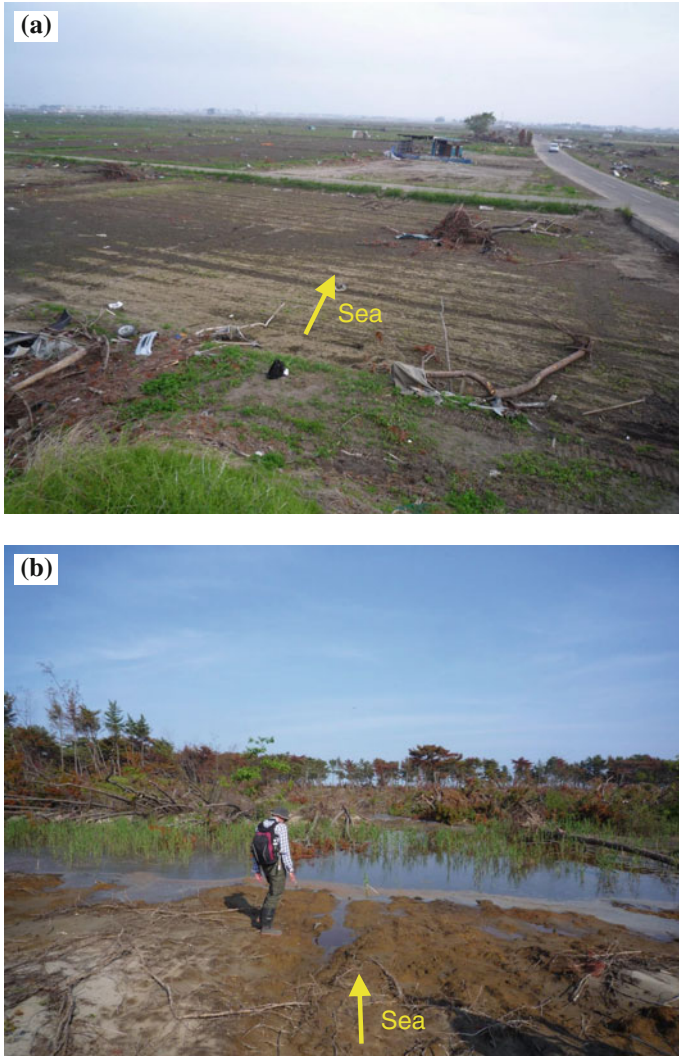
**Fig. 3.8** Photographs of **(a)** flat topography and coastal trees transported by the run-up flow and **b** erosion in sand dune in wide strand plain at Sendai City. Shooting locations and direction of photographs are shown in Fig. 3.7a

transported inland huge amount of beach and dune sand, and many pine trees planted on sand dune (Fig. 3.8b) with a long distance (Fig. 3.8a). Additionally, paddy soil landward of the road was eroded with several tens of centimeters depth. Inundation heights were 6.3 m above TP landward of the coastal forest and decreased inland (Fig. 3.9a). Inundation depths were 3 m at 1.6 km from the

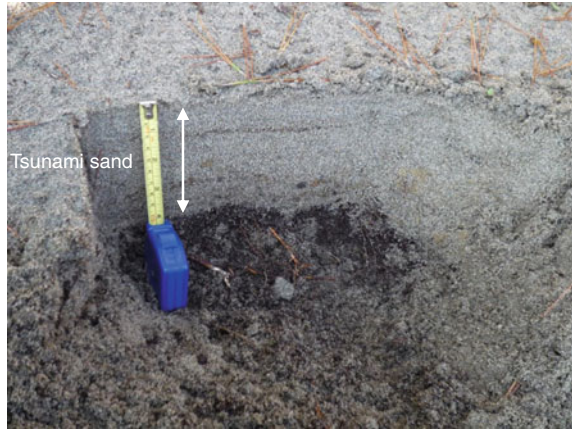
**Fig. 3.10** 11-cm-thick sand layer at 0.6 km from the shoreline (site b8 in Fig. 3.7b) in wide strand plain at Sendai City

tsunami deposit was sand-dominated and was composed of 0.5–10-cm-thick fine- to medium-grained sand layer with a mud cap in 0.1–3 cm thickness. Further inland (3.0–4.0 km), the deposit became mud-dominated and was composed of 1–3-cm-thick mud overlying a patchy thin layer of massive fine- to medium-grained sand (0.1–0.3 cm thick).

The tsunami sand layer thicker than 0.5 cm was found up to approximately 3.0 km inland, which corresponds to 74.5 % of the inundation distance. The sub-millimeter (sub-mm) tsunami sand layer and the mud layer were found up to approximately 3.9 km inland, which is equal to 97.3 % of the inundation distance.

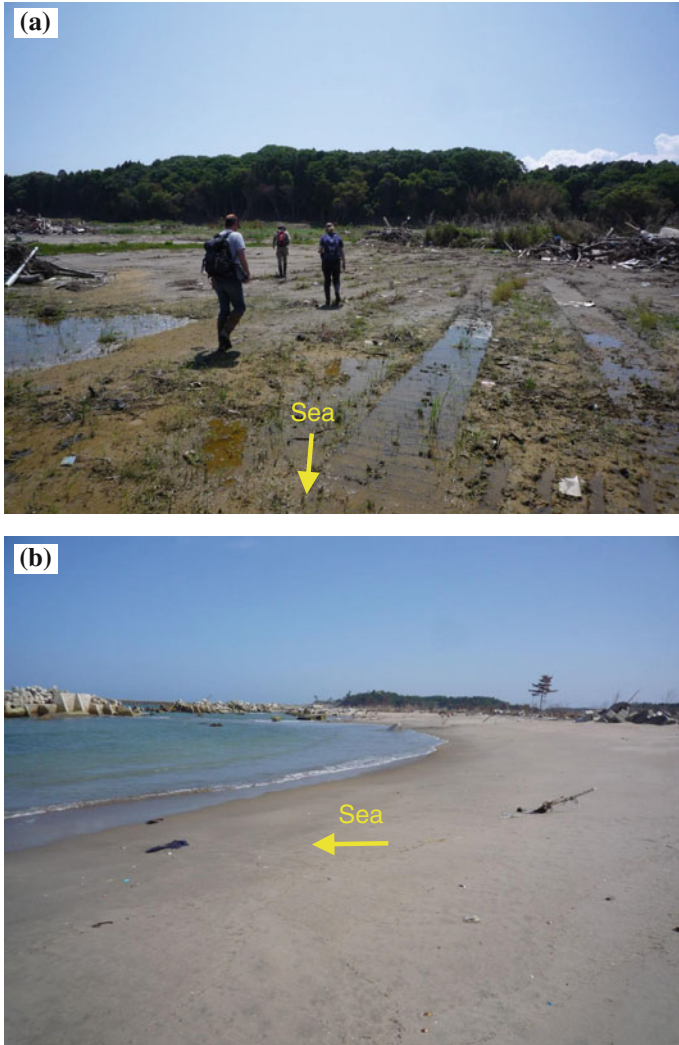
**Fig. 3.12** Photographs of **a** lowland and terraces and **b** erosion in sand beach and dune in narrow strand plain at Yamamoto Town. Shooting locations and direction of photographs are shown in Fig. 3.11a

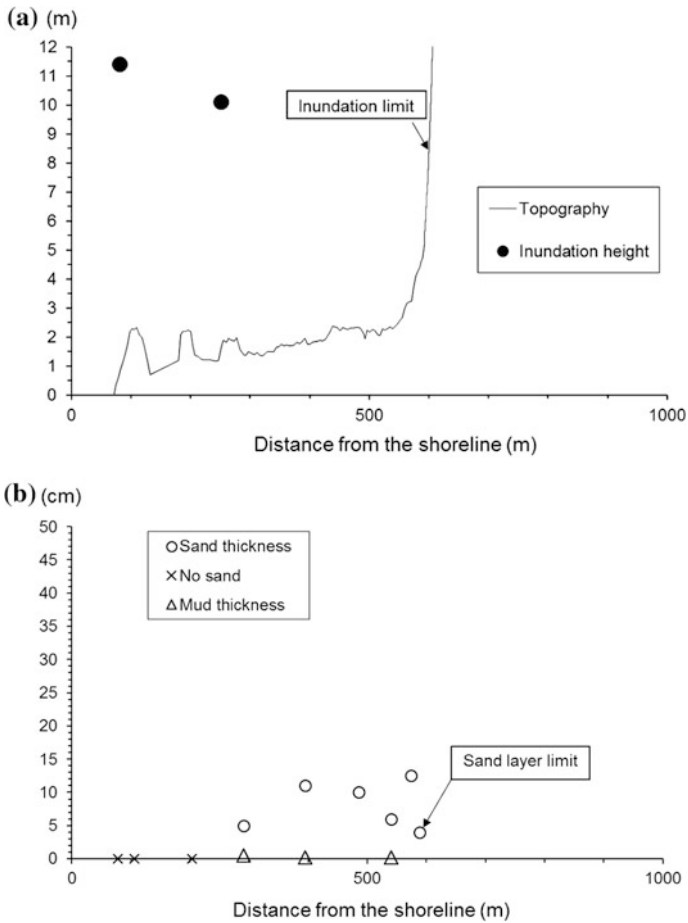
**Fig. 3.13** a Elevation, inundation height above TP, and inundation limit, b sand and mud thickness in narrow strand plain at Yamamoto Town

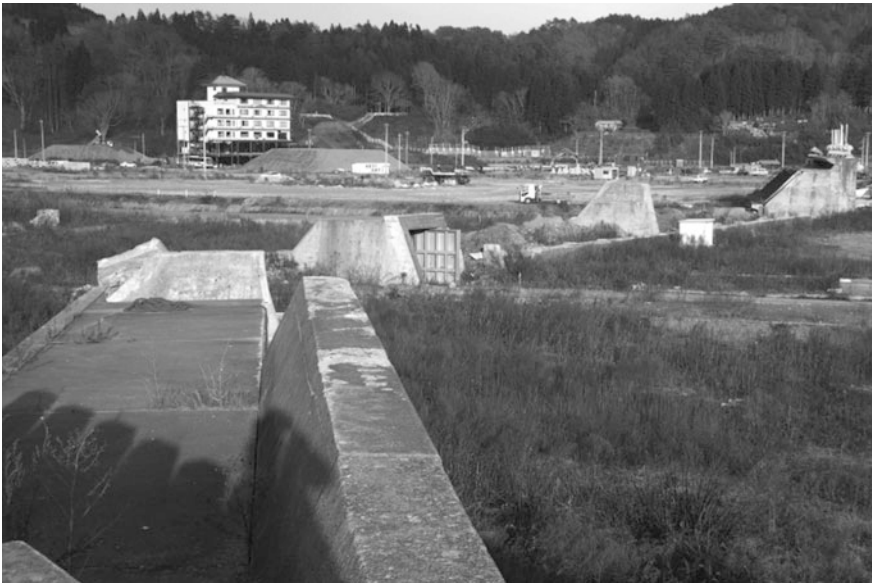
**Fig. 4.3** The destroyed mega seawalls of Taro. The upper right seawall was totally washed out. The lower left seawall was quite strong, so that this survived the tsunami overflow

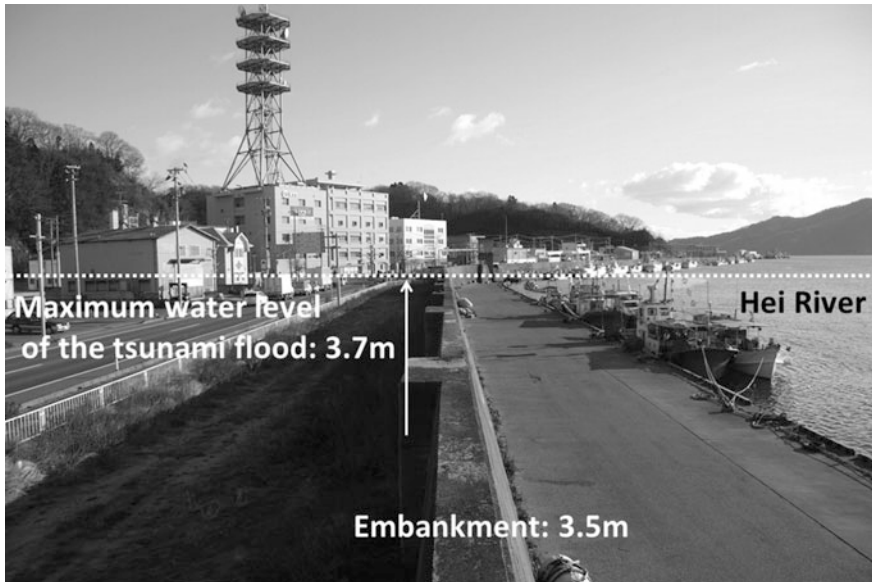
**Fig. 4.5** A concrete embankment along the lower Hei River beside the city hall in the Miyako City and the maximum water level of the tsunami flood

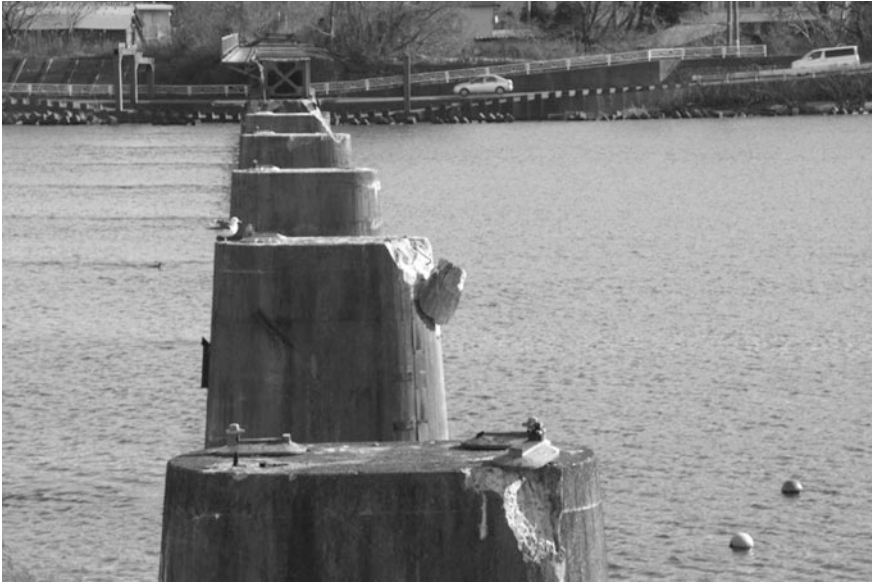
**Fig. 4.6** The washed-out railway bridge crossing the Hei River in the Miyako City

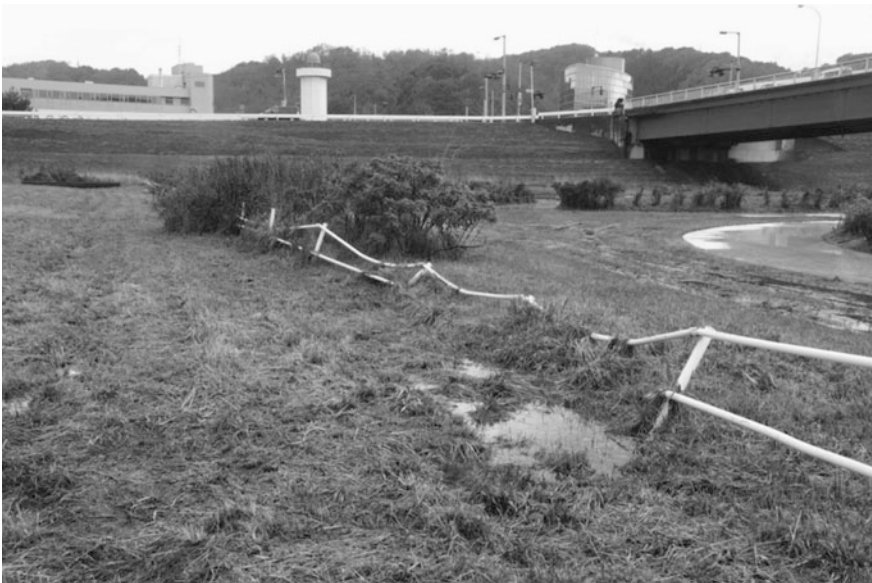
**Fig. 4.7** Bended steel fence in the river side floodplain

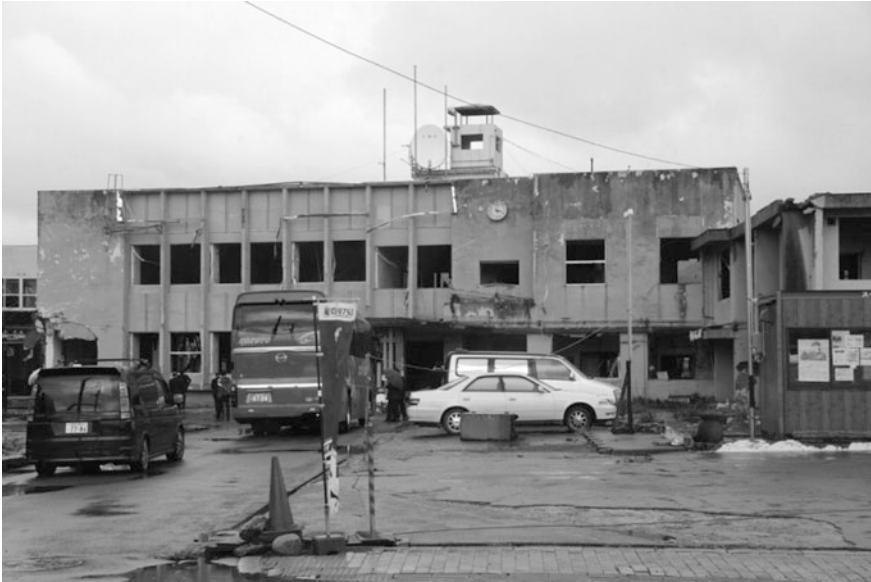
**Fig. 4.9** Destroyed town hall building in Otsuchi town

town hall and a hospital, were under water (Fig. 4.9). About 700 people of 4500 died in the town center area (Otsuchi Town 2011).

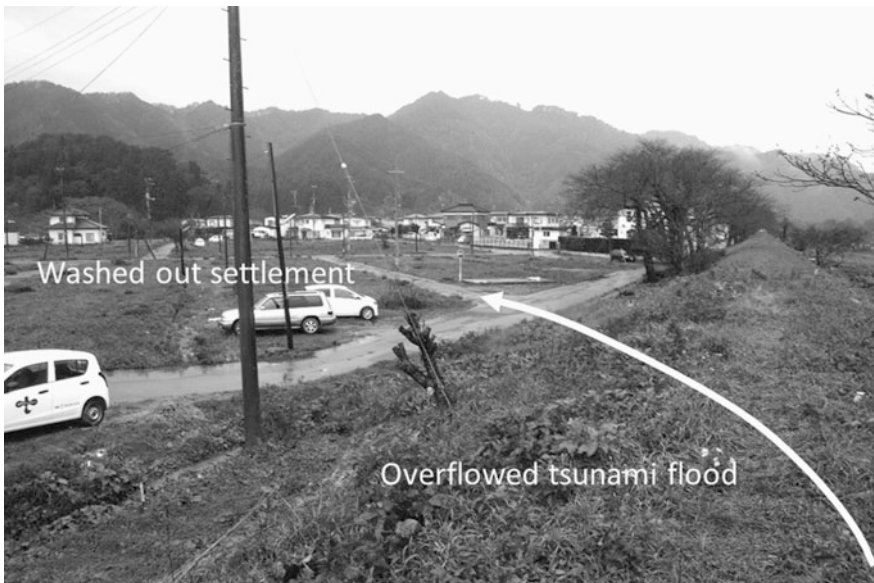
**Fig. 4.11** Damaged area caused by overbank tsunami flood flow

The tsunami ran up in the small lowland without diminishing depth, and the whole central part of the town in the lowland was severely damaged. Although the depth and strength of the floodwater suddenly decreased at the mouth of the valley, tsunami flow which ran up in the river course flooded over the embankment and caused severe damages in the habitation side of the floodplain in the upstream area. In the river course, the tsunami could reach upper area of higher elevation through the river.

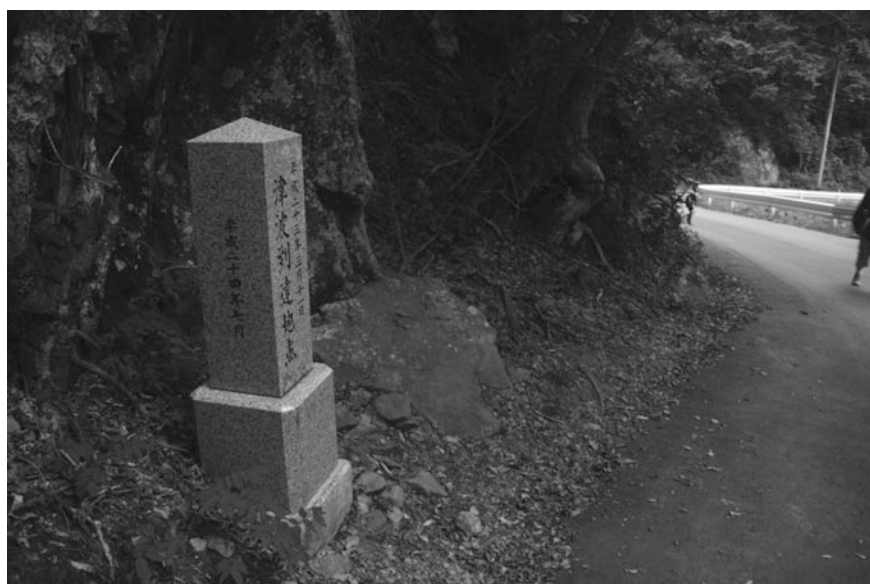
**Fig. 4.14** The monument of the 2011s tsunami ascending limit in the valley of Aneyoshi

elevation was one of the highest points on this tsunami event. Seawater was concentrated in tiny cove and small stream, so that the tsunami ran up to higher elevation in the valley than at the coast. The surface soil was stripped 5 m high from the valley bottom, and trees on the slopes were washed out to. Because a small fisherman's village, Aneyoshi, was located in the narrow valley floor which is more than 50 m in elevation, this village was not damaged. The 1896 tsunami and the 1933 tsunami attacked a village on the coast of the cove. Some people who survived the tsunami events had decided to move to higher area than former maximum tsunami attacked area, which was 45 m in elevation (Fig. 4.15). Because they continue to live in this area, all houses could survive this tsunami event.

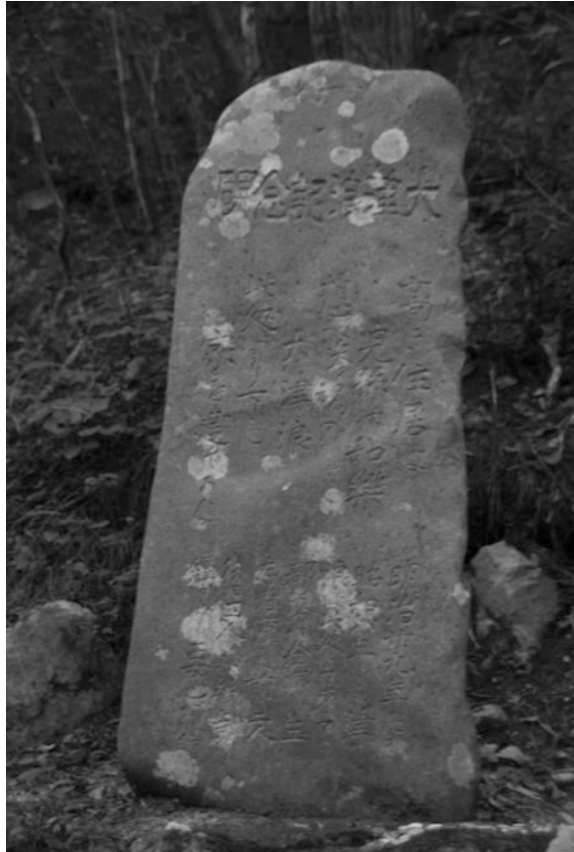
**Fig. 4.15** The monument showing the upper inundated limit of the former maximum tsunami. The message of “the people in this settlement must not build own house below this point” was engraved on this monument

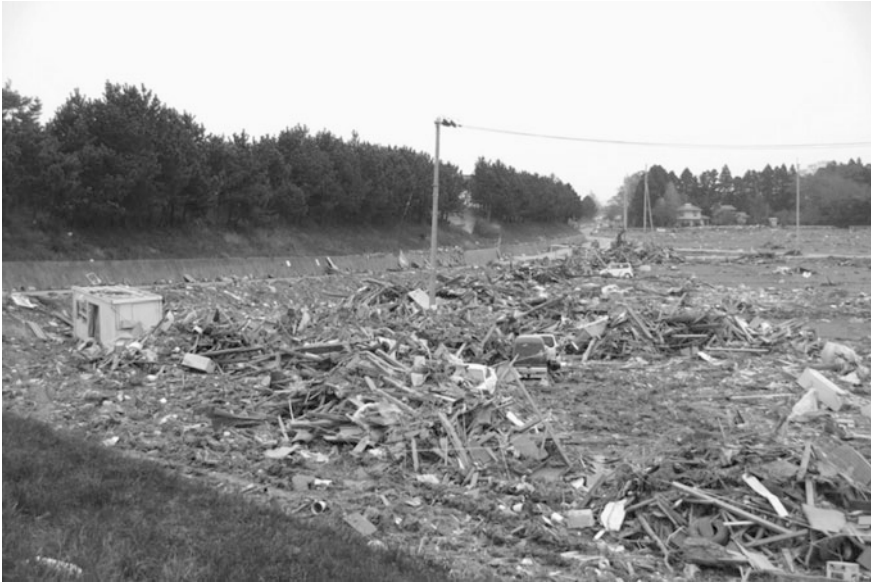
**Fig. 4.17** Tsunami dammed up by the elevated motorway. Much debris was deposited along the road

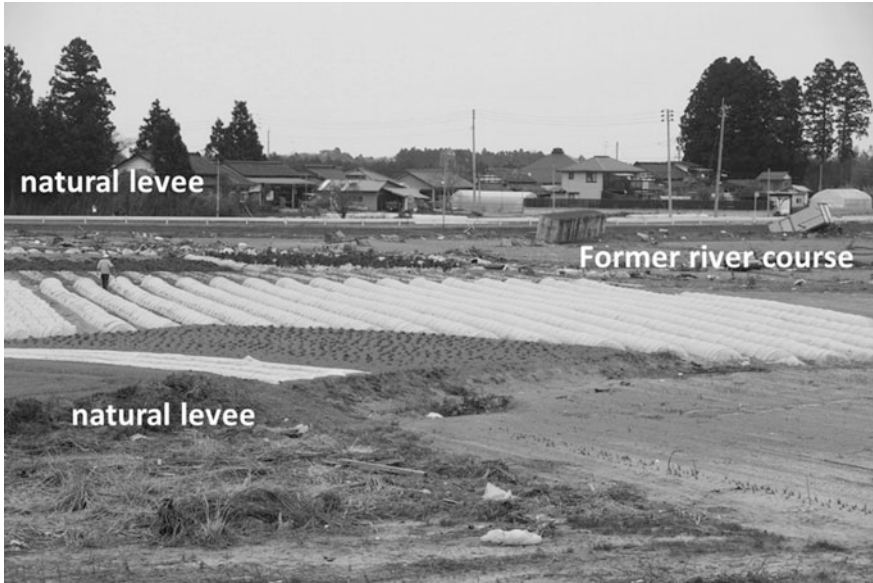
**Fig. 4.18** Little damaged old settlement on a natural levee and debris deposited former river course. Many debris including cars and containers were deposited in a former river course

In the land side of the motorway, shallowed floodwater was affected by micro-landforms. There are former river courses and natural levees whose relative height is less than 1 m. The floodwater with broken debris ascended only in the former river course. Old settlement on the natural levee was not or little damaged (Figs. 4.16, 4.18 and 4.19).

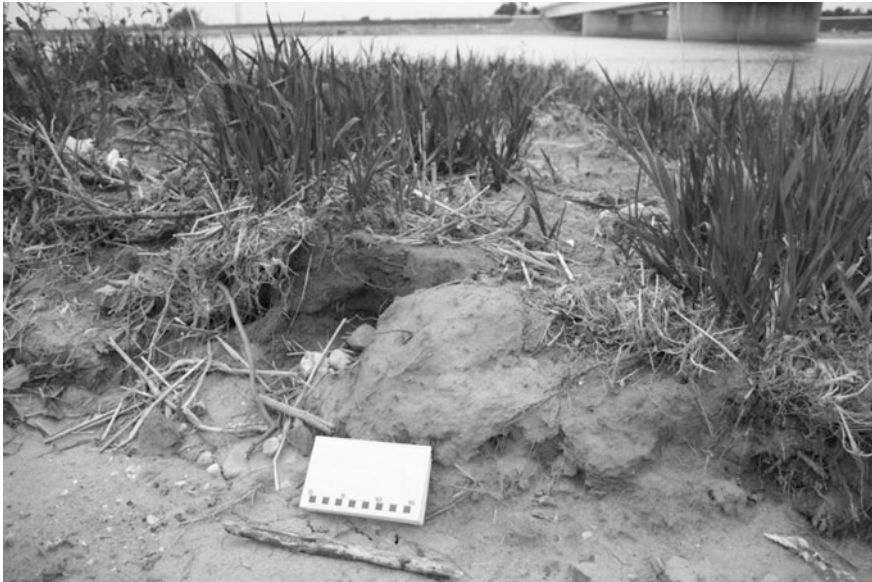
**Fig. 4.22** Erosional feature in the lower section of the Natori River (Loc. 1)

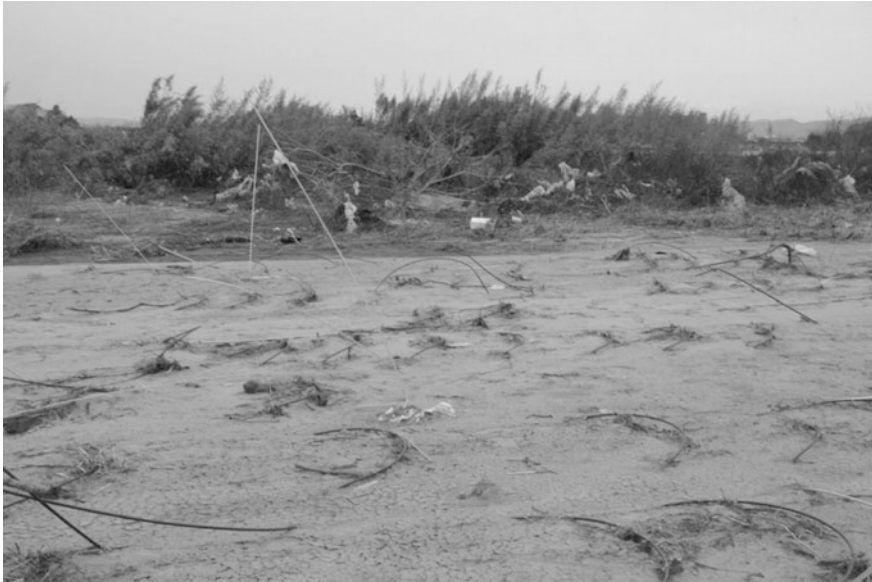
**Fig. 4.24** Washed-out plastic covers and leaned upward agricultural facilities in the vegetable field on the river side floodplain (Loc. 4). Sediments with surface incrustation buried a vegetable field. The tsunami ascended to right direction

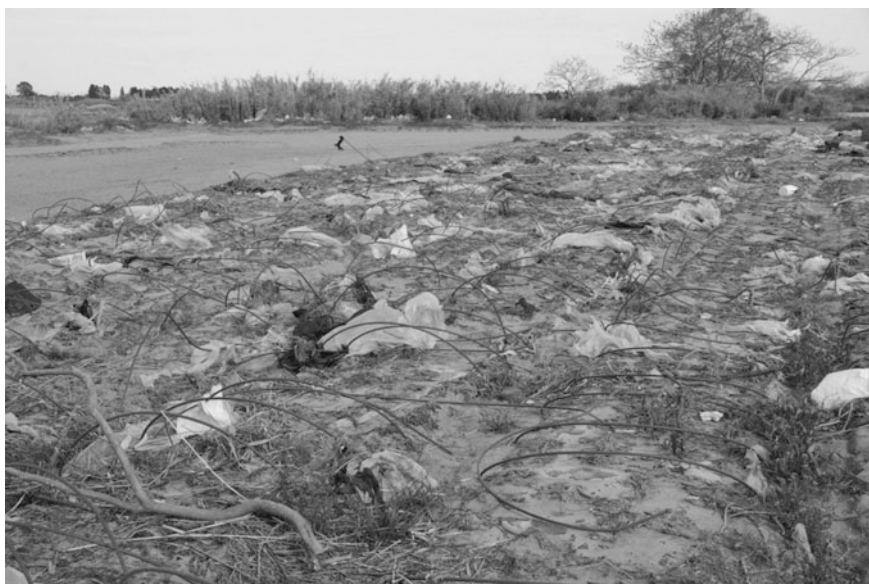
**Fig. 4.25** Plastic tunnel covers were washed out, and support posts remained (Loc. 5)

At the Loc. 5, plastic tunnel covers were washed out. On the other hand, support posts remained. Some of them leaned upstream and some stood as they were (Fig. 4.25). Live movies shot from the air by NHK show that the tsunami flood flow crushed all greenhouses around here. 1-cm-thick sediments of silty medium sand underlay hard and thin salty incrustation of fine sand sediments (Figs. 4.23 and 4.26). Growth of survived garlic was not enough. Although the river side floodplain was entirely affected by tsunami flood flow, influences were relatively weaker than the lower points in this section. Strong flood flow caused washout of the facilities and lean of the support posts, and relatively, weak ebb flow caused lean of flexible plants.

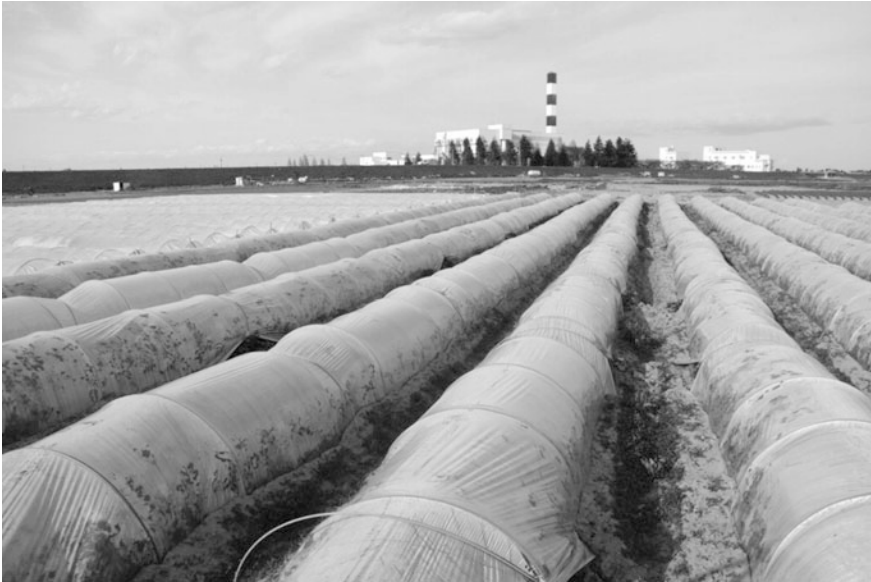
**Fig. 4.27** Cabbages growing as usual on the higher level of the surface (Loc. 6)

At the Loc. 6 in the higher level surface of the upper section, plastic tunnels survived tsunami and cabbages grew enough (Figs. 4.21 and 4.27). The lower level surface and the shallow ditch surrounding the higher level surface, growth of cabbages was poor. The surface of the shallow ditch was underlain by 2-cm-thick silty salt incrustation (Fig. 4.23). The lower surface was covered with granule and sand sediments with quite thin salt incrustation.

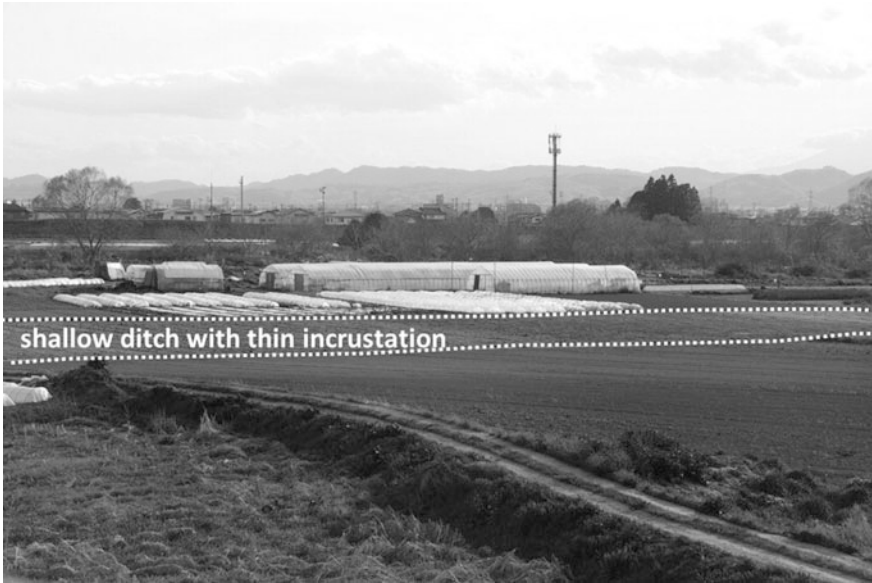
Fig. 4.28 Salt incrustation found in a shallow ditch (Loc. 7)

At the Loc. 7, in the uppermost section, most fields had begun to be recultivated. The salt incrustation was observed in shallow ditches below 4 m in elevation (Figs. 4.28 and 4.21). The tsunami inundated only in these shallow ditches. The other part of the field where was more than 4 m in elevation was not flooded by the tsunami water.

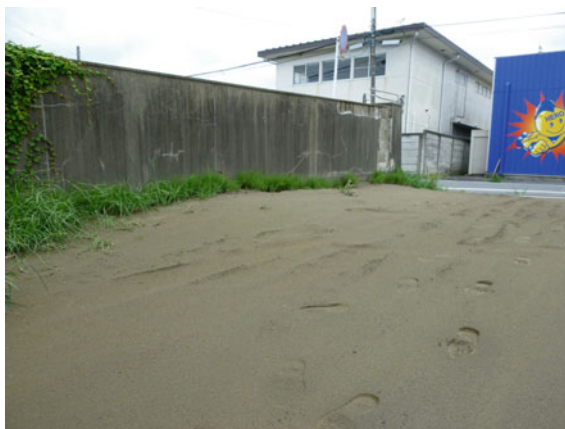
**Photo 6.1** Liquefaction point at Sawara located in the former river course (taken in July 2011)

Comparing geomorphologic land classification map with liquefaction zones in the lower Tone River after 2011 earthquake (Fig. 6.3), the greatest liquefaction occurrence areas were generally located on built-up areas in former lagoons, such as Hinode and Motoshin, and the other remarkable damages were occurred in the reclaimed former river courses and reclaimed land in the geomorphologic view. The boundary between natural levee and back marsh was another target area of liquefaction point. Some liquefaction points were located on the lowland under the buffs around terrace and hills. Photo 6.1 shows an example of liquefaction point on the reclaimed former river course of the lower Tone River, and Photo 6.2 is the occurrence point on the reclaimed former lagoon (Fig. 6.3). The paddy fields are

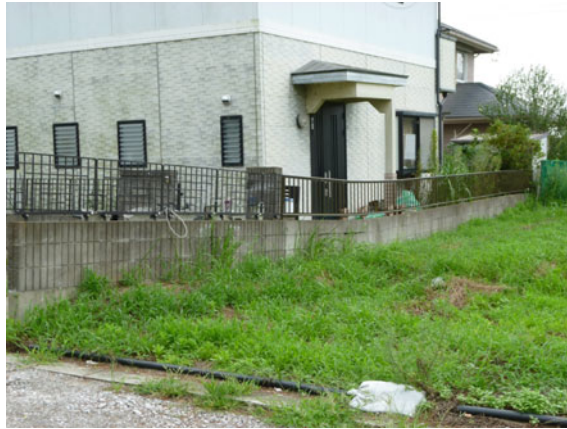
**Photo 6.2** Differential settlement landscape at Hinode reclamation area in the former lagoon (taken at July 2011)

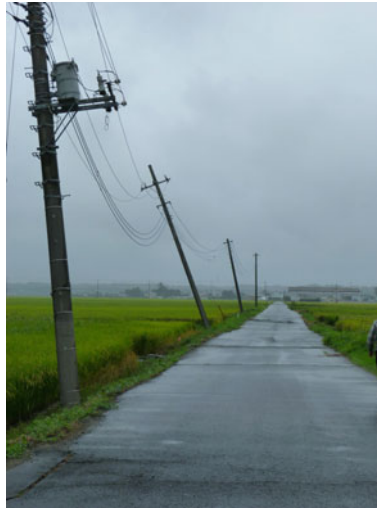
**Photo 6.3** Liquefaction of the boundary between natural levee and flood plain at Oogisima (taken in July 2011)

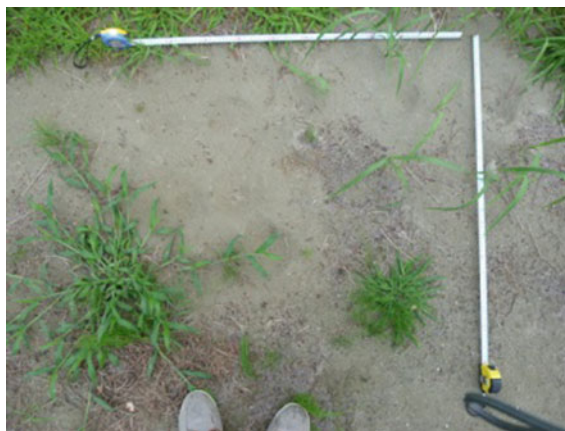
**Photo 6.4** Liquefaction points on the boundary line between sand ridge and flood plain at Showa (taken in July 2011)

are similar in sand ridge and natural levee boundary, and former lagoons in this study area (Fig. 6.4). The damages by liquefaction are shown in Photos. 6.3, 6.4, 6.5, 6.6, and the some buildings showed differential settlement, and electric pillars were lean because of boiling sand with water in the lower Tone River Basin. The emission of spray of sand and water was in paddy field and the line of holes with cracks buried by sands in the study area. The median grain size was investigated in the range from 0.05 to 0.9 mm and sandy. The grain size distribution of sediment on natural levee is difference from those of former lagoons. Average grain size is 0.66 mm at Sawara, 0.578 mm at Hinode, 0.059 mm at Showa, and 0.071 mm at Oogisima, and the grain size is larger on reclaimed former river course. There appears to be a relationship between areas of liquefaction and depth to the underground water table. The underground water level in this study area is generally shallower in the former river course related to sedimentation such as fine sand in the bottom of the channel landform.

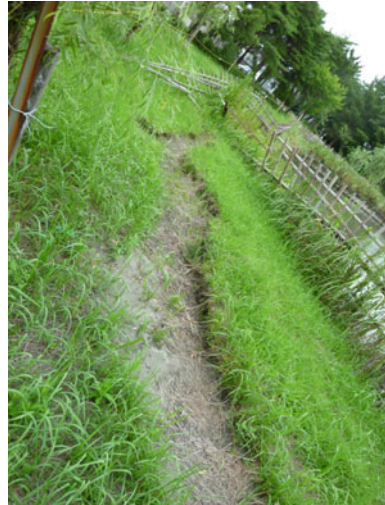
**Photo 6.5** Liquefaction at Hinode reclaimed land and boiling sand (taken in July 2011)

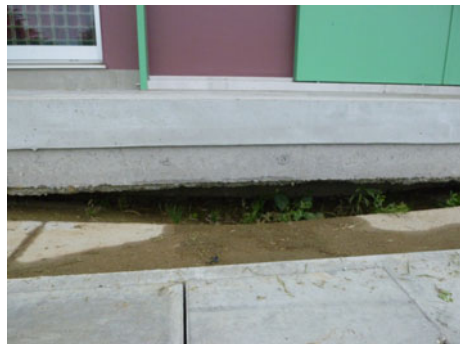
**Photo 6.6** Gymnasium hall of elementary school in Hinode getting sand bald of building (taken in July 2011)

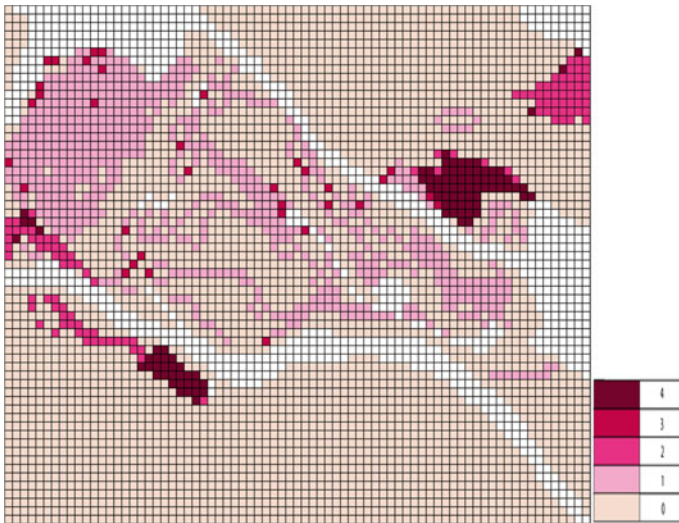
**Fig. 6.8** Mesh map of liquefaction vulnerability level in land use changing

Three vulnerabilities of liquefaction of the study area were assigned, such levels as (1) vulnerable, (2) more vulnerable, and (3) the most vulnerable (Figs. 6.7, 6.8) and liquidizing damage level is increasing with land use changing and reclamation process of the same location. To weigh landform with land use changing, the vulnerable of liquefaction was transforming and taking landform features into vulnerability is shown in Fig. 6.9. Even though same landform unit, the vulnerability is transformed in land use change.
