Chapter 7

Examples of Some Systems Vulnerable to MIC

Abstract It may come to mind that different systems will have different patterns for MIC. While this is true for many systems, there is a general pattern for MIC that can repeat itself in seeming far different industrial systems. This chapter describes some of these systems.

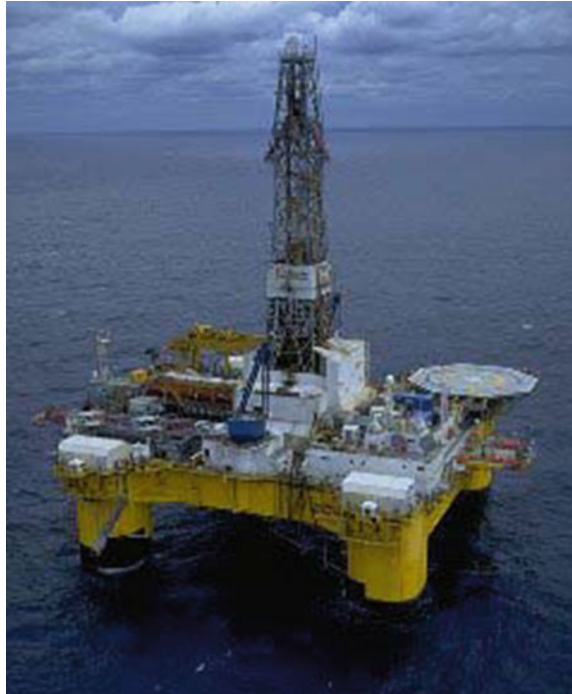
Fig. 7.10 A semi-submersible offshore platform (Source <http://www.rigjobs.co.uk/oil/semisub.shtml>)

The type of MIC-related problems that may be expected in, for example, submersible and semi-submersible platforms are, more or less, similar to stagnant water problems caused in firewater lines or pipelines. Such platforms have pontoons and columns that, when flooded with seawater, cause the pontoons to submerge to a predetermined depth. Figure 7.10 shows an example of a semi-submersible offshore platform.

In such platforms, the stagnant water becomes deaerated and oxygen-free so it becomes a good place for SRB to become active. In addition, it has been investigated that²² the decay of macro-organisms in sea water, in the presence of light, could encourage phototrophic sulphur bacteria's role in increasing anaerobic corrosion of metals. A routine countermeasure is the use of biocides. However, the biocide should not simply be introduced into the platform leg as it takes a
