# Demolition of steel structures: structural engineering solutions for a more sustainable construction industry

**Abstract.** This paper presents an introduction to structural demolition engineering as applied to steel structures. This work flows out of a research project aimed at providing design techniques for ensuring that structures can be both safely and efficiently demolished when they reach the end of their lifecycles. When a structure is to be demolished or imploded it is typically weakened such that when the collapse is triggered the collapse mechanism can be controlled and will occur as predicted. If structures are not weakened enough they may not collapse when required, but if weakened too much they could collapse prematurely killing demolition teams. This paper specifically discusses (a) a step-by-step analysis of the full-scale demolition of a large structure that the author filmed, explaining the structural mechanics of the system, and then (b) presents methods for weakening structures and how this influences failures. By providing verifiable methods for ensuring structural capacity, rather than relying on experience alone, the demolition process can become more effi

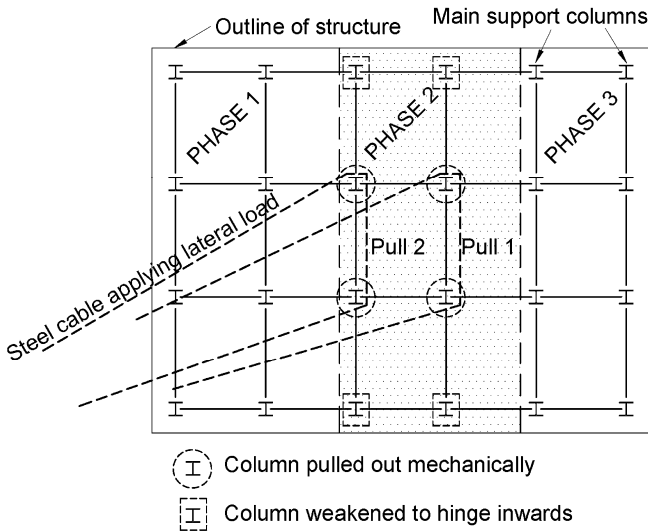
Fig. 1. Layout of furnace to be demolished, showing the phasing of the process

The figures below provide an understanding of the demolition process of a structure by considering a case study consisting of a large furnace. This structure was part of a very challenging project where the existing furnace shown had to be demolished within an operational factory, and a new furnace built in the same position, with the whole process needing to happen within around 3 months. Thus, the demolition team had to prepare and bring down the structure very quickly to allow for construction and mechanical teams to access the site. Figure 1 shows a plan layout of the structure. Mechanical demolition techniques were used with the columns and beams being weakened, and the overall process was carried out in three phases. The remaining figures and diagrams relate to the second phase of the process where the middle section of the structure was demolished. Phase 1 had previously been completed in a manner similar to that illustrated below.

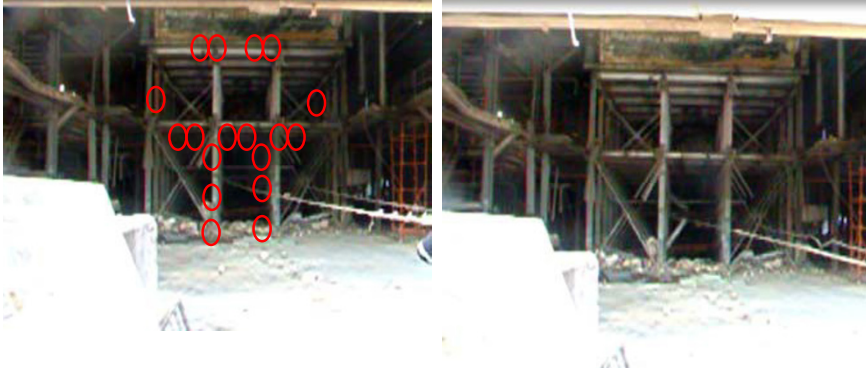
Fig. 2. (a) Furnace structure to be demolished. Red circles indicate where structure had been weakened; (b) Lateral load applied to structure to cause internal columns to pull out.

In Figure 2(a) the full structure is shown. The red circles indicate positions where the structure had been weakened. A layer of material around 1m thick had solidified in the furnace, providing a reasonable load on the weakened columns. It must be understood that up until this time teams had been working within this structure, which is potentially very dangerous if structures are weakened more than necessary, or if teams are inexperienced. Techniques for weakening structures typically vary, although in this case cutting torches were used to create holes in sections, or to fully cut members right through. The latter was used for the internal columns that were pulled out. Triangular cuts were used on the outer columns, whilst beams were either fully or partially cut through.

Once the structure was ready to be mechanically imploded a large construction vehicle was used to apply a lateral force to inner columns via a steel cable, as shown in Figure 2(b). The middle columns were prepared such that when this load was applied it caused column sections to fall out. The columns were pulled out by the cable in two steps, with the columns on the right of Figure 1 being removed first, "Pull 1", followed by the second row of columns, "Pull 2". The structure was left with sufficient integrity that when the first set of two columns was removed the structure still remained standing. When the second row was removed the collapse was triggered, as shown in Figure 3(a).

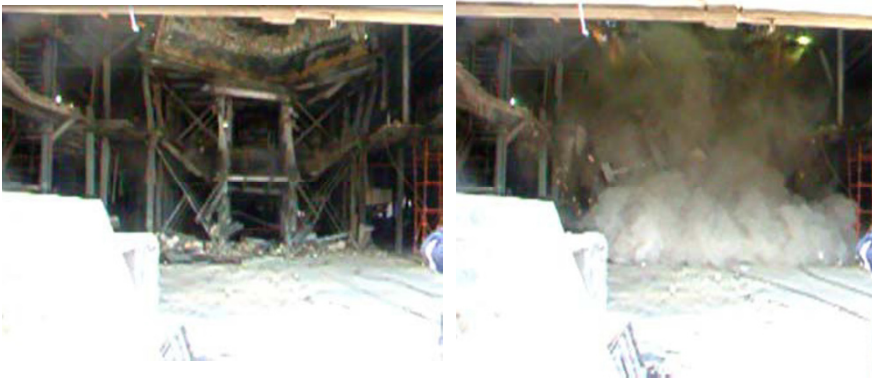
Fig. 3.(a) Structure in the process of collapsing after second line of columns removed;(b) Final pile of rubble which the demolition team could clear and recycle.

It can be observed that as the inner columns move downwards it pulls the upper components of the structure inwards. This ensured that the adjacent structure was protected and all material fell vertically. The resulting pile of rubble is shown in Figure 3(b). At this point in time demolition teams could access the rubble and recycle as much as possible. Once rubble had been cleared the next phase, Phase 3, of the demolition process could commence.
