## THE REVIVAL OF ONAHAMA SMELTER & REFINERY FROM THE DISASTER BY THE GREAT EAST JAPAN EARTHQUAKE

Naoki Horihata, Shoji Kawashima, Tetsuro Sakai

Onahama Smelter & Refining Co., LTD  
Onahama Smelter & Refinery  
1-1 Nagisa Onahama Iwaki-City Fukushima JAPAN

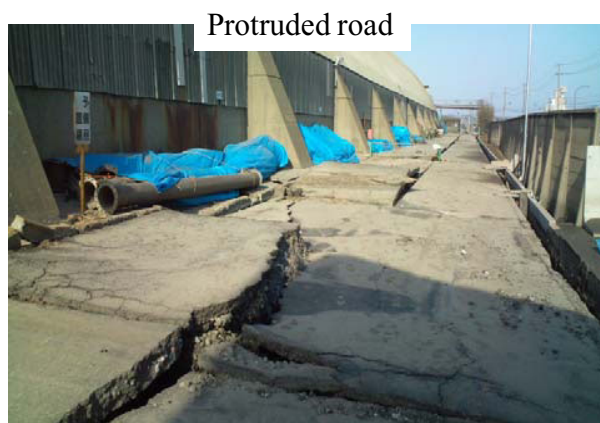
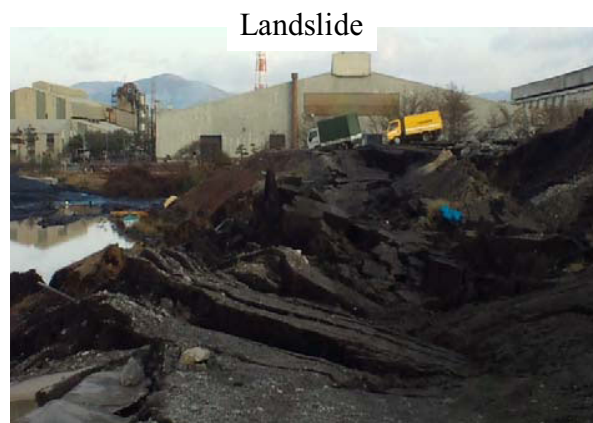
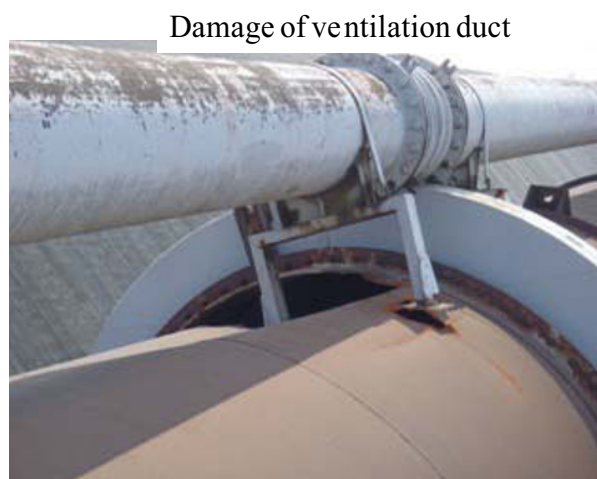
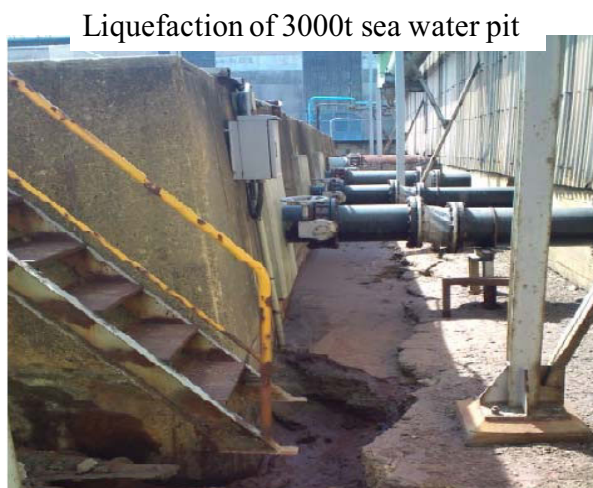
Figure 1 Photos of damaged facilities

Electricity, drinking water, plant water, seawater stopped promptly after the earthquake occurrence. After the urgent stop measures were executed in the trembling caused by an intense earthquake, all workers evacuated to neighboring ground. Fortunately there was not environmental and work related accident at all with the help of appropriate urgent correspondence and the evacuation procedure drilled regularly twice a year. The damage of each of plants is listed in Table II and photos of miserable damaged facilities are demonstrated in Figure 1.

<p><b>Smelter</b>                  S furnace, reverberatory furnaces, PS converters and anode furnaces stopped with full melt. The ceiling and the sidewall bricks of the reverberatory furnaces dropped more than 20,000 pieces.</p>
<p><b>Refinery</b>                  More than 140,000 sheets of anodes and cathods dropped into cells and inside lining of more than 80% cells was injured.</p>
<p><b>Acid Plant &amp; Gypsum Plant</b>                  Converters, drying towers and absorption towers stopped with SO<sub>2</sub> gas. Many cracks and breakings were observed in towers, plumbing and gas duct .</p>
<p><b>Utilites</b>                  Sea water pit was breaking. Many pipes of drinking water, plant water and sea water cracked. Outlet port of discharge drainage was collapsed. Numberless cave-ins and cracks were observed in all roads .</p>

The repair work was limited without the restoration of the lifelines which were supplied by Tohoku Electric Power, Fukushima prefecture and Iwaki city. It took 74 days though all lifelines recovered because the lifelines were damaged all over the Tohoku district. On the other hand, almost all facilities in Onahama Smelter & Refinery were also damaged. Therefore, it was judged that each of facilities was restarted one by one.

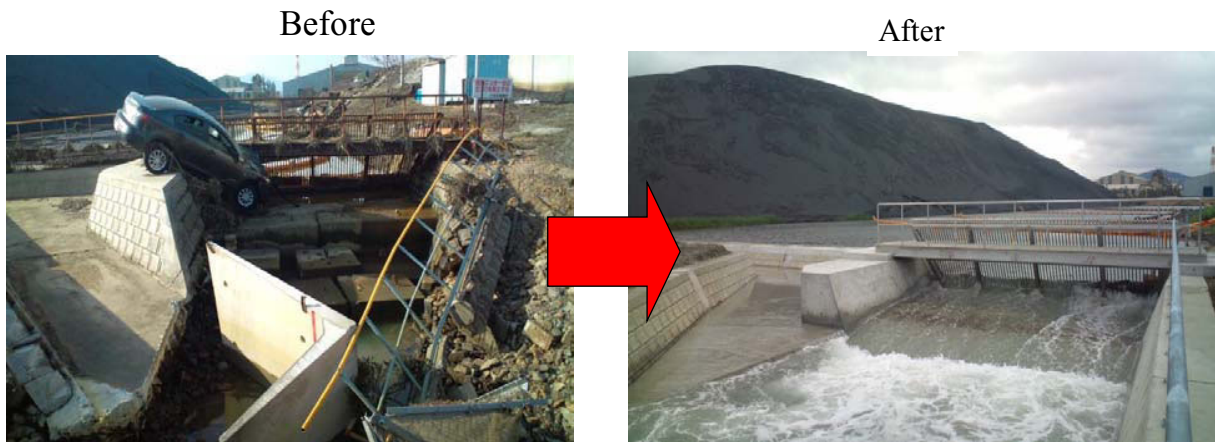
Figure 2 Photos of outlet port of discharge drainage

1. Repairs of the utility such as pits and plumbing of plant water and sea water were taken priority. Especially, an outlet port of discharge was completely collapsed by the tsunami and had to be remodeled to earthquake-resistant structure before sea water was supplied. Figure 2 shows photos of outlet port of discharge drainage.

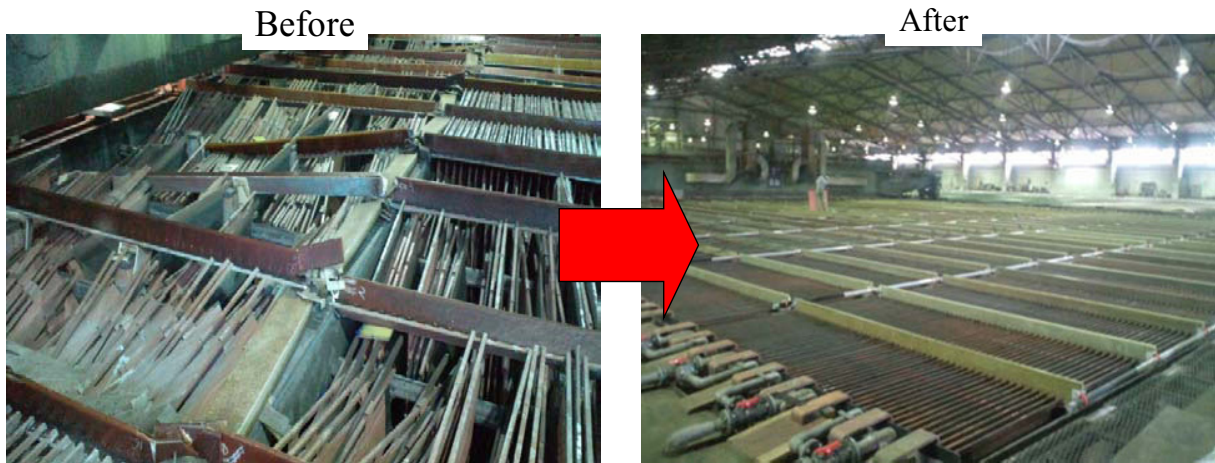
Figure 3 Photos of No.3 tank house

4. Starting sheet tank house and No.2 commercial tank house which were with a little damage comparing with No.1 & No.3 commercial tank houses shall be restored first at the refinery section. Figure 3 shows photos of No.3 tank house.

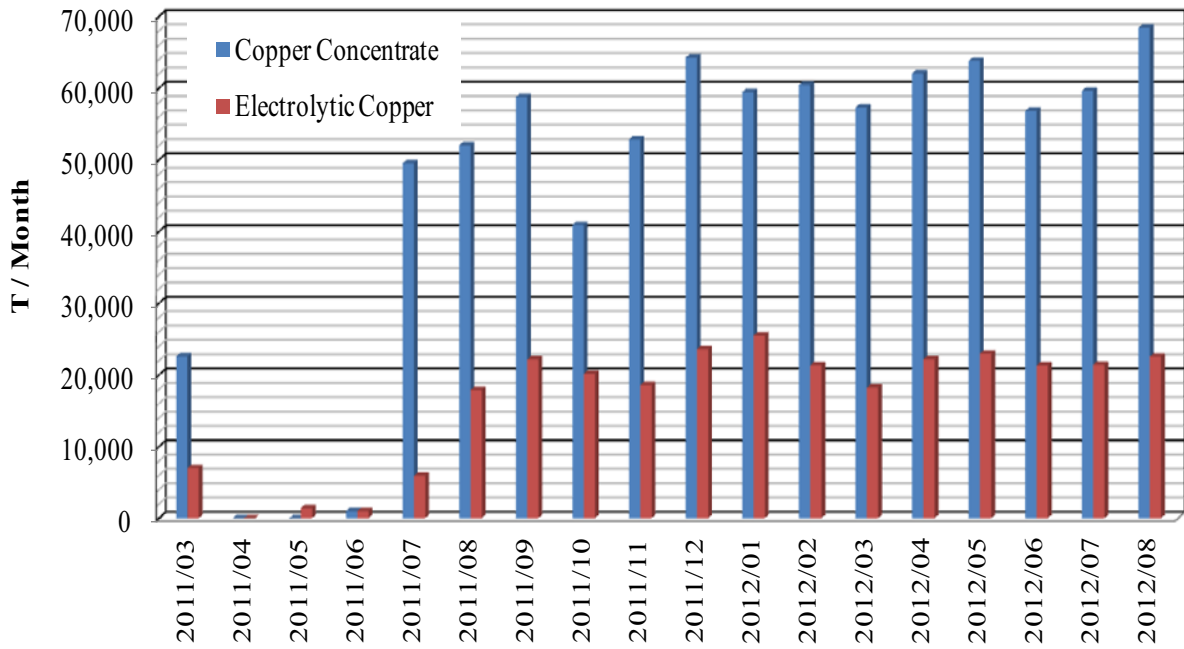
Figure 4 Amount of treated copper concentrate and produced electrolytic copper after revival.

Figure 4 shows amount of treated copper concentrate and produced electrolytic copper after revival. It was forced that the treatment of copper concentrate sometimes decreased or stopped by blackout or water supply troubles caused by the frequent aftershock, however damage of facilities in plants was not occurred at all by an effect of the earthquake-resistant remodeling. The supply of lifelines was recovered month by month, and improved further. Consequently the production also increased and the treatment of copper concentrates has achieved a new record of 68,425 metric-tons in August 2012. On the other hand, the collection of combustible waste materials such as shredder residue had decreased sharply after the operation was restarted as shown in Figure 5. It consisted of two reasons.

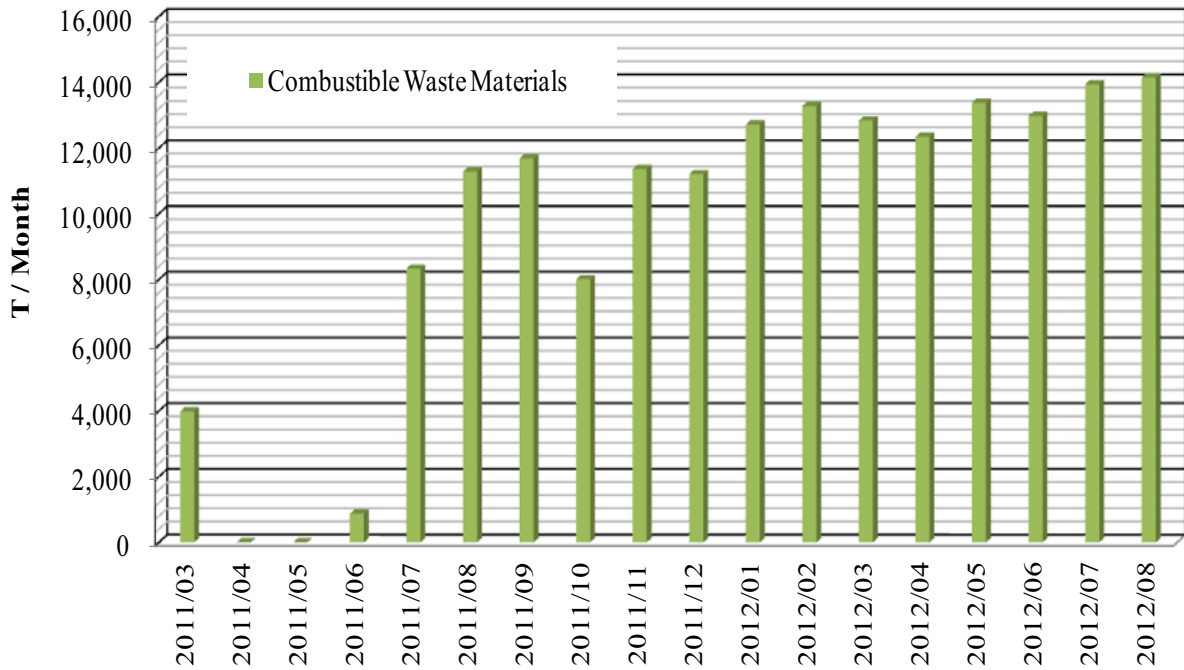
Figure 5 Amount of treated combustible waste materials after revival.

- 1) The earthquake disaster passed throughout East Japan and many scrap factories which generated shredder residue were driven into the shutdown.
- 2) Many people had to buy used cars immediately because many cars were carried away by the tsunami. As a result, a disposal car decreased sharply and the raw materials of the shredder dust also decreased sharply.

However, the collected amount of shredder residue gradually recovered and returned to the amount before the earthquake disaster since April 2012.
