# Chapter 29

## Integrated In Situ Investigations for the Restoration: The Case of *Regio VIII* in Pompeii

**Abstract** This chapter presents the study case of the integration of noninvasive in situ investigation methods able to provide information useful to survey and characterize the state of decay of some masonry walls and frescoes in two blocks (*insulae*) of the *Regio VIII* in Pompeii. The integrated investigations demonstrated the complementarity of ground-penetrating radar (GPR), seismic tomography, and infrared thermography (IRT) for the diagnosis of the state of conservation and the restoration of structures and surfaces of archaeological monuments. The investigation was very useful in planning the restoration work.

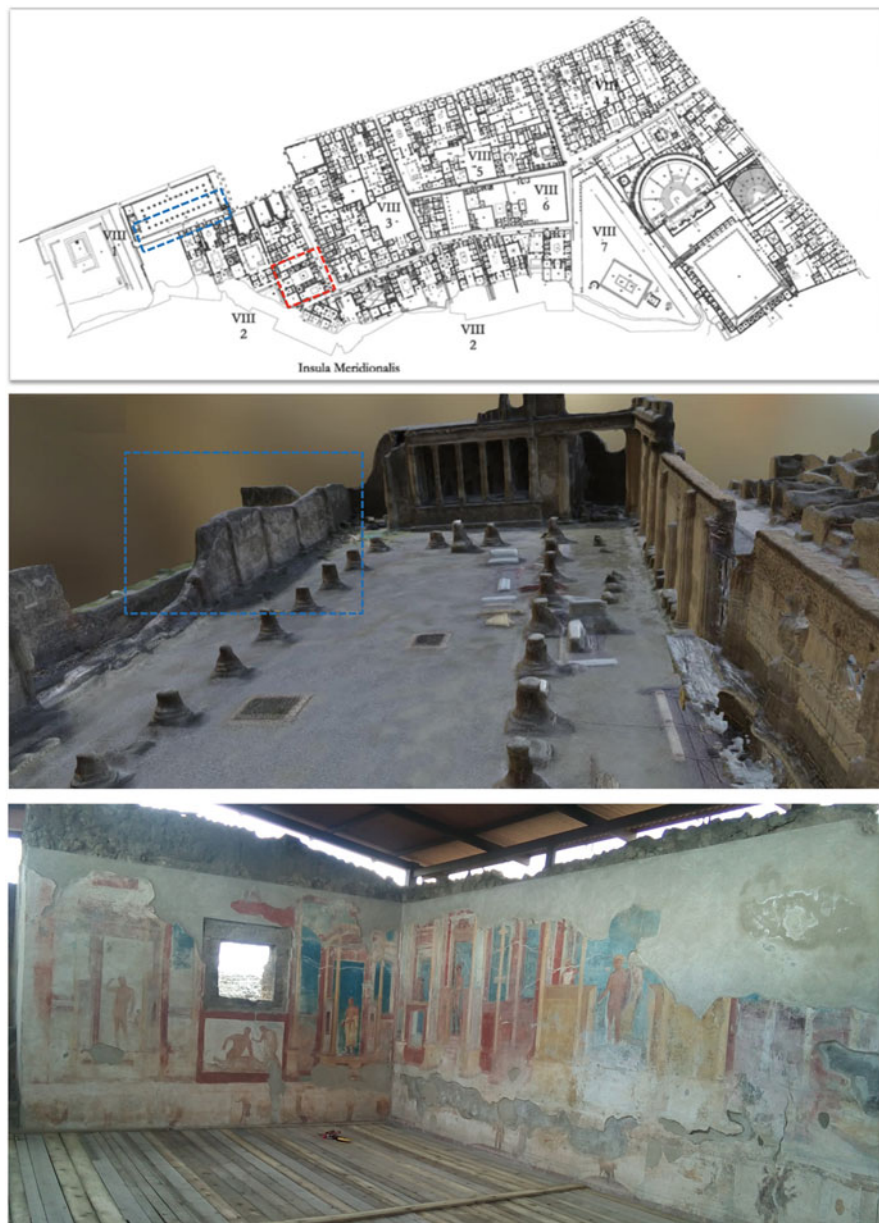
**Fig. 29.1** Plan of Regio VIII (*top*), three-dimensional (3D) model of Basilica (*middle*), with indication of the investigated area: southern wall of Basilica (indicated with *dashed quadrangular light blue box*) and wall paintings in the Gymnasium in Sarno Baths (*red box*). *Bottom*: detail of the wall paintings

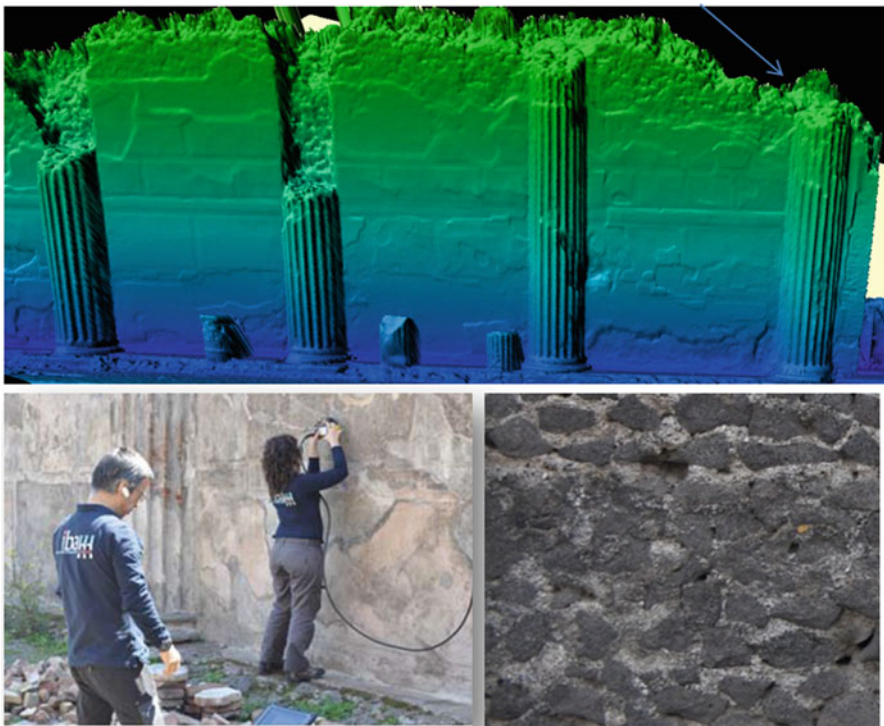
Some walls in *opus incertum* on the southern side of the Basilica have been investigated by GPR and sonic tomography (Fig. 29.2, bottom left) with the aim to evaluate the state of conservation of the masonry, including the detection of possible cracks, fractures, and voids. Before carrying out the noninvasive investigations, several surveys have been conducted with the aim to provide the geometry of the walls, identify possible deformations, and to obtain detailed ortho photographs useful to study the building techniques. The 3D geometry of the walls has been obtained by processing and integrating terrestrial and aerial images taken from a drone by using structures from motion-based software. In this way, it has been possible to establish that the walls do not exhibit significant out-of-plane deformations.

**Fig. 29.2** *Top*: Digital model of southern wall of the Basilica investigated by GPR and seismic tomography. The wall is interrupted by plastered fluted semicolumns built with bricks. *Bottom left*: GPR data acquisition. *Bottom right*: Detail of the masonry composed of irregular stone elements of Peperino

The investigated wall, interrupted by plastered fluted semicolumns, has a thickness of approximately 0.65 m and is partially plastered with mortar composed of pozzolana and sand (Fig. 29.2, upper). The wall is composed of three layers, among which the central one (about 30 cm thick) is sufficiently connected with two adjacent ones about 15 cm thick. The external layers are built by using irregularly shaped and randomly placed first-sized or uncut tuff blocks of dimensions ranging from 12 to 18 cm (Fig. 29.2, bottom right). The central nucleus is also composed by irregularly shaped and randomly placed uncut tuff blocks of dimensions ranging from 8 to 14 cm.

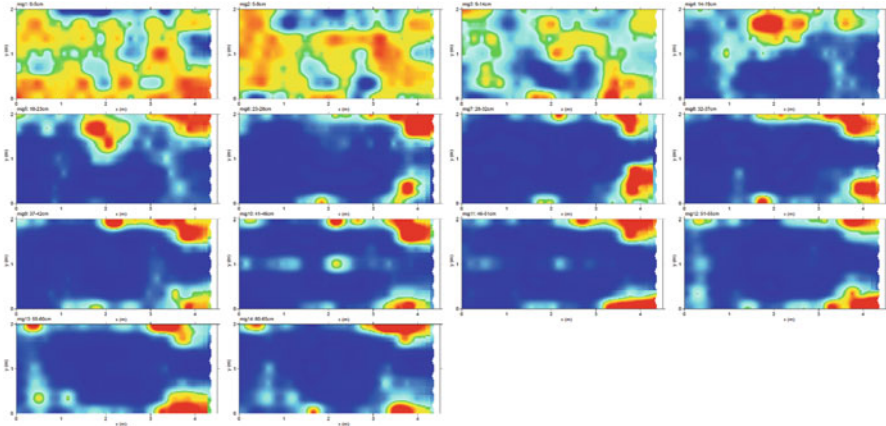
**Fig. 29.5** The Basilica walls: depth slices

within overlay time windows of width  $\Delta t = 1$  ns. The selected two-way time interval corresponds to a wall layer, approximately 0.04 m thick, and the time slices are located between 0 and 0.65 m in depth. The slices shown in Fig. 29.5 were obtained using the processed data. Several events are visible as high-amplitude anomalies. All anomalies are discontinuous and related to the presence of cracks and voids.

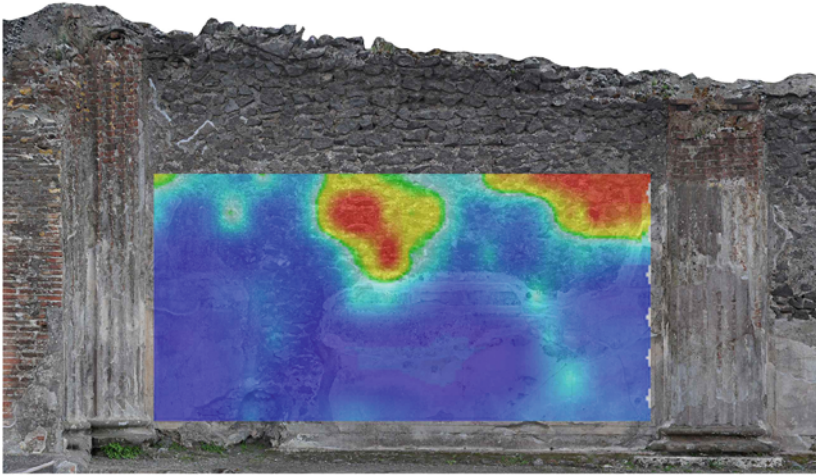
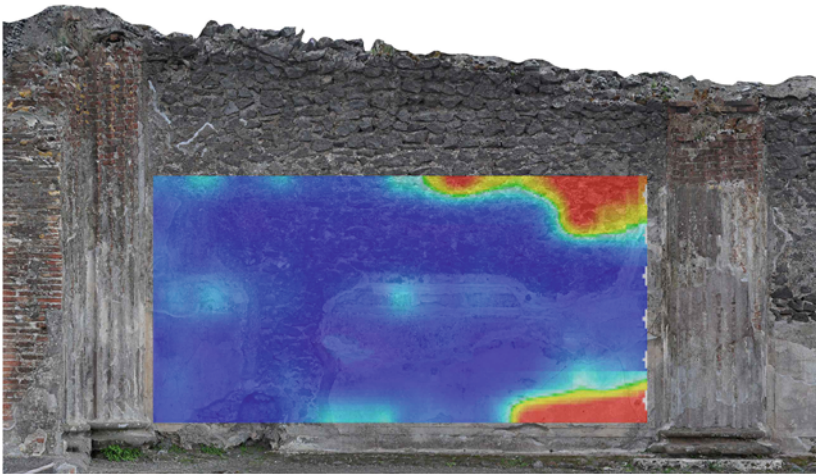
GPR time slice at 18-23 cm depth

GPR time slice at 46-51 cm depth

Fig. 29.6 GPR time slices at depths of 18–23 cm and 46–51 cm

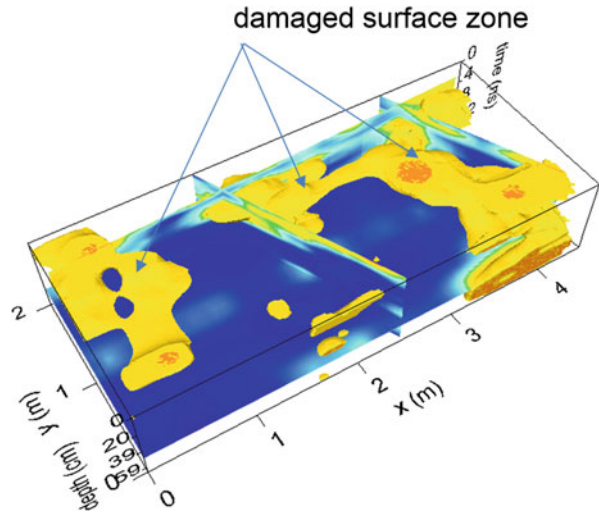
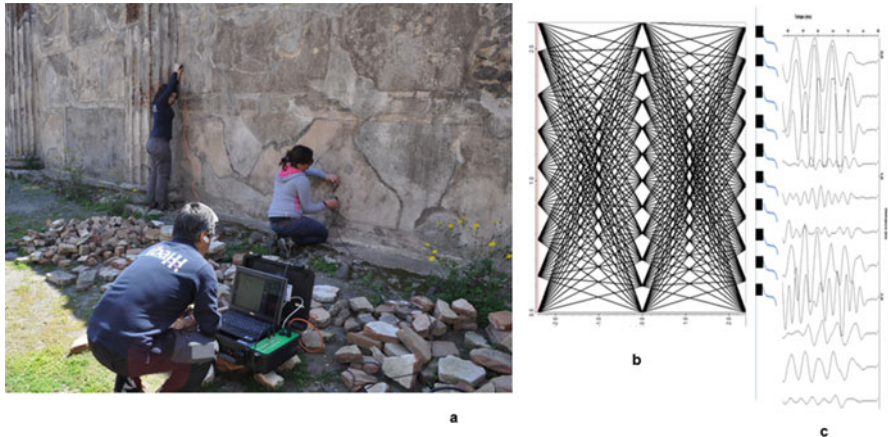
Seismic tomography of the Basilica walls consisted of 3D reconstruction based on the travel-refracted wave amplitude. Images were obtained from the first arrival of the waves. Data were acquired obtained along the 4 m × 2 m area (Fig. 29.8a).

**Fig. 29.7** The Basilica walls: iso-amplitude surfaces using a threshold value of 60%

**Fig. 29.8** The Basilica walls: seismic tomography. (a) Position of the accelerometers on the wall. (b) Ray paths in a hypothetic homogeneous wall. (c) Seismogram

A piezoelectric pulse at 55 KHz was used as the seismic source. Data were acquired with a high-frequency sensitivity accelerometer (55 KHz).

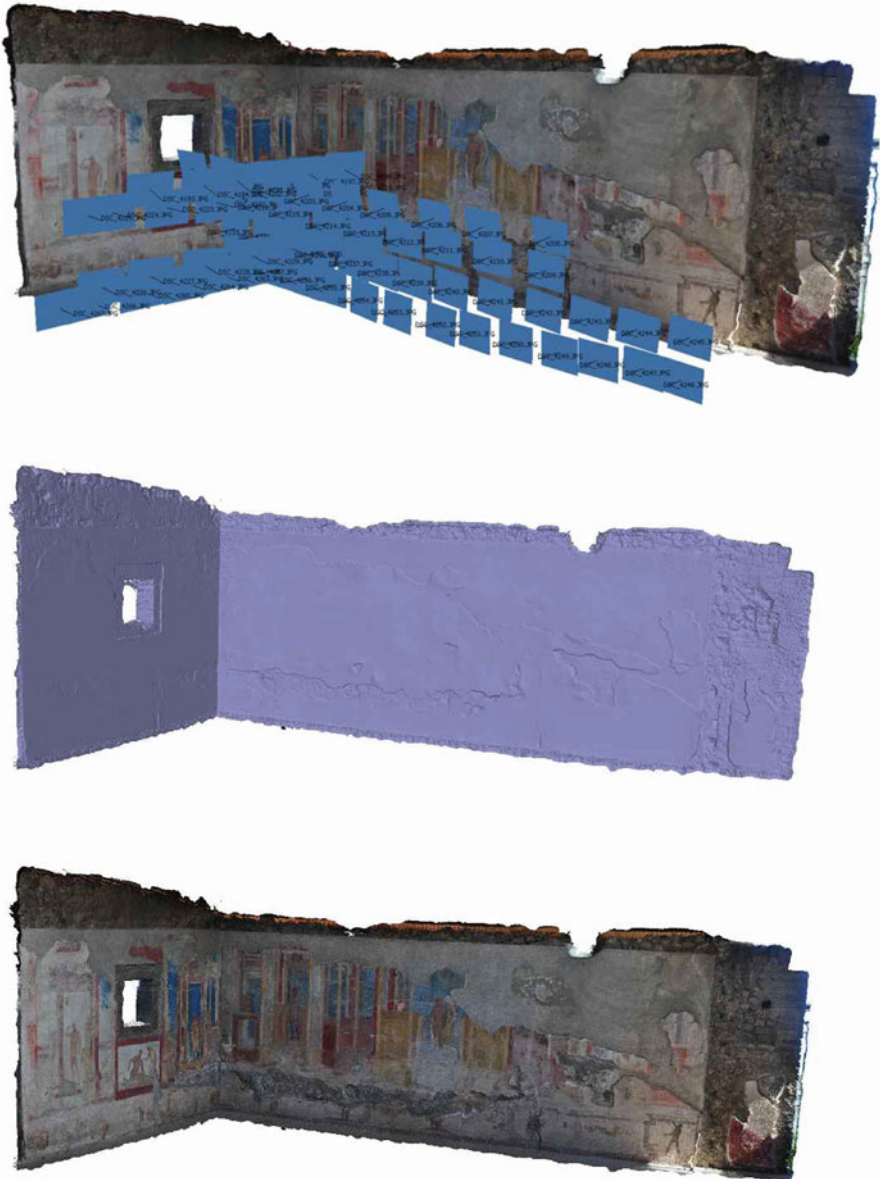
Before GPR and IRT inspections, an architectural survey was performed by structure-from-motion photogrammetry, by processing multiple photographs with a large overlap. In this way, orthophotographs and digital models of the wall paintings were achieved whose details allowed us to map decay pathologies of paintings. Figure 29.12 shows the 3D visualization of the two wall paintings located at South and East, respectively. The 3D mesh and textured models (Fig. 29.12: upper and bottom, respectively) indicate the lack of the external layer of fresco as well as other decay pathologies such as deposits, biological patina, and efflorescence (salt coating).

**Fig. 29.12** 3D mesh and textured model of the wall paintings in the Gymnasium

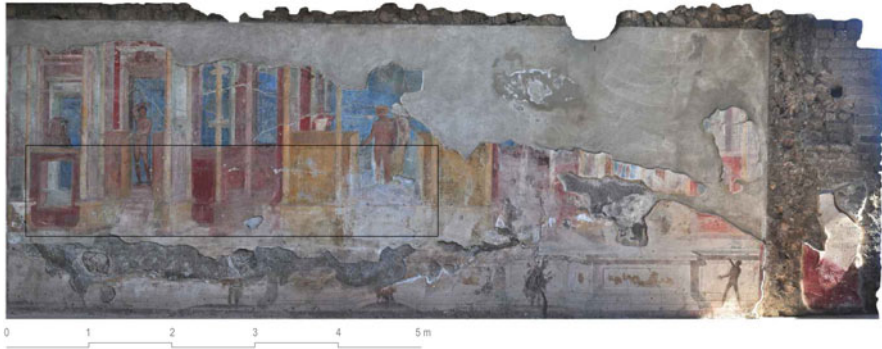
For sake of brevity we discuss only the results obtained from GPR and IRT investigations on one of the two investigated wall paintings, in particular, the largest one (south wall), shown in Fig. 29.13.

**Fig. 29.13** The Gymnasium: Orthophotograph of the south wall painting. The *black rectangular box* denotes the area of fresco investigated by GPR

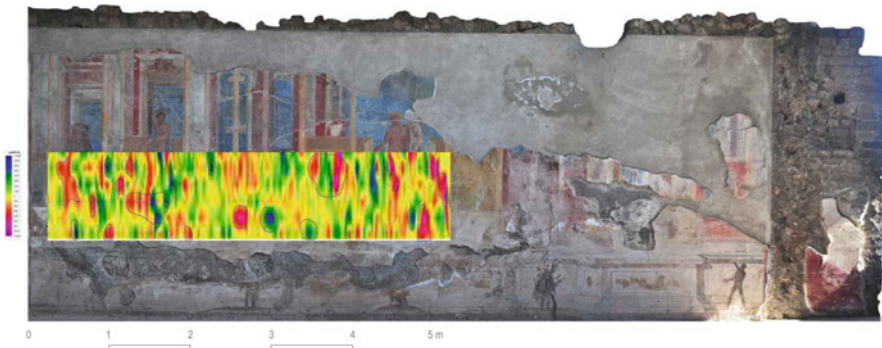
**Fig. 29.14** The Gymnasium: Detail of the wall painting with GPR time slice at 4.7 cm depth. *Light blue lines* border areas characterized by high amplitude

The highest values of radar amplitude are observed at the depth of 4.7 cm in correspondence to the interface between the plaster (the third layer, the deep *arriccio*) and the wall (see Fig. 29.14). Other significant values of radar amplitude

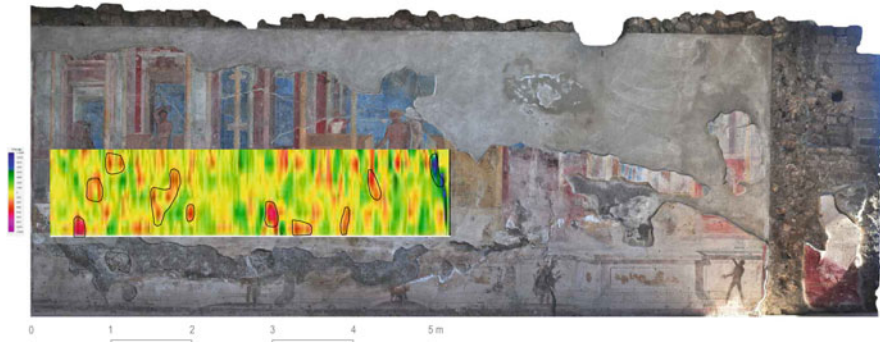
**Fig. 29.15** The Gymnasium: Detail of the wall painting with GPR time slice at 3.5 cm depth. *Black lines* border areas characterized by high amplitude likely referable to detachment between two plaster layers (arriccio and deep arriccio)

are at a depth between 2 and 3 cm near to the interface between ‘arriccio’ and ‘deep arriccio’ (see Fig. 29.15).

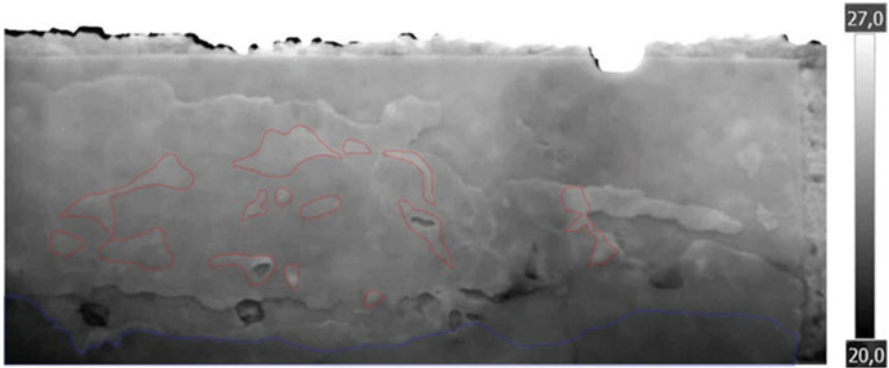
**Fig. 29.16** The Gymnasium: Detail of IRT image of the wall painting. *Red lines* border areas characterized by thermal anomalies likely referable to detachment. *Blue lines* indicate areas affected by rising damp

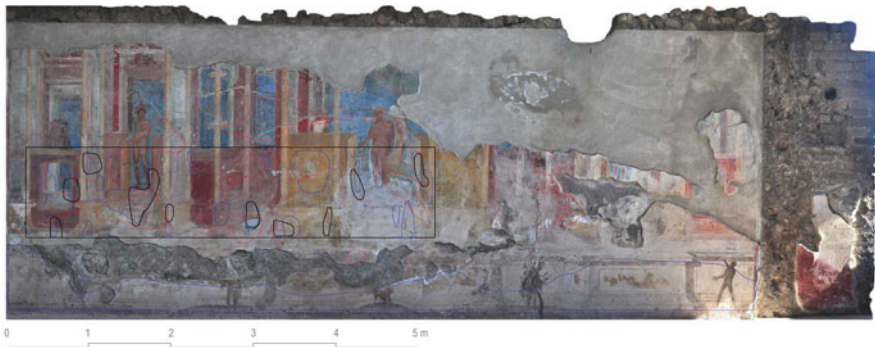
The integration and fusion of GPR and IRT methods (see Fig. 29.17) provided a map of possible areas of interest likely referable to decay pathologies or inhomogeneities in the multi-layered structure of the frescoes.

In particular, the matching between GPR reflectors and thermal anomalies could be reasonably considered an indicator of detachments or scarce adherence between plaster and wall or of problems of delamination between the plaster layers.

**Fig. 29.17** The Gymnasium: Detail of the wall painting. *Black and light blue lines* border areas characterized by high-amplitude GPR at 3.5 and 4.7 cm depth, respectively. *Red lines* border areas characterized by thermal anomalies. *Blue lines* indicate areas affected by rising. The images show that most of the thermal anomalies are characterized by GPR at high amplitude at 3.5-cm depth, likely resulting from the presence of detachment or scarce adherence between the plaster layers of the fresco
