An Early Warning System of Unstable Slopes by Multi-point MEMS Tilting Sensors and Water Contents

Abstract

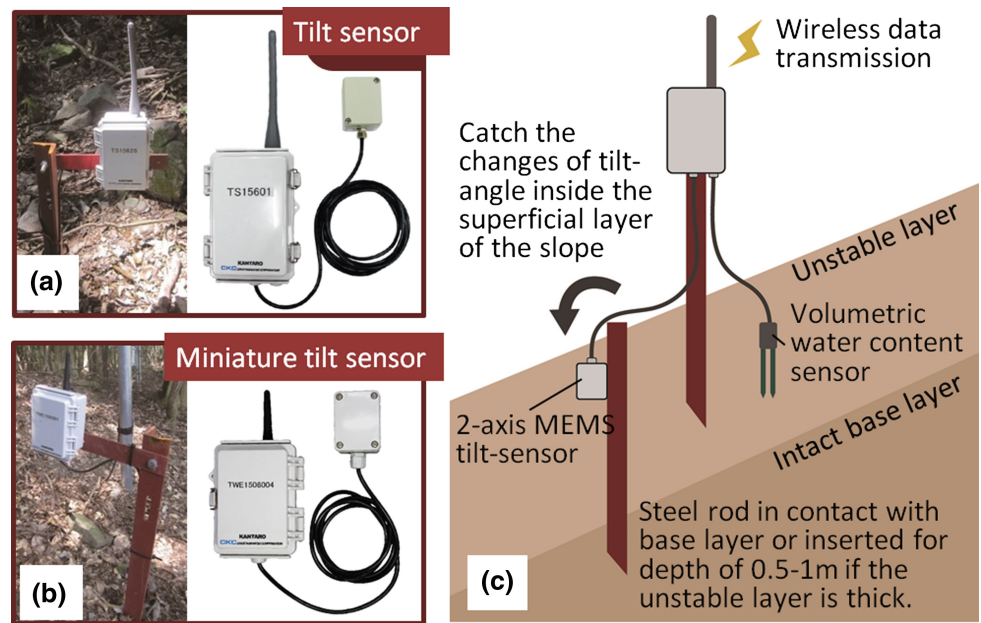
Fig. 1 Schematic illustration of MEMS tiltmeter sensor for early warning

In this paper, an early warning system for slope failure is proposed and its development is described (Fig. 1) (Uchimura et al. 2011). The system consists of a minimum number of low-cost sensors strategically placed on a slope, with monitoring data that are collected being transmitted via

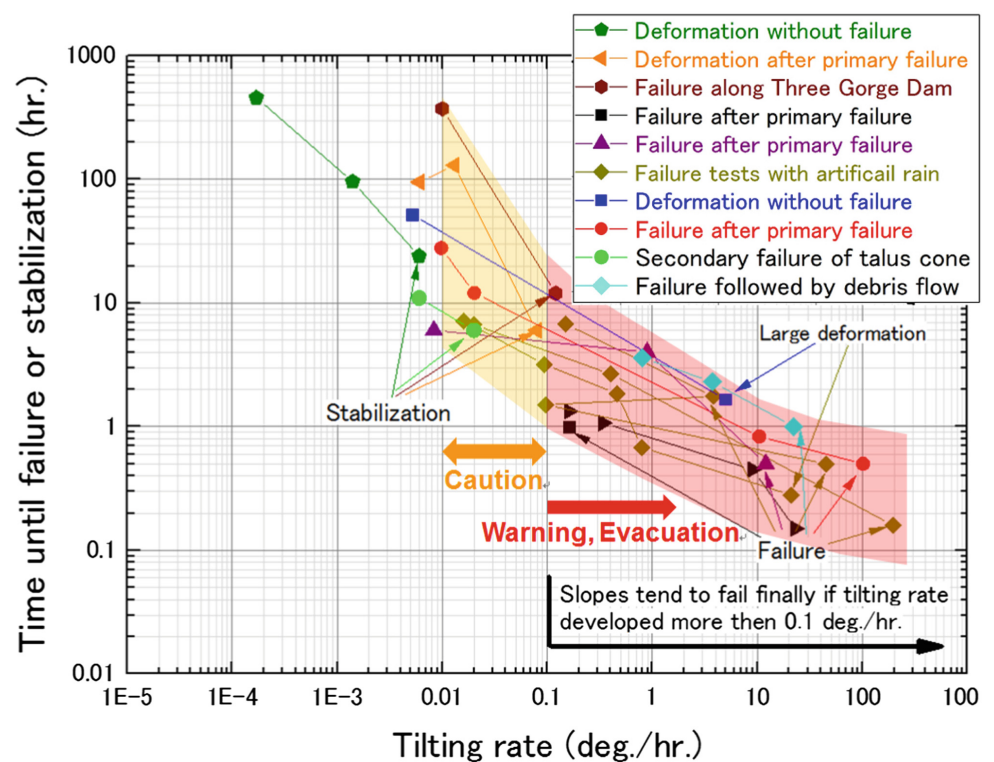
Fig. 2 Graphic illustration of the tilting rate as a function of time before slope failure (or stabilization) for several case studies

Uchimura et al. (2015) summarized case studies of slope tilting rates during pre-failure stages obtained on several natural slope sites under natural or artificial heavy rainfall. Figure 2 presents an example of the typical monitoring data

obtained, in which the tilting rate (X-axis) can be related with the time elapsed until slope failure or slope stabilization (Y-axis). Figure 3 shows the definition of the tilting rate and the time in Fig. 2, in which T_i is the time until failure or stabilization, and R_i is tilting rate.

According to Fig. 2, the order of tilting rate observed with slope deformation varied widely, from 0.0001 to 10°/h depending on a number of factors. The tilting rate tends to increase towards failure with a relatively short time until failure, when a higher tilting rate is observed. The observed tilting rate was >0.01°/h for all the cases in which the slope failed or nearly failed, while it was <0.1°/h for all other cases. Durations of 1–10 h were observed before failure for a tilting rate of 0.1°/h.

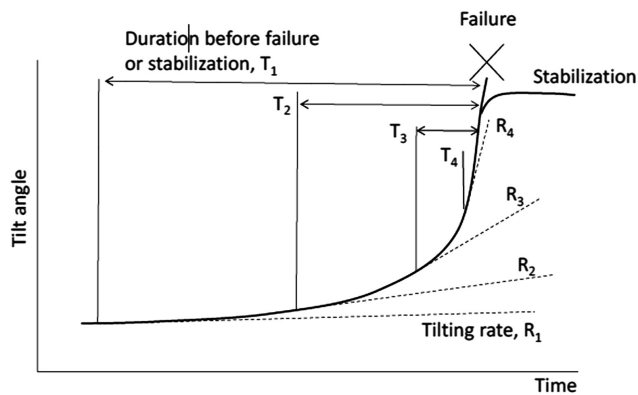
Fig. 3 Definition of the tilting rate and the durations

In cases where the slope failed at the position of the tilt sensor, the elapsed time is measured from the time when

tilting accelerated to the time of failure. In cases where the slope did not fail but instead stabilized, the time is measured from when tilting decelerated to the time when the slope stabilized.

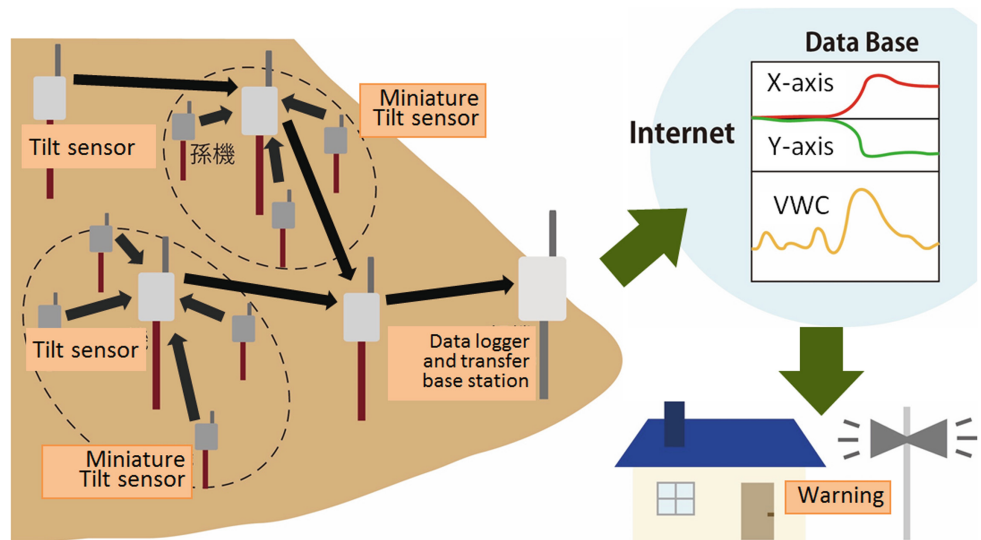
Fig. 4 An early warning system of slope failure by multi-point tilt and volumetric water content

Figure 4 illustrates the typical arrangement of two types of proposed sensors, with data transfer pathways also shown. Despite the advantages described above, the new type miniature tilt sensors have relatively short radio transmission distances (~30 m in non-ideal conditions). They are arranged densely on high-risk areas of a slope, with one conventional tilt sensor unit collecting all the data of each area. The data are transmitted over greater distances (300–600 m), and uploaded to an internet server.

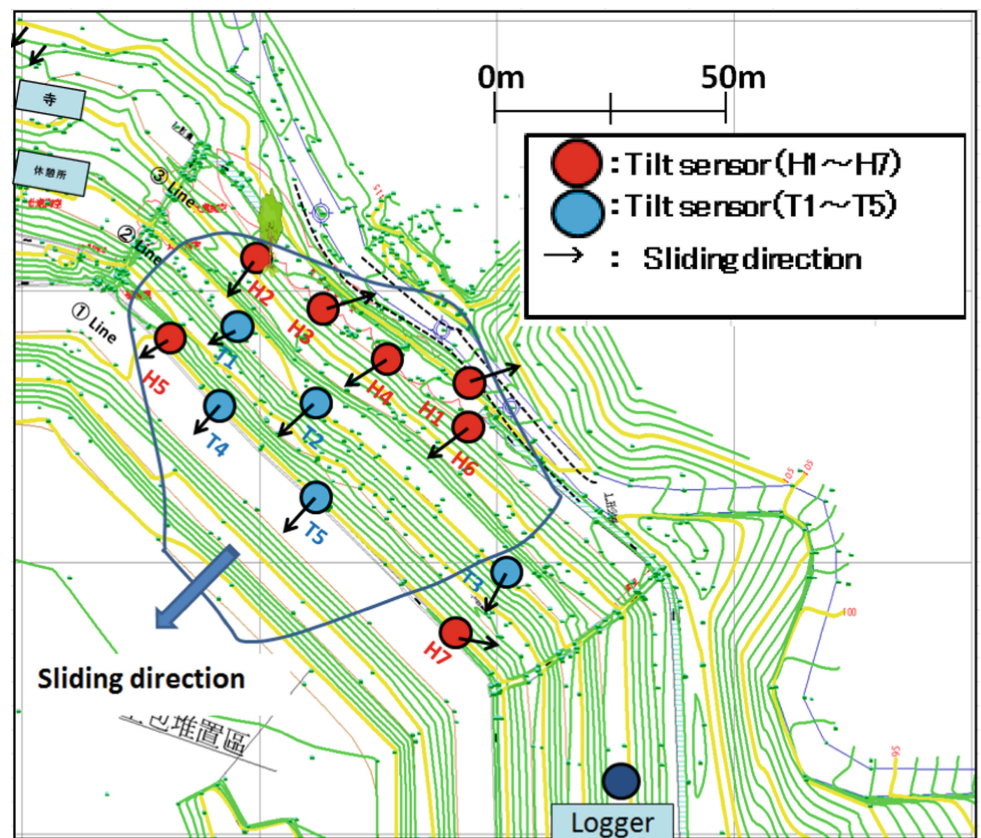
Fig. 5 Arrangement of the tilt sensors on the moving cut slope

Prototypes of the proposed new sensor units were installed on a cut slope site in Yenchoo, Kaohsiung, Taiwan at the end of 2014. The slope is on a municipal waste disposal site, and the cut slope began moving gradually after excavation works were conducted during construction. The slope, consisting of modern clay shale, is sliding along the established geological jointing direction (Fig. 5).

Figure 6 shows typical tilt behaviors of X-axis, and Fig. 7 shows Y-axis behaviors with time histories. These data were obtained from 21 to 30 May 2015. Because of one week continuous rainfall shown in Fig. 8, the Sensors H5, T4, T3 showed some significant inclination changes. The tilt behavior varied across sensors and there was some time delay following the heavy rainfall event. Notably, it was also found that T3, which is outside of the sliding block, recorded movement after the heavy rainfall event. Distribution of surface tilt behaviors, together with time histories, can be determined based on these data, the movement histories of every sensors can be recorded as shown in Fig. 5.

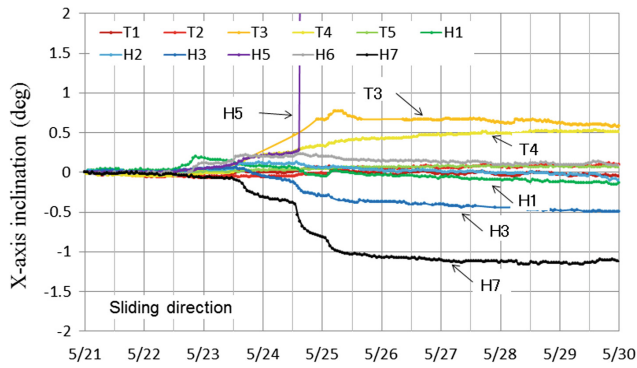
Fig. 6 Time histories of X-axis inclinations

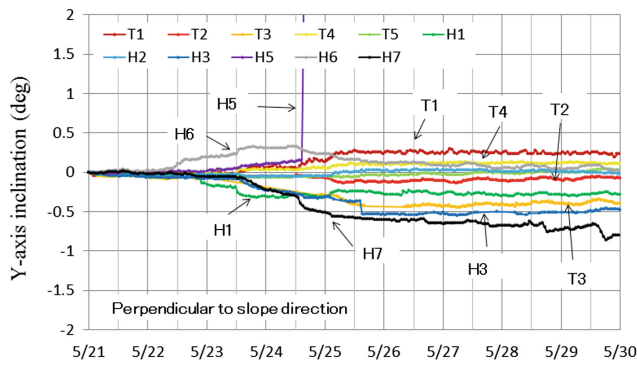
Fig. 7 Time histories of Y-axis inclinations

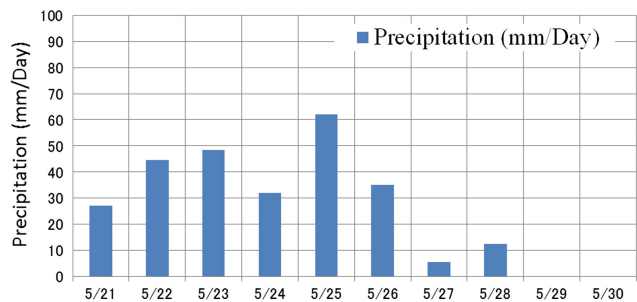
Fig. 8 Rainfall record during the disaster in 2015

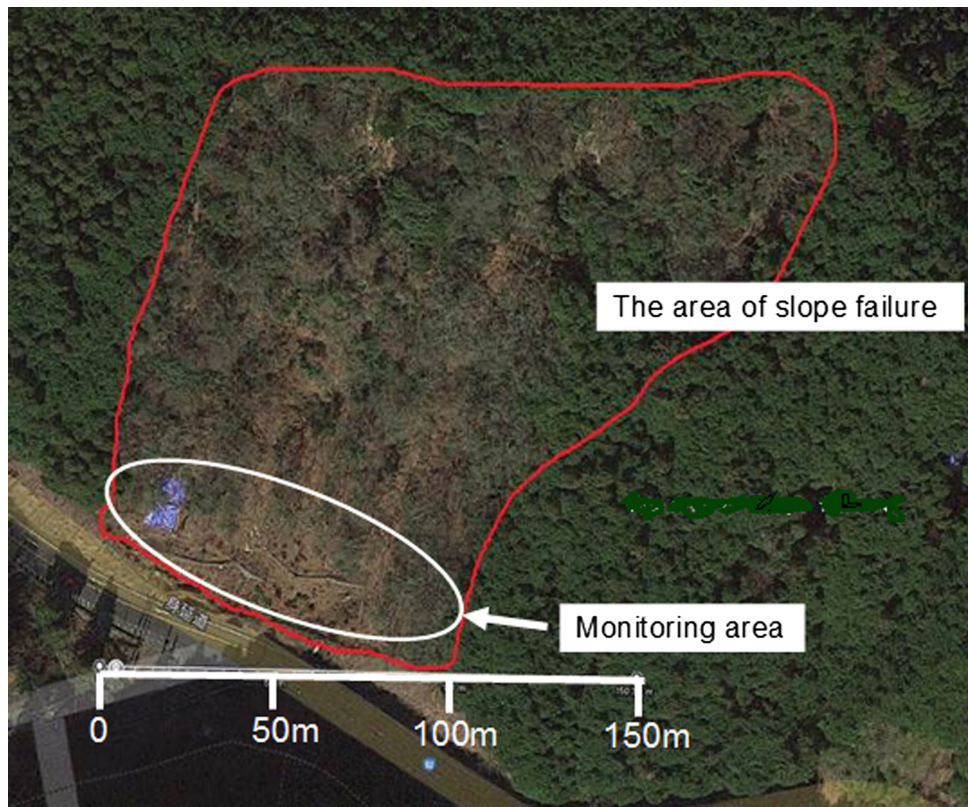
Fig. 9 Area of slope failure at Manzawa site, Japan

Figure 9 shows the scale of Manzawa slope failure site, and Fig. 10 shows the arrangement of the multi-point tilt sensors and locations, where two types of tilt sensor were used. The arrangement interval of the sensor is designed to five meters. A total of 66 sets of sensors were deployed.

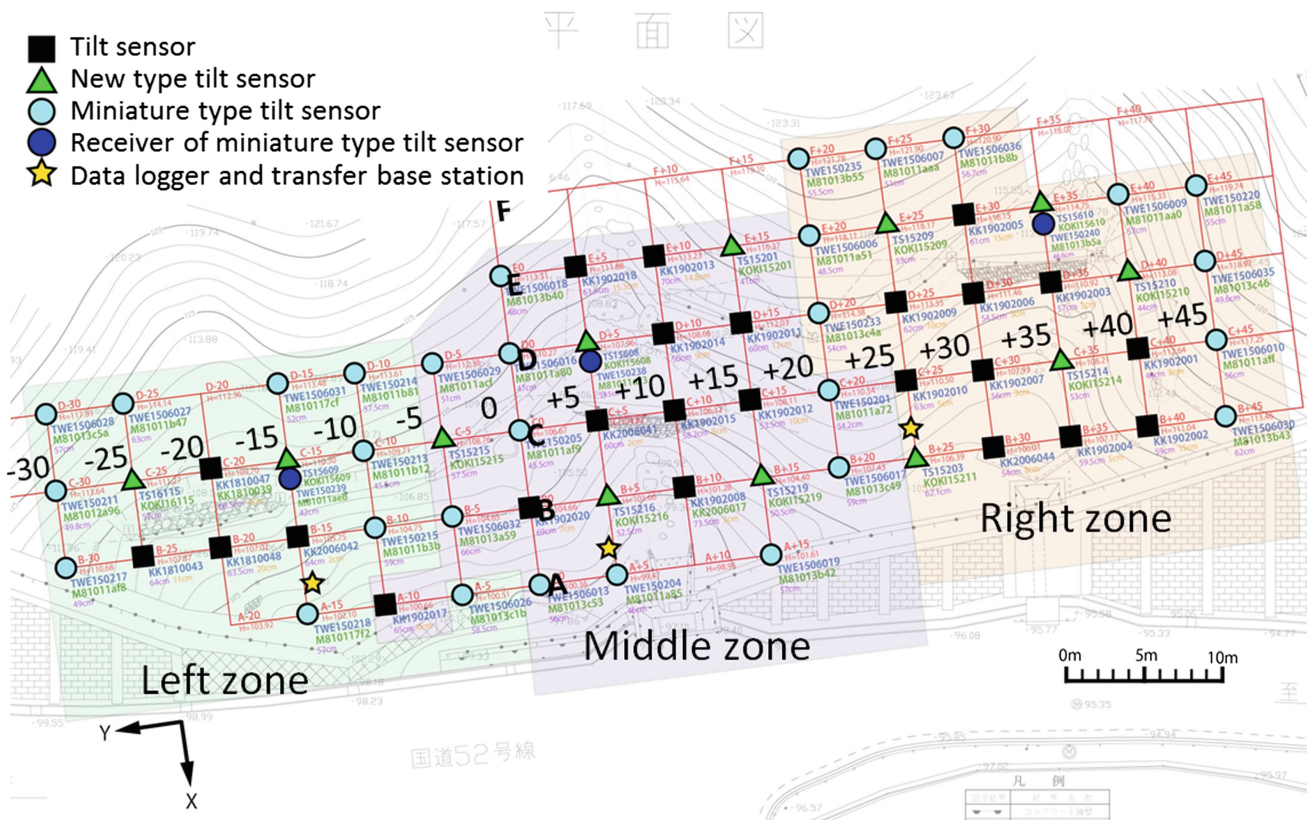
Fig. 10 Arrangement of the multi-point tilt sensors

The 66 sensor units are divided into three groups, left/middle/right zone, and one data receiver unit and one logger/gateway unit for internet collect all the data from respective group as shown in Fig. 10. There were eight heavy rainfall event during summer of 2015 shown in Fig. 11, and the tilt angles accumulated distribution due to each rain are summarized as Fig. 12. The tilting rate averaged during each rainfall event is shown in Fig. 13. Distribution of tilting behaviors is figured out by multi-point monitoring.

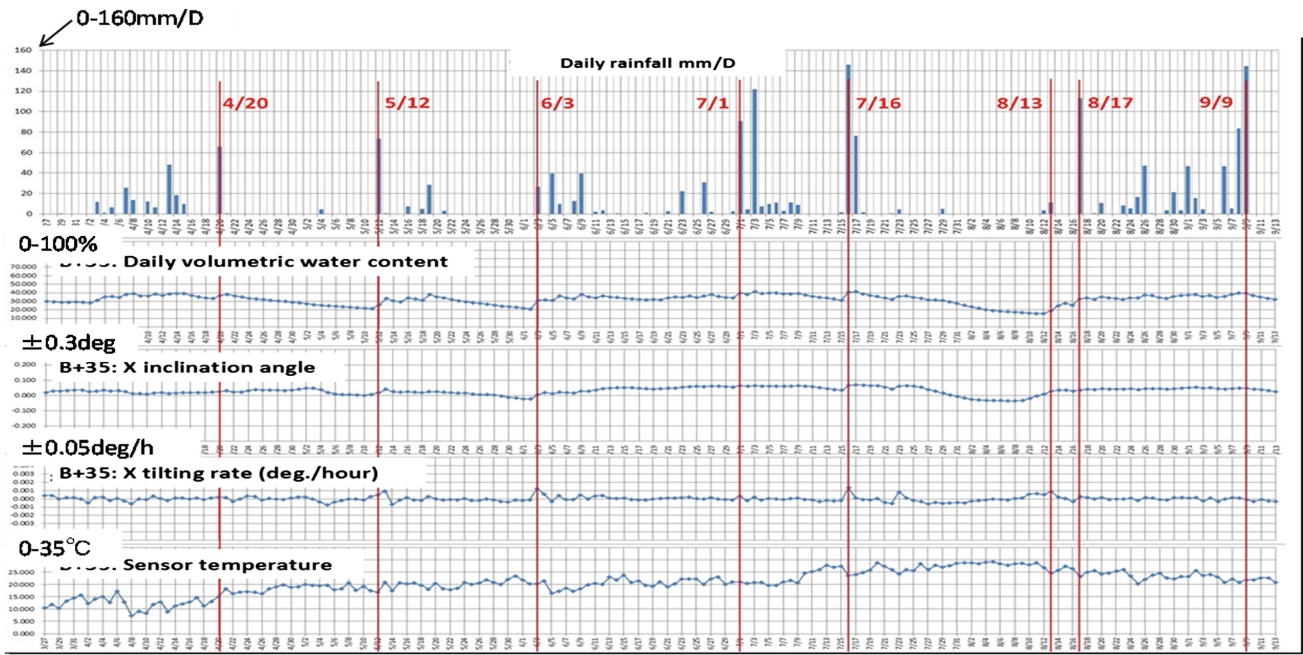
Fig. 11 Time histories of movements in rainy days

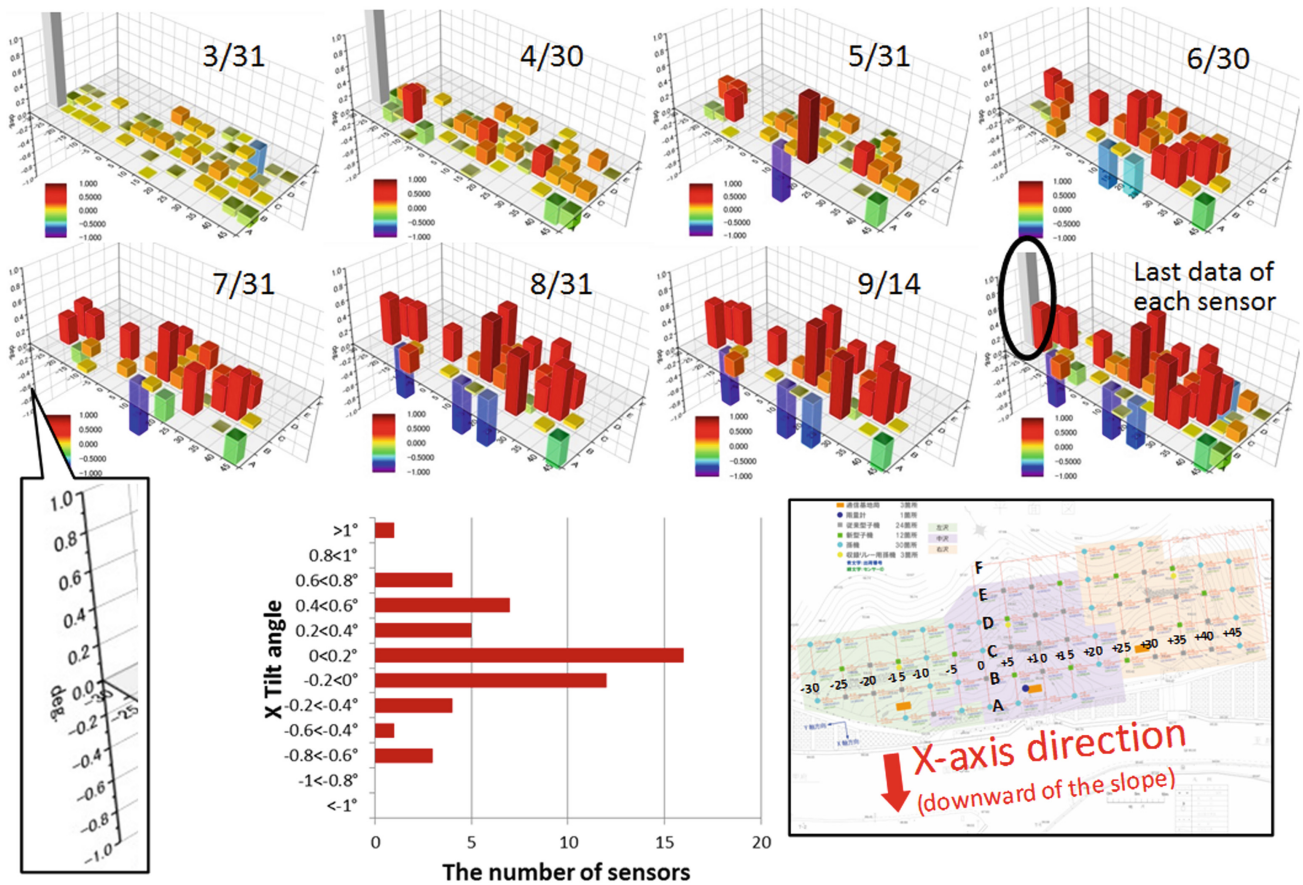
Fig. 12 Distribution of accumulated inclination angle

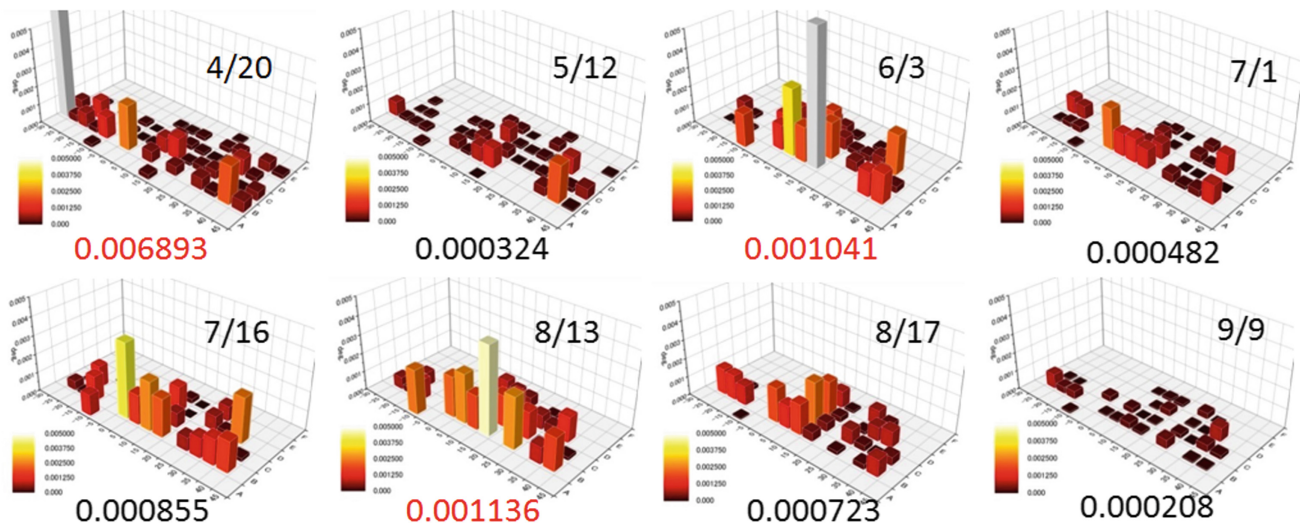
V_{alarm} X in rainy days (deg./hr.)

Fig. 13 Distribution of tilting rates during each rain day

Here, n is serial number of tilt sensors, V_n is tilting rate of slope sliding direction at the n-th sensor, A_n is the area of installation of the n-th sensor, A_0 is the total area of monitored slope, and n is a constant weight for the n-th sensor decided considering geology, geography, vegetation, and other factors. As the simplest example, values calculated with $n = 1$ for all the sensors are indicated in Fig. 14. The rain on 4/20, 6/3, and 8/13 caused relatively higher value of V_{alarm} in this case, but did not exceed precaution threshold of $0.01^\circ/h$.
