Complications of First Metatarsal Phalangeal Joint Implants

Laurence G. Rubin and Michael Gentile

M.S. Lee, J.P. Grossman (eds.), Complications in Foot and Ankle Surgery, DOI 10.1007/978-3-319-53686-6_14

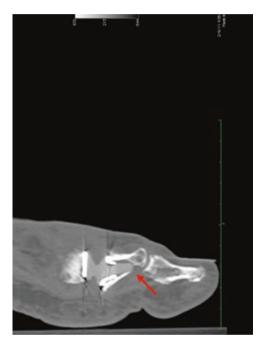
Fig. 14.1 Detritic synovitis from a silicone implant

The type of implant material plays a crucial role in the mode of failure. Silicone of the past presented with varying degrees of detritic synovitis and cystic changes in the bone due to shards of silicone breaking loose over time [8, 9] (Fig. 14.1). Contemporary silicone implants hold up better and reports of such failure have diminished. In addition, the introduction of titanium grommets also improved the situation [10, 11]. There can still be bone erosion secondary to the movement of the implant within the bone (Fig. 14.2).

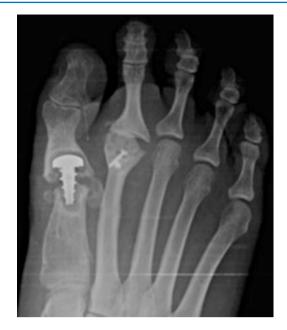
Fig. 14.3 Loosening and subsidence of a hemi-implant

in hemi- and total implants. This will often have significant bony destruction. Even in the case of a hemi-arthroplasty, bone loss can be significant enough that revision requires the use of a structural bone graft to restore normal metatarsal weight-bearing parabola [5, 12, 13] (Figs. 14.3 and 14.4).

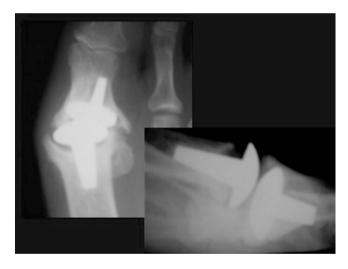
Fig. 14.4 Loosening of the implant in the head of the metatarsal and subsidence of the implant into the base of the proximal phalanx

Weight-bearing plain films are evaluated for the presence of peri-implant lucency (Fig. 14.4). This likely suggests instability but should also be considered as a sign of infection if coupled with other clinical evidence. An inventory of bone loss and disturbance of the weight-bearing parabola is taken and severity determined. This is an essential component of the evaluation as this will have a profound impact on the reconstructive plan. With defects of >1 cm, serious consideration should be given for a staged reconstruction. Acute correction of defects of this size or larger may result in vascular and/or neural injury.

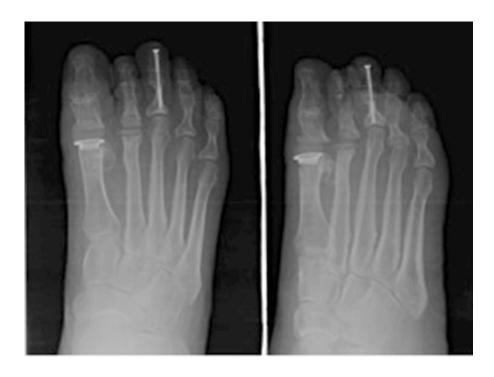
Fig. 14.12 Resection implant arthroplasty

Subsidence, bone over growth, or implant failure can occur over time. These can be handled by either excisional implant arthroplasty or conversion to an arthrodesis. Excisional implant arthroplasty will give the patient a short toe and will most likely not be a stable platform for propulsion (Figs. 14.11 and 14.12).

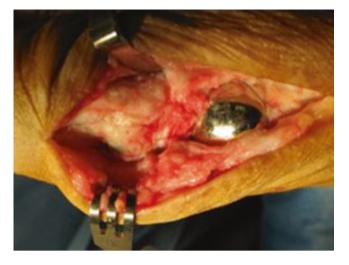
Fig. 14.13 Subsidence of implant

Arthrodesis can be a technically challenging procedure but will allow the surgeon to maintain length and provide stability to the hallux, which will aid in propulsion. Once the decision to remove the implant and convert to an arthrodesis has been made, the surgeon will need to decide whether the patient will need a bone block graft to maintain length or whether an end to end fusion is possible. Even if an end-to-end fusion is planned, it is advised to be prepared to have grafting material available to fill in the bone defects from the implant removal. Garras et al. [5] required bone graft in all 18 fusions. Both Garras [5] and Gross [20] showed there was a longer time to fusion than a primary arthrodesis. Gross [20] also had a 58% reoperation rate in their study. Fusions, after implant failure, should follow the same basic surgical principles as any other fusion. The surgeon must debride to healthy bleeding bone and fixate the fusion. The debridement will often remove more bone than anticipated. In cases where a bone block graft is used, the fusion should be fixated with a plate (Figs. 14.13, 14.14, 14.15, 14.16, and 14.17).

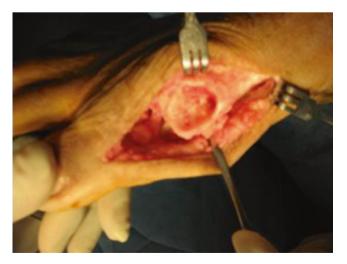
Fig. 14.15 Debridement of the bone after the implant is totally removed
