Flash Flood Hazard Assessment in an Ungauged Piedmont Basin in the Sierras Pampeanas Western Region, Province of Córdoba, Argentina

Karina V. Echevarria, Susana B. Degiovanni, Mónica T. Blarasin
and M. Jimena Andreazzini

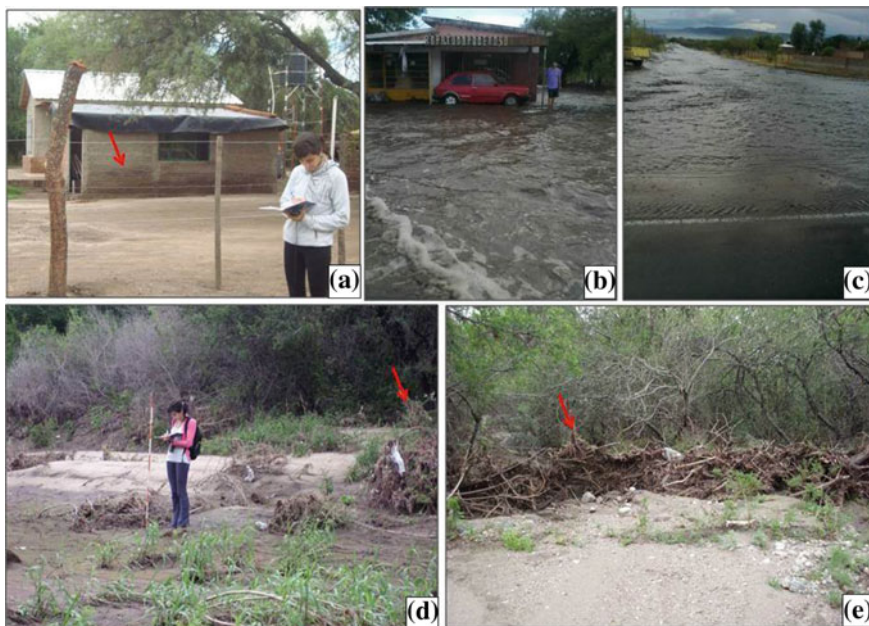
Fig. 10 Water height during the flash flood (a, b, c) and water-level marks considering the vegetation (d, e). Photograph locations in Fig. 9: a P4, b and c P5, d P1, e P3

Flood mark observations indicate that the height reached by the water was not higher than 1.5 m, decreasing significantly in the direction of national route 20.

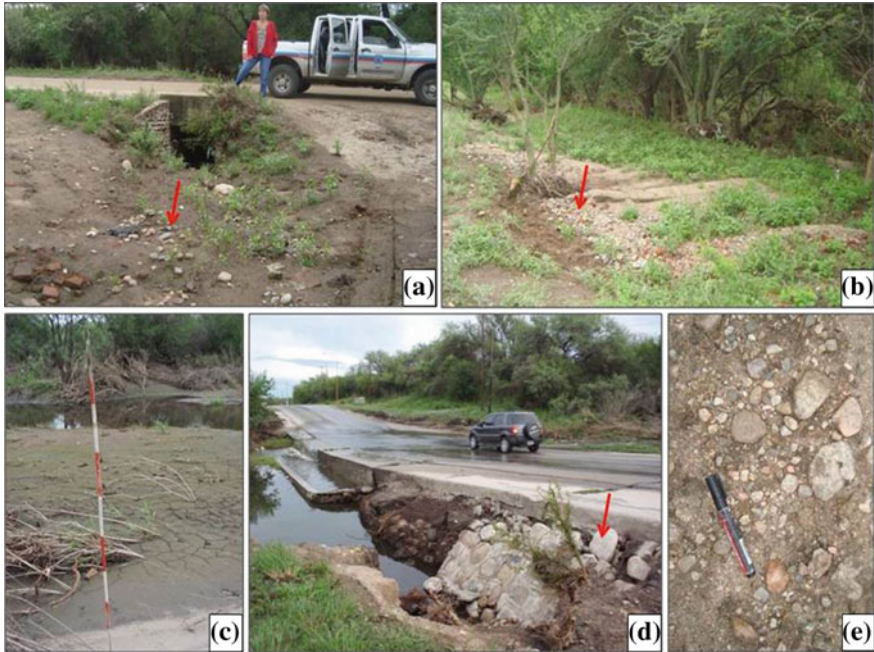
Fig. 11 Clasts transported by the flow during flash flood event. Photograph locations in Fig. 9: **a** P4, **b** P3, **c** and **d** P1, **e** P2

Downstream of P1, in the middle to lower reaches of the Arroyo Chuchiras, the threat is spatially distributed, conditioned mainly by the geomorphological characteristics and processes in the alluvial fan. At this point, water can circulate westward to national route 148 or drive along the NW–SE topographic depression toward national route 20, as it was the case in the event of flood analyzed. In this area, the depth roads constitute a pathway of water circulation, where the velocities are equal to or less than 2 m/s, with clast sizes mobilized by the stream that vary between 76 and 140 mm (P2, P3, and P4).
