## The 16 September 2015 Chile Tsunami from the Post-Tsunami Survey and Numerical Modeling Perspectives

**Abstract**—On September 16, 2015 a magnitude Mw 8.3 earthquake took place off the coast of the Coquimbo Region, Chile. Three tsunami survey teams covered approximately 700 km of the Pacific coast. The teams surveyed the area, recording 83 tsunami flow depth and runup measurements. The maximum runup was found to be 10.8 m at only one small bay, in front of the inferred tsunami source area. However, it was observed that runup in other locations rarely exceed 6 m. Tsunami runup was larger than those of the 2014 Pisagua event, despite the similar earthquake magnitude. Moreover, tsunami arrival times were found to be shorter than those of previous tsunamis along the Chilean subduction zone. Numerical simulations of the tsunami event showed a good agreement with field data, highlighting that tsunami arrival time and the spatial variation of the tsunami amplitudes were strongly influenced by the bathymetry, coastal morphology and the slip distribution of the causative earthquake.

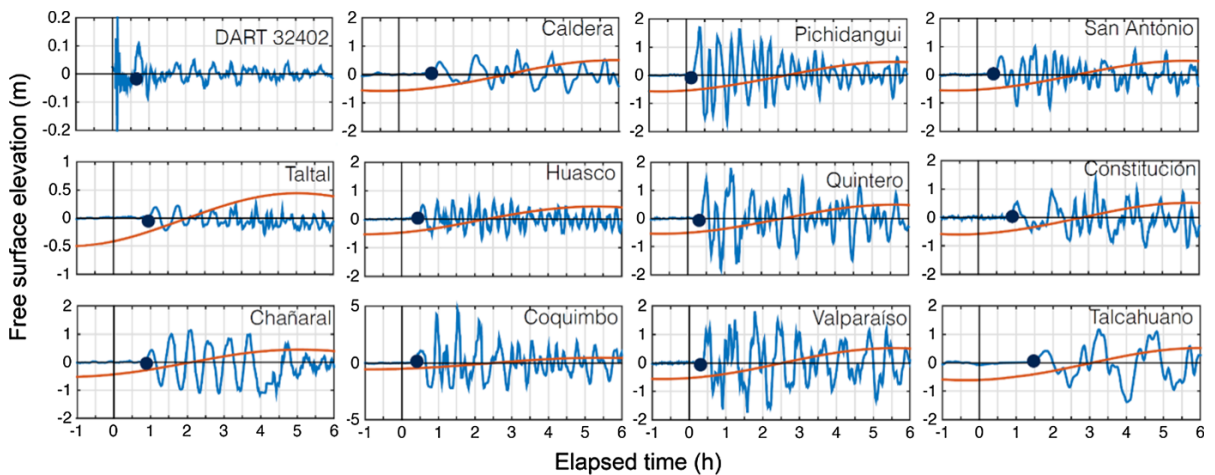
Figure 2

Tide gage records of the 2015 Illapel tsunami at locations indicated in Fig. 1a. The red line indicates the predicted tide level during the tsunami

wave, after which tsunami oscillations were persistent and periodic, but did not exceed 2 m in amplitude. About 100 km south of the rupture, the tsunami arrived at Quintero and Valparaíso within

23 min. The maximum amplitude of the first wave was 1.5 m, 30 min after the shock at Quintero and 1.22 m, 34 min after the shock at Valparaíso. However, the maximum amplitude at Valparaíso was

found to be much lower than at Coquimbo, reaching 1.90 m 108 min after the earthquake. Tide gage stations located farther north and south show a significant decrease in tsunami amplitude, with amplitude not exceeding 1 m. However, the behavior was noteworthy at Chañaral (26.32°S, 70.60 W) and Talcahuano (36.71°S, 73.11 W), where tsunami amplitudes were larger than stations located closer to the rupture patch, such as San Antonio and Constitución. Talcahuano was one of the most affected areas during the 2010 Chile tsunami (FRITZ *et al.* 2011) and large amplification due to tsunami resonance has been identified (YAMAZAKI and CHEUNG 2011; ARANGUIZ 2015). This significant spatial variation of tsunami amplitudes at tide gage stations is consistent with the near-field behavior reported for the 2010 Maule and 2014 Pisagua tsunamis (FRITZ *et al.* 2011; CATALAN *et al.* 2015), and observed for the 2011 Tohoku far-field tsunami.

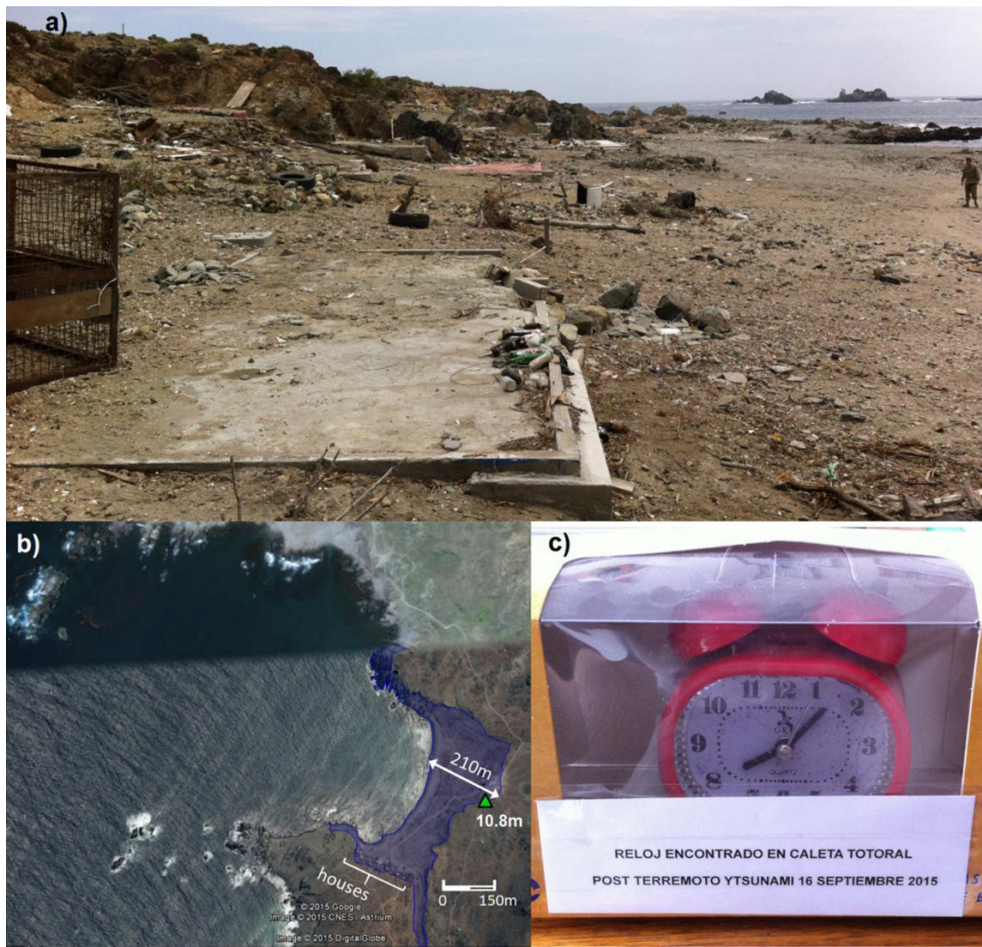
Figure 4

Tsunami impact in Totoral. **a** Remnants of destroyed houses located along the southern shore of the Bay. **b** Estimated inundation area (source: Google Earth). The *green triangle* indicates the measured runup. **c** Clock found at Totoral with time indicating the arrival of the first flooding

inland and washed away several wooden houses, leaving only their foundations (Fig. 4). According to local residents, at least five large waves flooded the bay in a slow manner, with an almost uniform inundation height in the whole bay. In addition, the first wave arrived a few minutes after the earthquake. As a proxy for first tsunami arrival time, Fig. 4c shows a clock found by the Chilean Navy at Totoral which stopped at 8:06 pm, arguably due to flooding, suggesting that the village may have been flooded 12 min after the initiation of the earthquake. However, doubts of the clock precision, the exact cause of clock malfunction put uncertainties around that arrival time estimate. Despite the short arrival time, only one person died due to the tsunami in Totoral Village. The body was found at Caleta Hornos, some 90 km north of Totoral (LA TERCERA 2015).

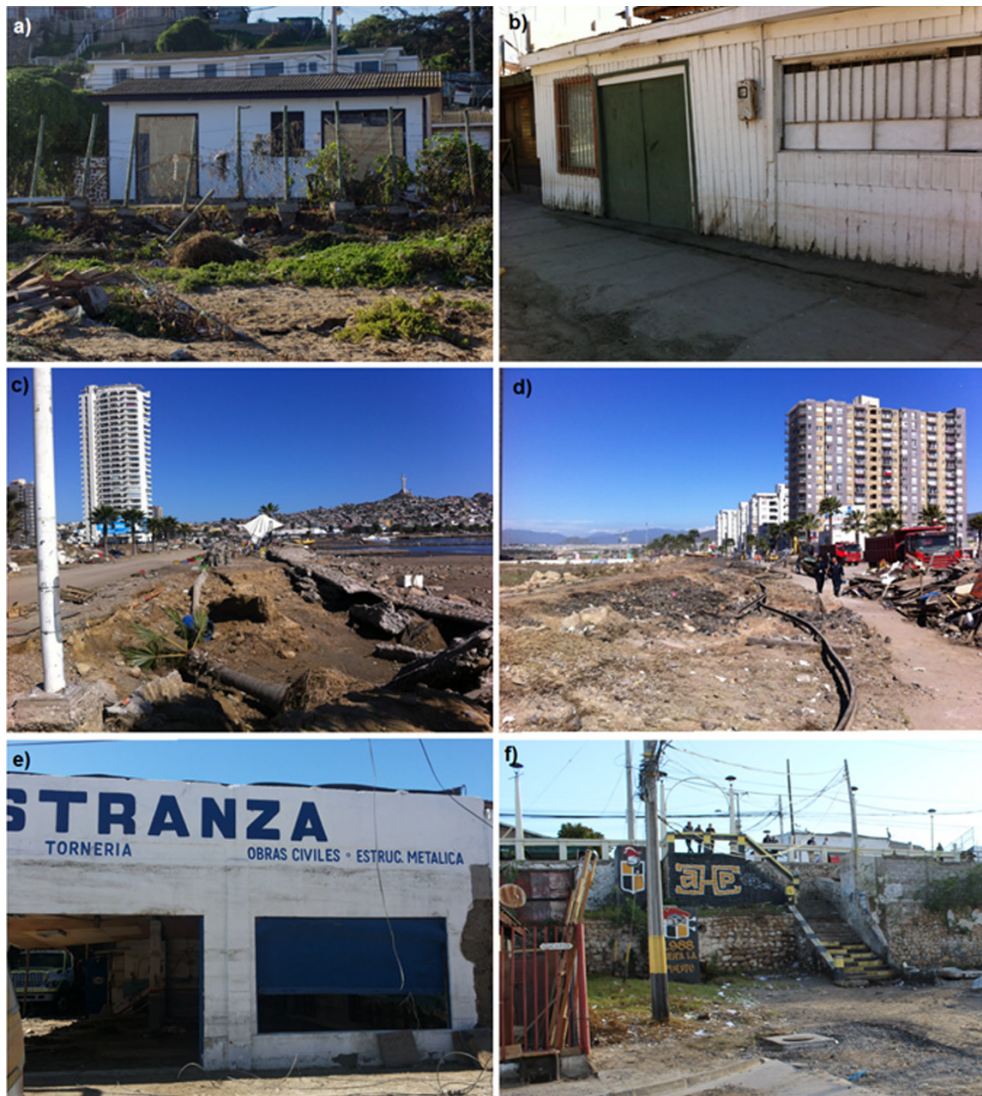
Figure 6

**a** Seaweed and tsunami debris in a fence at Los Vilos. **b** Water mark on a wooden house in Tongoy. **c** Damage on the coastal road in Coquimbo due to tsunami overtopping. **d** Damage on the railway at Coquimbo. **e** Several water marks on a masonry house at Coquimbo. **f** Retaining wall in Coquimbo

steeply sloped, relatively narrow ( $\sim 70$  m) and is backed by an almost vertical cliff at the southern end. Consequently, inundation extent was only about 150 m. Despite this, the tsunami inundated the first line of houses and in some cases drifting boats from the pier located at the southern end of the bay travelled to the northern side and caused significant destruction (Fig. 6a).

The greatest tsunami inundation distances were found in the north-facing bays of Coquimbo and Tongoy. In Coquimbo Bay we measured a maximum inundation distance of 700 m. Near this area of maximal tsunami penetration, tsunami waves overtopped the coastal road as well as a railway embankment, generating severe damage on the landward (Fig. 6c, d). The tsunami reportedly arrived from the north with at least three large waves. The number of waves were confirmed during the survey by the number of mudlines observed on sides of flooded houses (Fig. 6e). In the town of Tongoy,

maximum inundation reached 600 m inland, temporarily isolating the Tongoy Peninsula as an offshore island, an effect also reported—albeit at much larger scale—at the northern tip of Sumatra Island during the 2004 Indian Ocean tsunami (BORRERO 2005). In this locality, the maximum runup was 5.72 m, with a very narrow inundation extent, indicative of splashing up, near the eastern shore of the peninsula (Fig. 5) while it was 4.51 m in the town. As mentioned earlier, runup at the western shore of the peninsula reached only 3.89 m. Despite the large inundation height, due to the topography the flow depth ranged between just 1 to 2 m (Fig. 6b).

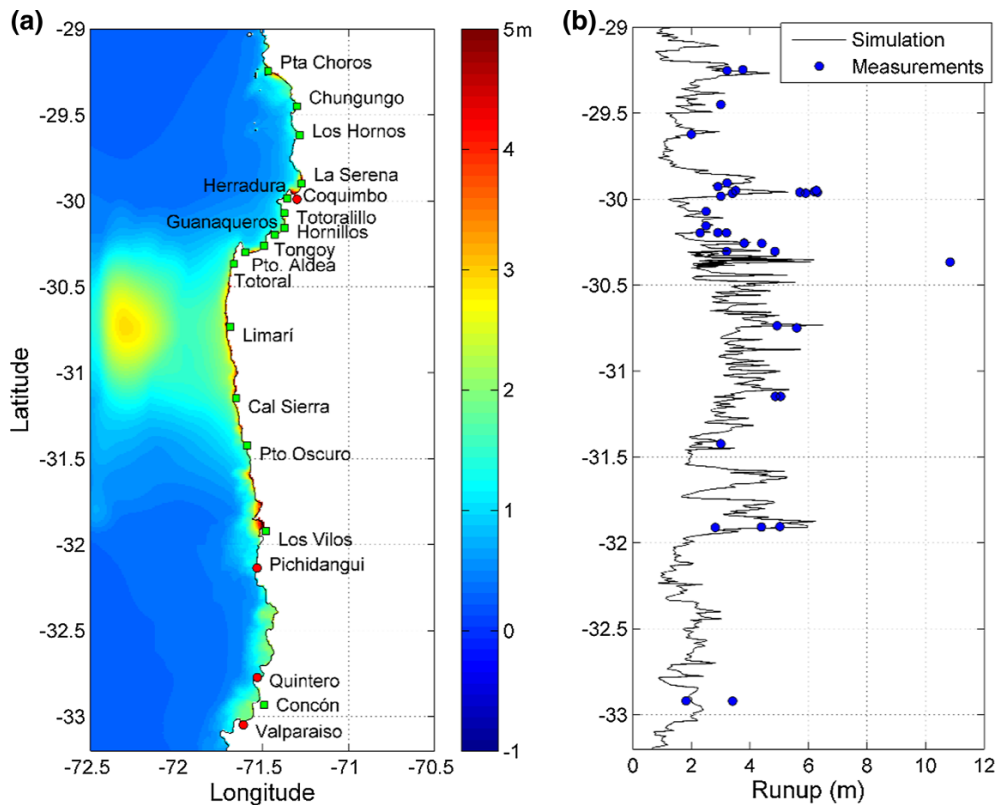
**a** Maximum tsunami amplitudes from the numerical simulation. **b** Comparison of tsunami height measurements and numerical simulation

Figure 8 shows the maximum tsunami runup along the coast obtained from the level 2 and 3 grids. In general, it can be seen that the numerical simulation is in good agreement with the measurements. However, the maximum runup at Totoral is underestimated by the model. A possible reason for this is the relatively coarse modeling grid ( $\sim 180$  m) as compared to the entrance of the bay which was only  $\sim 500$  m across. Figure 8 shows that modeled tsunami runup ranged from 2 to 6 m and resolved the

runup peaks at Los Vilos and Coquimbo Bay to the south and north of the epicenter.
