Field Survey of the 2015 Chile Tsunami with Emphasis on Coastal Wetland and Conservation Areas

Abstract—The September 16th 2015 Illapel M8.3 earthquake, Chile, generated a tsunami that affected a sparsely populated region, causing 15 casualties and destroying 1069 houses (USGS 2015). A maximum surface elevation of +4.5 m was observed in Coquimbo's tide gauge while in other sites of the tide network, the tsunami did not exceed +2.0 m. A post-tsunami survey team comprised by local researchers was deployed from September 17th to November 14th 2015. The survey covered approximately 80 sites along 500 km of the primary impact zone, from the northernmost site where damage was reported, Bahía Carrizalillo (29.11°S; 71.46°W), southward to El Yali National Reserve (33.75°S; 71.73°W) beyond which no tsunami damage occurred. The results of the survey in coastal towns with evident damage and isolated sites where the tsunami signature remained almost intact are summarized in this paper. A large amount of quantitative material is presented; including (1) inundation lines in five coastal sites, (2) 157 profiles including wave runup and flow depths and (3) 47 interviews to eyewitness, generally 2

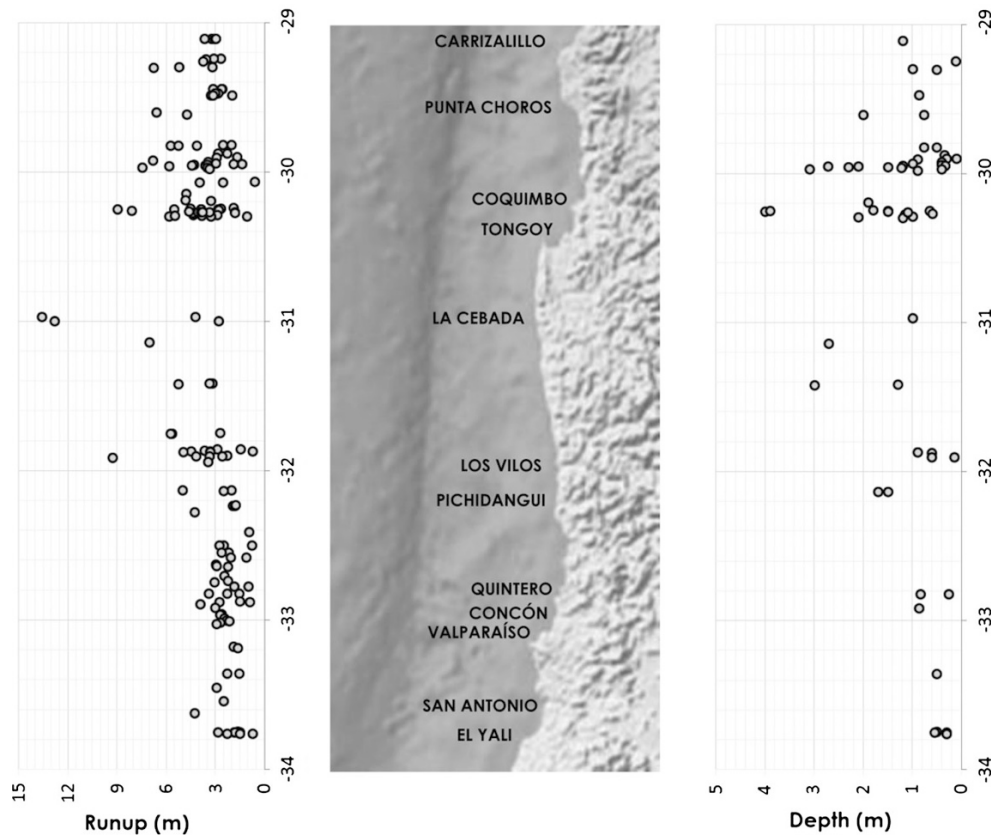
Figure 1
Measured inundation depths and run-up heights along the Chilean coasts

Tongoy, Los Vilos and Coquimbo). Details of the dataset are included in Fig. 1 and Appendix Table 1.

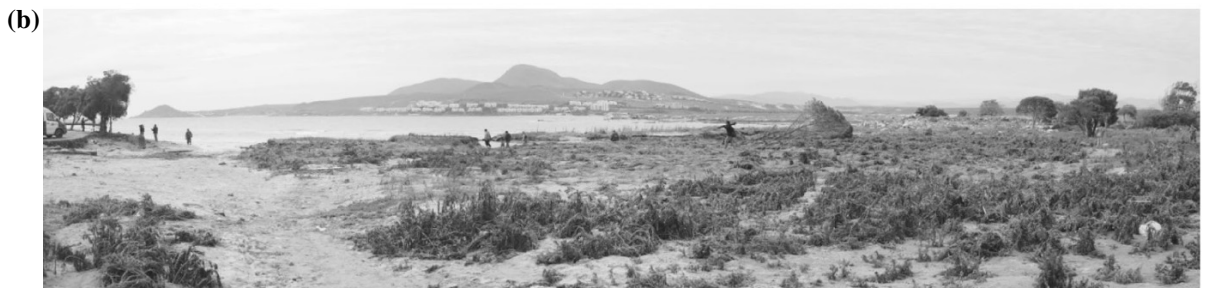
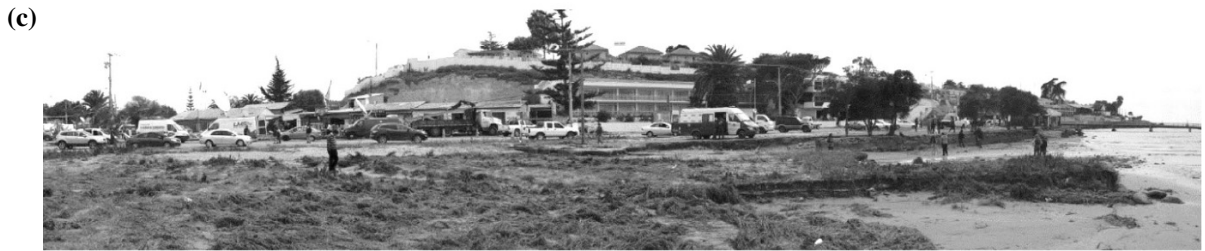
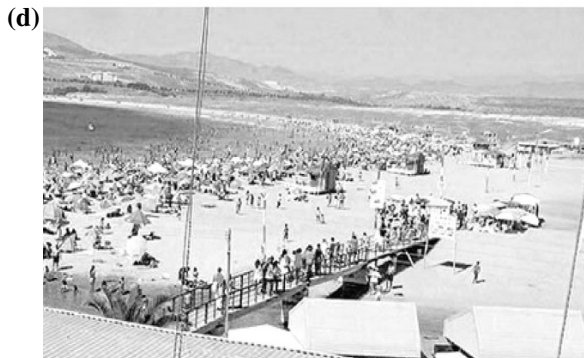
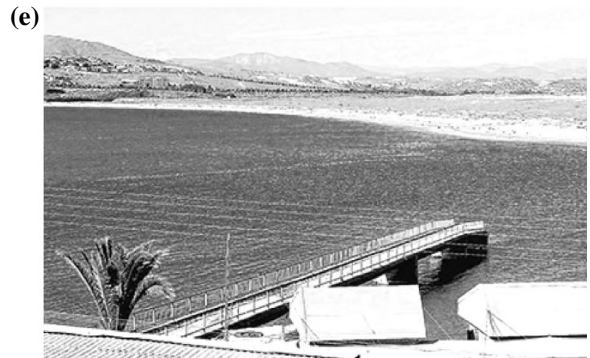
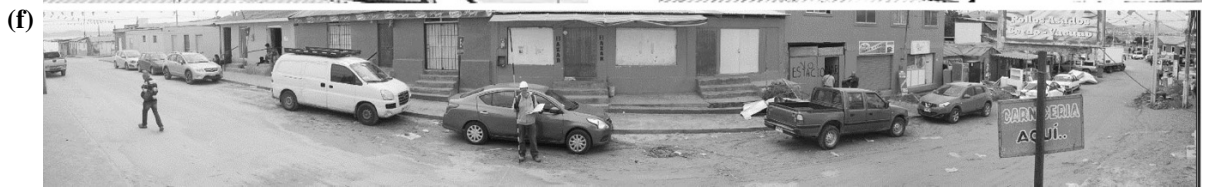
◀Figure 6

a Flooding area in between Punta Lengua de Vaca and Tongoy. Outlet of the estuary towards **b** the north and **c** the south. Socos beach **d** before and **e** after the tsunami (TERCERA 2015b, September 22). **f** Sediment mark on Gomez Carreño Street

while in the sheltered area of the bay runup did not exceed 4 m (Fig. 6). In Puerto Aldea (30.29°S; 71.61°W), a small fishing town within the bay, light houses were destroyed and the road northward was severely scoured. The tsunami traces gradually became smaller towards the southern border of Tongoy (30.30°S; 71.55°W).
