# Methodology of Analysis and Virtual Recomposition: The Case of Retrosi, Amatrice

**Abstract.** This paper is an initial report on an interdisciplinary project regarding an integrated methodology for analyzing architectural heritage damaged by earthquake, combining 3D survey, critical survey and virtual reconstruction. The case study using this methodology was Retrosi, in the municipality of Amatrice (RI), Italy, damaged by earthquakes on August 24th and on October 30th, 2016. Researchers from different disciplines (Representation, Restoration, Building Science), worked together to obtain an analytical understanding of the building criticalities caused by the earthquakes. The method is based on a semantic model linked to a database in which specific building elements, constructive, structural, masonry types etc. are classified as data, that includes instabilities and damages.

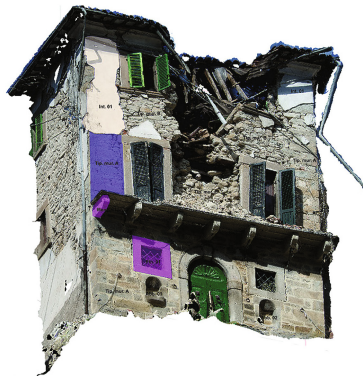
**Fig. 1.** Structure of the database with fields defining building type, coating, architectural details and damage and a semantic model, linked to database.

- (c) On the basis of the two previous stages, the third phase aims at the virtual reconstruction of the buildings in the pre-seismic state [5, 6]. The procedure was based on the comparison between its state preceding the earthquake, derived in this case from photographic images, and a semantic model that describes the post-seismic state, linked to database. The system, by database queries, allows highlighting the categories of damages or those relating to the repositioning of the elements.

integrated: some notes and annotations on the spot drawings, that integrate the survey data, supplement the interpretation and facilitates the transition from the pre-seismic state to post-seismic state and vice-versa (Fig. 7). The database connected to the specific elements of the models, has an organized structure with fields related to constructive aspects (types of masonry, coating, architectural detail and seismic aspects (masonry quality, types of damage).

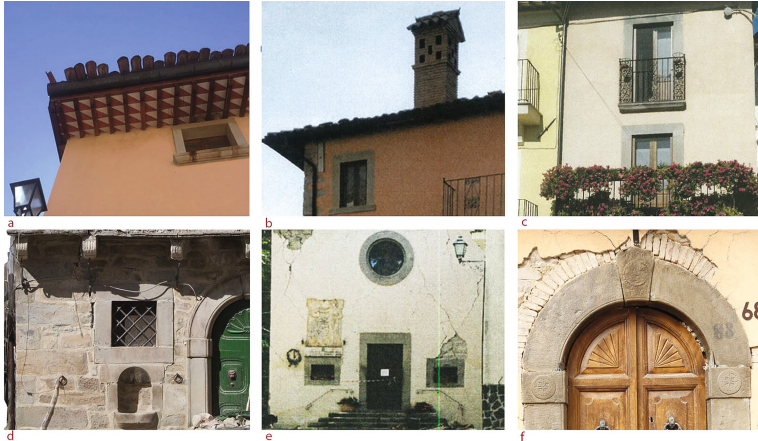
**Fig. 4.** Examples of Retrosi building elements: (a) roof with decorated rafter tails; (b) brick chimney; (c) (d) (e) portals and windows in grey sandstone or limestone; (f) keystone decorations with medieval iconography.

Regarding the buildings in Retrosi, there are many similarities with the near Abruzzesi materials and constructive traditions. First of all, the masonry texture consisting predominantly of ashlar stones, rough-hewed or squared, layered with little mortar and with few diatoni (bondstones) to strengthen the binding between the outer layer, inner layer and the core; in the section of most ancient walls, one can see horizontal elements made with thin wood sections, as seismic safeguards (together with the traditional

metal chains). Furthermore, original portals can still be found *in situ*, built mainly in pietra serena (gray sandstone), although there are examples of limestone or of arenaria (sandstone) with the piers and keystone decorations with engraved motifs of ancient medieval iconography (Fig. 4).

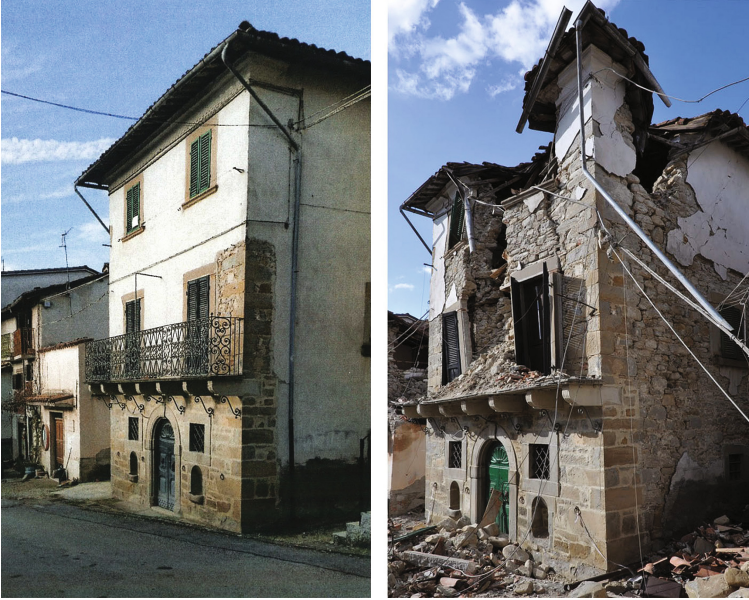
**Fig. 5.** a. Collapse of the central part of the façade with an example of well clamped angular masonry; b. Partial collapse of the structure in concrete blocks; c. Collapse of the angular masonry; d. Bulging angular masonry; e. The Church after the collapse of the roof; f. Masonry connected without the necessary clamping (evidenced by the lesion at the vertical plane of contact).

In the case study regarding a specific building (Fig. 5), near S. Clemente church, some architectural elements are well machined and noteworthy: the arched portal disposed in axis, the balcony slab and corbels in stone support (some restoration), well clamped in the masonry, two stone troughs beneath the windows of 1st level, framed, like the other of the upper levels by thick plates also in stone.

Type A, relative to the first level is of fair craftsmanship and constructed, like the cornerstones along the entire height, with square blocks, also of considerable size, arranged alternately front and side (those of the head are probably bondstones to reinforce the entire wall) and mortar joints of varying thickness;

Type B of the second level is more typical of many buildings in Retrosi, with roughhewn ashlar blocks for the outer layers, filling stones for the inner one, with a few binding diatones; a medium-sized wooden beam reveals the anchoring of the slab to the masonry.

From the photos of the pre-seismic state, one can observe how the second level, corresponding to the B-type masonry, was plastered, while the entire right corner, as well as the first level masonry (type A), was left as exposed bricks.

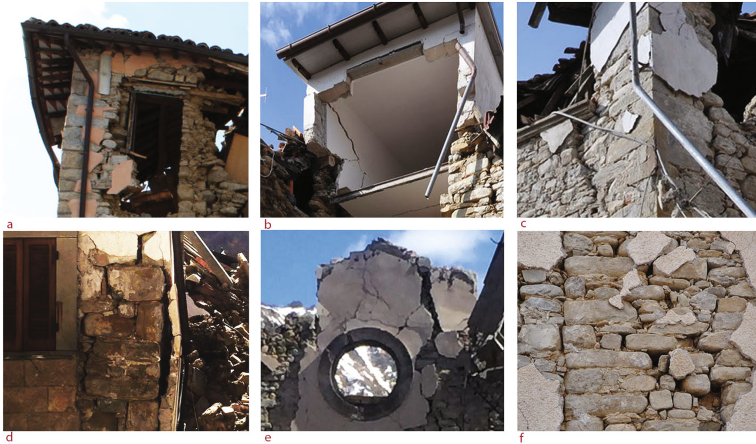
**Fig. 6.** The building before and after the earthquake October 30th, 2016.

Regarding those aspects related to the seismic event, one need take into account that the “traditional masonry suggests the idea of a possible division of the building organism into elementary portions” (Fig. 6) [10].

In the case study of the building, the elements that have suffered the most damage due to seismic action were mainly: the second level masonry (type B), partial collapse in the central area probably due to its modest construction quality; the roof, which underwent a failure derived from the collapse of the underlying wall; the masonry of the front of the second level (the sides), which shows a bulging in both the horizontal and the vertical plane (shown by the sections *in situ*). Among the elements that instead have suffered minor damage, the masonry type A is the most integral, because of its constructional characteristics; the balcony, although loaded by the debris of the collapsed central wall, is still standing, thanks to the shelves firmly anchored to the masonry.
