## Rupestrian World Heritage Sites: Instability Investigation and Sustainable Mitigation

Claudio Margottini, Peter Bobrowsky, Giovanni Gigli, Heinz Ruther, Daniele Spizzichino, and Jan Vlcko

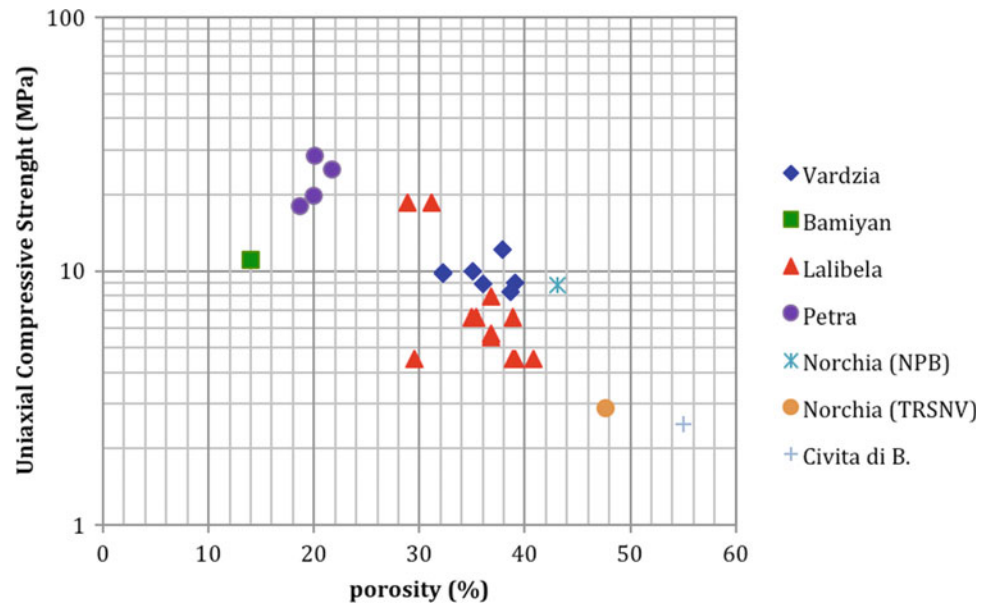
**Fig. 1** The relationship between Uniaxial compressive strength and porosity for some of the case studies discussed in this paper

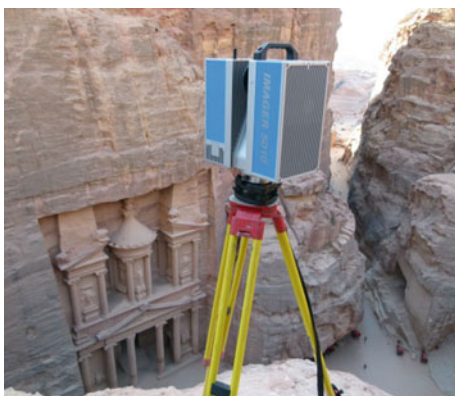
**Fig. 2** Laser scanner (Z&F) above Al Khazneh (Petra, Jordan)

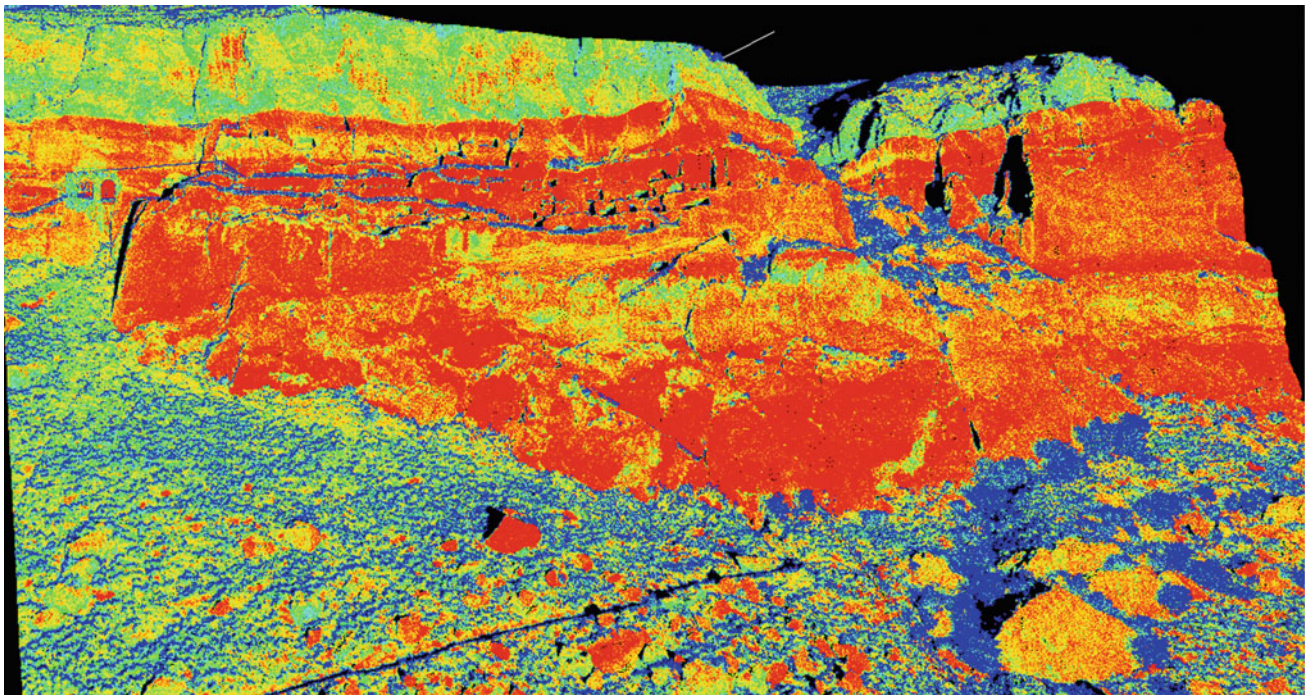
**Fig. 3** Textured 3D model and reflectivity map of the cave monastery of Vardzia (Georgia) from TLS techniques

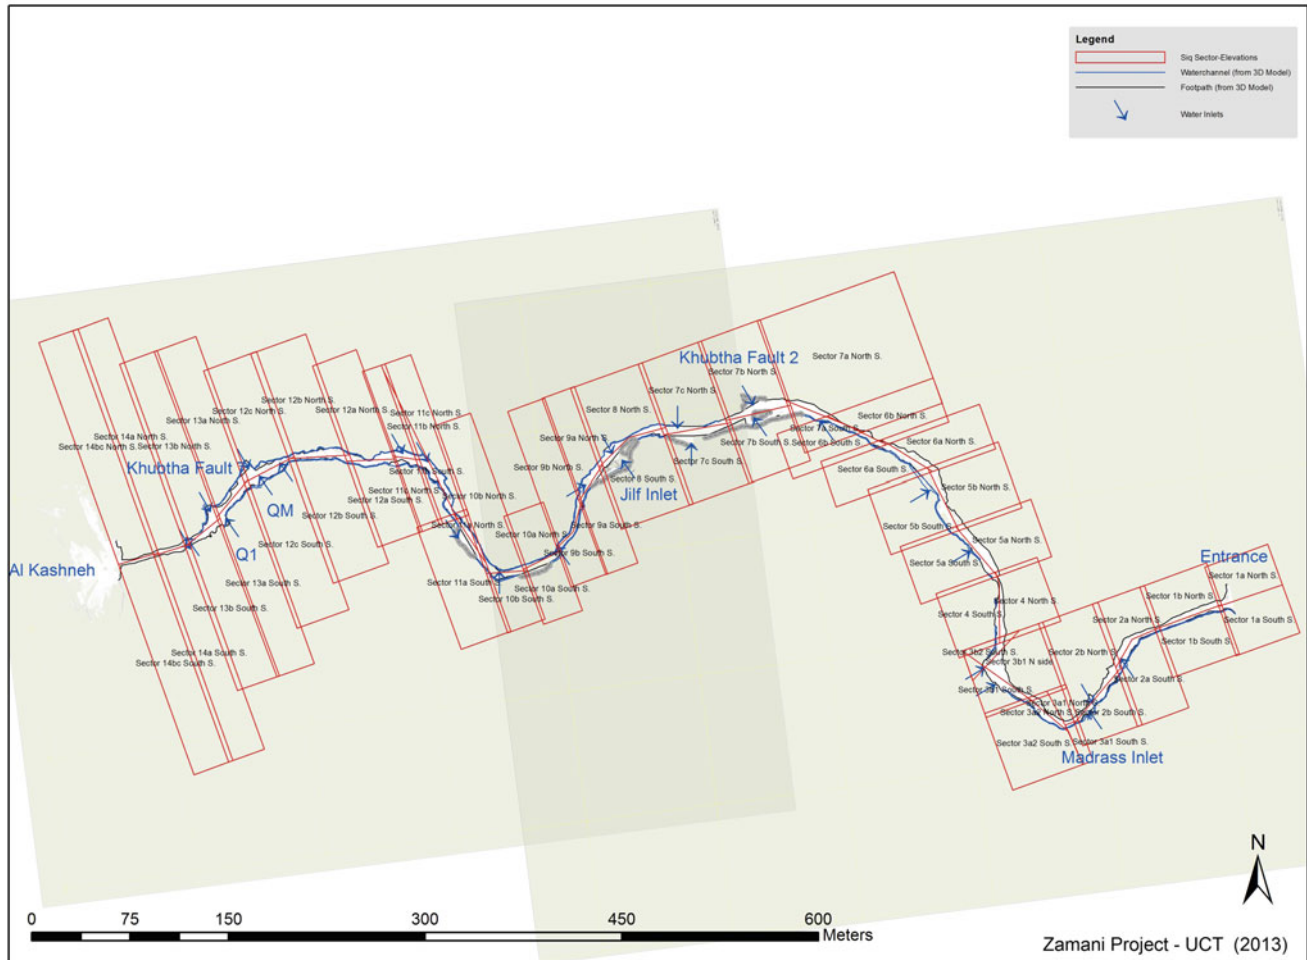
Fig. 4 Top view of 1.2 km Siq point cloud (Courtesy of Zamani Project)

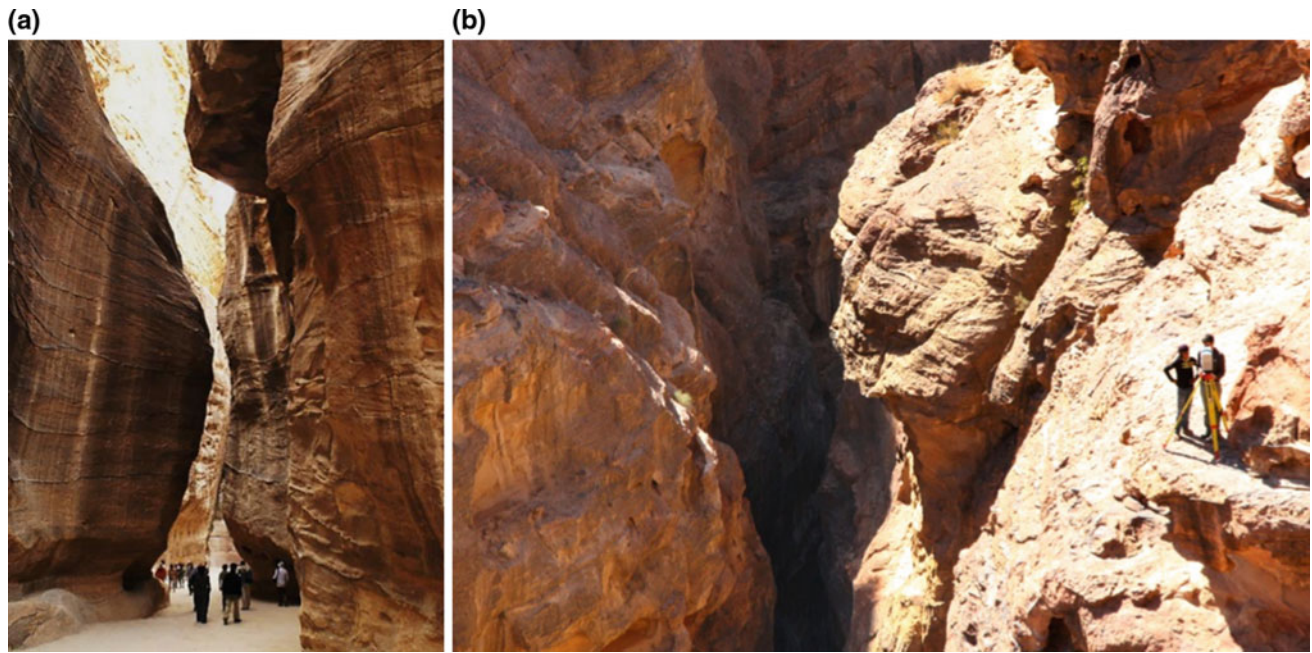
**Fig. 5** Narrow passage in the Siq which makes the acquisition of upper parts of the slopes by TLS impractical if not impossible (a) and scanner positioned at one of the few places where scanning from the top was possible (b)

For the Siq survey, the scanner was positioned on the Siq floor at intervals of not more than 10 meters (Ruther et al. 2014). The lower wall areas over the entire length of the Siq were thus captured up to a height varying from 20 to 80 m, depending on visibility (Fig. 5a). In addition to this, a

number of scans could be taken from points at the upper edge of the Siq (Fig. 5b). The scans at high elevations provided, in some cases, surface data from Siq floor to the top of the rock walls. The total number of scans in the Siq was 220 with an average point interval of approximately 3 cm, resulting in a point cloud of five billion points. This is only a part of the complete point cloud which the Zamani team acquired for the Siq, Wadi Musa and Wadi Farasa. This collective point cloud comprised 25 billion points. The relative accuracy of points, i.e. the accuracy of neighbouring points is estimated to be in the order of a cm or better, whereas the absolute accuracy, i.e. the accuracy of points over the entire length of the Siq is in the one or two decimeter range. The final model (example in Fig. 6) can be viewed in 3D viewing and processing software. Coordinate and dimension measurements can be taken in applications such as the open source system Meshlab (meshlab.sourceforge.net). The 3D model and the GIS are referenced to UTM coordinates on WGS 84 (ITRF8) determined via GNSS survey by the Zamani team.

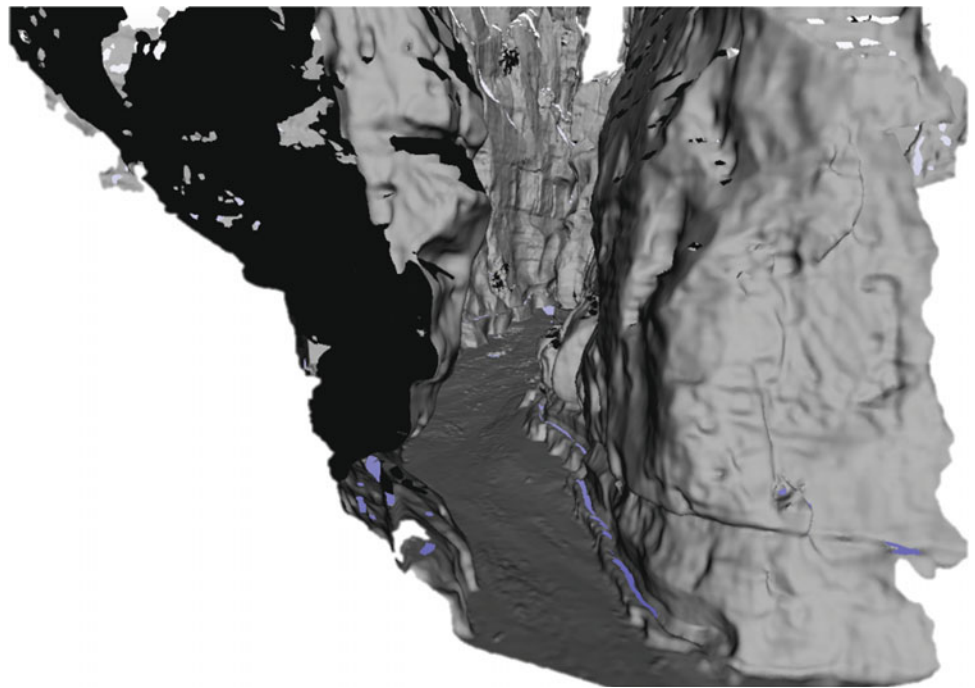
**Fig. 6** Example of the Siq surface model. The large black area to the left is seen, in this perspective, from inside the rock wall whereas the smaller black patches inside the Siq are areas invisible to the scanner

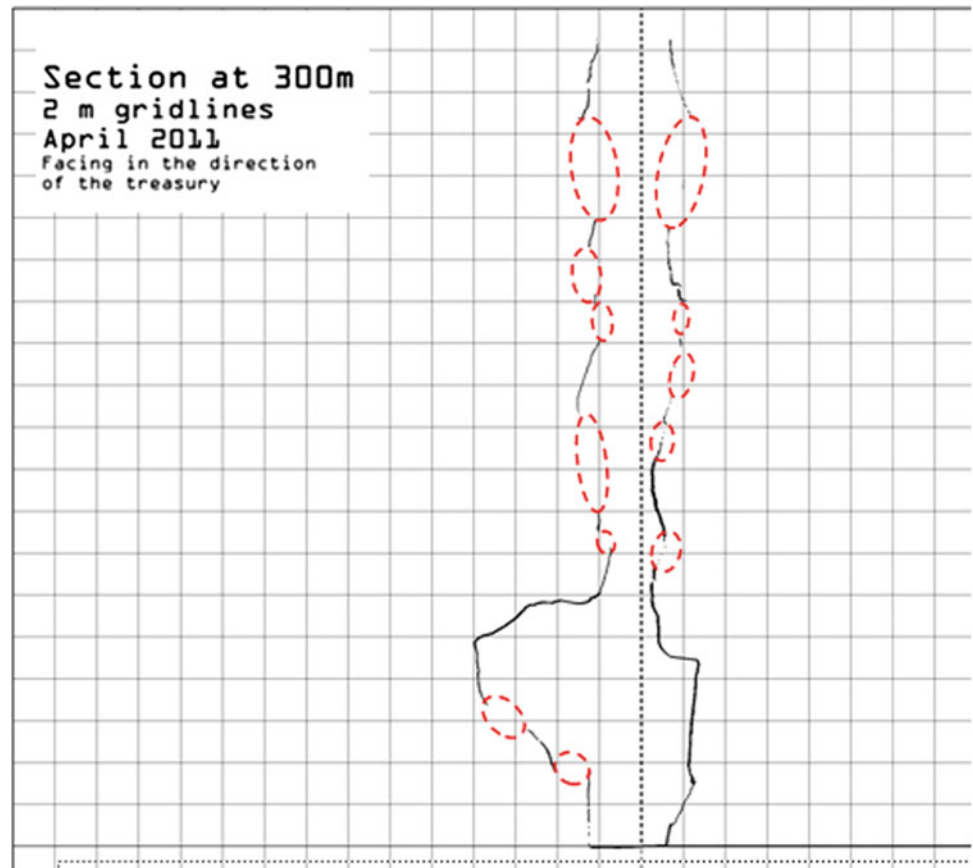
**Fig. 7** Cross-section through the Siq. Invisible areas are indicated in red

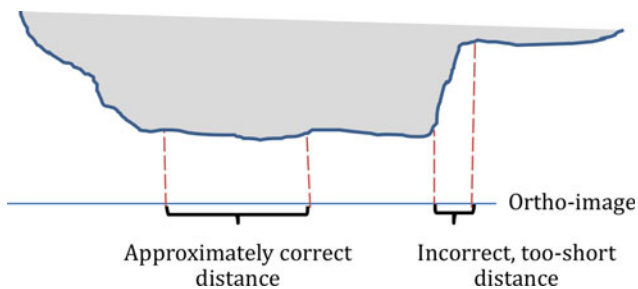
**Fig. 8** Distortions in ortho image due to irregular surface shapes

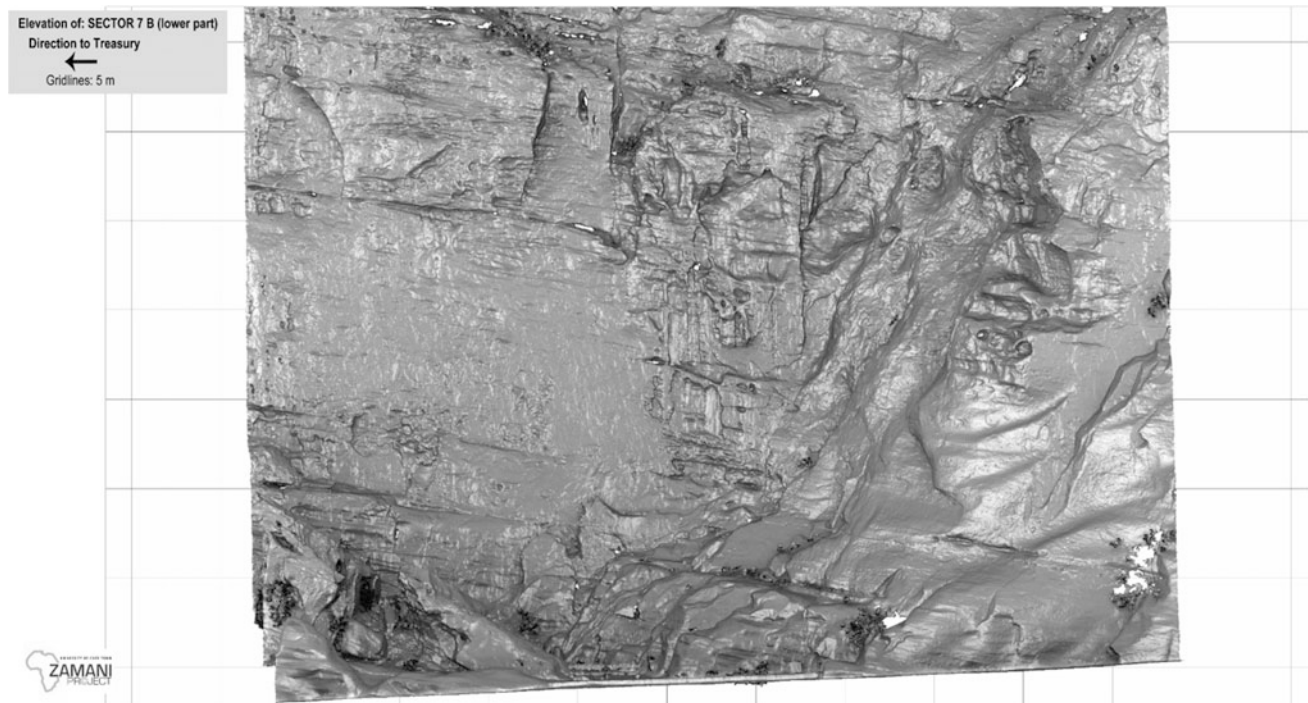
**Fig. 9** Ortho image of rock wall showing surface details

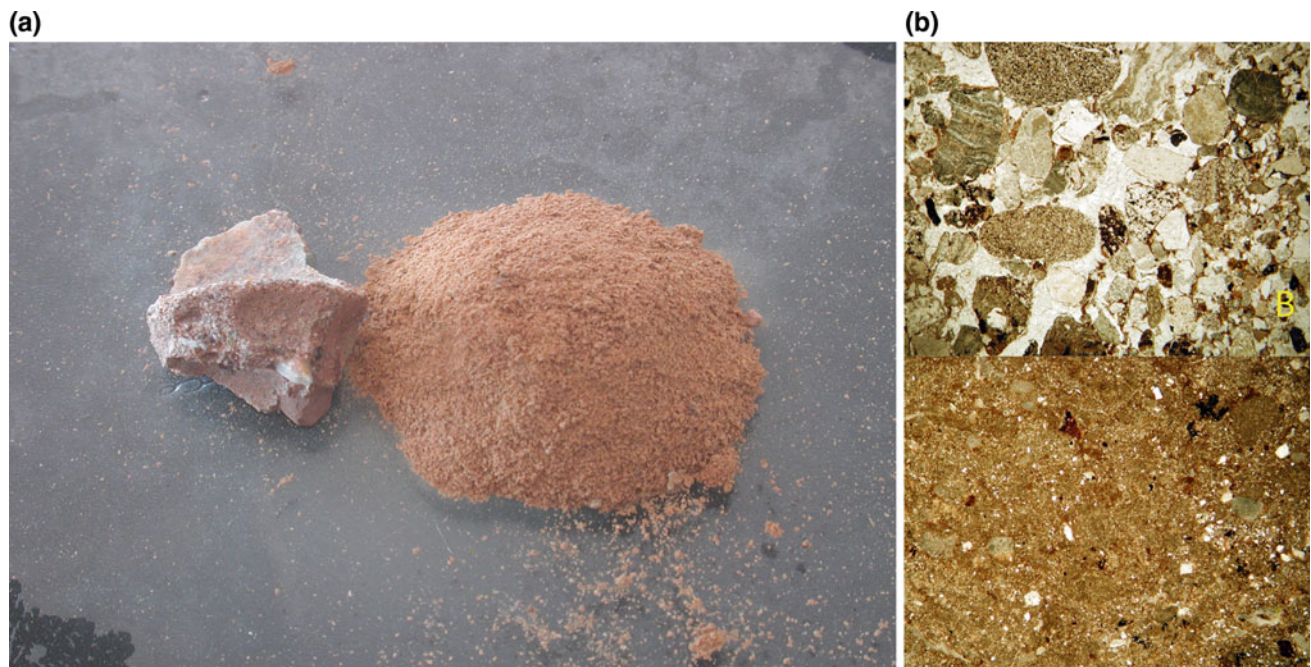
**Fig. 11** Stability of conglomerate (*left in a*) and degradation of siltstone (on the *right in a*) when saturated. Thin section of conglomerate with white carbonate cement (**b**) and thin section of siltstone (**c**) (Margottini 2014a, b)

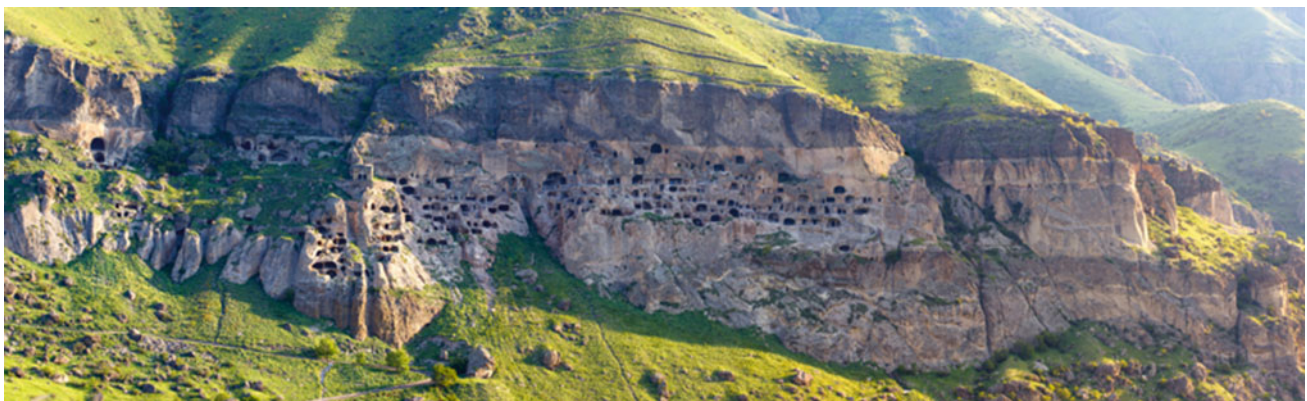
**Fig. 12** General view of rock-cut city of Vardzia (Georgia)

In order to implement a kinematic analysis and further hazard analysis in rock slopes, discontinuities must be identified and mapped. Availability of TLS data make this step more advanced, allowing the structural analysis to be implemented through a semi-automatic method. As an example, the case study of the rock-cut city of Vardzia is reported. Vardzia is a cave monastery located in south-western Georgia, excavated from the slopes of the Erusheti mountains on the left bank of the Mtkvari River. The main period of construction was the second half of the twelfth century. The caves stretch along the cliff for some eight hundred meters and range in height over fifty meters within the rocky wall. The monastery consists of more than six hundred hidden rooms spread over thirteen floors, which protected the monastery from the Mongol domination (Fig. 12).

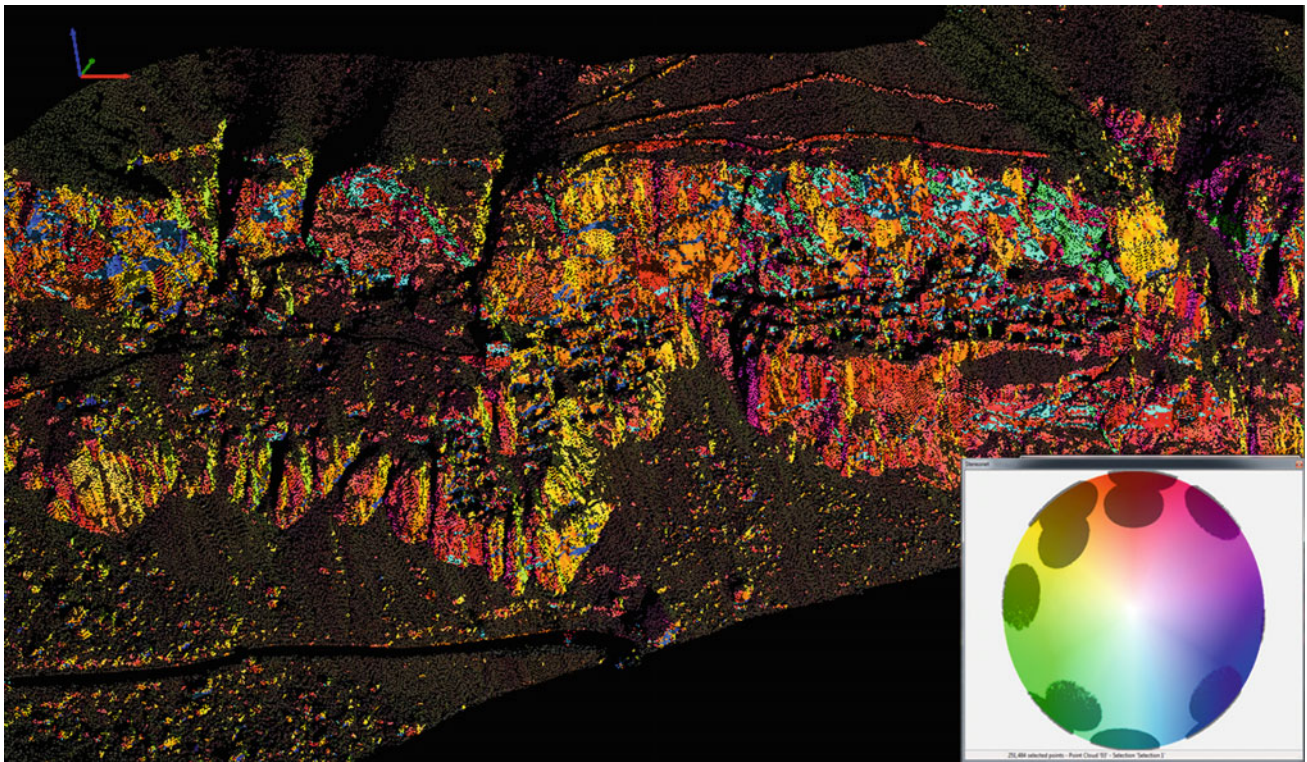
**Fig. 13** The exposed rock faces of Vardzia cliff and detected slope aspect and slope angle, also on a Schmidt-Lambert stereonet (Margottini et al. 2016a, b, c, d)

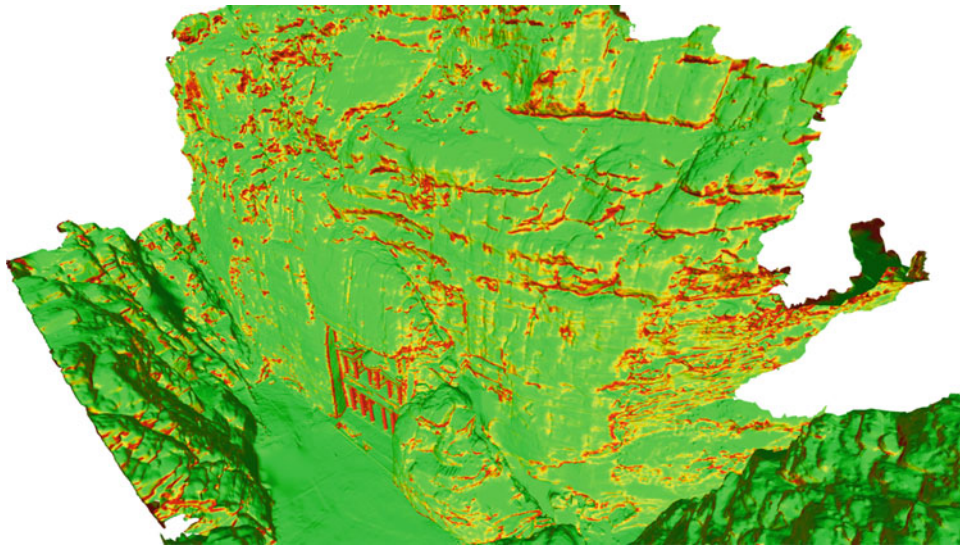
**Fig. 14** Integrated result from the 3D individual kinematic analysis for the different analyzed instability mechanisms (block toppling, flexural toppling, wedge failure, plane failure and free fall) in the

Treasury area (Petra, Jordan). The probability of occurrence (hazard) is expressed following a common colour scale (0–30% of probability to be involved in a kinematic process)

A synthetic view was also provided, integrating all the different probability of occurrence for the different kinematic conditions, into a single evaluation. This elaboration, as in Fig. 14, may help in the general management of the site, identifying the most endangered places, however a detailed case by case investigation is still required.

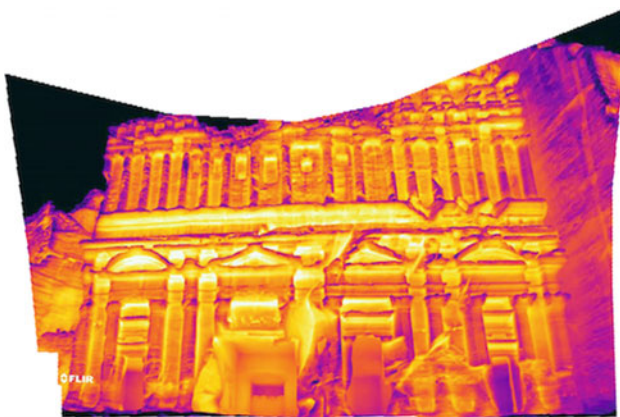
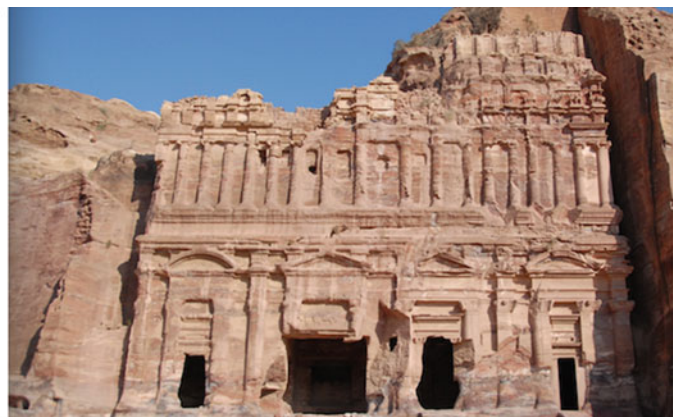
**Fig. 15** Thermal image of the Palace Tomb in Petra, compared with the image as seen by a normal camera

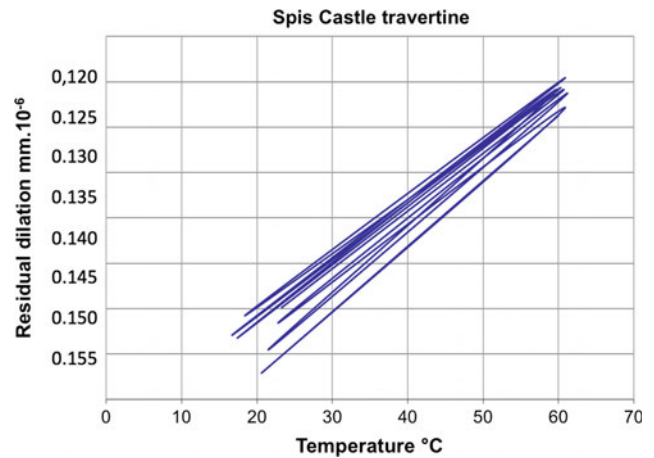
**Fig. 17** Residual dilation vs temperature determined in thermodilatometer by multiple test performed within the temperature range 20–60 °C

The highest value of linear thermal residual strain or plastic deformations (in some papers assigned as residual dilation) was determined with the max value  $\Delta L_r = 3.9 \times 10^{-6}$  m, which means that 10% of recorded rate of displacements are triggered by the temperature fluctuations. If we calculate that in the natural conditions volumetric (three dimensional) deformation is the usual case, the percentage is even higher.

Since the maximum rock face temperature reaches the difference in temperature of 35 °C several times per year one must conclude that the permanent dilation or plastic deformations significantly contribute (up to 20%) to rate of movements, that despite the fact that lateral spreading is the representative mode of failure at the Spis Castle.

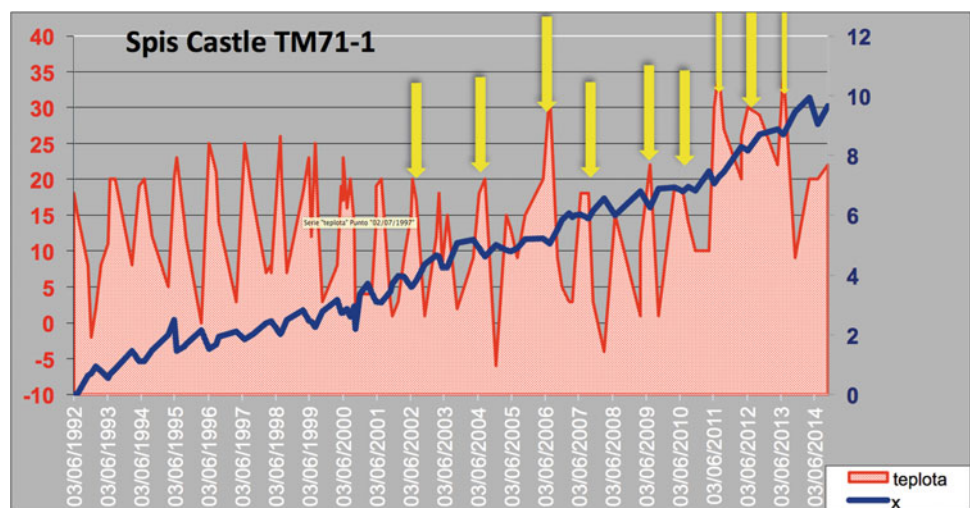
**Fig. 16** Temperature versus displacements

As an example we may present our experience with Spis Castle (UNESCO site) from eastern Slovakia where since 1980 and 1992 three TM-71 type crack-gauges (TM-71) installed at the castle subgrade operate. Within this period mean annual displacement recorded at this site reached the value of 0.3–0.9 mm (mean value 0.33 mm/yr). According to the rate of displacements the slope movements maybe assigned as extremely slow (Varnes 1978). Significant for the monitoring records is that regardless of rainfall data as the most frequent slope movements trigger, the increment in the rate of displacement is quasi “stable” and as can be seen corresponds to the cyclic temperature variations (Fig. 16).

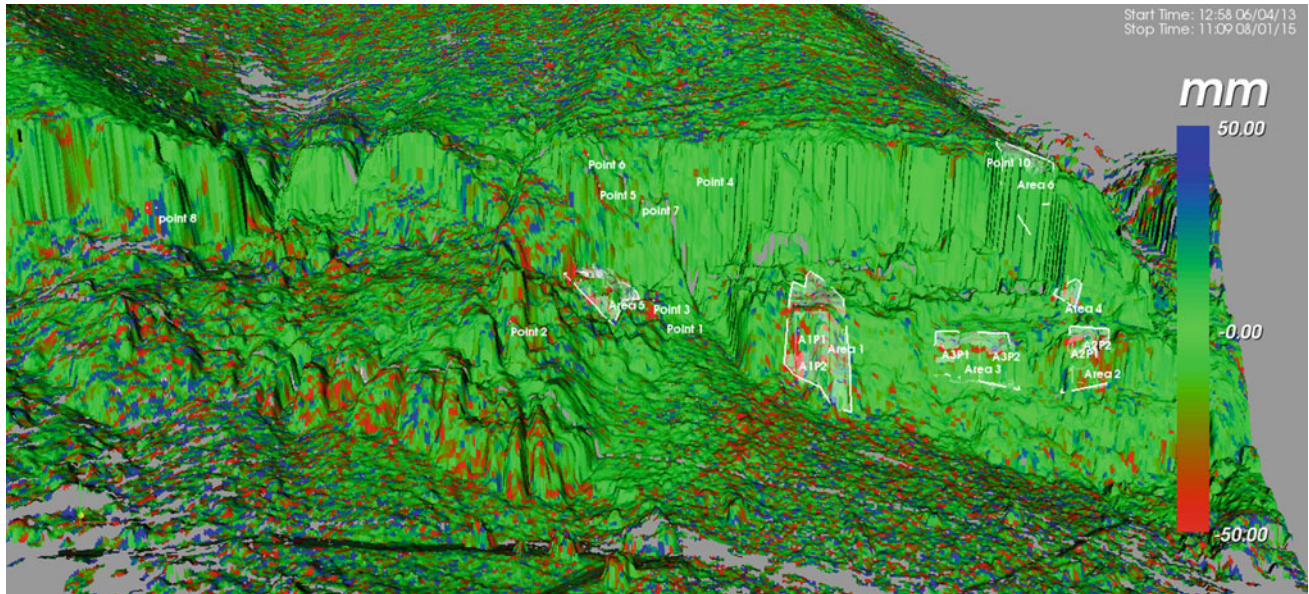
**Fig. 18** Displacement detected from ground based radar interferometry on the rock cliff of Vardzia in the period 6 April 2013–8 January 2015. Displacements are plotted against distance from the Radar installation

With the exception of some ostensible changes in individual control points (mainly due to noise factors related to vegetation) the investigated area is stable and under control (Fig. 18). In the next 6 months on site verification of the main critical outcomes of the monitoring systems will be carried out along the cliff in order to calibrate and correct the results and define the most active zones in which down-scaling of the landslide hazard and risk assessment is recommended.

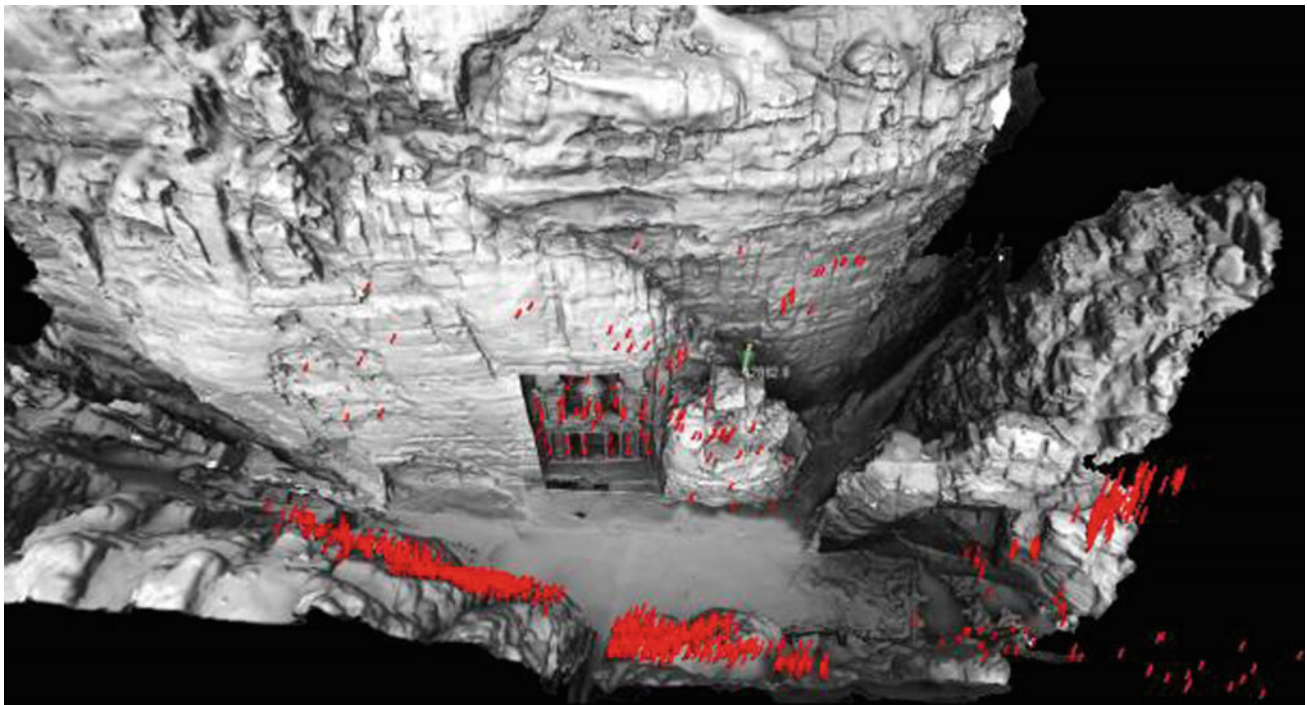
**Fig. 20** Reflector-less surveyed points in the Treasury area (Petra, Jordan), superimposed on the terrestrial laser scanner

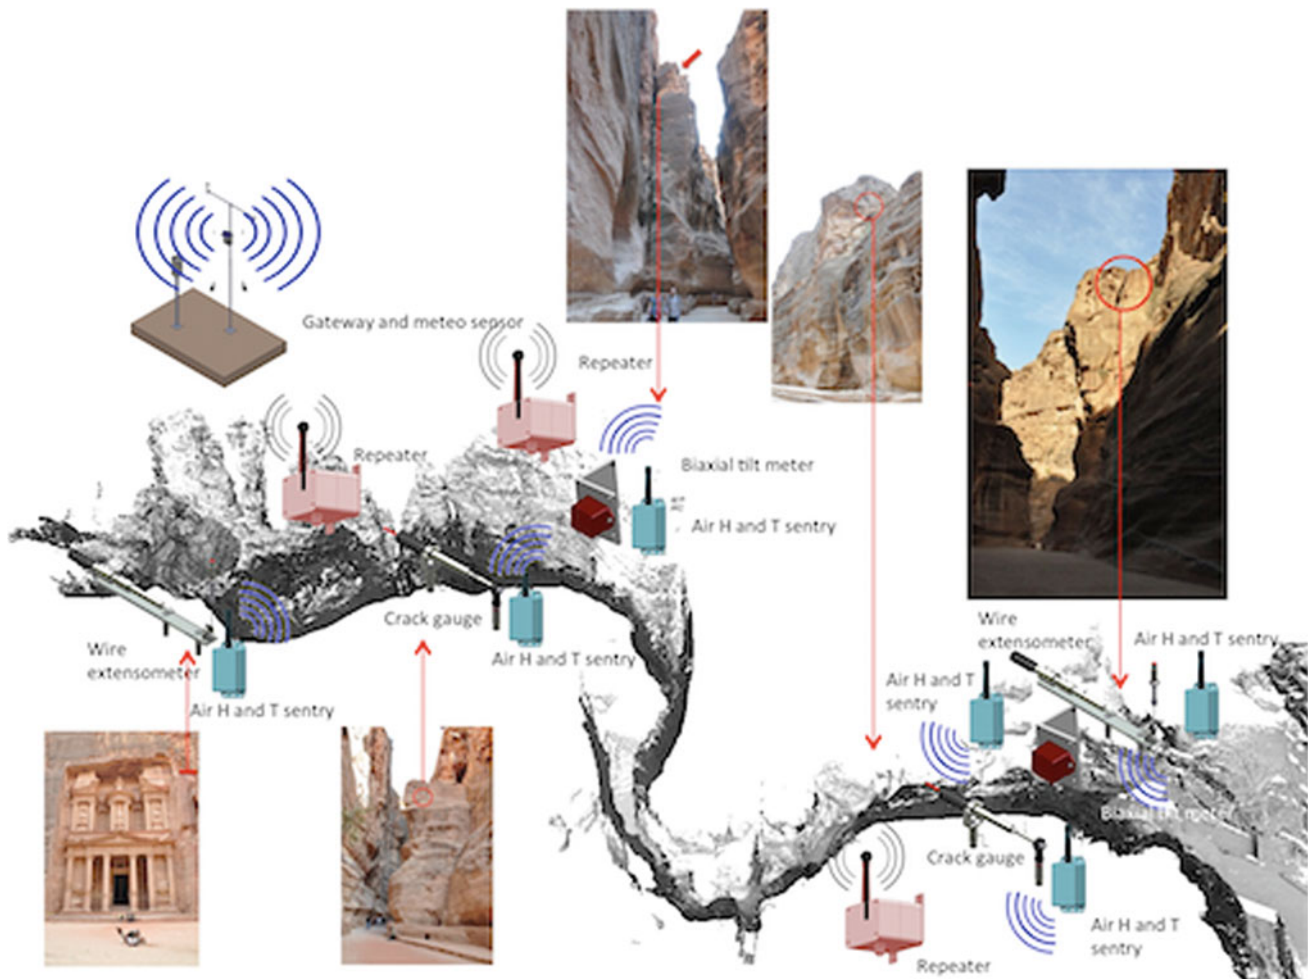
**Fig. 21** Details of the geotechnical wireless monitoring network in the Siq of Petra (Jordan), superimposed on the 3D laser scanner of Siq

In order to define possible deformation paths and with the final aim to measure active displacement upon selected medium-large rock blocks affected by potential instability process, a proper permanent monitoring network was designed, implemented and installed along the entire Siq of Petra. The monitoring network (Fig. 21) consists of:

- n.2 tiltmeter sentries;
- n.2 wire deformometer sentries;
- n.2 crack meter/gauges sentries;
- n.6 air humidity and temperature sentries;
- n.1 meteorological station.

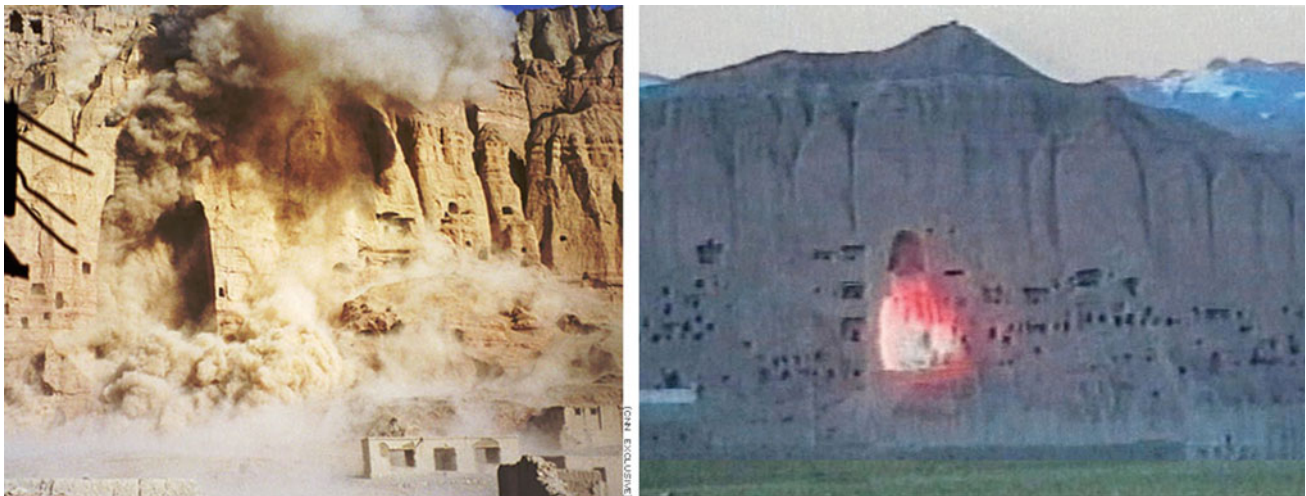
**Fig. 22** Explosion and destruction of the Western (*left*) and Eastern (*right*) Giant Buddha Statues

The historical site of Bamiyan is affected by geomorphological deformation processes which were worsened by the explosion of the Buddhas in March 2001, which destroyed the statues that date back to the 6th century AD (Fig. 22). Not only was invaluable cultural heritage irremediably lost, but the consequences of the explosions as well as the collapse of the giant statues also added greatly to the geological instability of the area. Traces of rocks which recently slid and fell are relevant proofs of the deterioration of its stability conditions and most parts of the site now appear prone to collapse in the near future.

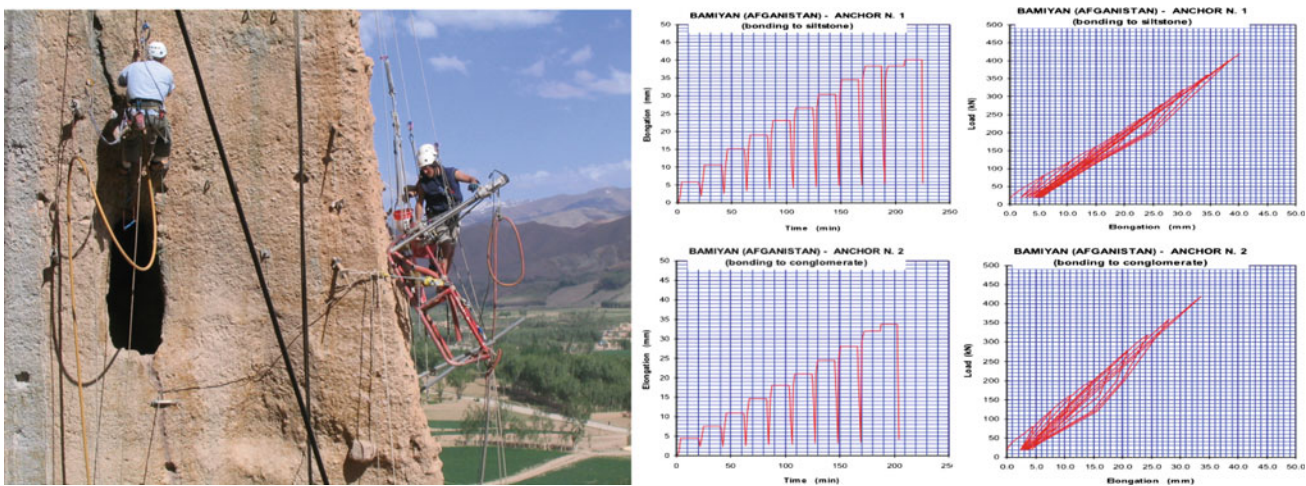
**Fig. 23** Anchoring the Eastern Buddha niche (*left*) and pull-out tests for the use of 1 m length anchor in siltstone and conglomerate (*right*). The load (kN) and respective time (min) and elongation (mm) are

reported showing, till 40 ton, the uphold of elastic domain and still the missing of any permanent deformation for the tested anchors

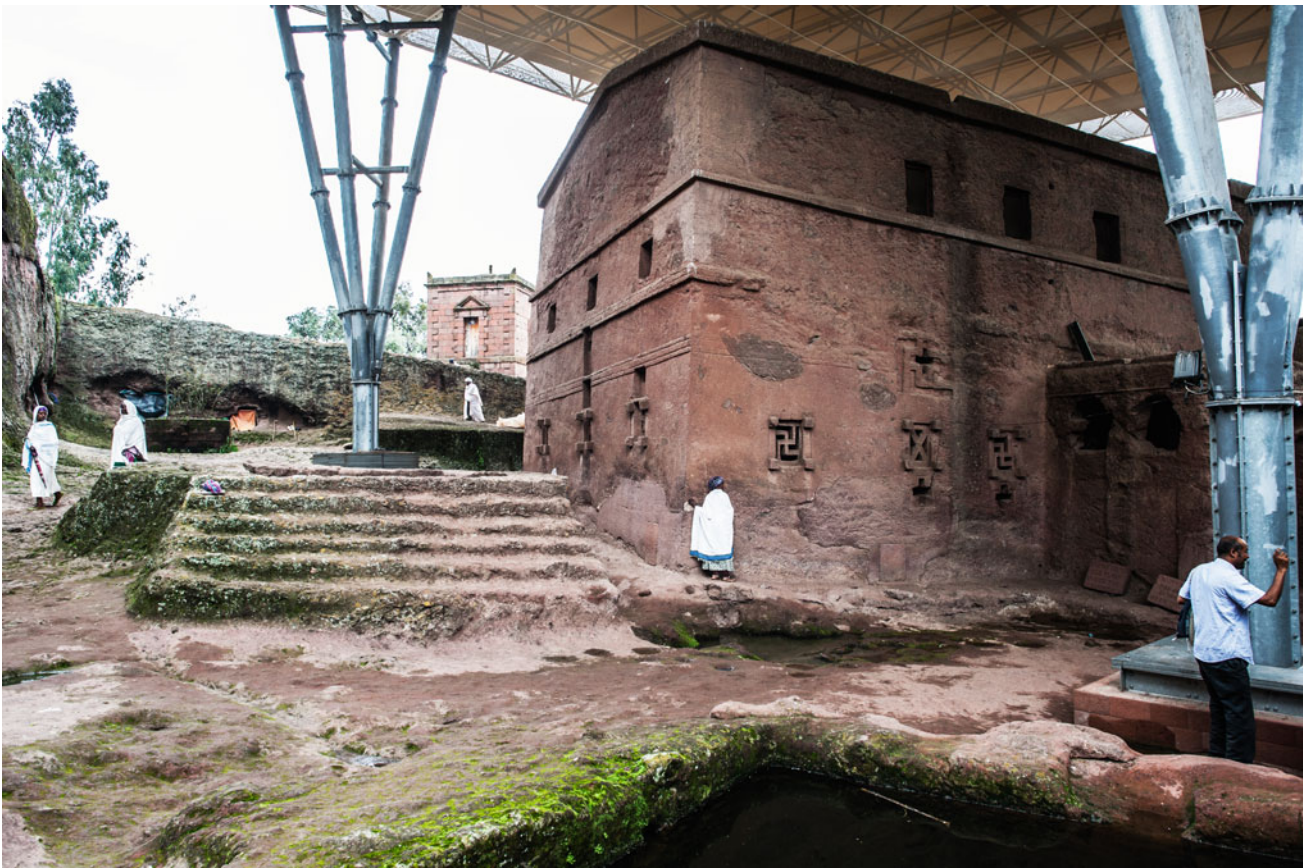
**Fig. 25** The modern shelters covering the rock-hewn churches of Lalibela (Ethiopia) (source [www.flickr.com](http://www.flickr.com))

measurement before a correct conservation plan can be realized (Fig. 25).

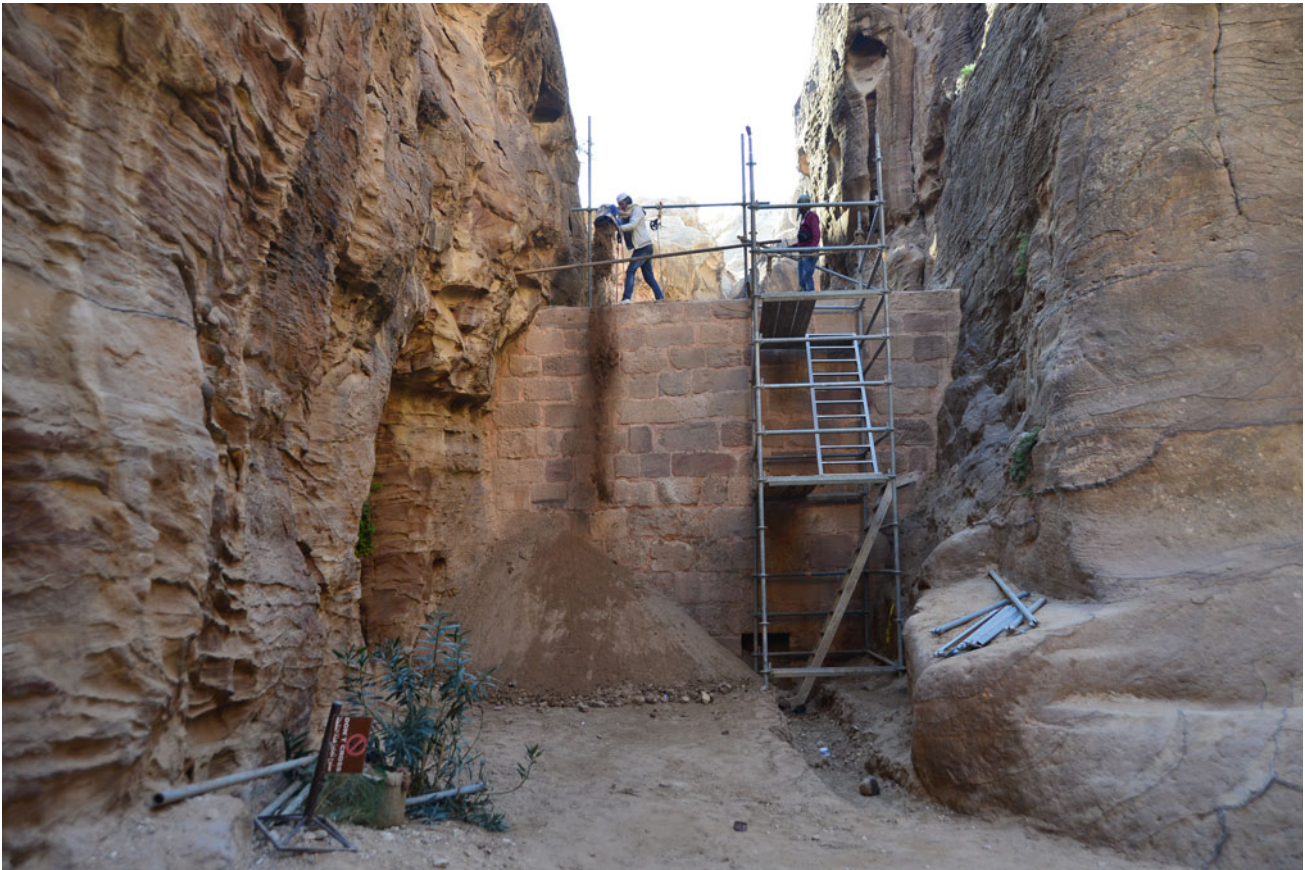
**Fig. 26** Manual and proper cleaning of stone dams, to protect the Siq of Petra from flash flood

Depending on typology and volume, several kinds of mitigation works have been suggested. In any case, such techniques cannot be applied without a local investigation on the site. In detail, the selection of potential working typologies has to take into account their impact on the peculiarity of the site geo-cultural environment (geomorphology, landslide types, presence of archaeological remains) so that only some specific typologies of consolidation interventions are recommended. Clearly, any intervention has to take into consideration the minimization of the environmental/visual impact of works, the local sustainability and feasibility, and the transfer of know-how to the local system. All these details are included in specific Guidelines (Margottini 2015) for the benefit of Jordanian authorities. Particular attention is given to the traditional techniques and the proper maintenance of such practices (Fig. 26).

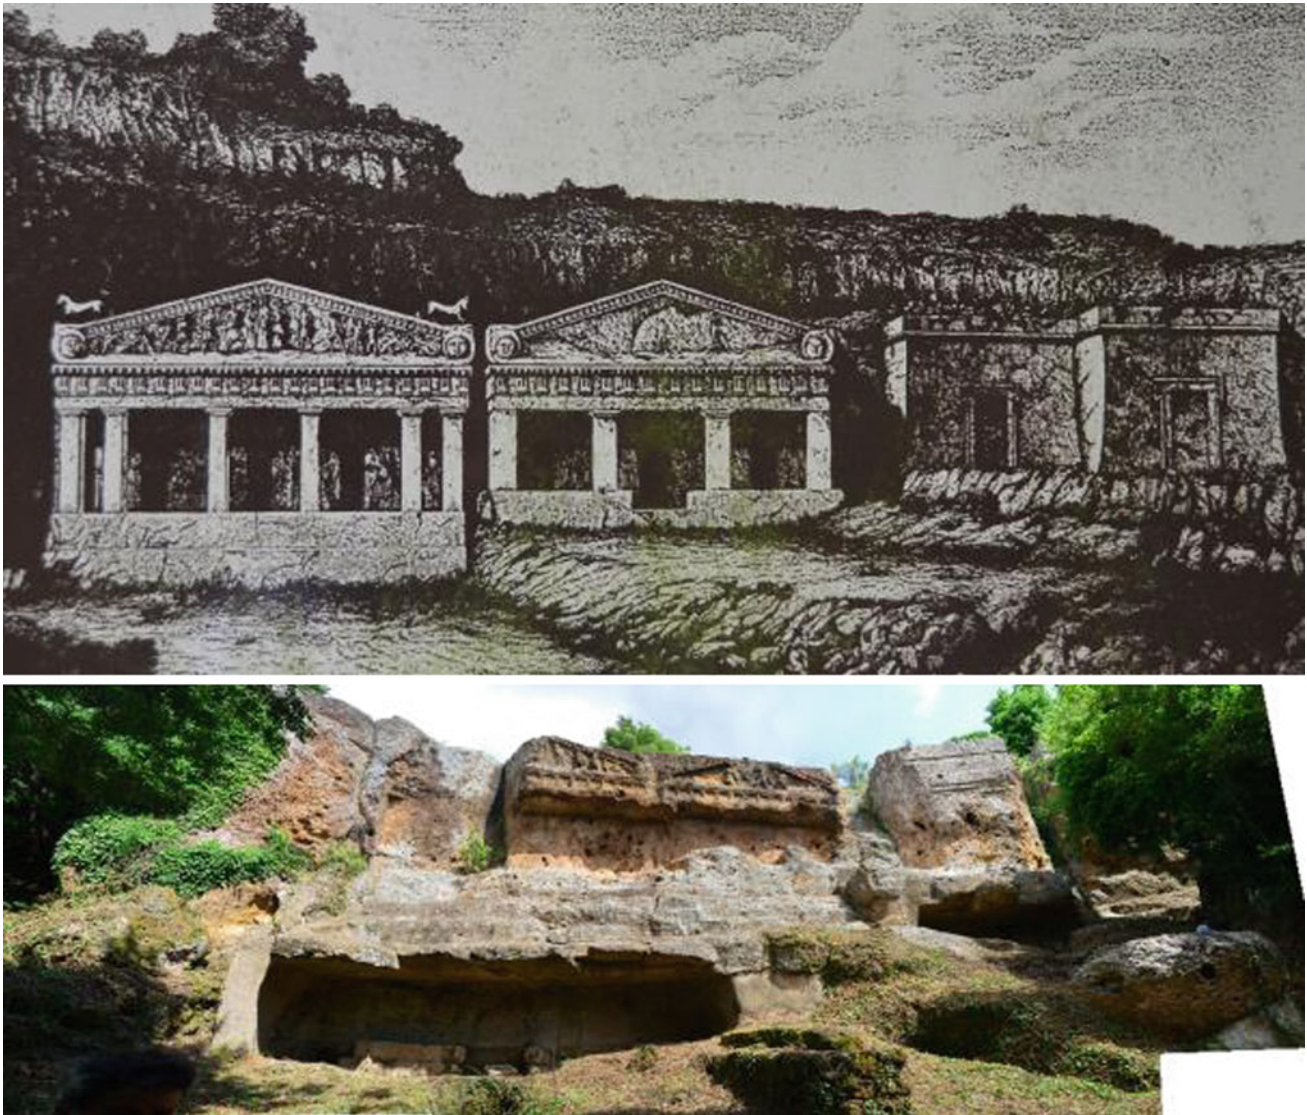
**Fig. 27** The temple tombs of Norchia, as reconstructed from Canina (1851) and after the cleaning of vegetation in Spring 2016

and Volsini volcanic apparatus; as bedrock, a plastic clay formation is positioned (Fig. 27).

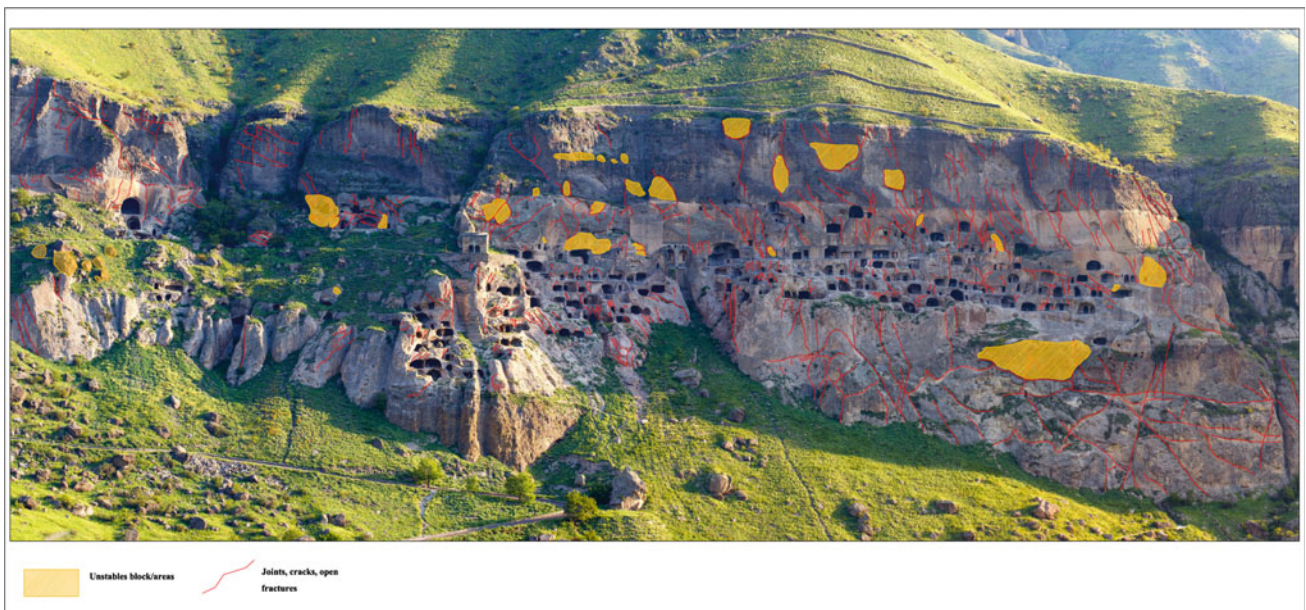
**Fig. 29** Joints, cracks and unstable blocks in Vardzia cliff

All the performed investigations allowed the definition of the most unstable areas. The map is reported in Fig. 29.
