## Rupestrian World Heritage Sites: Instability Investigation and Sustainable Mitigation

Claudio Margottini, Peter Bobrowsky, Giovanni Gigli, Heinz Ruther, Daniele Spizzichino, and Jan Vlcko

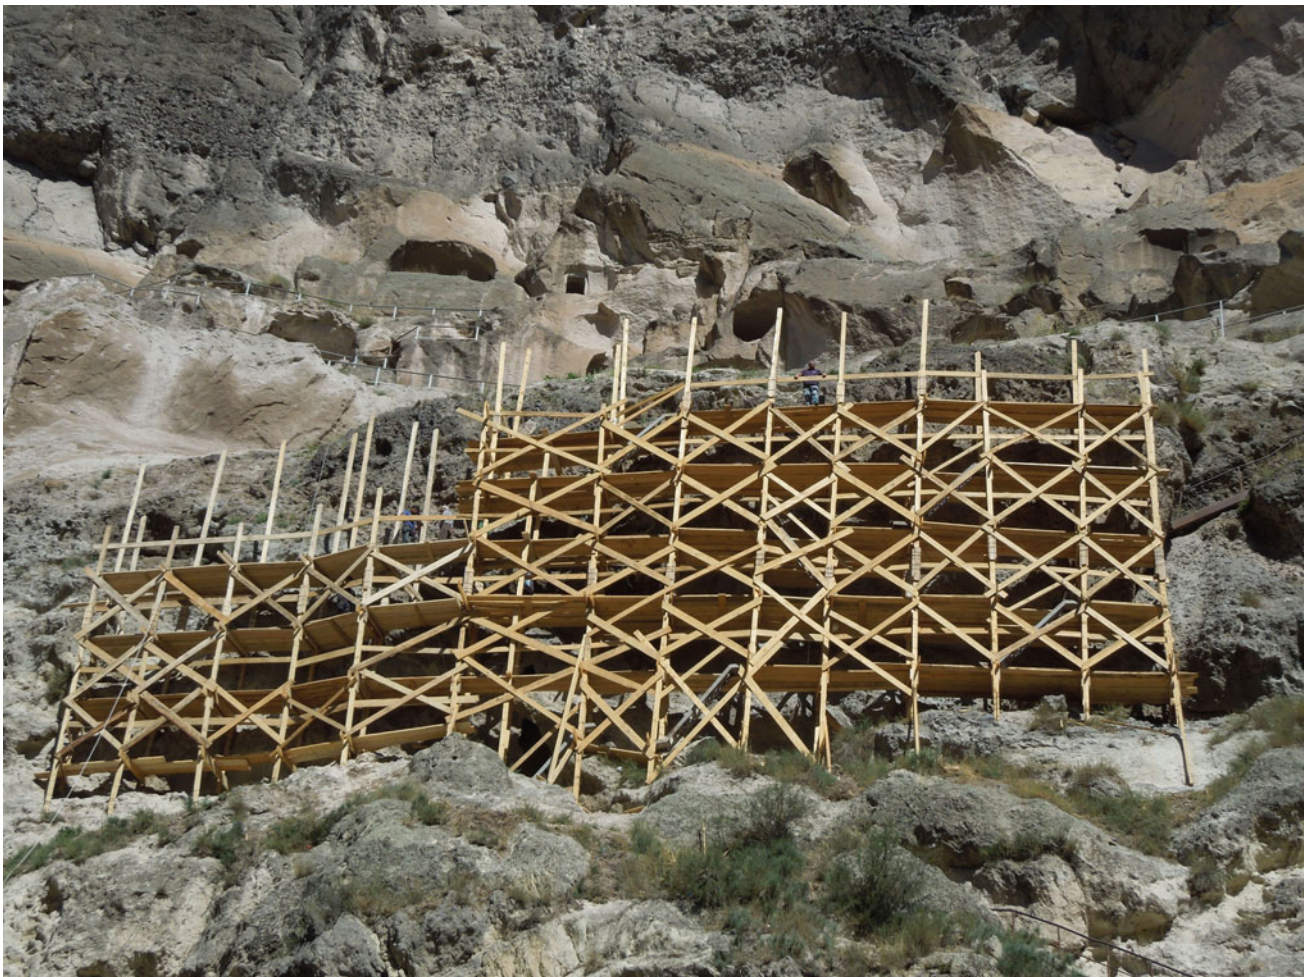
**Fig. 30** The wood scaffolding realised in Vardzia

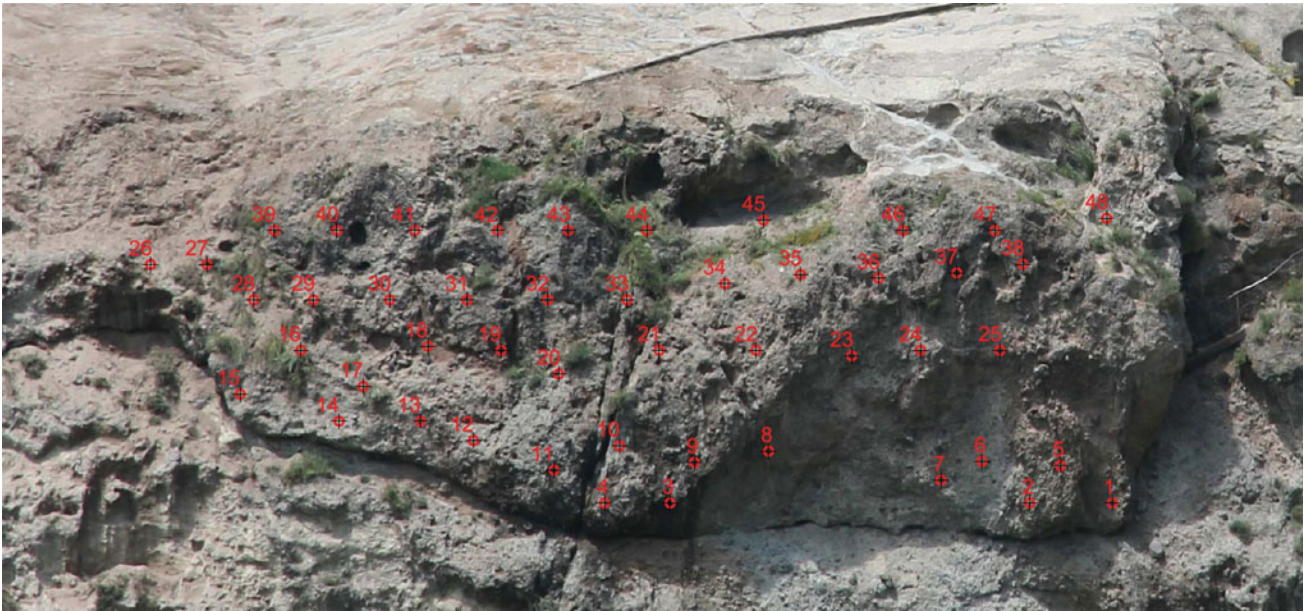
**Fig. 31** Positioning of the the 48 installed dowels
