Achieving Sustainable Buildings via Energy Efficiency Retrofit: Case Study of a Hotel Building

Abstract. Recent studies show that demand for green buildings with minimal environmental impact is increasing. Among the buildings in anywhere, existing buildings consume more energy than new ones. Because of that, building energy efficiency retrofit plays a very important role for achieving sustainable building targets. In addition to creating possibilities to reduce energy consumption, retrofitting also improves occupants' health and comfort. Tourism sector is one of the largest energy consuming sectors in the world. However conducted energy retrofit studies mainly focused on domestic buildings so far. The focus of this paper is to make a literature review of energy efficiency retrofits and present an approach to find the most appropriate, energy efficient and cost effective way renovate a hotel building. In this paper, a hotel building is energy efficiently retrofitted according to the TSE Green Building Certificate standards. Results from the analysis ensure that energy efficiency retrofit, helped to reduce energy consumption of the building and decreased in operational costs and CO₂

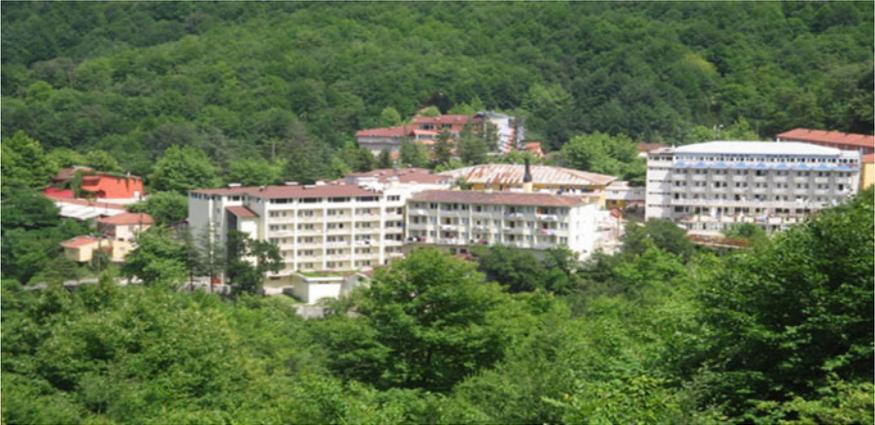
Fig. 1. Hotel building

Thermal hotel facility which is located in Oylat, Bursa was selected in this study to serve the research purpose. Famous thermal water springs of Oylat has been using in the hotel's spa and baths. Hotel facility has 252 rooms and 5 floors above ground with a total floor area of 11,808 m² (Fig. 1). In particular, coal is used for the facility heating and thermal water is used in baths and spas.

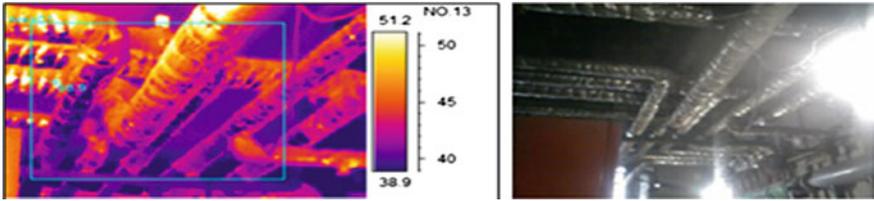
As means of uncovering inefficiencies in the HVAC system and building envelope, a thermographic inspection of the case study building was performed by using an infrared camera. Infrared images produced during the inspection were analyzed for heat loss. According to the visual inspection, building envelope appears to be in good condition and meet the current regulation demands. The inspection also revealed that mechanical installation is a significant source of heat loss and has a high potential for energy efficiency improvements. Due to TS-2164 thermal installation regulation, temperature difference between insulated surface and indoor air supposed to be of a maximum of 5 °C. However, thermographic inspection revealed that temperature difference is between 9 and 12 °C (Fig. 2). As a result of that, most of the pipelines have been replaced with pre-insulated geothermal pipes.

Fig. 2. Thermographic inspection of installation systems

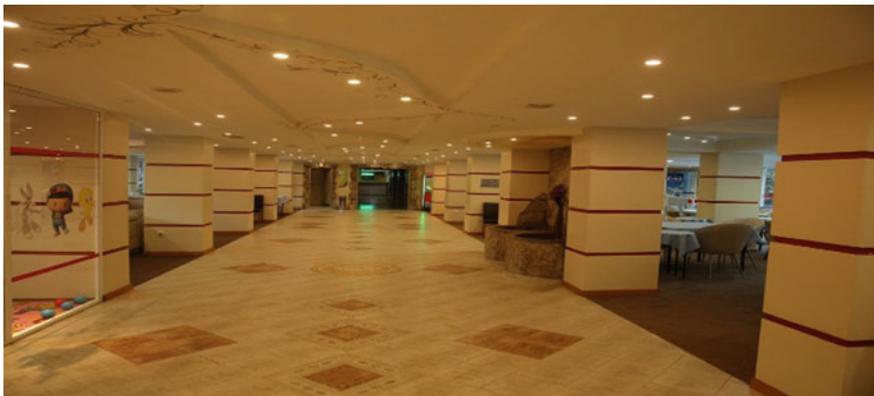
Energy conservation from artificial lighting is very important in hotels, since several areas of the building remain with the lights on throughout the night hours [14]. Almost 21.3% of the electricity that generated in Turkey is consumed for lighting, and if a good design is made, the total energy consumption for lighting purposes can be reduced by 20%. In order to investigate the efficiency of the lighting system, light measurement is made by using a lux meter. According to the measurements, lighting levels of the interior spaces need to be enhanced in terms of safety and comfort (Fig. 3).

Fig. 3. Hotel lobby lighting

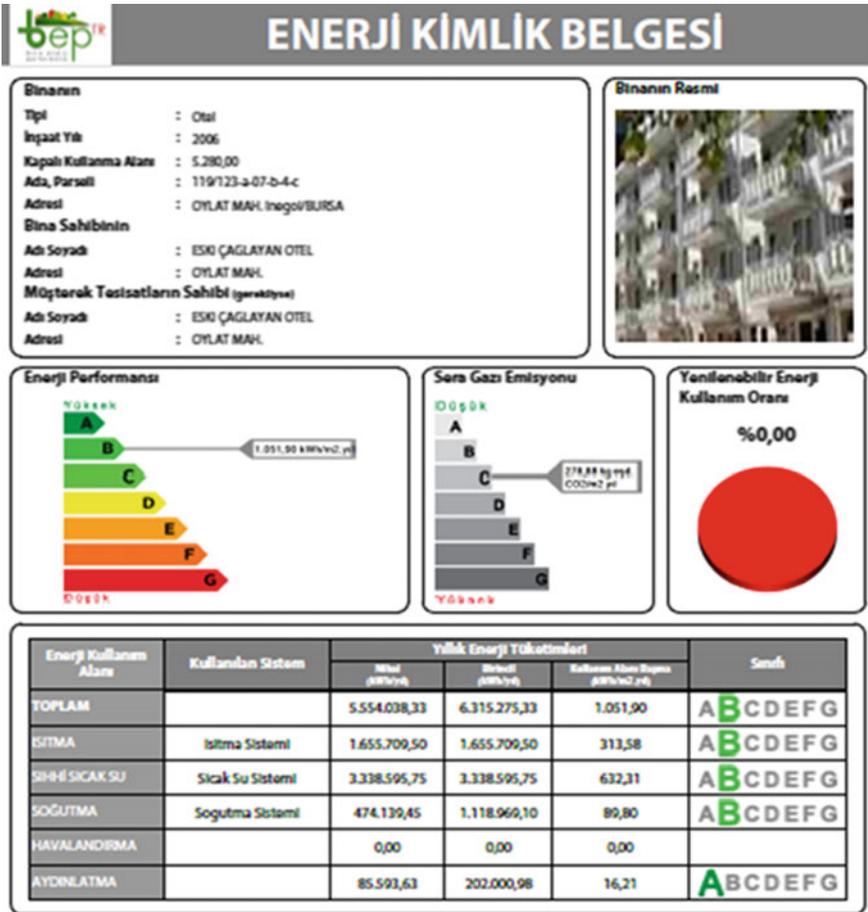
In order to be evaluated according to Energy category credits of TSE Green Building Certificate, Turkish Building Energy Performance Certificate document must be provided. After applying retrofit actions, hotel building's annual energy consumption and greenhouse gas emissions shown in Fig. 4. According to this certificate, the hotel building's energy performance class is B and CO₂ gas emission class is C.

Fig. 4. Energy performance certificate of the hotel building
