# Experimental Vibration Analysis of Composite Bridge Superstructure with Excessive Deformations

Mieszko Kużawa<sup>(✉)</sup> and Jan Bień

Department of Civil Engineering,  
Wrocław University of Science and Technology, Wrocław, Poland  
mieszko.kuzawa@pwr.edu.pl

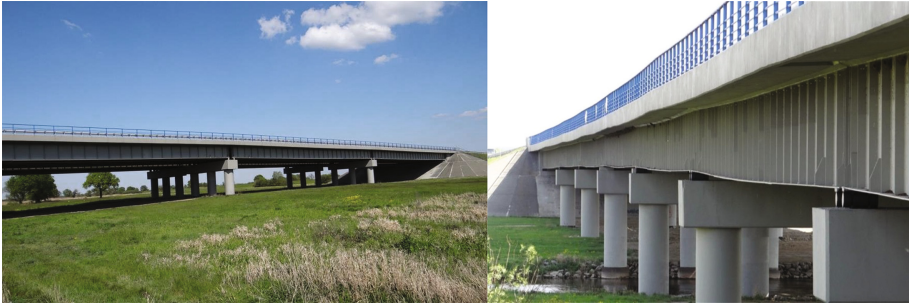
**Fig. 1.** Side view of investigated bridge – visible excessive permanent deflection of superstructure

The investigated bridge structure over the Warta River (built in 1989) is a part of the highway A2, one of the main highways in Poland, going from Warsaw to Berlin, Germany. The bridge consists of two separated superstructures, each built of seven semi-continuous beam type spans. Every span is constructed of four steel plate girders, 2.5 m high, composed with typical RC slab of variable thickness. Theoretical length of each span is 41.0 m. The composite superstructure has in each span an excessive, permanent deflections, up to 10 cm, possibly resulting from creep and shrinkage of RC slab as well as design and construction faults. The structural form of the investigated bridge is presented in Figs. 1 and 2, as well as in Fig. 4.

- the static system of superstructure which is in the form of semi-continuous beam – the adjacent spans are connected by the deck slab only (see Fig. 2),
- an excessive, up to 10 cm, permanent deflections of all spans and consequently – unevenness of the highway pavement,
- relatively low stiffens and mass of spans.

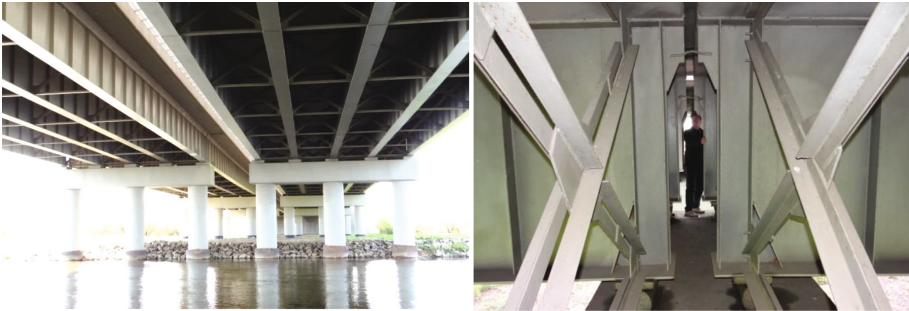
**Fig. 2.** Investigated bridge: (a) bottom view of superstructure, (b) view of intermediate support area

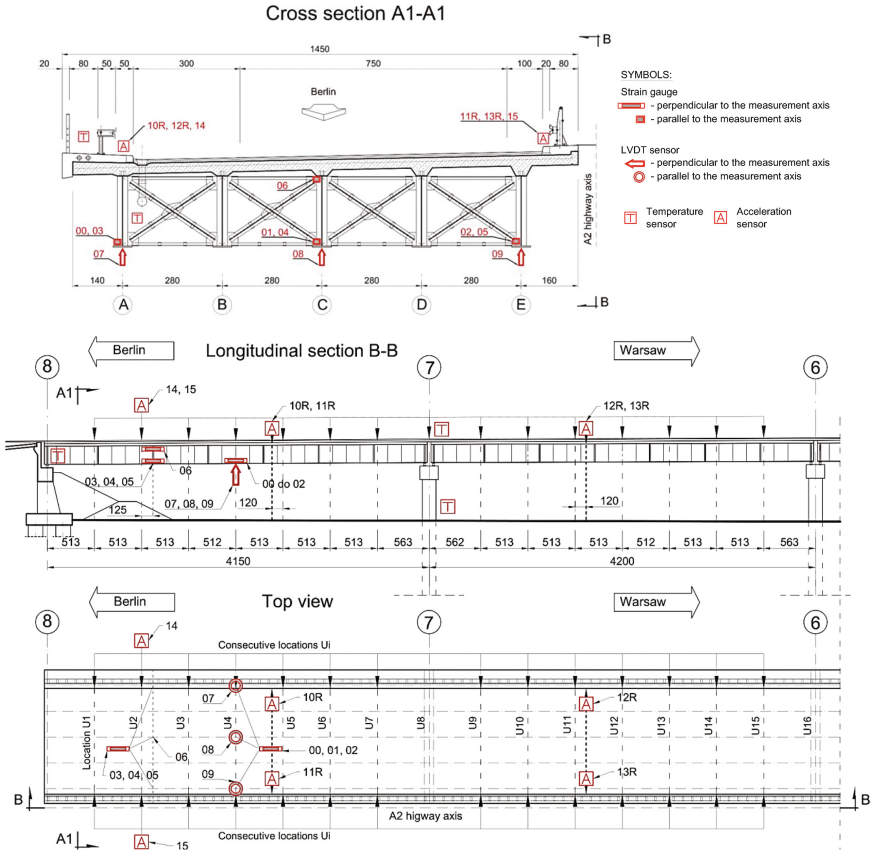
**Fig. 4.** Gauges arrangement scheme: (a) cross section, (b) longitudinal section, (c) top view

During consecutive four measuring sessions gauges arrangement scheme has been slightly modified according to current needs of the bridge evaluation. Exemplary gauges arrangement scheme applied during 4<sup>th</sup> session is presented in Fig. 4. According to presented sensors layout during the last testing session the following physical quantities were measured:

- strains induced in lower flanges of steel girders in span 7–8 at the measuring points numbered from 00 to 06 shown in Fig. 4; measurement was conducted using a strain gauges – see Fig. 5a,

- vertical displacements in the middle section of span 7–8 at the measuring points numbered from 07 to 09; measurement was conducted using a LVDT sensors – see Fig. 5b,
- vertical accelerations at selected points of bridge deck numbered from 10R to 13R and 14 to 15 (shown in Fig. 4) located along both edges of single carriageway in spans 6–7, 7–8; measurement was conducted using a accelerometers – see Fig. 5c.

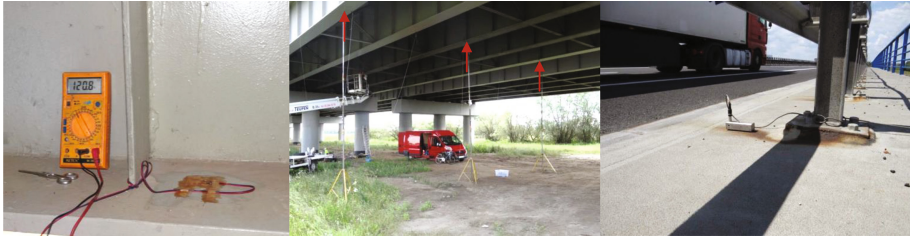
**Fig. 5.** Exemplary location of different types of measuring sensors in span 7–8: (a) strain gauge at point 00, (b) LVDT sensors at points 07–09, (c) accelerometer at point 10R

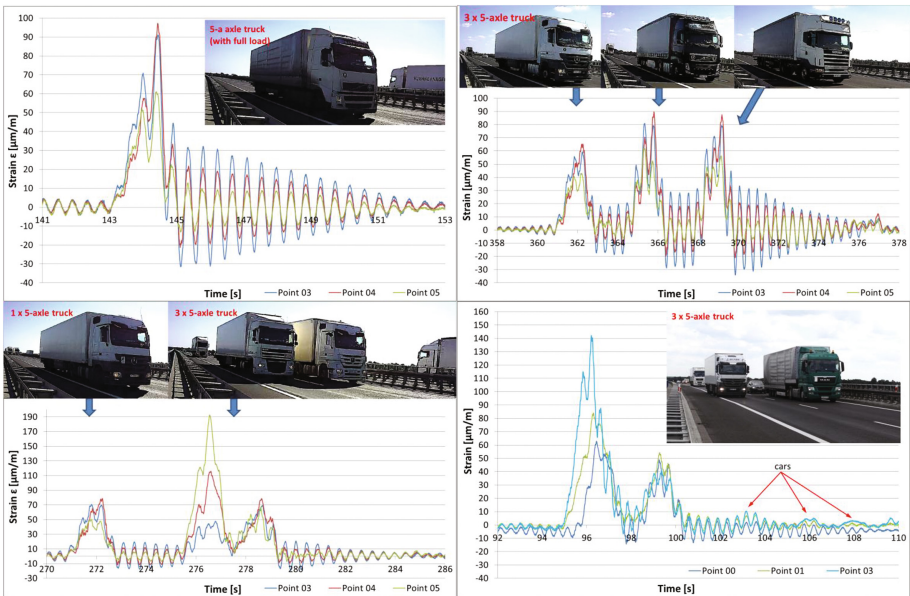
**Fig. 6.** History of strains induced in main girders by various schemes of 5-axle vehicles

Measurements under service loads were made to get real-time information of the superstructure performance under normal traffic loads. During each measuring session between 20 and 25 measurements (10 min each) were carried out with the sampling frequency of 300 Hz. Selected results of the 4<sup>th</sup> testing session (September 14<sup>th</sup>, 2016) between 8.30 am and 18.00 pm are presented in Figs. 6, 7 and 8.

On the basis of analyzes of presented results it can be concluded that the whole structural system exhibit excessive, low-damped vibrations induced by typical cargo traffic crossing the bridge. Physical quantities caused by trucks are quite significant, clearly perceptible and visible to the naked eye. Even a single heavy vehicle generates considerable vibrations of bridge superstructure and the dynamic effects induced by those kind of trucks travelling in groups, especially moving simultaneously on both traffic lanes, are almost twice as large as caused by a single vehicle. The peak values of registered quantities shown in Figs. 6, 7 and 8 were as follows:

- for single 5-axle vehicle with total maximum weight of 40 tones crossing the bridge:
  - maximum strains (tension) of steel girder –  $\varepsilon_{\max} = 98.16 \mu\text{m/m}$  (20.12 MPa),
  - maximum deflection of span –  $w_{\max} = 7.16 \text{ mm}$ ,
  - maximum vertical acceleration of deck –  $a_{\max} = 0.68 \text{ m/s}^2$ ,
- for pair of 5-axle vehicle with total maximum weight of 40 tones each, crossing the bridge simultaneously on both traffic lanes:
  - maximum strains (tension) of steel girder –  $\varepsilon_{\max} = 190.82 \mu\text{m/m}$  (39.12 MPa),
  - maximum deflection of span –  $w_{\max} = 13.20 \text{ mm}$ ,
  - maximum vertical acceleration of deck –  $a_{\max} = 1.66 \text{ m/s}^2$ .

It was found that measured values of strain ranges caused by heavy vehicles, especially traveling in groups, in the light of current knowledge (e.g. according to [2, 3]) can affect fatigue life of steel main girders. Assuming for bridge plate girders with transverse stiffeners welded to lower flanges fatigue category 71 MPa according to [14], the corresponding fatigue cut-off limit below which micro-damages do not accumulate in material is 103  $\mu\text{m/m}$  considering safety factor  $\gamma_M = 1.35$  and 118  $\mu\text{m/m}$  for safety factor  $\gamma_M = 1.15$ . While calculated maximum strain ranges from strain history depicted in Fig. 6 are the following:

- $D\varepsilon_{\max} = 120.61 \mu\text{m/m}$  (24.72 MPa) resulted from a single 5-axle truck travelling along slow lane of traffic,
- $D\varepsilon_{\max} = 196.34 \mu\text{m/m}$  (40.24 MPa) resulted from pair of heavy vehicles moving simultaneously on both traffic lanes.

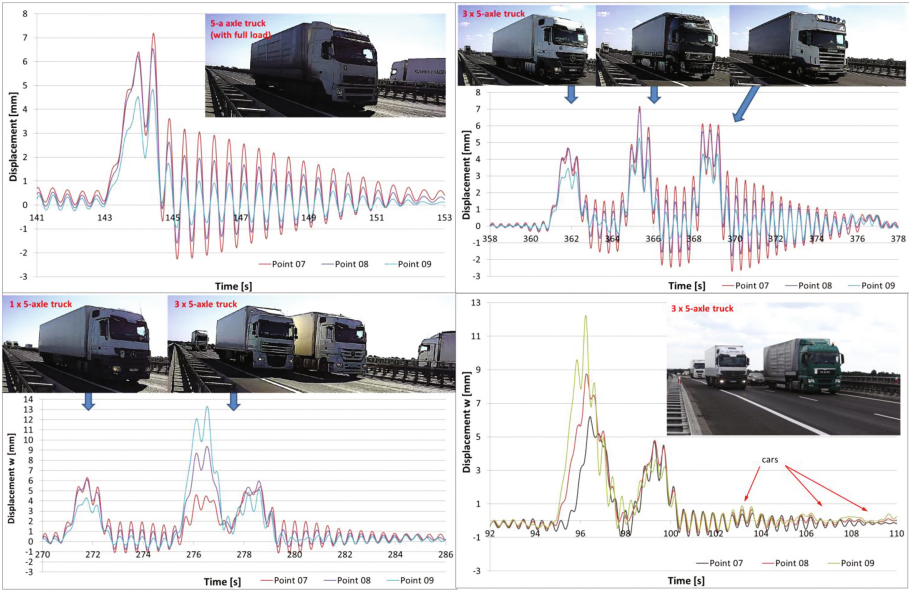
Fig. 7. History of main girders displacements induced by various schemes of 5-axle vehicles

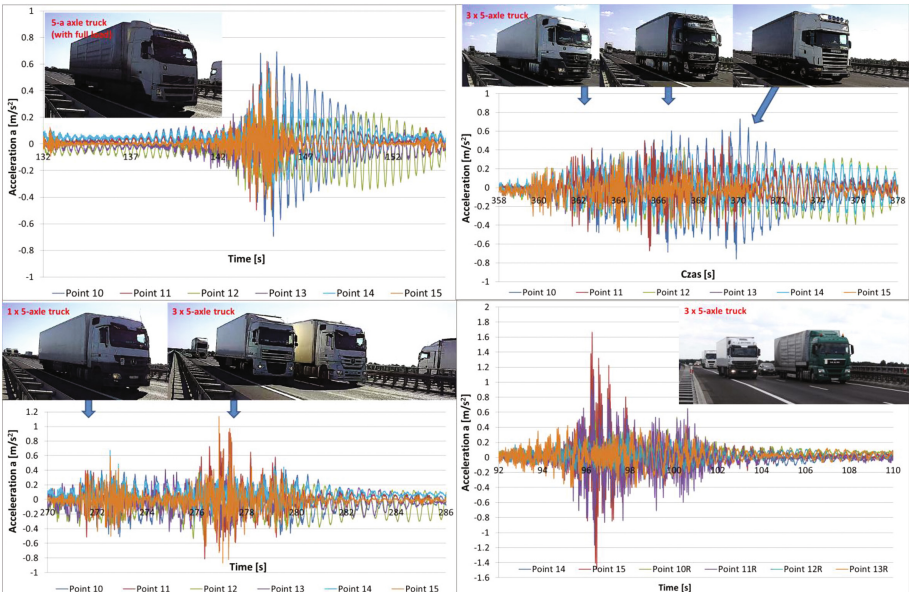
Fig. 8. History of main girders accelerations induced by various schemes of 5-axle vehicles

In general, the vibrations magnitude, in terms of amplitudes of displacements, strains and accelerations, is greater for the external spans than for intermediate ones but the outmost spans cease to vibrate faster than the others. This is due to the beat phenomenon (e.g. see point 12R in Fig. 8a) observed which is caused by mutual amplification of vibrations caused by similar vibration frequencies of adjacent spans.

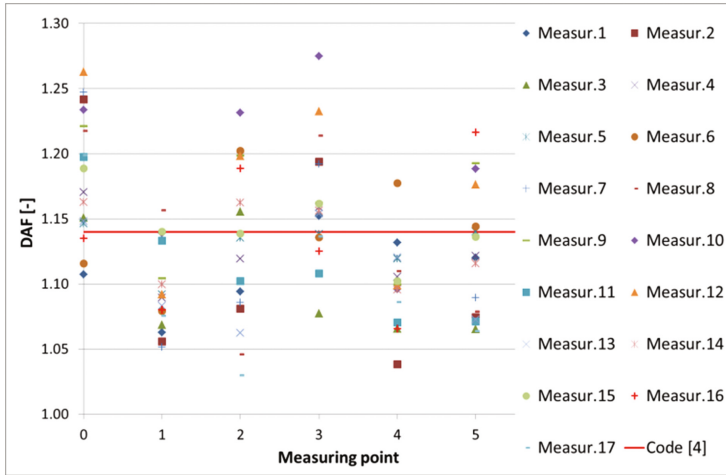
**Fig. 10.** Maximum values of Dynamic Amplification Factor (DAF) for consecutive measurements determined on the basis of experimental data

where  $R_{dyn}$  is a maximum dynamic response and  $R_{dyn}^{fil}$  is quasi-static response obtained by filtering the dynamic response, taken at the time when the maximum dynamic response occurs. Obtained values of *DAF* for selected measuring points are presented in Fig. 10. In the diagram the dynamic factor  $\phi = 1.14$  calculated according to the Polish Design Code [16] is also included. Polish Standard for bridge design [16] defines the dynamic factor  $\phi$  as a partial safety factor calculated individually for every single component of superstructure using the formula:

It can be clearly seen that maximum values of *DAF* obtained for all performed measurements in many cases exceed the code's assumed value of  $\phi$ . The maximum calculated *DAF* amounted for 1.27. It has been found that for a single vehicles passing the bridge the value of *DAF* is close to 1.14, which is suggested by code's [16] formula. In the vast majority of cases greater values of *DAF* than 1.14 were obtained during passing through the bridge a group of vehicles, e.g. moving one by one in close proximity to each other.
