Structural Health Monitoring Systems for Smart Heritage and Infrastructures in Spain

F. Javier Baeza, Salvador Ivorra, David Bru and F. Borja Varona

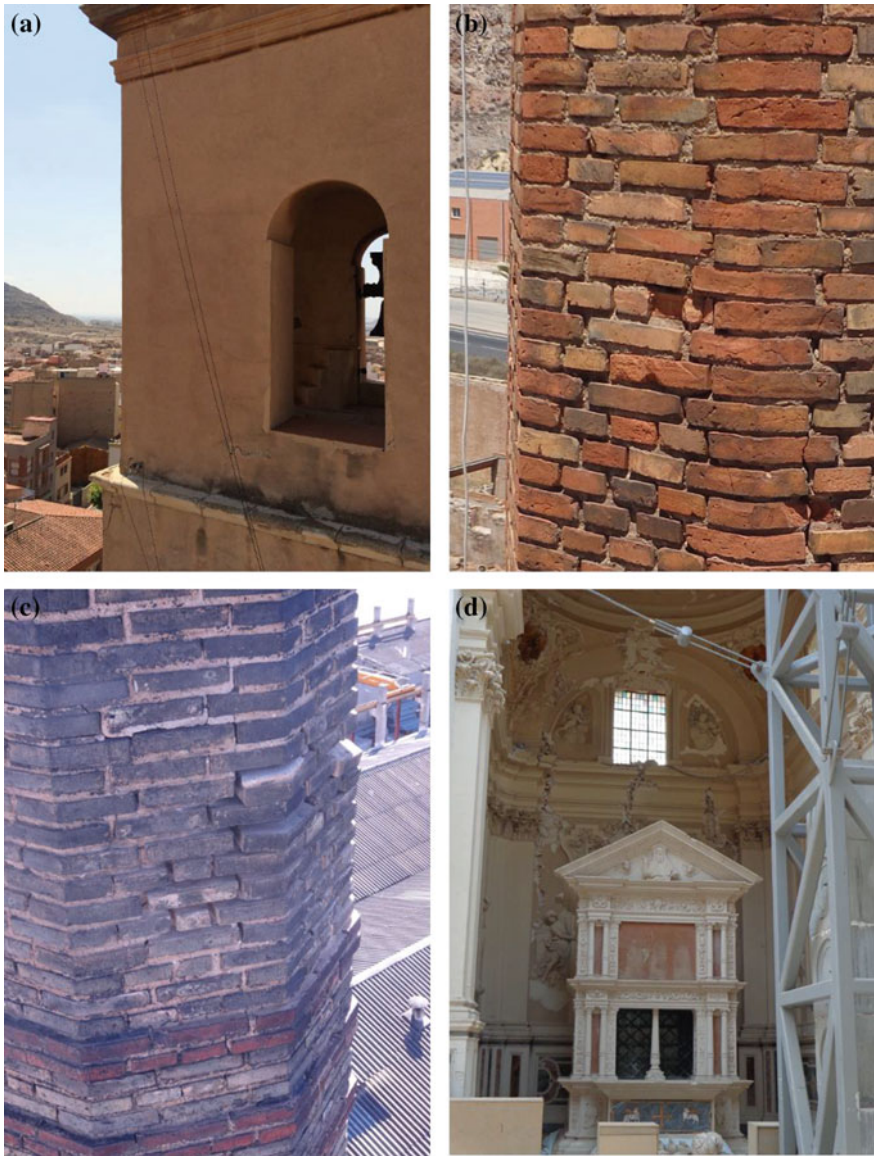
Fig. 1 The most frequently observed pathologies in built heritage: **a** discoloration, **b** spalling, **c** mortar loss, **d** cracking

- *Discoloration of masonry materials*, Fig. 1a which can be directly linked to changes originated by chemical effects. Buildings located in heavily polluted

- *Spalling in the surface of stone-like materials*, Fig. 1b. The loss of material can occur due to salt content in the internal water. Damage will be more severe with greater wind exposure or groundwater filtration. In addition, materials with higher porosity are prone to this type of damage.

- *Mortar loss in masonry joints or plaster*, Fig. 1c. Similar to spalling, this pathology is an important factor in the stability of slender structures such as industrial chimneys or bell towers, especially when they are built in masonry bricks, because it can generate loose brick elements. If an external plaster layer is present, its debonding and possible spalling is also a frequent pathology related to hygrothermal effects.

- *Cracks*, Fig. 1d. Unreinforced masonry has almost no tensile strength. Hence, crack initiation and propagation must be controlled to guarantee structural stability. The causes can differ widely—for example, ground movements or seismic events. Crushing cracks in columns can appear due to high compressive stress, which can be a problem if water content is high, as stone strength diminishes in saturated conditions [50]. Because structural performance can be severely compromised if cracks remain active, crack monitoring is an important basic parameter in long-term heritage SHM systems.

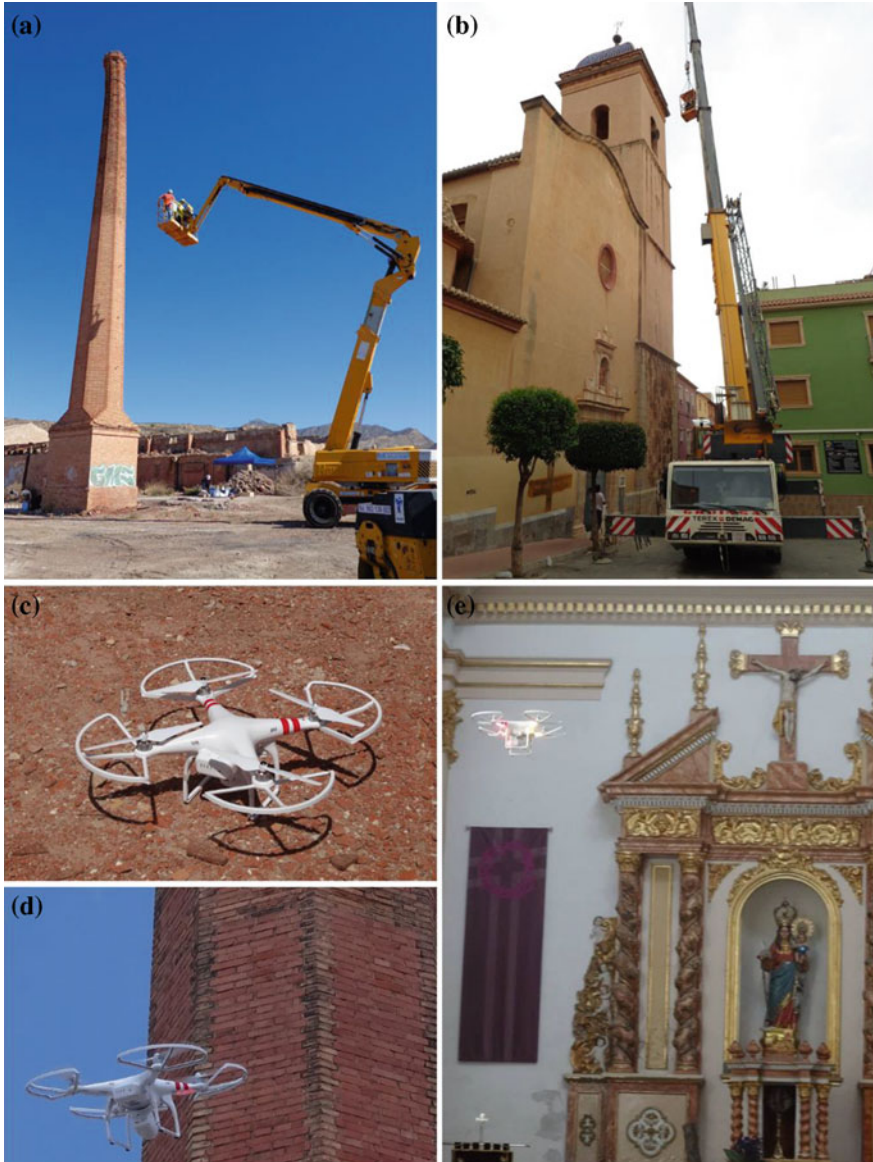
Fig. 2 Human visual inspection: **a** masonry chimney and **b** bell tower, both protected structures in Agost (Alicante). **c** UAV for automated inspection used in **d** masonry chimney and **e** interior inspection of Saint Peter's Church, both in Agost

Visual inspection can provide a general idea of the structural conditions and the parameters of interest for monitoring. Traditionally, human inspections have been limited to areas of access or have required specific machinery or equipment for this purpose (e.g. cranes). Today, the development of UAV allows this task to be performed more safely and at lower cost. Figure 2 includes examples of different visual inspections. In Fig. 2a, b the use of cranes was necessary to reach the areas for inspection, with consequent temporary disruption of road traffic in some cases. The UAV shown in Fig. 2c was used to complement the inspection of the masonry chimney in Fig. 2a, d. This robot-aided inspection can even be performed inside buildings, as shown in Fig. 2e.

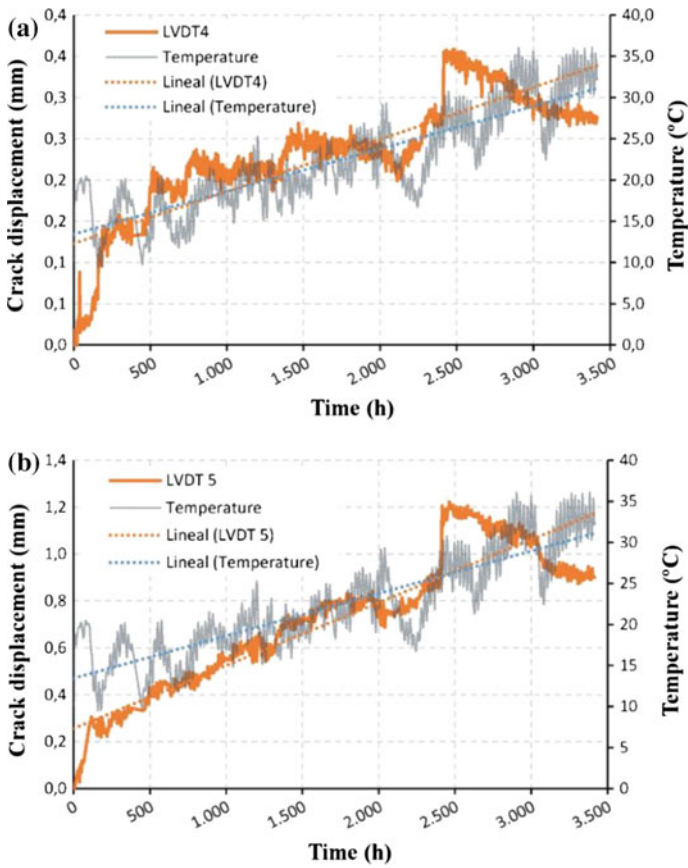
Fig. 5 Temperature and displacement measurements of LVDT located in the arch over the high altar, **a** in the lower part of the keystone and **b** in the joint between the arch and the upper diaphragm

An SHM system was also used to evaluate the performance of the scaffolding solution. Figure 5 shows the time evolution of two displacement sensors located in the arch above the high altar, one in the lower part of the keystone and another in the joint between the arch and the upper diaphragm. Temperature measurements obtained in a thermocouple next to the LVDTs are also included in order to exclude thermal effects in the structural displacements. Results for the first five months of

monitoring are included. The effect of the scaffolding can be observed in the changes registered after 2000 h. At around 2500 h, a readjustment of the scaffolding was necessary after the detection of a sudden displacement increase.

Subsequently, the widening trend in the crack opening has been reversed. This type of monitoring will also be useful during foundation reinforcement work and structural reloading when the scaffolding is dismantled.

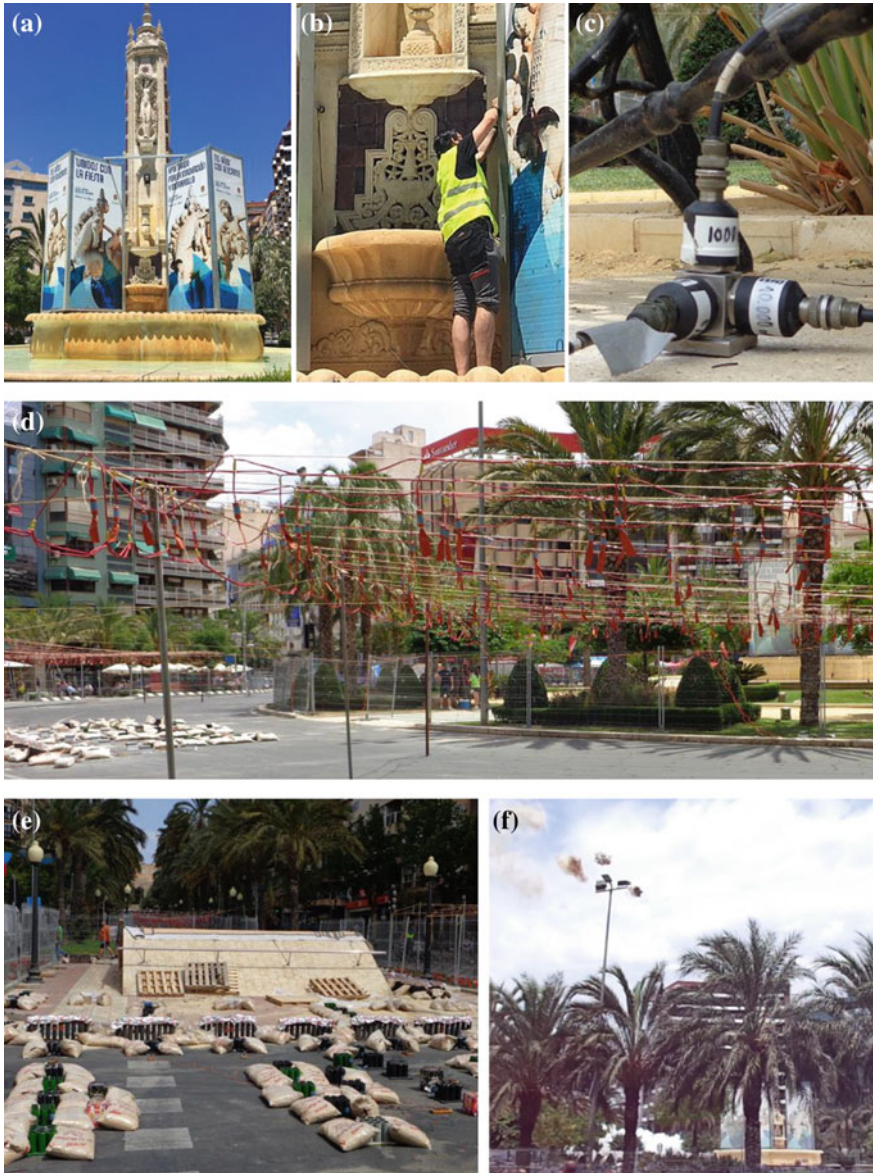
Fig. 6 a General view of the fountain and the protective screens; b sensor installation; c triaxial setup; d relative position of the fountain and explosives; e detail of the fireworks devices; f view of the fountain during the spectacle

The fountain in the center of the Plaza de los Luceros in Alicante, Fig. 6a, is one of the city’s most important monuments. This modernist structure, built in 1930, is composed of a central body and four horse sculptures. It was repaired several times in the early 2000s, and a retrofitting using composite materials is currently being evaluated. One of these interventions consisted in the total dismantlement and

The most common types of damage are superficial cracking and spalling as a result of nearby road traffic, water from the fountain and corrosion of the embedded steel elements of the fountain installation. However, another possible cause should be taken into consideration: Each year during the city festivities, several fireworks displays (called *mascletàs*) are held in the plaza, near the fountain. These *mascletàs*, and their location, have led to a public debate on their possible effects on the fountain's health. As a temporary measure, each horse sculpture has been protected with composite protective panels during these events, Fig. 6a.

In this case, dynamic monitoring has been selected to evaluate the effect of the blasts on the fountain elements. A monitoring system comprising eight accelerometers attached to the fountain and on the ground was installed to measure vibration levels due to the fireworks. The sensor installation can be observed in Fig. 6b; an example of a triaxial setup, attached to the ground near the fountain, is included in Fig. 6c. The relative location of the explosive charges with respect to the monument and a detail of them are include in Fig. 6d and e, respectively. An example of the pyrotechnic arrangement for this performance is shown in Fig. 6f.
