Oil-Related Mangrove Loss East of Bonny River, Nigeria

Erich R. Gundlach

Abstract

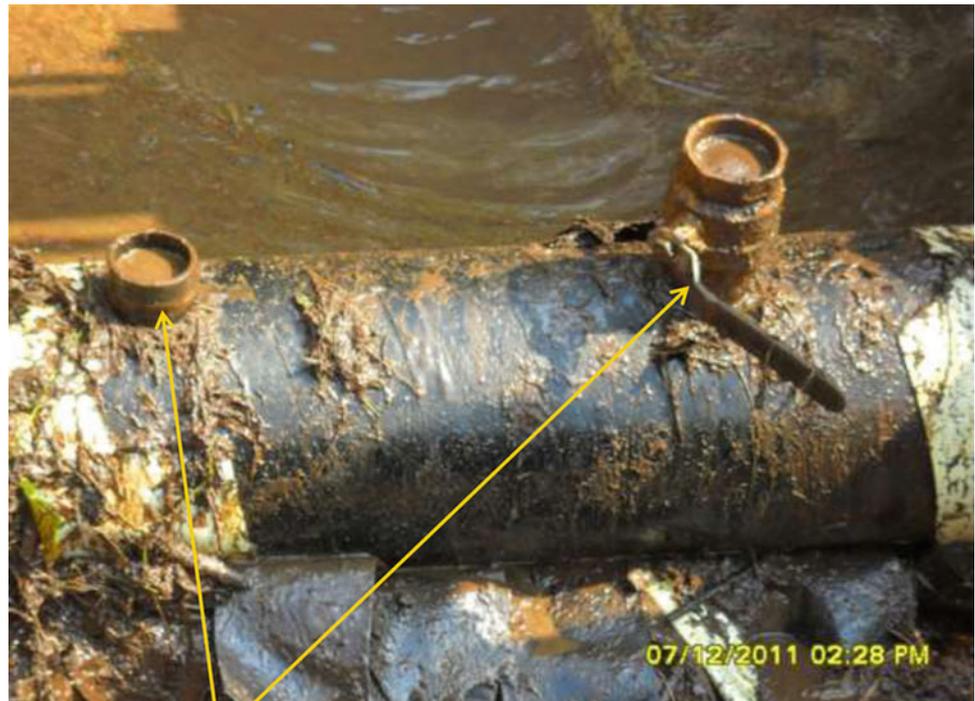
Fig. 13.9 Example hot-tap valves from the 12" Imo River 1 pipeline joint investigation report number 750226 (<http://www.shell.com.ng/sustainability/environment/oil-spills.html>)

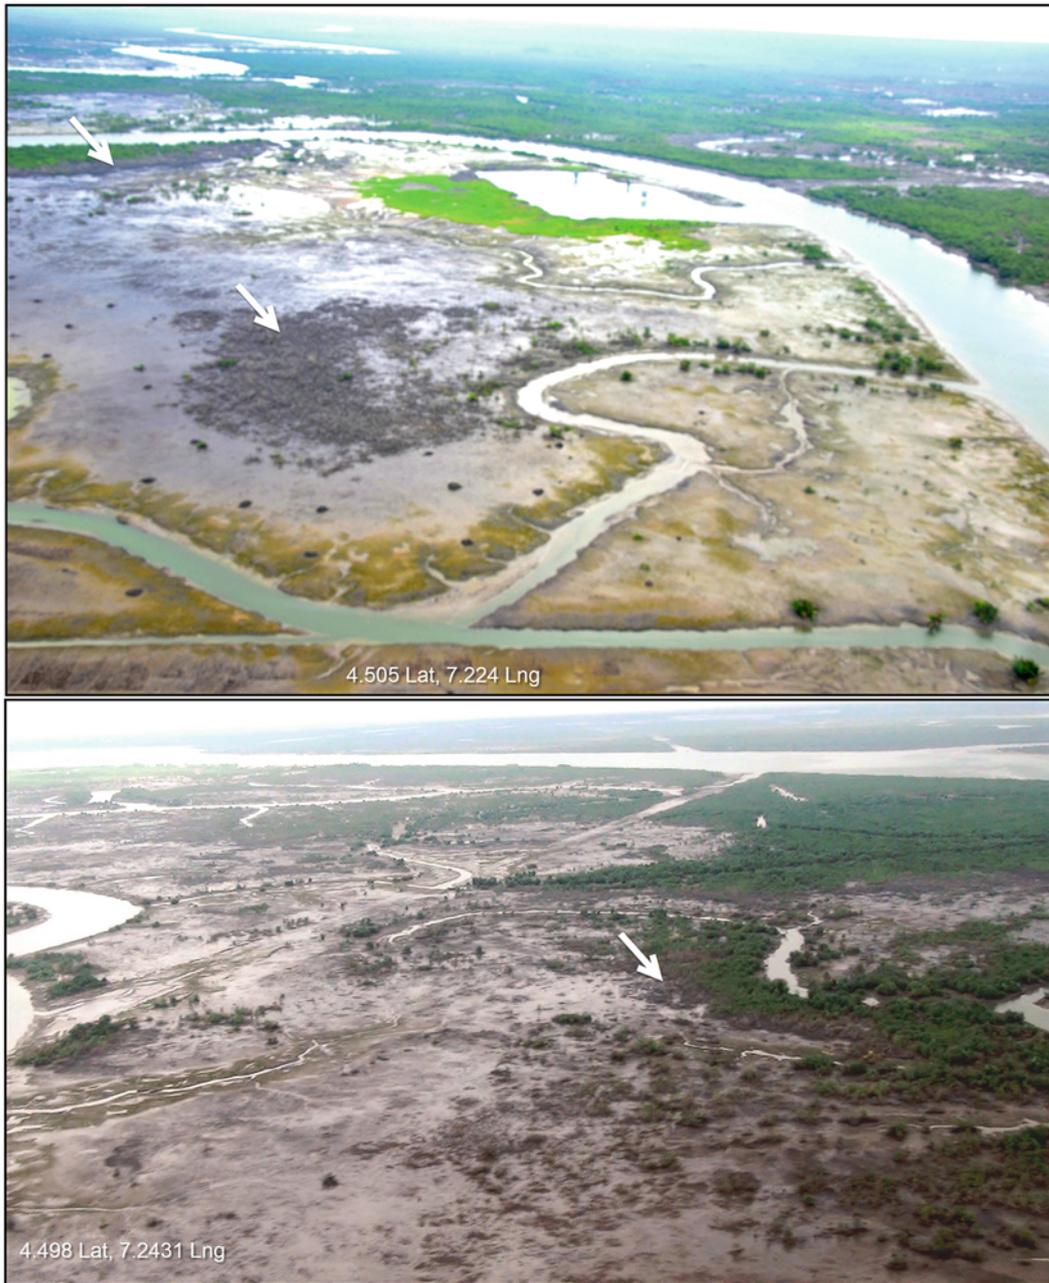
Fig. 13.17 Aerial photographs from 15 September 2015 of two sites in the Bonny study area showing the condition of former mangrove habitat. See Fig. 13.15 for location. *Arrows* indicate areas were alive in the image from 18 Dec 2013 but are dead in 2015

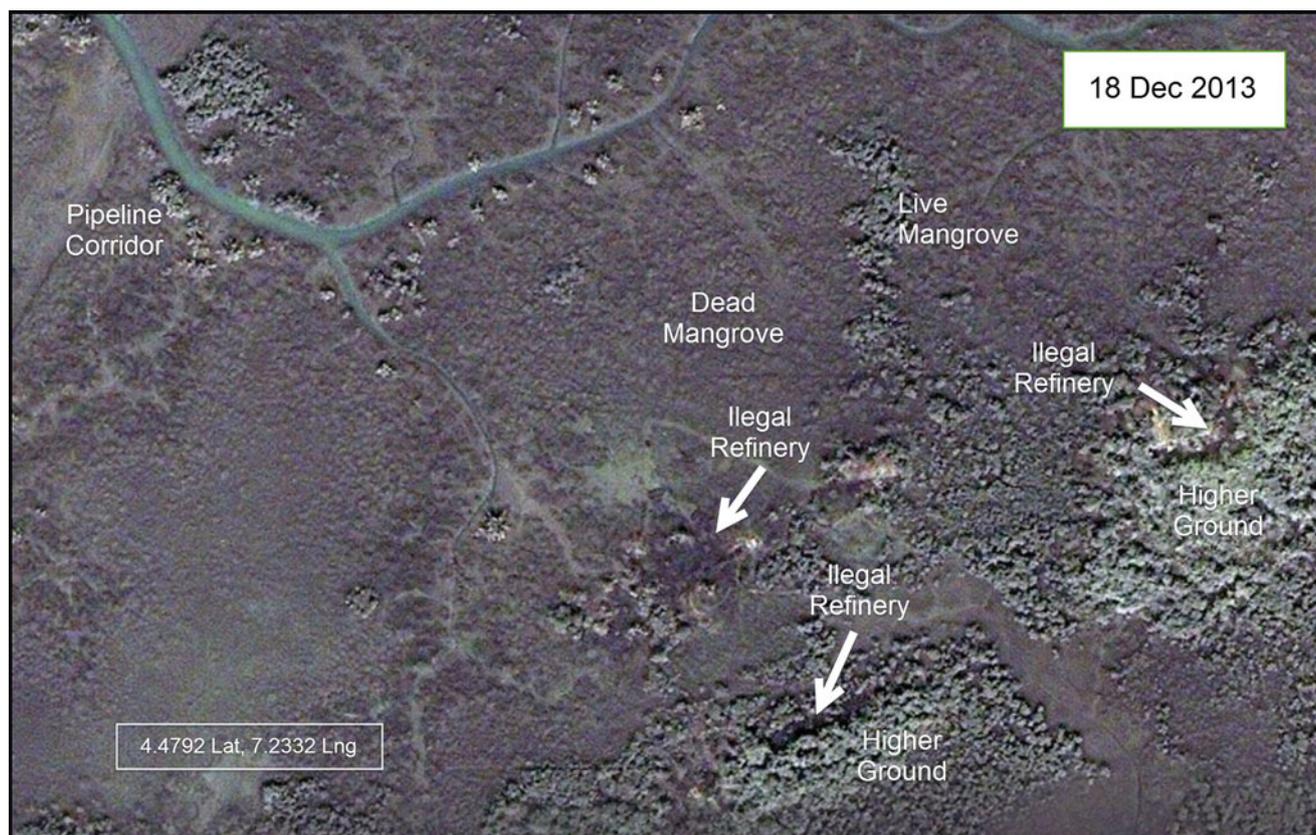
Fig. 13.18 Illegal refineries and associated habitat condition on Bonny Island, 18 Dec 2013

Illegal refineries are not common in the Bonny Island area. Four were found in higher ground near the pipeline corridor in the south-central part of the study area (Fig. 13.18).

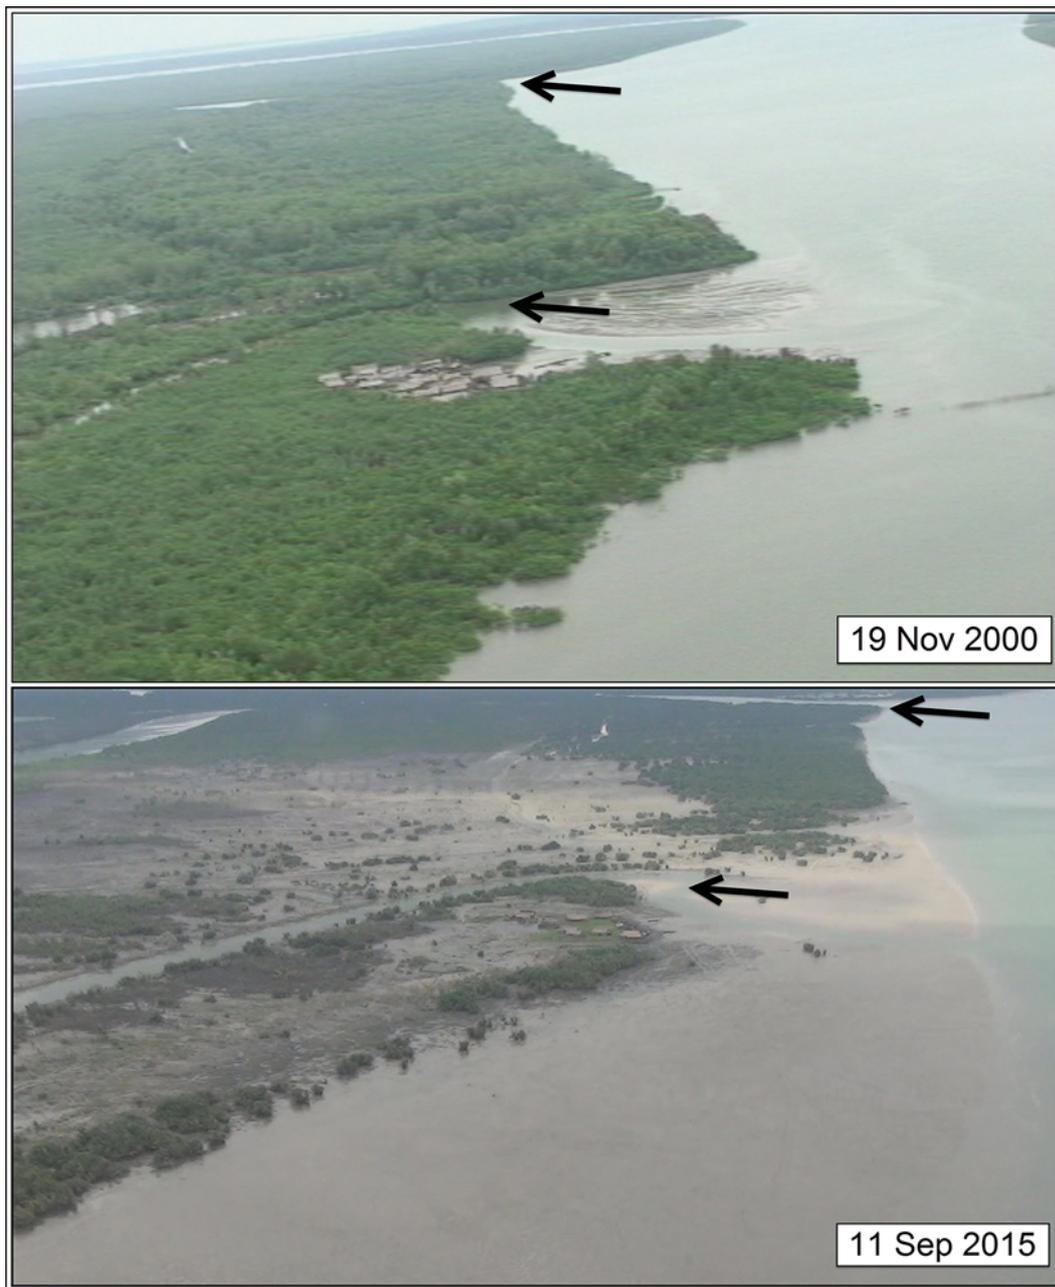
Fig. 13.22 Aerial photographs showing change in mangrove cover from 2000 to 2015. Site location is shown in Fig. 13.19. A coastal village and arrows indicate the same locations on each photograph

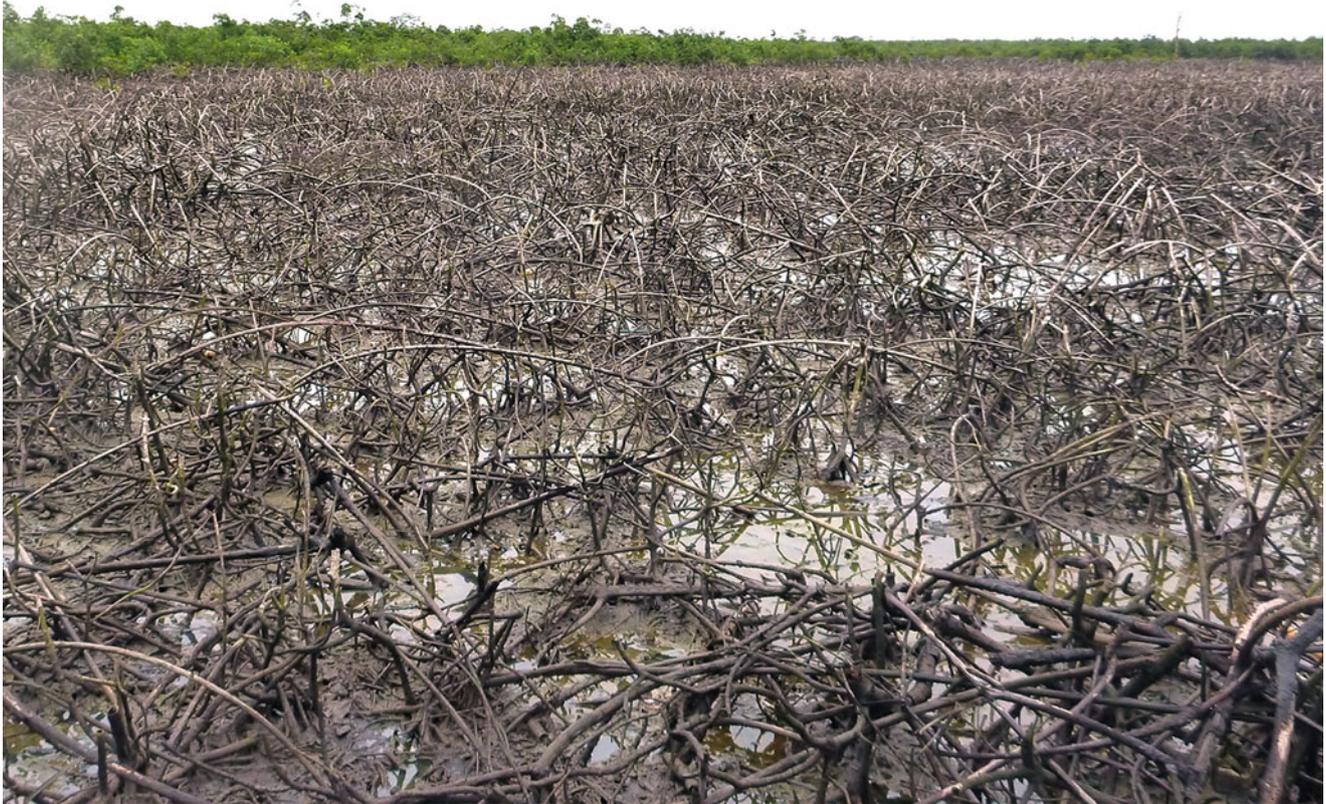
Fig. 13.31 View in 2013 across dead mangroves looking east at the site of the December 2008 operational spill site in Bodo West area ‘B’ from Fig. 13.25

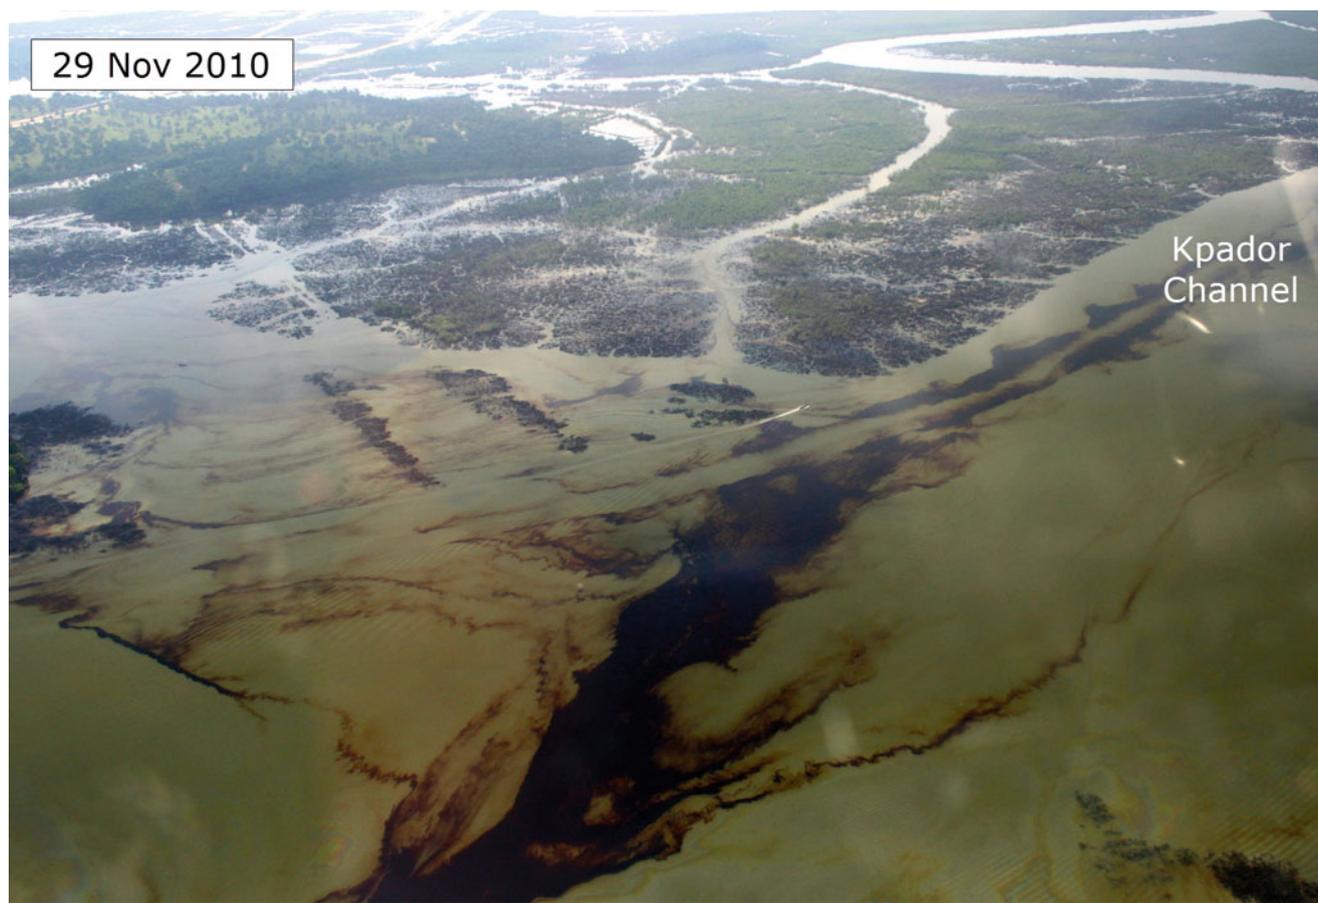
Fig. 13.34 Aerial photograph on 29 November 2010 overlooking Bodo West area 'D' looking south. Large concentrations of black oil are common on the water's surface. The site location of area 'D' is shown in Fig. 13.25. T. Kallnischkies photographer

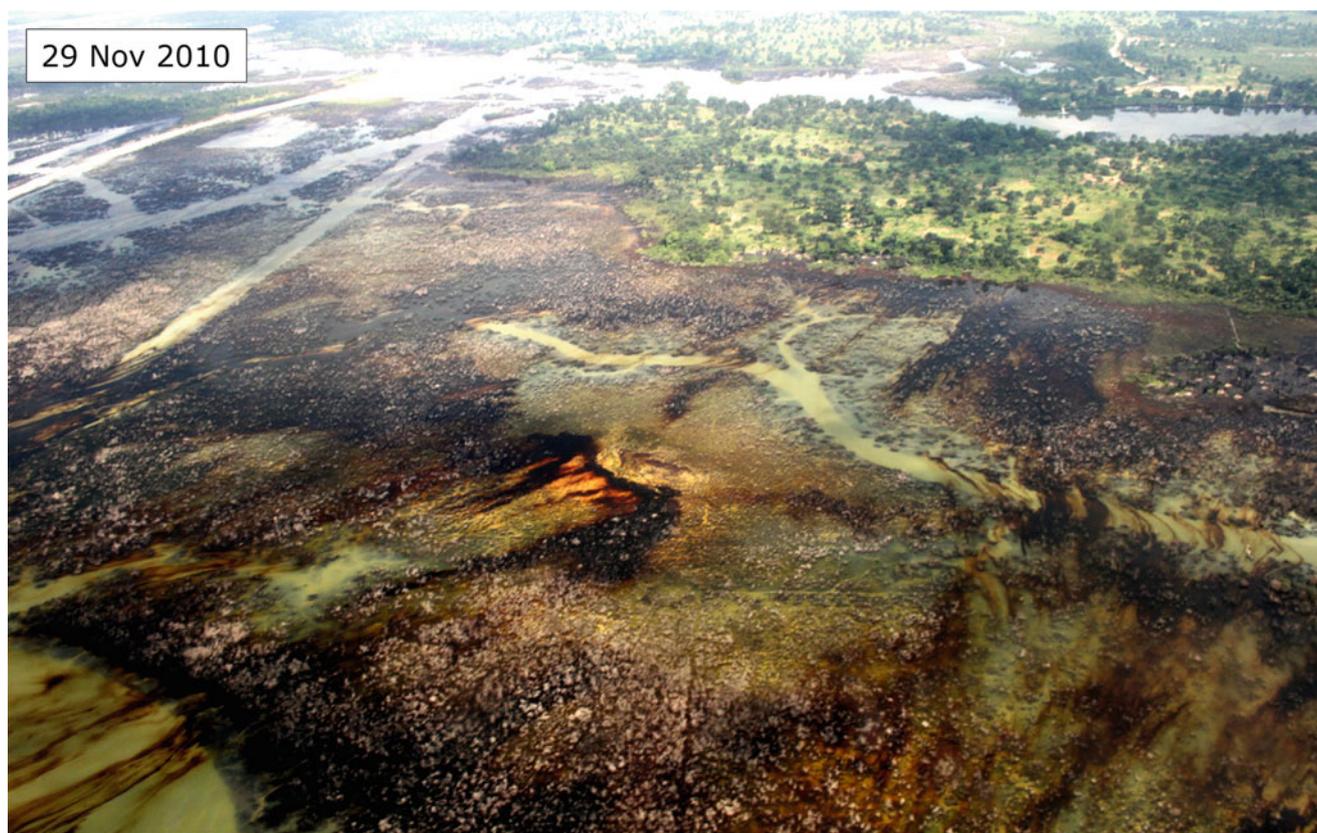
Fig. 13.38 Aerial photograph from 20 November 2010 of the Bodo East area 'A' (Fig. 13.35) looking NNE showing heavy oil concentrations. T. Kallnischkies photographer

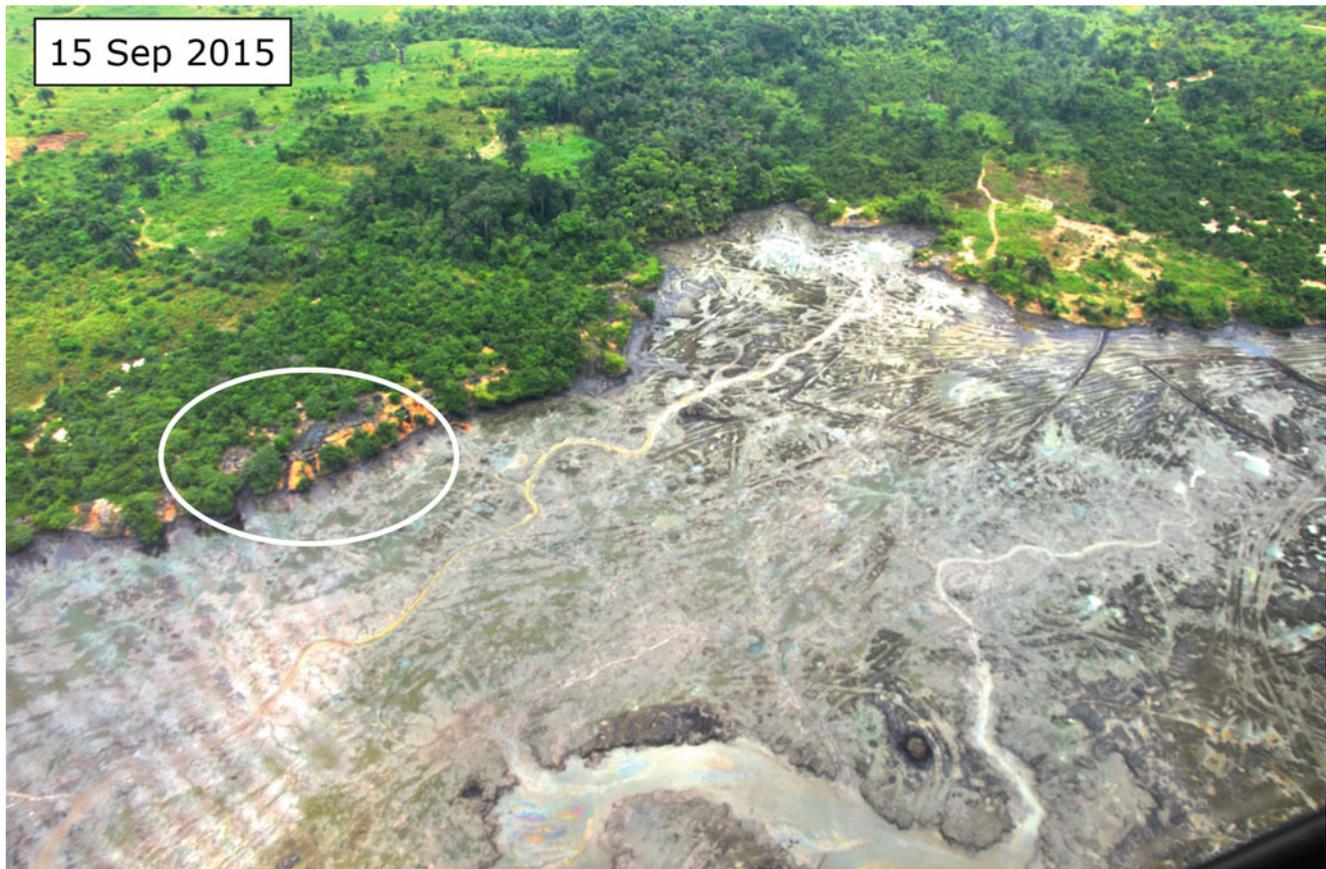
Fig. 13.45 Aerial photograph from 15 September 2015 of the northeastern section of Bolo area ‘B’ from Fig. 13.41. Scrape marks potentially from a cleanup operation are evident. Oil is in the water and along
