Preliminary Methodological Indications for the Restoration of Ancient Buildings: The Protocol Implemented in the So-Called *Dépendence* of the Villa of the Sette Bassi in Rome

Carla Maria Amici and Alessandra Ten

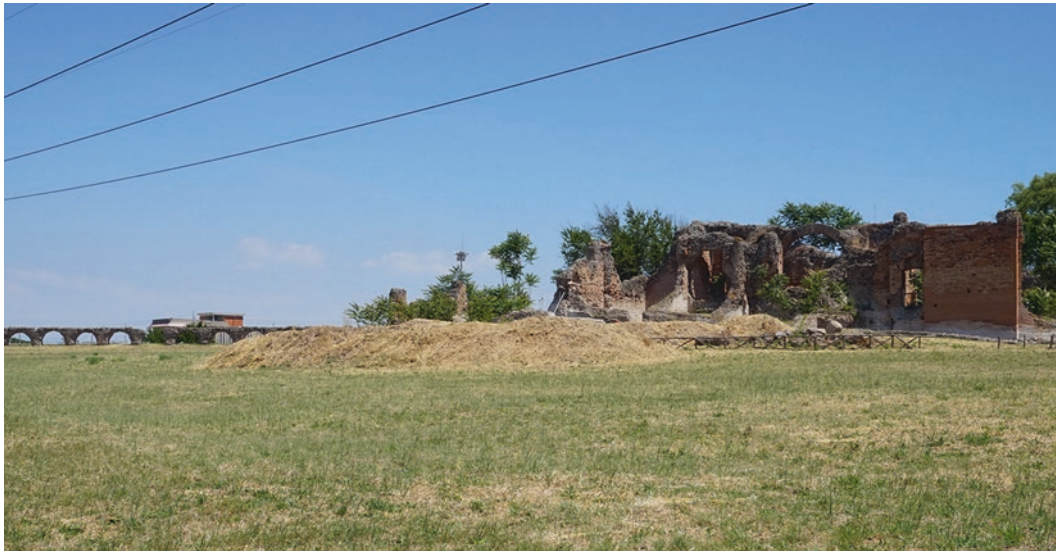
Fig. 52.1 Rome, Villa of the Sette Bassi, aka *Dépendence*; the aqueduct can be seen in the background

When faced with such a compromised situation, and on such a huge scale, the Soprintendenza Archeologica di Roma found itself obliged to concentrate its efforts, resources and work on a limited portion of the complex, known as the “*Dépendence*” (Fig. 52.1), of uncertain function, apparently detached from the main complex.

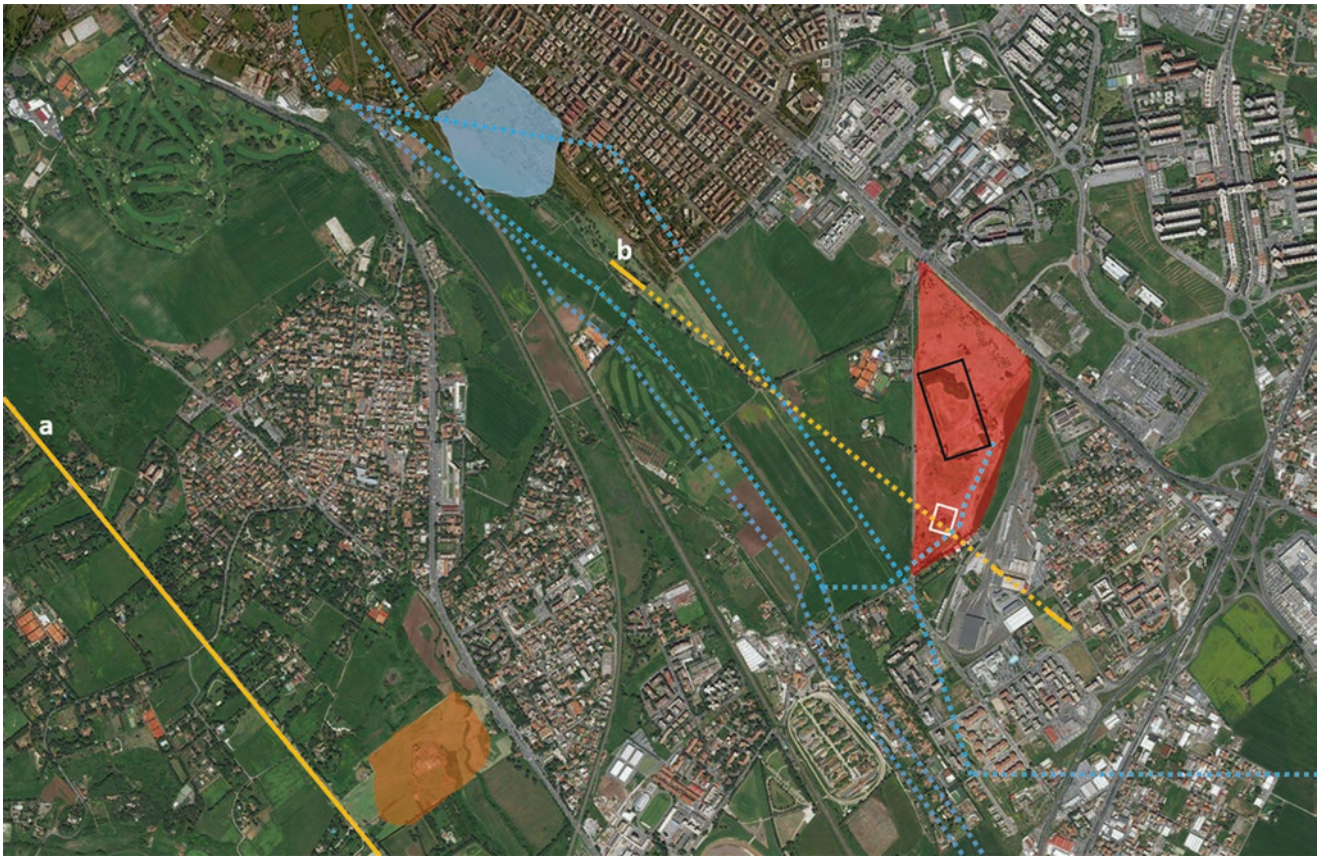
Fig. 52.2 Aerial photo of the area (from Bing Maps) showing the archaeological site in its context. The dotted blue lines show the aqueducts and the yellow lines (a) the Via Appia and (b) the Via Latina. The coloured areas show the Villa delle Vignacce (grey), the Villa of the

Quintili (orange) and the Villa of the Sette Bassi (red). In the Villa of the Sette Bassi, the black rectangle shows the area of three main blocks, the white rectangle shows the Dépendence

earth as a result of changing needs. The presence of an important road, the Via Latina, in the immediate vicinity encouraged the reuse of the ruins, which bear the signs of their transformation over time for different purposes. As a result, the investigation clearly defined the route taken by the Via Latina close to the site, the identification of ruins from a similar period in the immediate vicinity and the identification and location of any other infrastructures, such as aqueducts and cisterns. At the same time, the study looked for and found support in the historical, iconographic and bibliographic archives, which helped complete the data concerning the various periods in the life of the complex (Fig. 52.2).

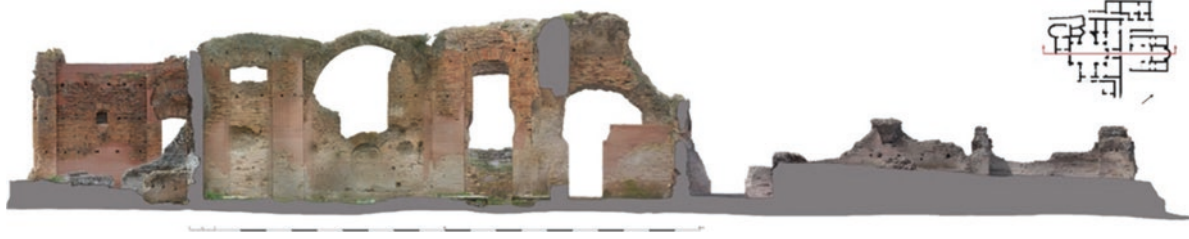
Fig. 52.3 Rome, Villa of the Sette Bassi, aka Dépendence. Transversal section of the building

Transversal and longitudinally perspective sections were obtained using image rectification, completing the result with autoptic verification made possible by the presence of temporary scaffolding (Fig. 52.3). At the same time, a meticulous analysis of the wall and floor coverings, distinguishing between periods of use of the complex, made it possible to acquire further information for piecing together the overall picture. The critical summary of the data thus obtained made it possible to determine both the probable volume of the construction and the specific use of the complex: a bath complex with auxiliary rooms of average size but with architectural fittings of high quality.

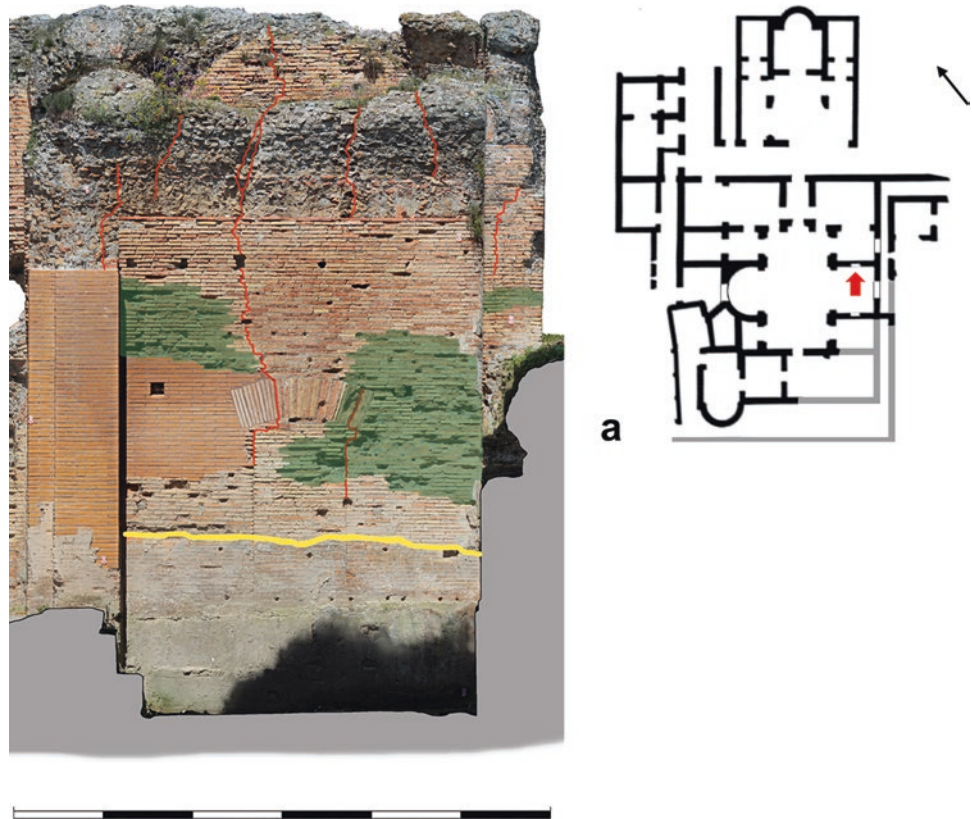
Fig. 52.4 Quadrangular pool of the frigidarium, map of the cracks, detail. (a) Location map. In red, lesions more than 5 mm wide; in transparent green, sectors with severe damage to the surfaces of the curtain wall. The yellow line indicates the ground level at the start of works

Particular attention was also paid to mapping the cracks and damage to the surfaces of the curtain wall (Fig. 52.4), with a view to planning targeted conservative restoration based also on the particularities of the materials used. Also, the different levels of earth fills were recorded, some of them very persistent in time, which have modified and greatly affected the current appearance of the wall surfaces, in some cases making them hard to interpret.

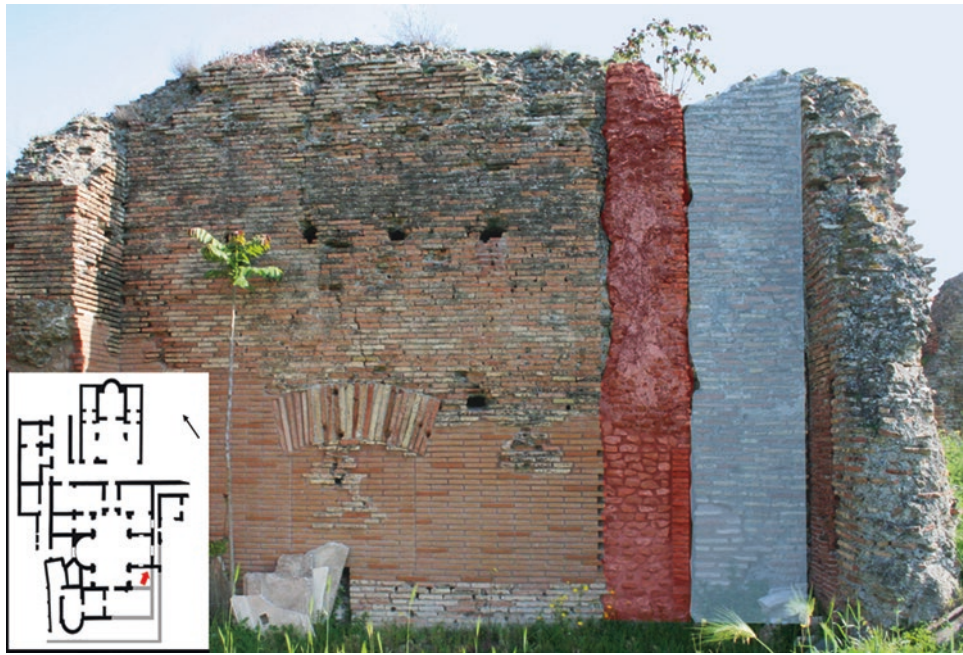
Fig. 52.5 Frigidarium, southeast wall of the quadrangular bath, exterior. The new use to which this sector of the building was put modified the layout of the rooms and transit areas, levelling the masonry flush with the wall on the eastern side in the room next to the bath (in red) and closing the services corridor with a brick infill interspersed with very thick layers of mortar (in grey). The entire surface was then clad with

the frigidarium was turned into a place of Christian worship, which led to the greatest modifications of the original structure. Most of the peripheral buildings were abandoned, leading to an alteration of the distribution systems, while the difference in floor levels was exploited to create a large number of burial sites. Tombs were also placed in the passageways above floor level, which in the end isolated the large central hall, which thus became the main centre of the place of worship. The alterations also affected the wall and floor coverings, often reusing marble slabs from the previous phase. The syntax of this evolutionary process is impressed on the surviving structures, which illustrate its fundamental stages even in small portions. A precious palimpsest of this can be seen in one of the walls in the southern sector, where the effects of these interventions are circumscribed in an exemplary manner (Fig. 52.5).

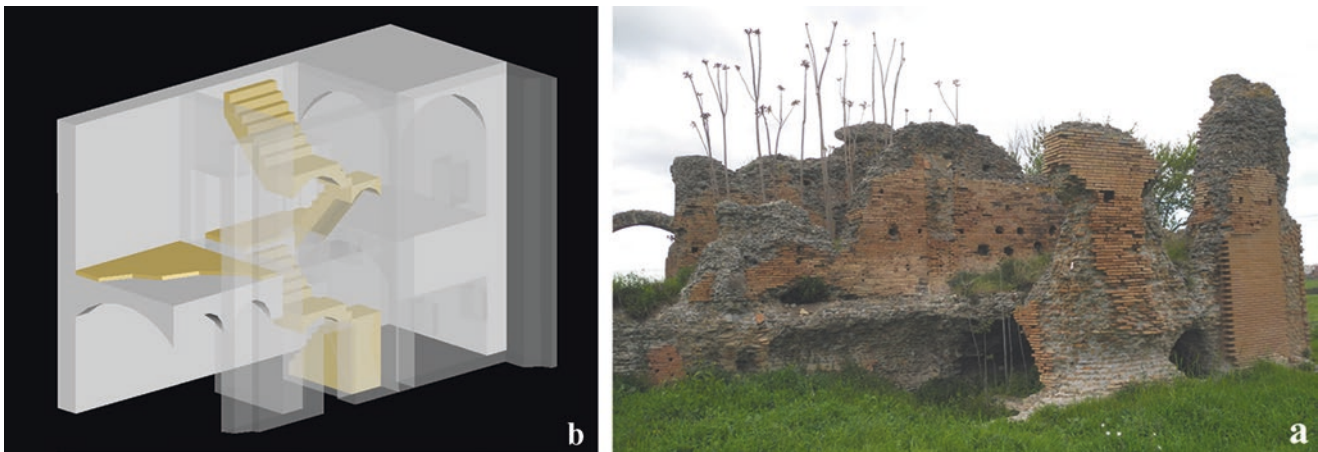
Fig. 52.6 3D model of the bath complex, detail of the stairwell; outer perimeter wall shown in semitransparency. The reconstruction (b) was made possible by an in-depth analysis of the remains that are still visi-

ble on site (a) coupled with archive images and information, with reference to the particular category of architecture

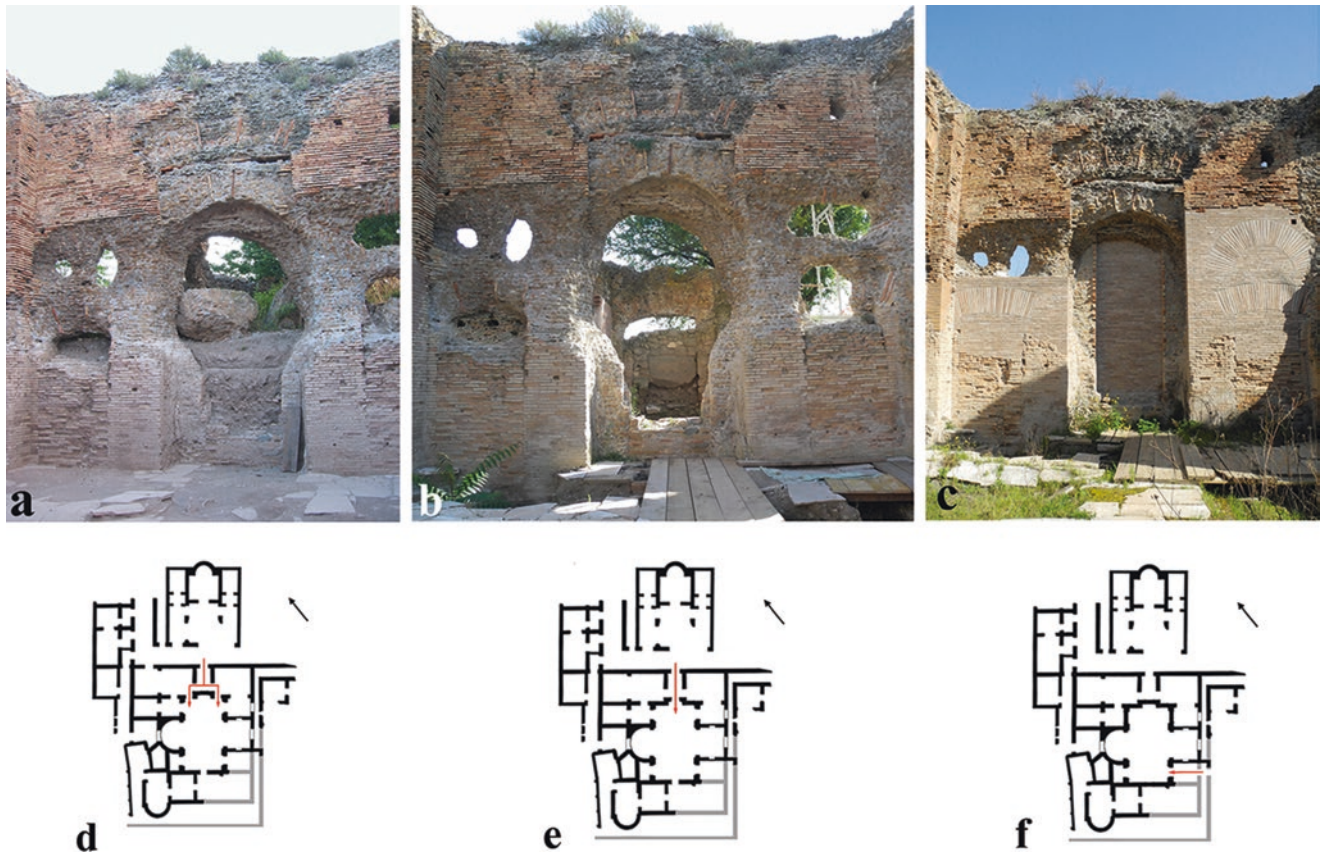
Fig. 52.7 *Frigidarium*, north-eastern wall, (a) during excavation; (b) after elimination of the earth materials, (c) during restoration. As shown by the detailed analysis of the masonry, the original design provided for a large central niche, flanked by two doors placed symmetrically on either side. (d) In the final configuration, however, the niche was turned into a door surmounted by a further relieving arch, while the two side doors were closed, altering the transit routes in this part of the building.

(e) At a later date, when the *frigidarium* was probably turned into an ecclesiastical building, the door was once again closed, and the access moved to the western wall. (f) In planning the restoration work, which is still under way, it will be probably decided to give priority to, and thus restore, the configuration as it was in the second phase, which was when the building was used for the longest time, respecting its original function as a bathing hall
