# The Effect of the Environment on Saint Petersburg's Cultural Heritage

Results of Monitoring the Historical Necropolis Monuments

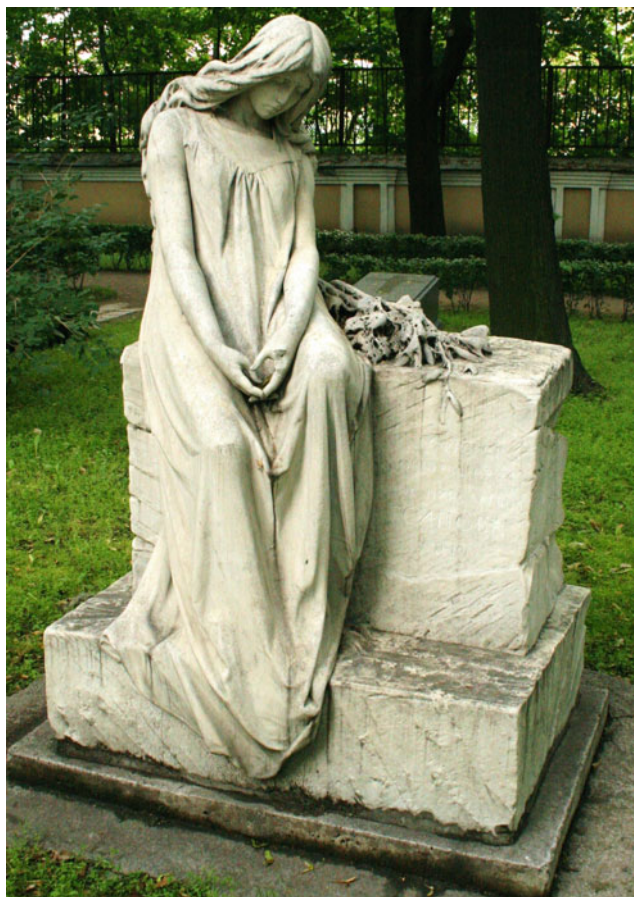
**Fig. 2.1** Monument to A.N. Esipova from white Italian marble in the Necropolis of Masters of Arts

Memorials of marble are, undoubtedly, the treasures of the Necropoleis. The most common is *milky white homogeneous fine- and medium-grained (grain size < 1 mm) marble* (Fig. 2.1). Such marble often has a cloudy pattern (indistinct spots and/or bands) (Fig. 2.2), as, for example, on the gravestones of A.N. and A.P. Mordvinovs, Y.G. Bryansky, M.P. and A.M. Kolychevs, E.A. Rantsova. White homogeneous marble was widely used for manufacturing various ornamental parts of monuments: sculptures, reliefs, vase lamps, urns. Monuments made of this stone are often characterized by a complex shape and have a unique artistic value. These include the tombstones of A.I. Kosikovsky (sculptor P. Catozzi), E.A. and V.N. Kochubeys (sculptor A. Costoli), A.Y. Okhotnikov (sculptor F. Thibaut), Z.A. Khitrovo (sculptor P. Triscorni) and others.

The results of field observations and laboratory studies (polarization microscopy, X-ray phase analysis) showed that the rock is composed of isometric grains of carbonates (calcite, less often together with dolomite), 0.05–1.00 mm (mostly 0.3–0.6 mm) in size (Fig. 2.3). Mosaic structure of the marble is typical for rocks of uniform composition and formation conditions. Quartz is found among impurity minerals.

The mineralogical and petrographic characteristics of the marble in question and the archives of the Museum of Urban Sculpture (Timofeev et al. 2006) indicate that this is the famous Italian Carrara marble, called Statuario (statuary) marble (Shuman 1986). The Carrara marble is a collective name for marbles in northern Italy, near the town of Carrara in the province of Tuscany, at the foot of the Apuan Alps

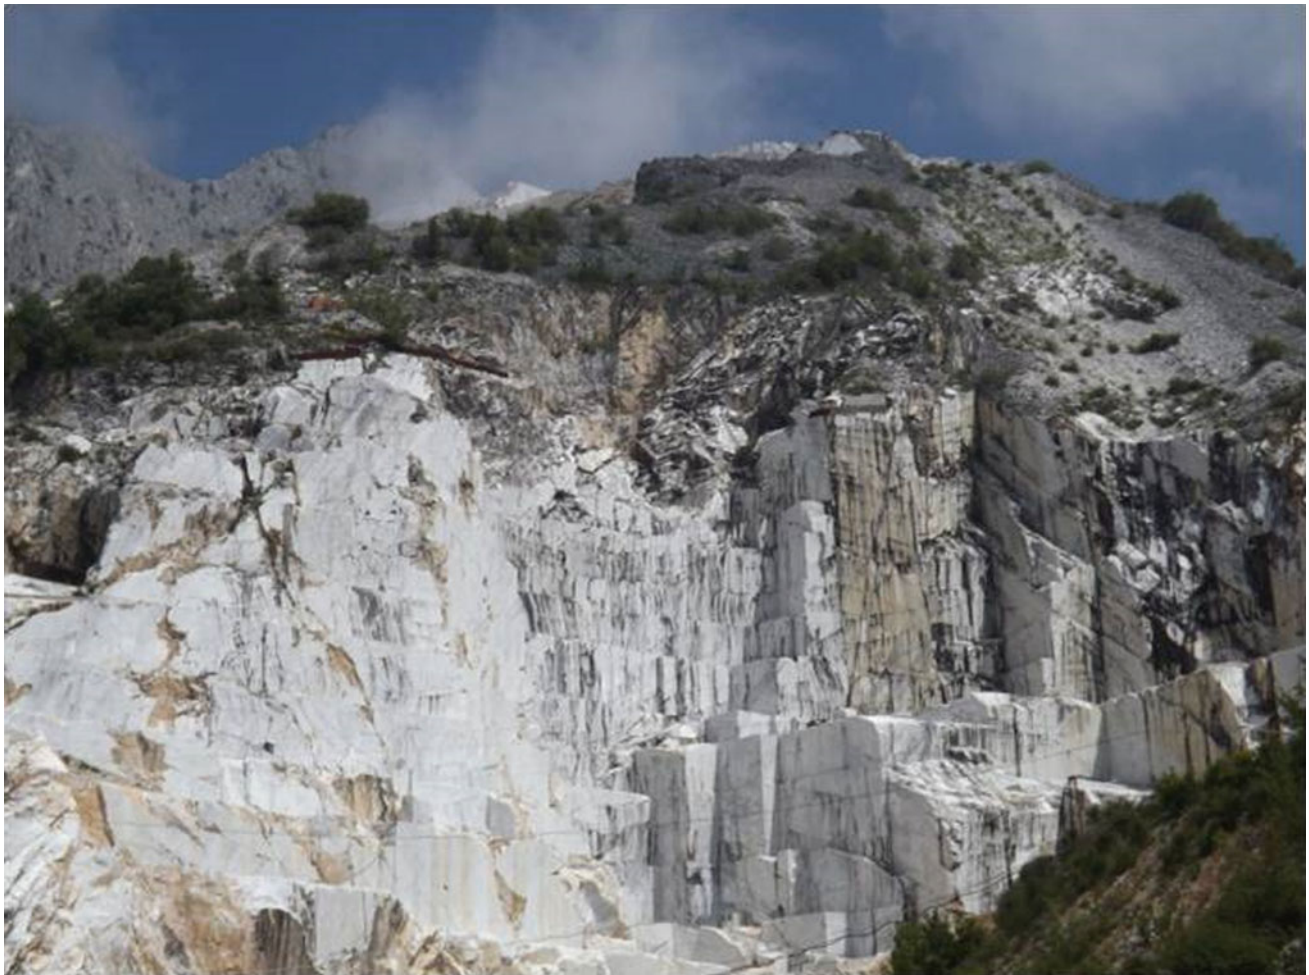
**Fig. 2.4** Carrara quarries (<https://limanskaia.tourister.ru/excursions/6436>)

(Fig. 2.4). It was quarried in the days of ancient Rome and is still quarried to the present day. The Carrara marble has served as a material for many masterpieces of world sculpture. In St. Petersburg, sculptures in the Summer Garden

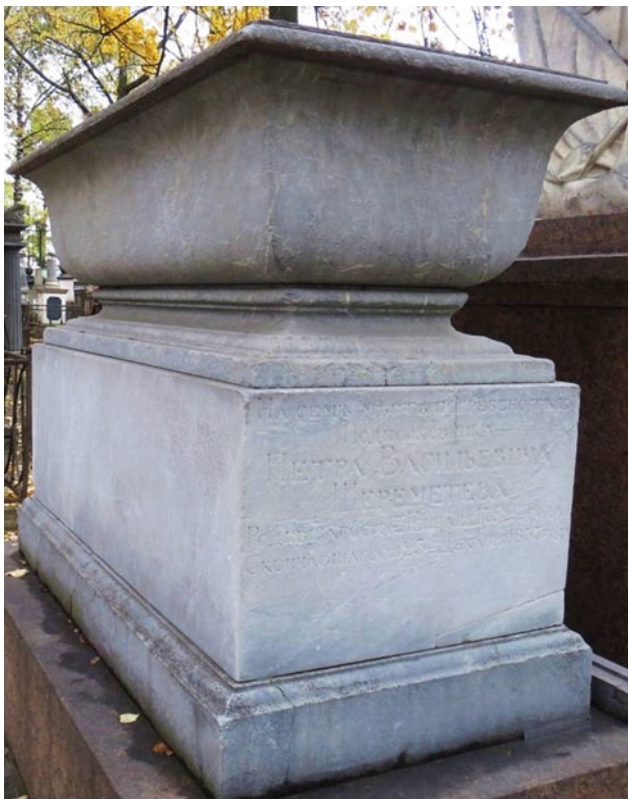
**Fig. 2.6** Monument to P. Sheremetev from light gray homogeneous marble in the Necropolis of the 18th century

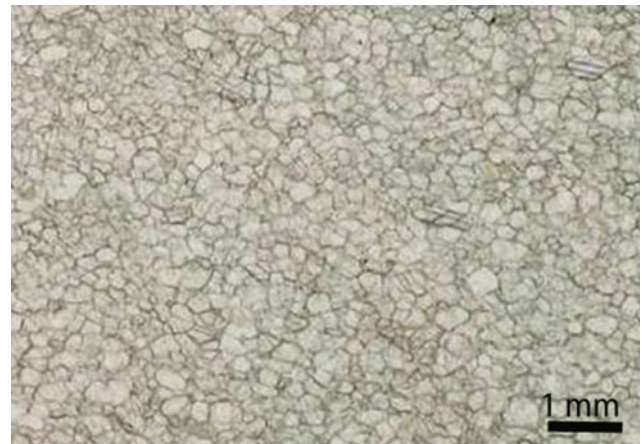
**Fig. 2.7** Light microscope image (PPL) of the thin section of light gray homogeneous calcite marble (the monument to A.K. Imeretinsky) Here and below: PPL—plane—polarized light

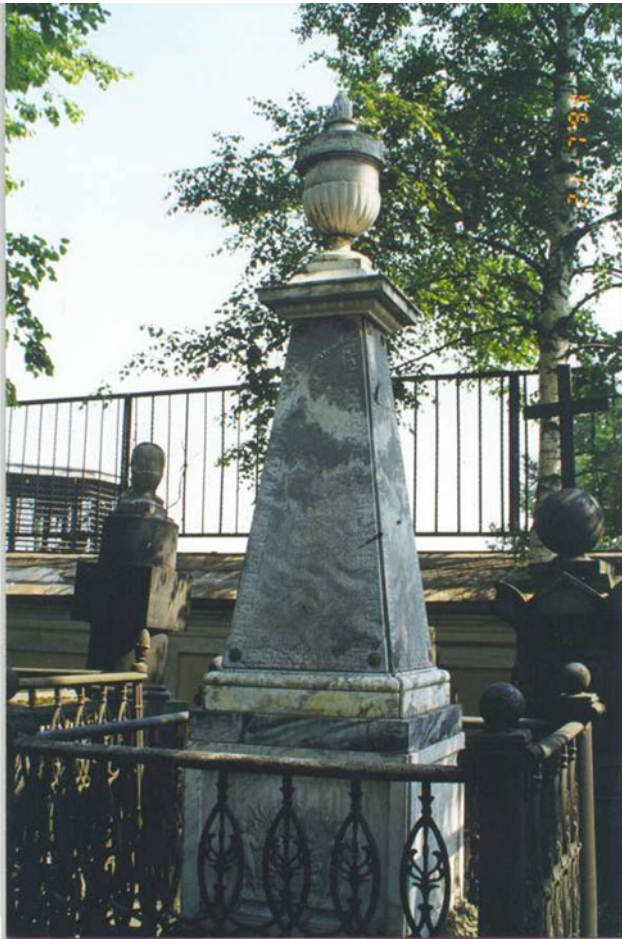
**Fig. 2.10** Monument to S.K. Münnich from gray banded marble (Necropolis of the 18th century)

The next most common after the white homogeneous Italian marble is *gray banded, heterogeneous inequigranular marble*. Dark gray and light gray bands vary considerably in width and can be very contrasting (Fig. 2.10). Often there are agglomerates of green grains, which can form bands and spots (Fig. 2.11). Such marble was widely used for monuments and individual details (semicolumns, pedestals, vase lamps). Gravestones of S.K. Münnich, E.A. Demidova, E.M. Konstantinova, P.P. Bakunin, E.A. Rummel were made of it.

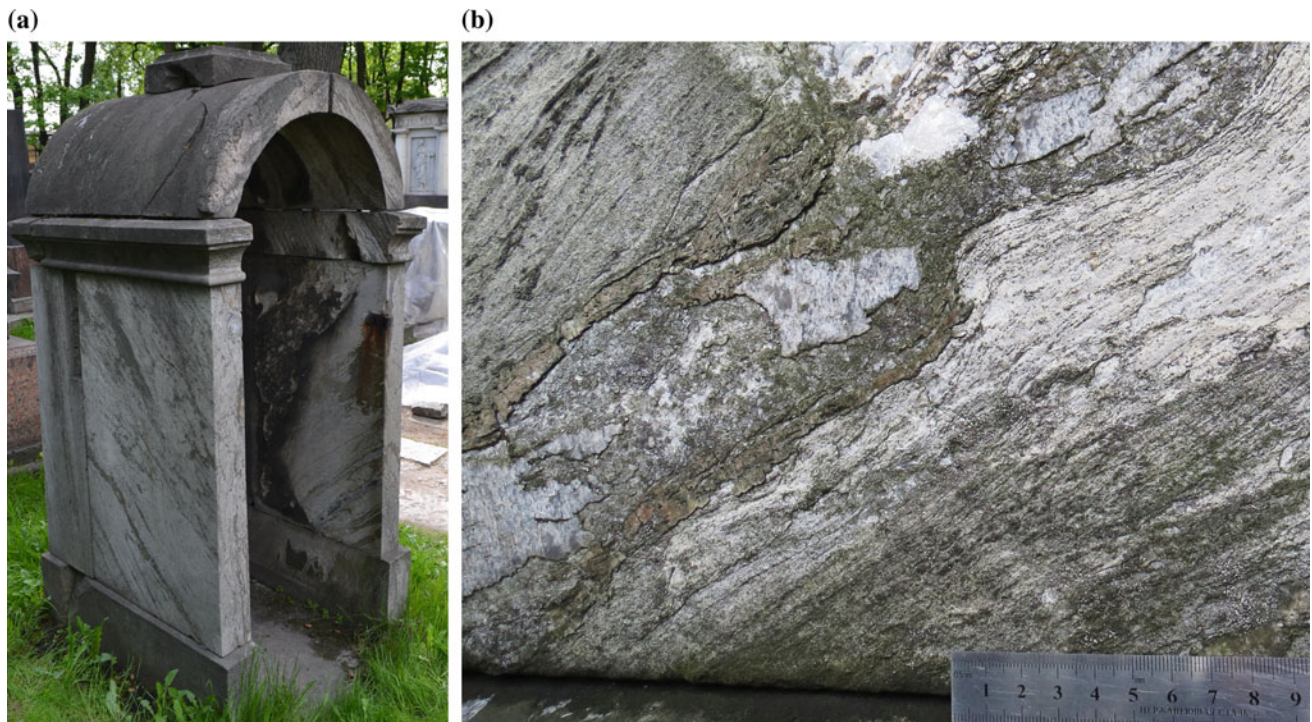
**Fig. 2.11** Monument to E.A. Rummel from gray heterogeneous marble: **a** general view, **b** fragment of the rock. Gray-green stripes and spots can be seen

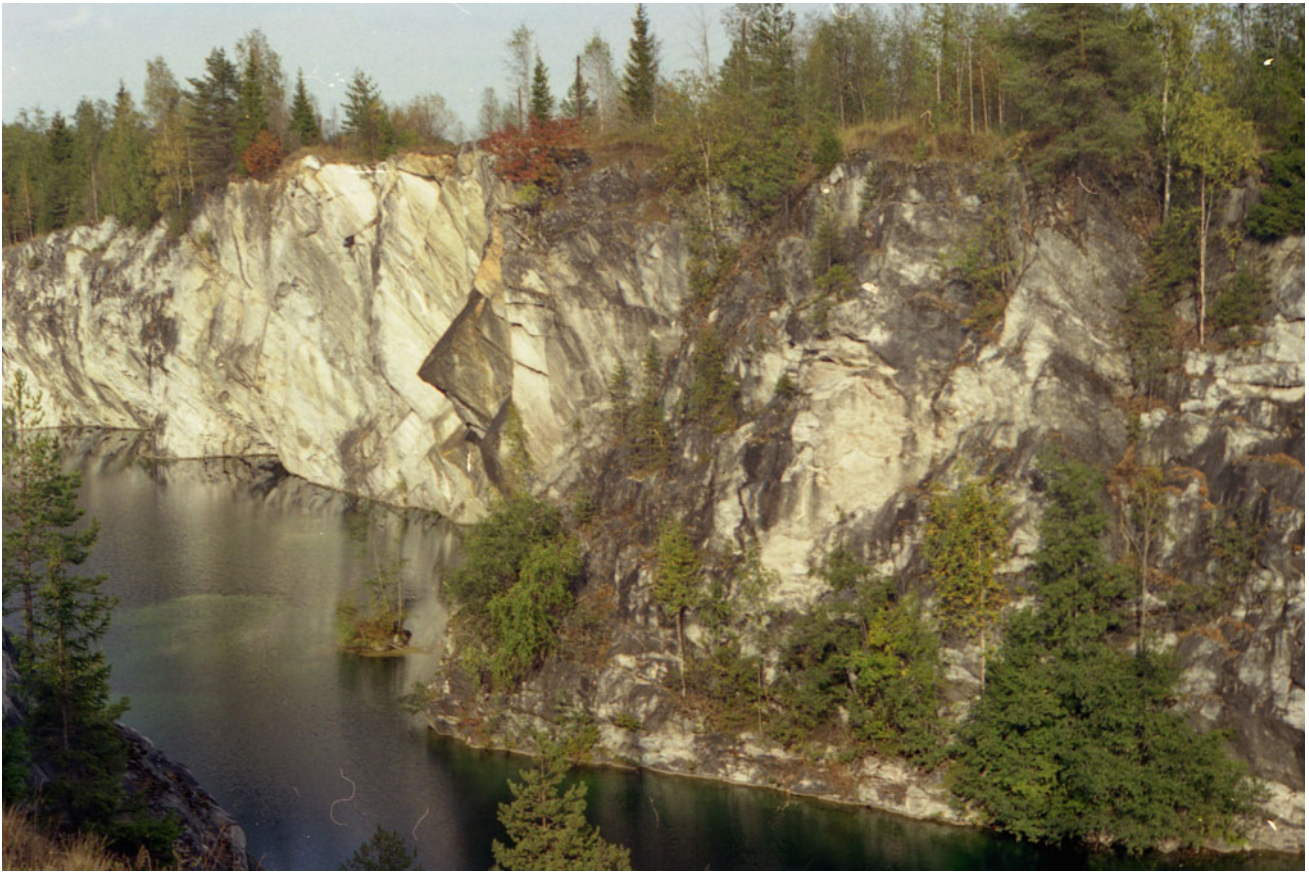
**Fig. 2.13** Marble quarries of Ruskeala (Karelia). Photos by Dmitry Yu. Vlasov, 2008

Mineralogical and petrographic characteristics of the silicate-carbonate rock under investigation are typical for the Ruskeala marble field (Fig. 2.12b) (Kitsul 1963; Bulakh 2005). This deposit, which is located in the area north of Lake Ladoga near the village of Ruskola (Ruskeala) near the town of Sortavala (Karelia), has been under development since the middle of the 18th century. At present, on the basis of the Ruskeala open casts, where marble was quarried to face the walls of St. Isaac's Cathedral, the Natural Park of Ruskeala operates (Fig. 2.13), which annually hosts thousands of tourists from different countries (Borisov 2008a).

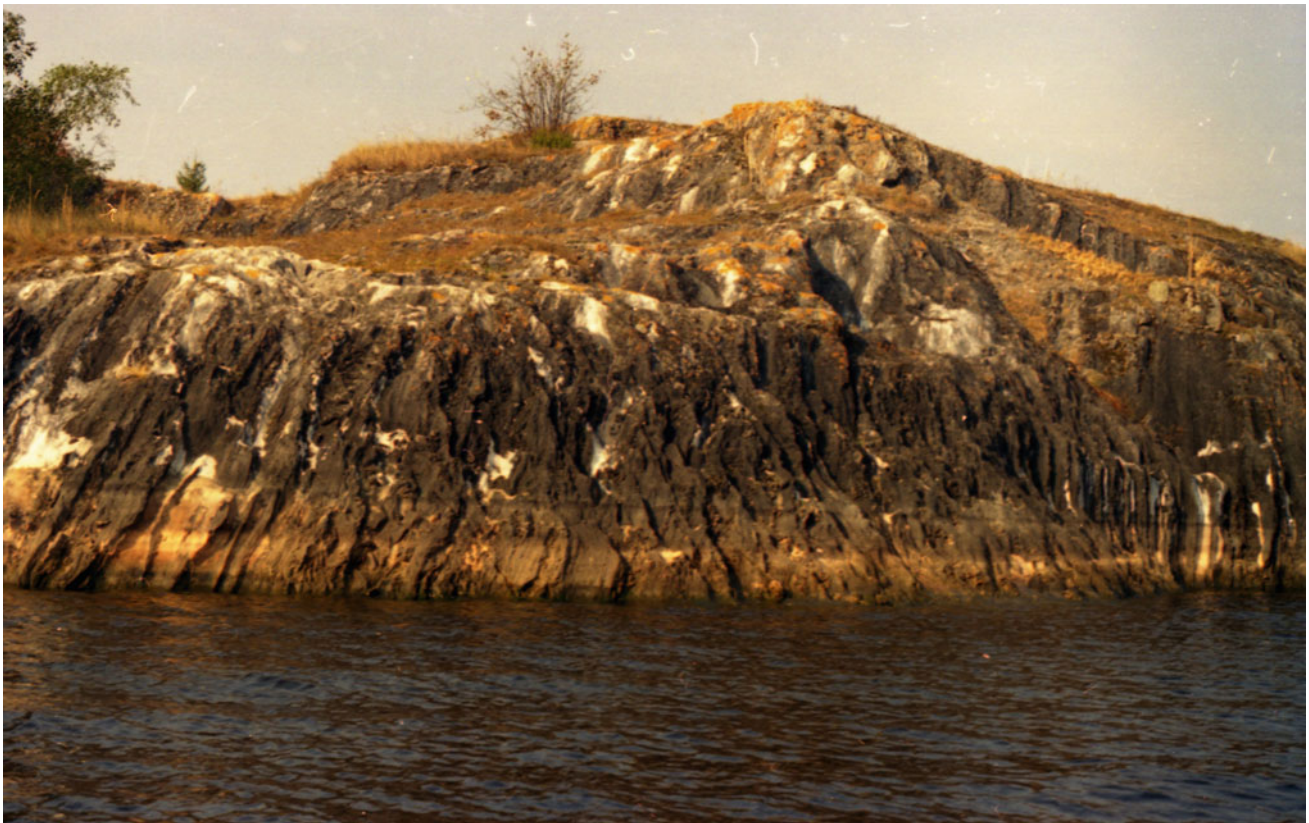
**Fig. 2.16** Island of Uven (Karelia) . Photos by Dmitry Yu. Vlasov, 2008

This coastal island (Fig. 2.16) (150 m long and 80 m wide) is located off the village of Läskelä, close enough to the village of Ruskeala. The Uven marble belongs to the complex of carbonate and silicate-carbonate rocks of the Ruskeala deposit. The Uven pits were in operation from 1769 till the early 19th century, and abandoned because of tough mining conditions (Borisov 2008a). This marble was used in the external and internal decoration of the Marble Palace (Ukhnaev 2002) and other architectural structures of St. Petersburg (Bulakh and Abakumova 1987, 1993; Bulakh 2005, 2012).

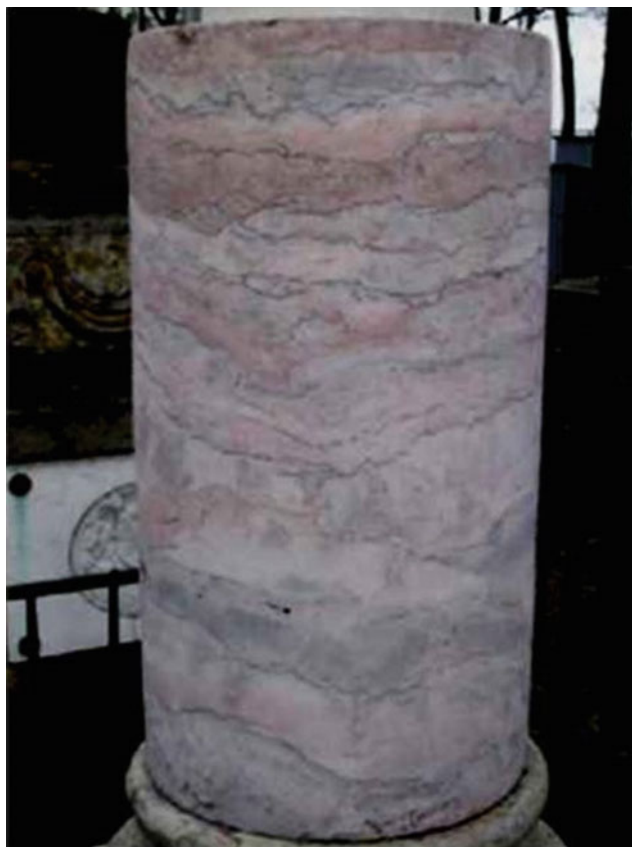
**Fig. 2.17** Monument to V.N. Bibikova from pink patterned marble (Necropolis of the 18th century)

One of the most beautiful marbles of the Necropoleis is the pink veined inequigranular marble (Fig. 2.17). It is diverse in colour patterns (from pink, gray-pink, white-pink to crimson and violet). The colour of the rock is unevenly distributed and is determined to a large extent by the quantitative ratios of oxides and hydroxides of iron. Marble can be uniform, banded, brecciated, which is often emphasized by different shades of colour (Fig. 2.18). It contains veins of calcite and quartz. Of this marble, pedestals and semicolumns were usually made: the gravestones of L.I. Kusheleva, V.N. Bibikova, S.A. Balakshin, A.D. Litke, and A.V. Khrapovitsky.

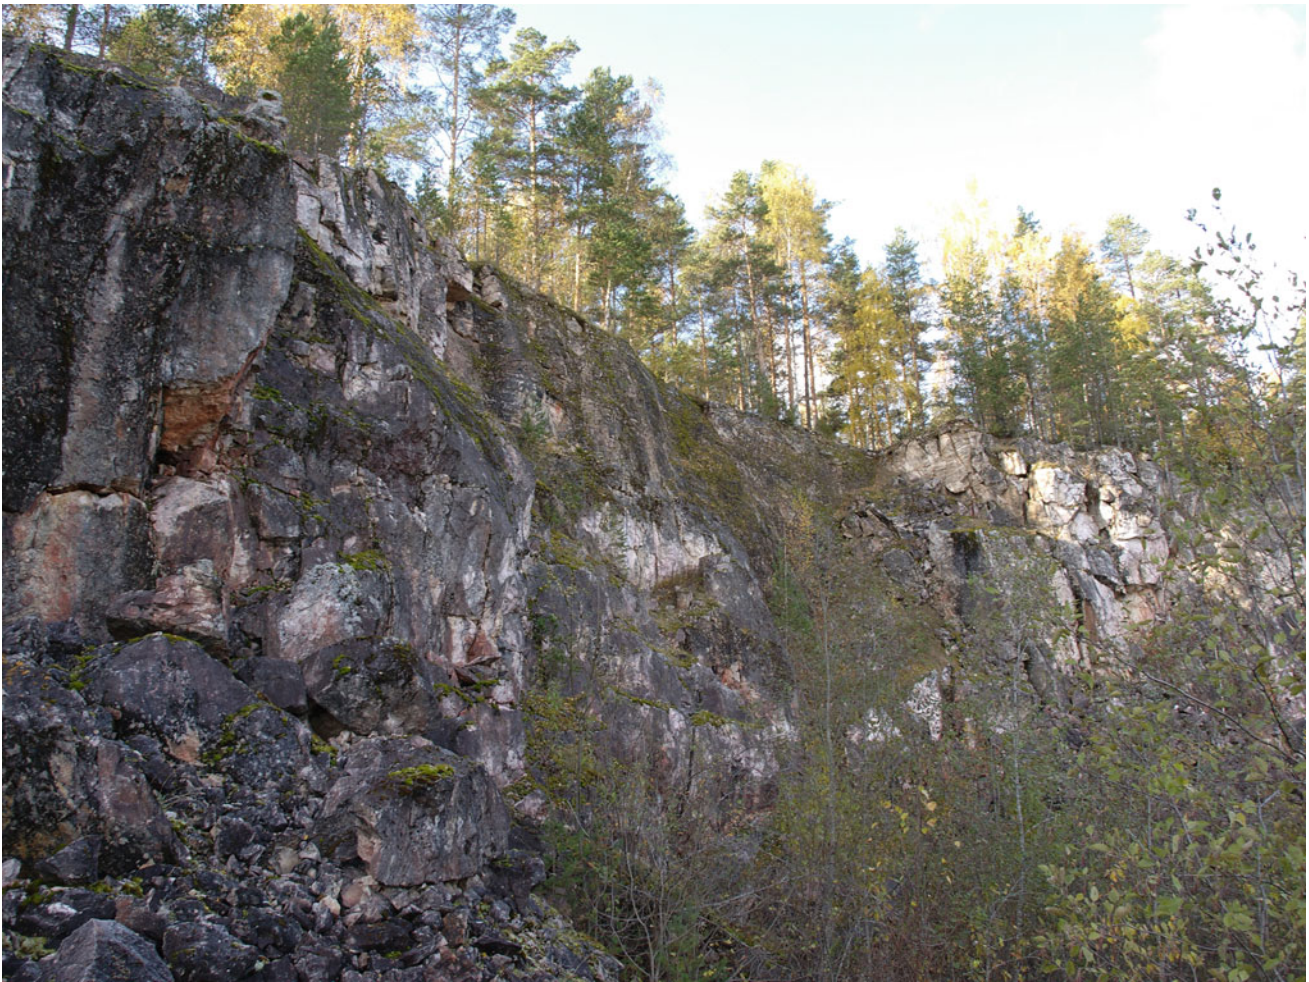
**Fig. 2.20** Tivdiysky stone quarry (<http://regionavtica.ru>)

the Belogorsky (Tivdiysky, Olonetsky) marble (Fig. 2.19b). This marble was quarried in Lake Onega area from the 18th century. It is usually called the Tivdiysky (after the name of the village—Tivdiya), or Belogorsky (by the place of the main open casts near the village of Belaya Gora), or Olonetsky (according to the ancient name of the land). The Belogorsky open cast is one of the largest mining and geological sites of Karelia, interesting for the variety and artistic value of its marbles (Fig. 2.20).

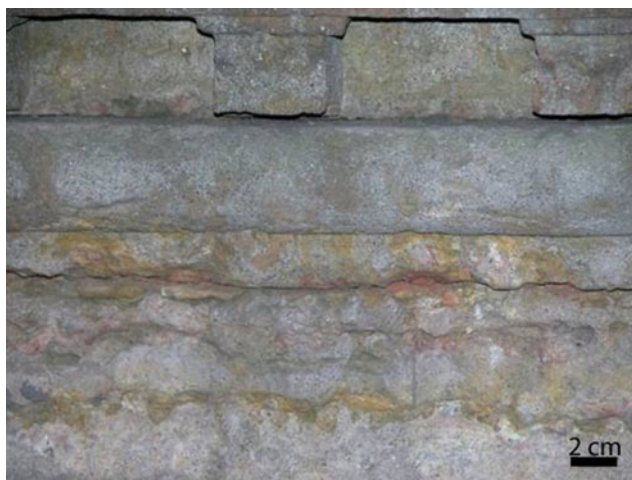
**Fig. 2.29** Gray flaglike limestone with yellow-brown interlayers

yellowish-gray dense limestone, often with brown spots is the most common in the Necropolis (Fig. 2.29). There are also grayish-green, gray-pink, rusty-yellow (ochre-coloured), brownish-red, pink-violet varieties. Numerous fossils can be seen. Foundations of most of the memorials in the Necropolis are made of such limestone. For the manufacture of semi-columns, sarcophagi, tomb canopies it was used more

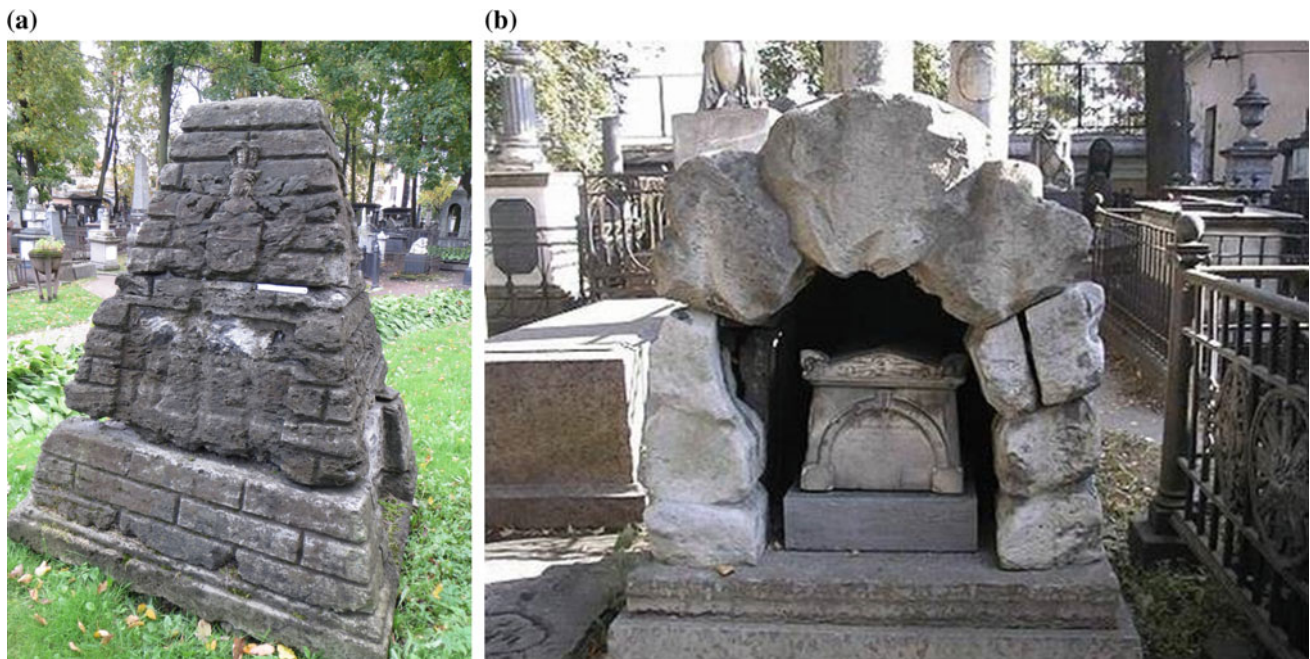
**Fig. 2.34** Monuments from travertine: **a** to the Unknown (N-18 No. 901), **b** to P.A. Golitsyna

*Porous, spongy, gray or yellowish-gray limestone—travertine* is much rarer in the Necropolis of the 18th century (Fig. 2.34). There are portions of brown or yellowish-brown colour, stained by oxides and hydroxides of iron (Fig. 2.35). Such limestone, which is often called calcareous tufa, was used in the manufacture of canopies, grottoes, pyramids (memorials of N.S. Bem, P.A. Golitsyna, V.I. Potemkina, and others).

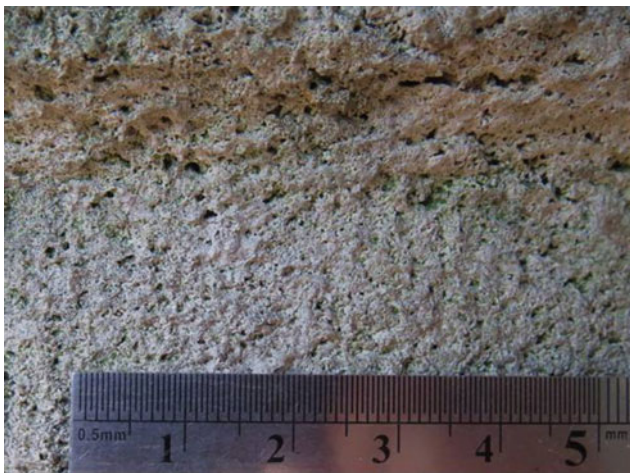
**Fig. 2.35** Gray porous travertine with traces of ferruginization

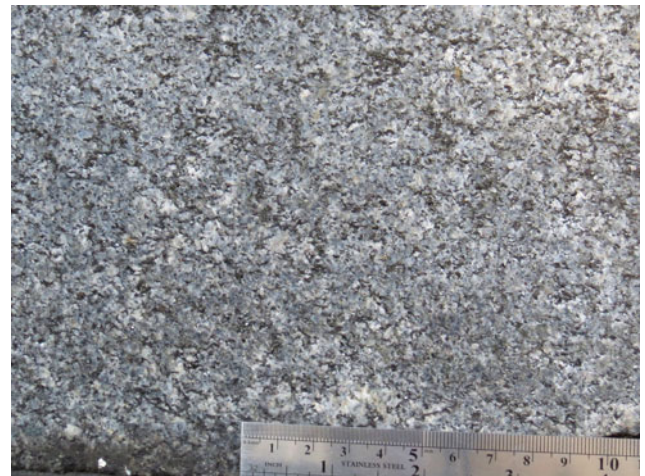
**Fig. 2.46** Gray homogeneous gneiss granite (monument to F.A. Vlasova)

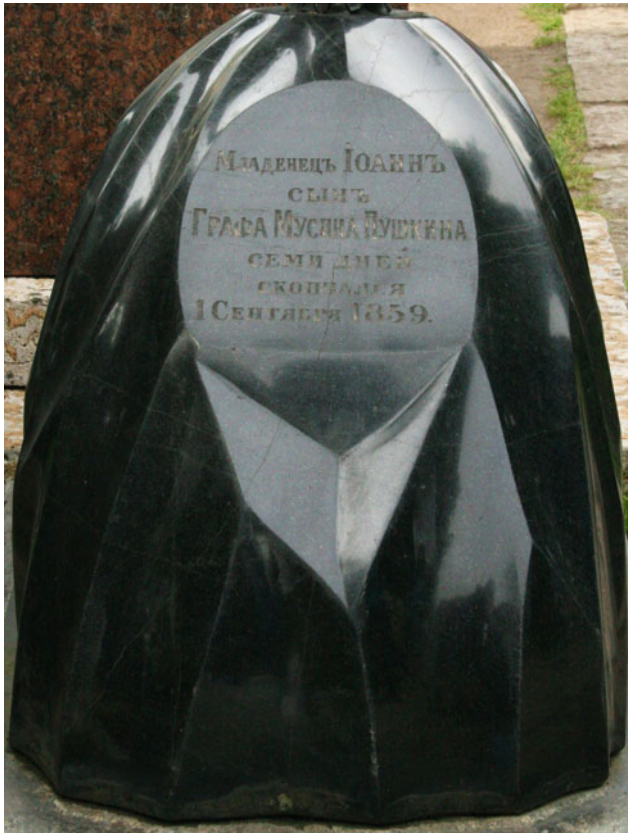
**Fig. 2.49** Monument to I. Musin-Pushkin from gabbro-type rock

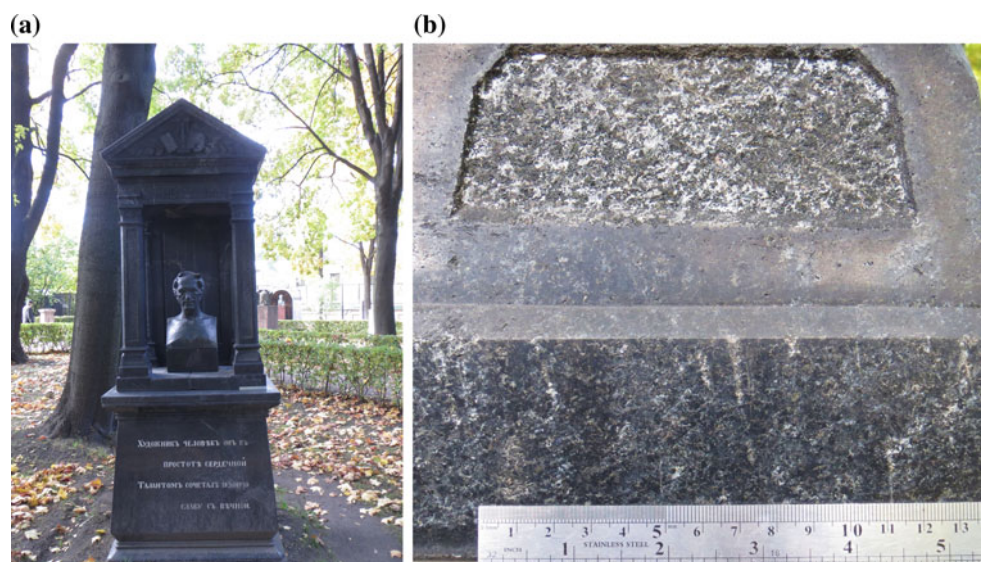
**Fig. 2.50** Monument to N.I. Utkin from amphibolite: **a** general view of the monument, **b** fragment of the rock

The tomb of N.I. Utkin in the Necropolis of Masters of Art is made of *dark gray-green dense, fine- and medium-grained silicate rock with poorly manifested banding* (Fig. 2.50).

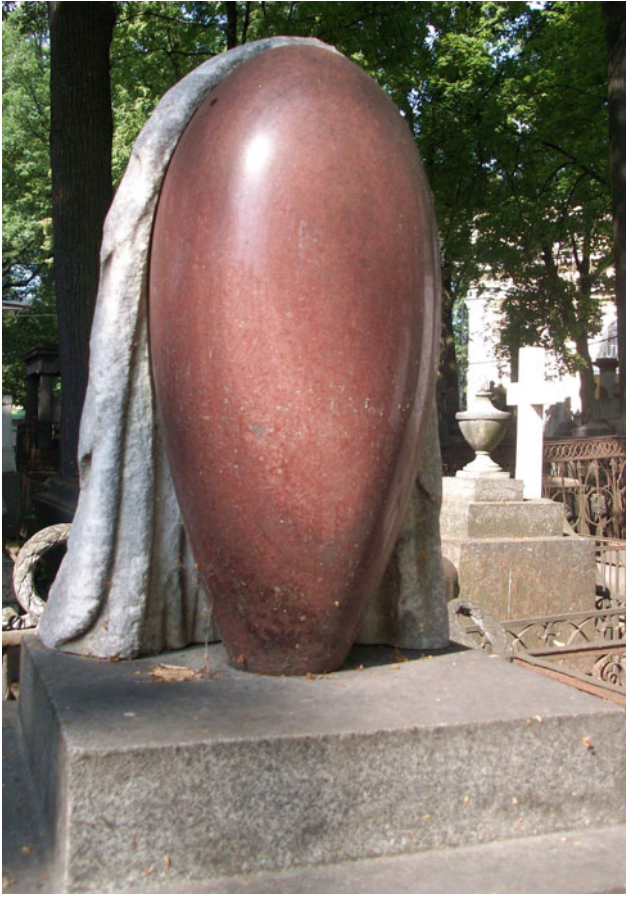
**Fig. 2.58** Urn from red quartzite (the monument to A.V. Skrypitsyn in the Necropolis of the 18th century)

18th century. Details of the monuments to A.V. Skrypitsyn, A.F. Turchaninov, P.M. Arsenyev, N.S. Nertovskaya and others are made of this stone. The laboratory studies of the stone of A.F. Turchaninov's and the Unknown's tombs (N-18 No. 959) showed that it is a monomineral aggregate, composed of different-sized isometric quartz grains (0.05–1.50 mm) (Fig. 2.59). The crimson-red colour of the rock is due to the presence of iron oxides and hydroxides in the intergranular space.

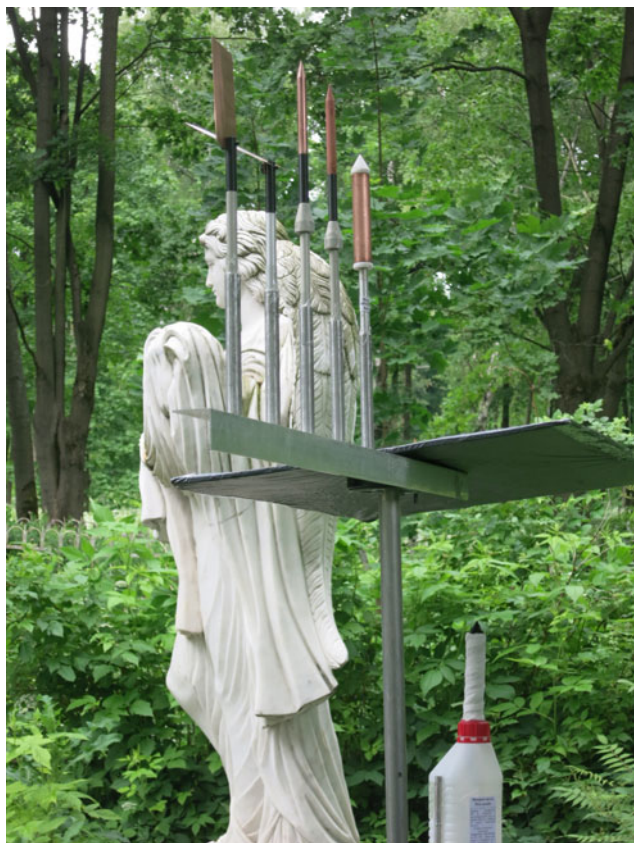
**Fig. 3.1** Devices used to determine the corrosivity of atmospheric air: at the top—corrosion coupons of various shapes, at the bottom—the “wet candle”

complex is installed on Maly Prospekt. A “wet candle” was used to determine the average annual fallout of chloride ions in accordance with ISO 9225:2012 (Fig. 3.1). This standard does not recommend the “wet candle” for a short exposure time, therefore, monthly fallouts of chloride ions were not measured.

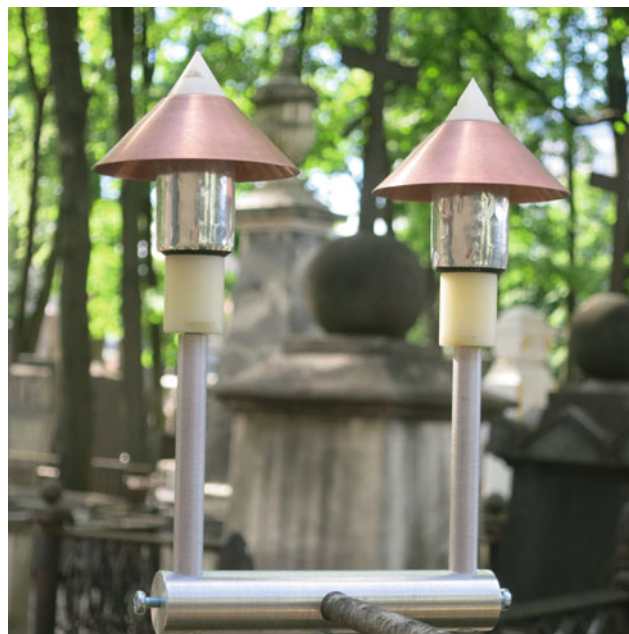
**Fig. 3.2** A system of two corrosion coupons to determine the corrosivity of the ambient air and the nonstationary microclimate near the monuments. Dimensions of the truncated copper cone: base diameter—70 mm, height—24 mm, wall thickness—1 mm, cone angle—90°

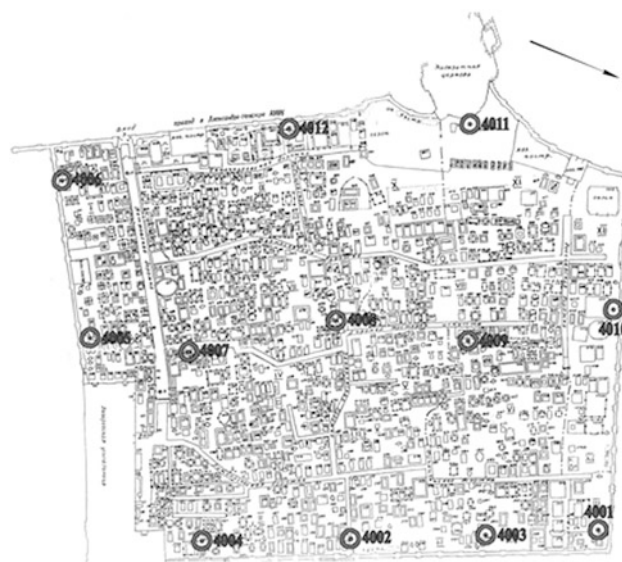
**Fig. 3.11** Places of soil sampling in the Necropolis of the 18th century. Sample numbers are shown

Soils or soil-like bodies are an essential part of terrestrial ecosystems in the areas where the monuments are located. Urban soils surround monuments, while newly-formed primary soils can be formed on the monuments themselves (more often on horizontal surfaces) (see Sect. 5.5.2). Soil sampling was conducted in the field season of 2006. Samples were taken by Yu. A. Gruzdev in various parts of the Necropolis of the 18th century, at different distances from the busy transport routes, the Neva and Monastyrka rivers (Fig. 3.11; Table 3.8).

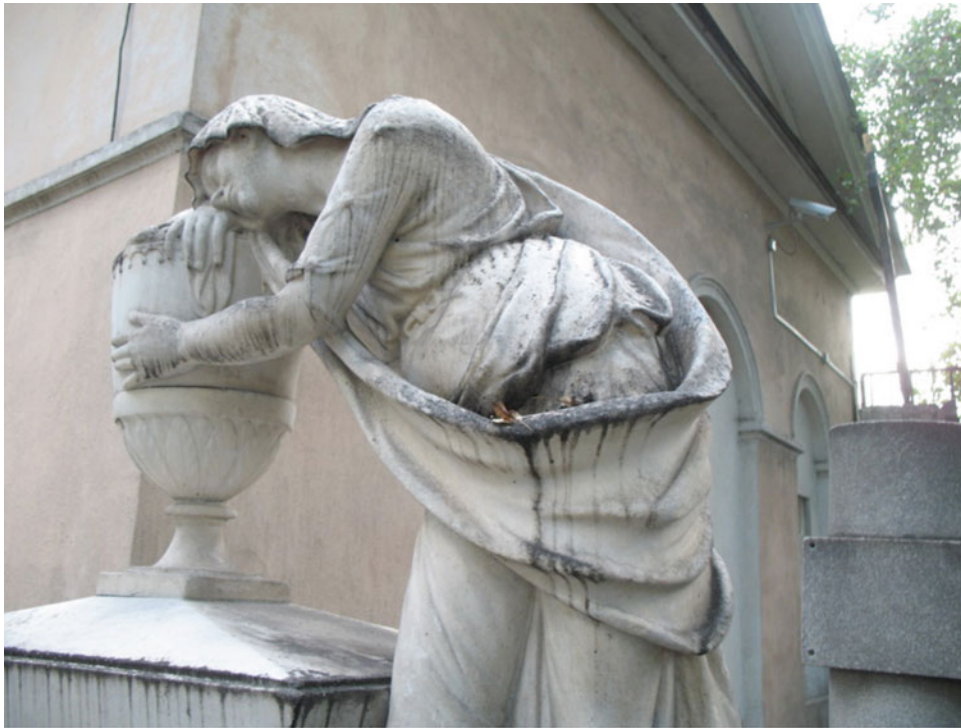
**Fig. 3.18** Black streaks on the marble surface (gravestone of Z.A. Khitrovo, Necropolis of the 18th century), appearing in the places where rain water flowed

Excretory products of plants and pollutants from the air, getting on the stone substrate with rainwater (Fig. 3.18), are the main source of nutrition for fungi and bacteria. On the tree leaves one can often see a black coating («sooty mold») formed by fungal colonies, plant excreta, and settling airborne dust. This picture is most typical for the leaves of lime trees growing on the territory of Necropolis (Figs. 3.19 and 3.20). It is important to note that fungi occurring in black deposits on tree leaves easily get on the surface of monuments, where they continue to develop. These include black yeast-like fungi from the genera *Aureobasidium* and *Hormonema*. In the Necropoleis, they are found everywhere in dark-colored biofilms on the surface of marble, limestone and granite. The same fungi were discovered in gypsum crusts, mud deposits and places where the stone surface disintegrated. In general, the most intensive development of biological stains is observed on the surface of monuments under the trees.

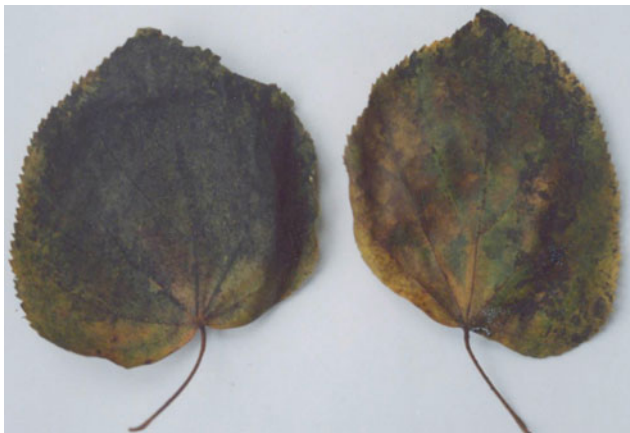
**Fig. 3.19** Black stains on lime tree leaves

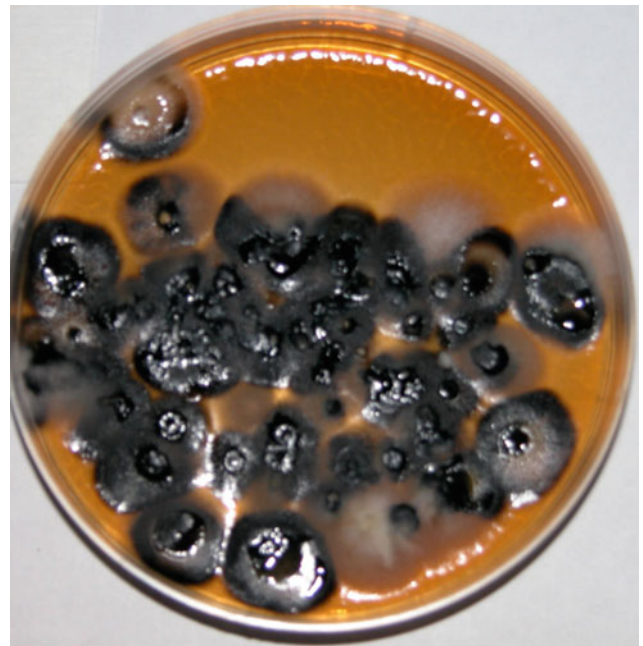
**Fig. 3.20** Micromycetes isolated from the black coating on the surface of lime tree leaves

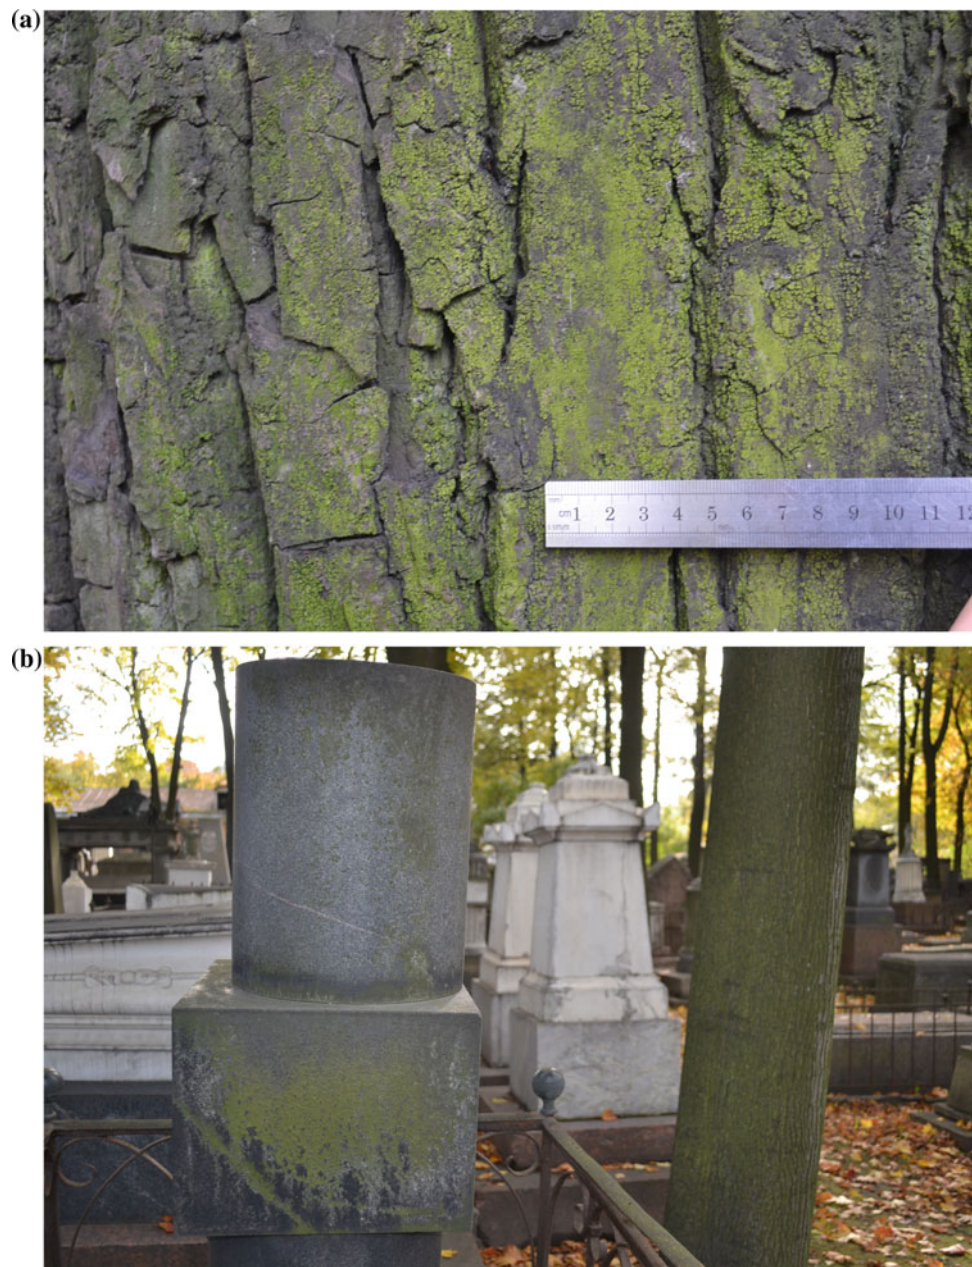
**Fig. 3.21** Aerial algae colonies (Chlorophyta division) on the bark of trees: **a** in the Necropolis of Masters of Arts, **b** in the Necropolis of the 18th century. The same algae develop on the trunk of a tree and on a neighboring monument of gray granite

Aerial algae (aerophyton), that is, algae capable of surviving in the air environment (Fig. 3.21), also actively develop on tree trunks in the Necropoleis. These organisms form continuous green deposits (fouling) on the lower part

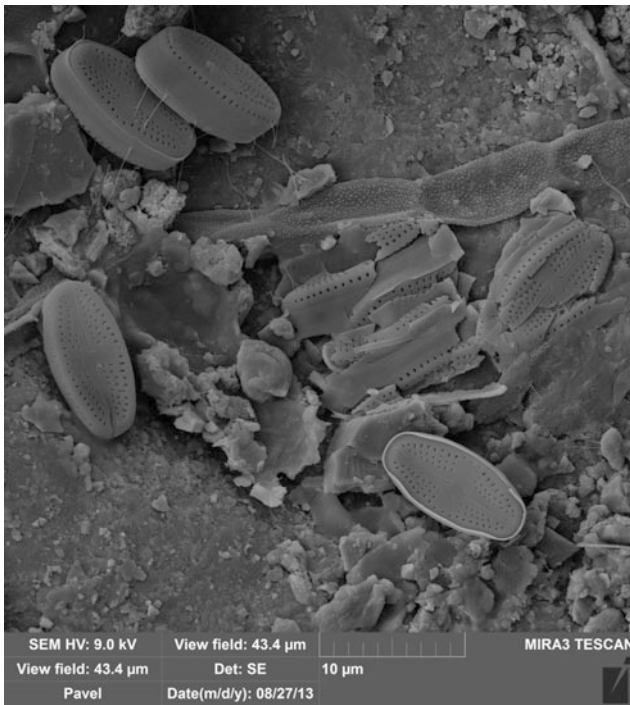
**Fig. 3.22** Cluster of diatom algae cells on the surface of quartzite. Tomb of the Unknown (N 18 No. 959), Necropolis of the 18th century

of diatomic algae, the cells of which are clearly visible under the electron microscope. Cells of these algae are often found on the surface of monuments (Fig. 3.22).

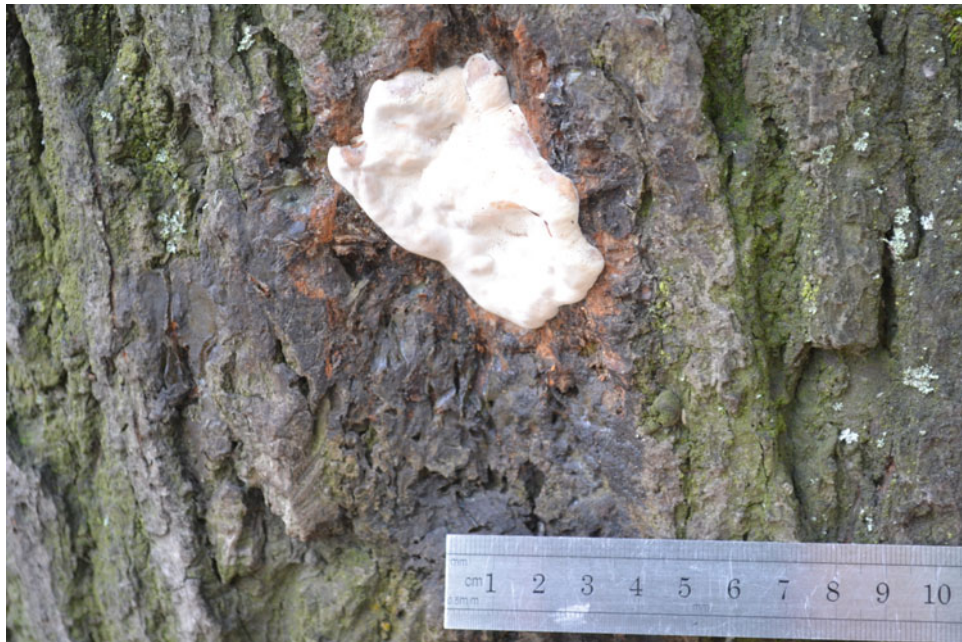
**Fig. 3.23** Development of the fruiting body of a wood-destroying basidiomycete. Necropolis of the Masters of Arts

Over the periods of environmental surveys in the Necropoleis, formation of fruit bodies of wood-attacking fungi was repeatedly registered (Fig. 3.23). They developed both on living trees and on stumps remaining after felling. High incidence of wood destroyers is characteristic of the suppressed tree growth.

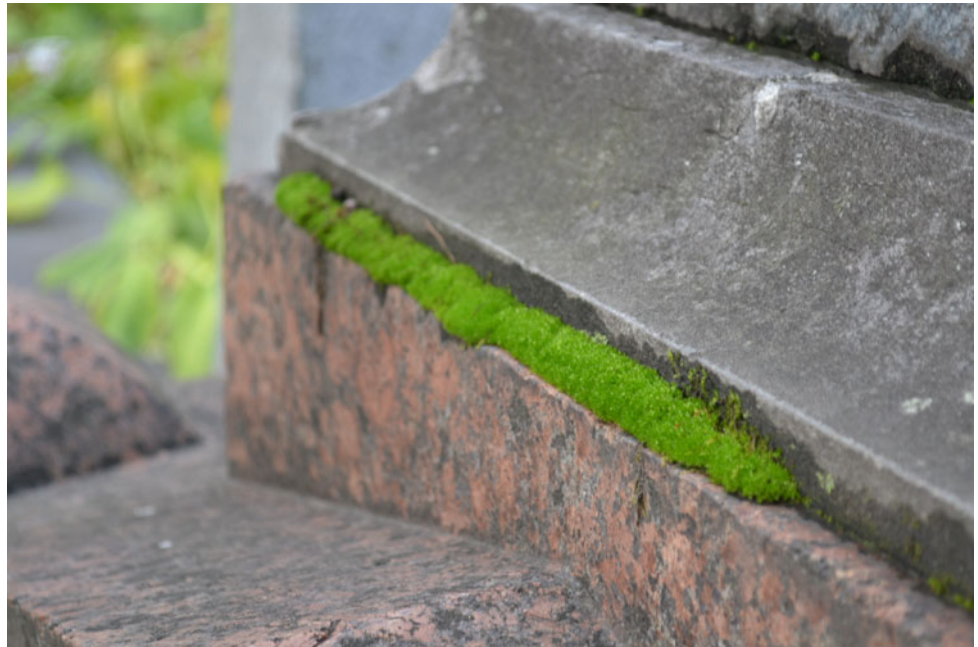
**Fig. 3.25** Intensive fouling by mosses of a monument from the Putilovo slab. The patches of moss merge in places, forming a continuous cover on the horizontal surface of the monument. Necropolis of the 18th century

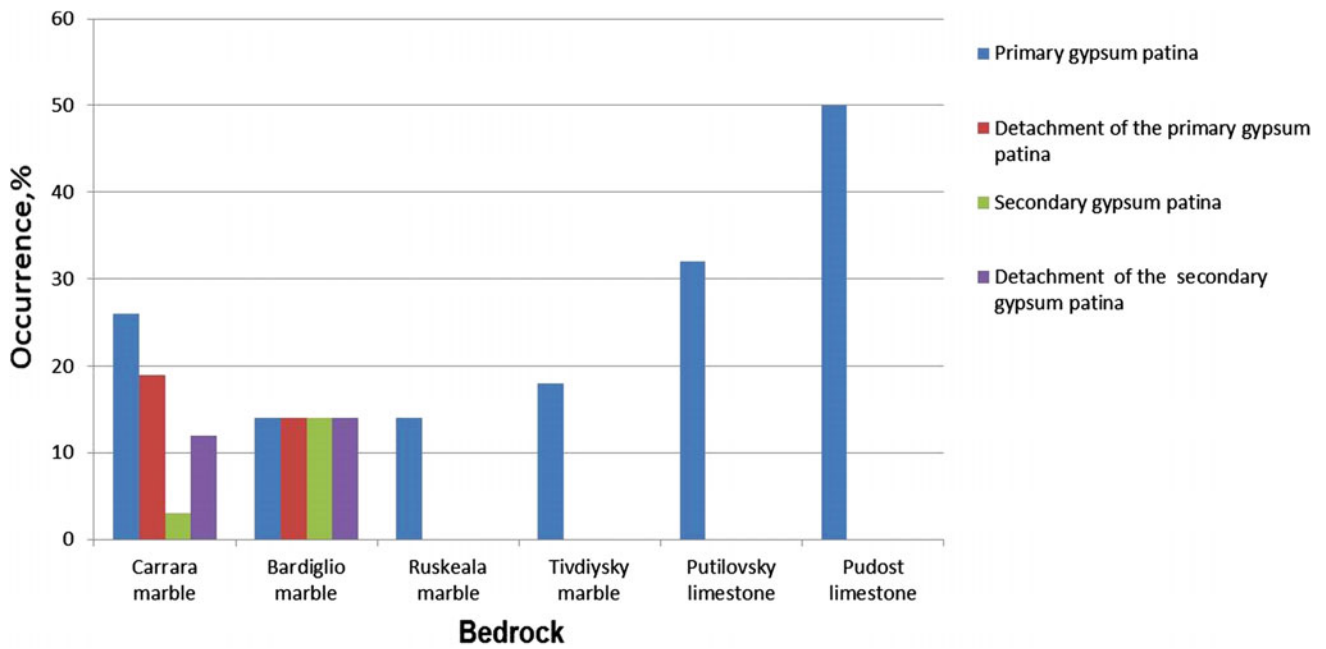
**Fig. 4.6** The occurrence (%) of gypsum-rich patina on the surface of the examined monuments of carbonate rocks in the Necropolis of the 18th century

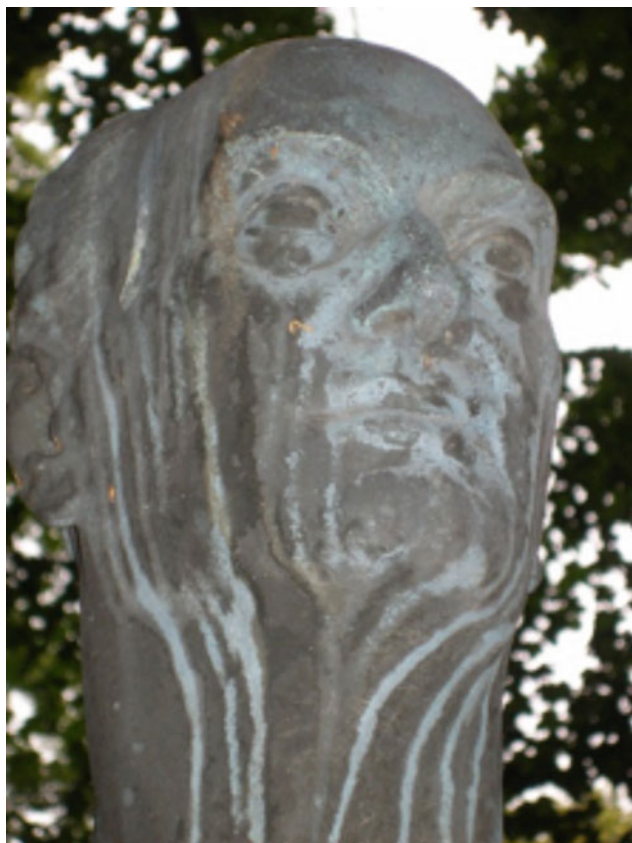
**Fig. 4.19** Non-uniform distribution of colored patina (as vertical streaks of gray-green color) on the surface of the monument to P.Z. Andreev

The results of visual inspection and light microscopy showed that the patina on the surface of bronze and copper monuments of the Necropoleis is usually a multi-layered formation: the upper dark layer, under which green and blue grains are distributed with varying degrees of density, and in the gaps between a lower solid black layer is seen (Fig. 4.19). The top layer is the mud component of the patina, the two lower ones are corrosion components.

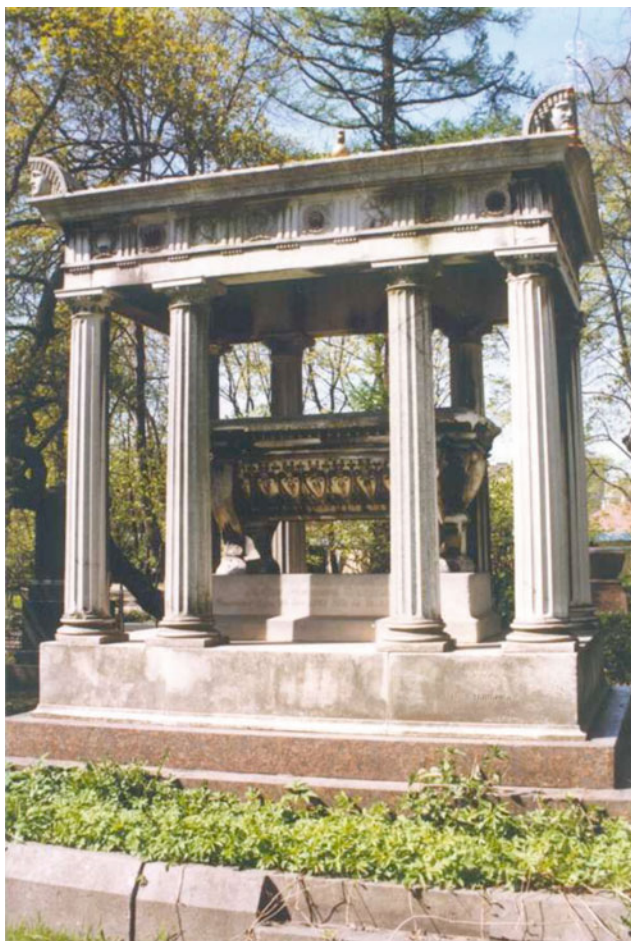
**Fig. 5.1** Monument to A.I. Kosikovsky (view from the south side) 2000

The examination of 2000–2001 (before the restoration) revealed that the monument was in a catastrophic condition (Figs. 5.1 and 5.2).
