# The Effect of the Environment on Saint Petersburg's Cultural Heritage

Results of Monitoring the Historical Necropolis Monuments

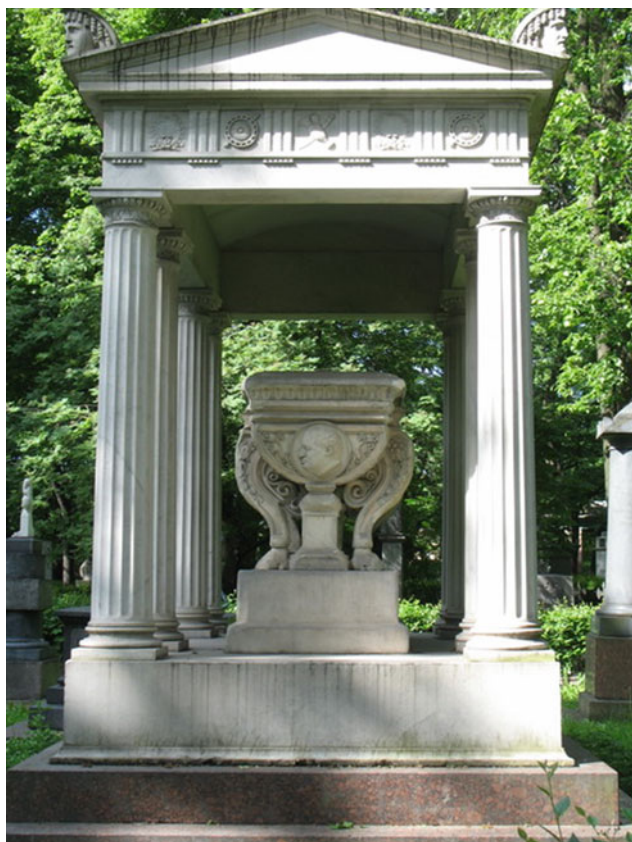
The examination of A.I. Kosikovsky's tomb (5–6 years after restoration) showed that its condition significantly improved (Figs. 5.4 and 5.5).

**Fig. 5.4** Monument to A.I. Kosikovsky after the restoration (view from the east side) 2010

The number of micromycete species decreased from 21 (before restoration) to 13 after restoration (Table 5.1). However, the dominant species remained the same as before the restoration. On the surface of the monument dark-colored micromycetes predominate. In affected areas, the count of fungi turned out to be quite high, reaching 6000 CFU per 1 g of sample. In general, the state of the stone is that of the initial stage of gypsum-rich patina formation. To slow down sulphation, regular conservation of the marble surface is required (removal of fouling and biocidal treatment). In addition, it is necessary to strengthen the marble surface on the sarcophagus.

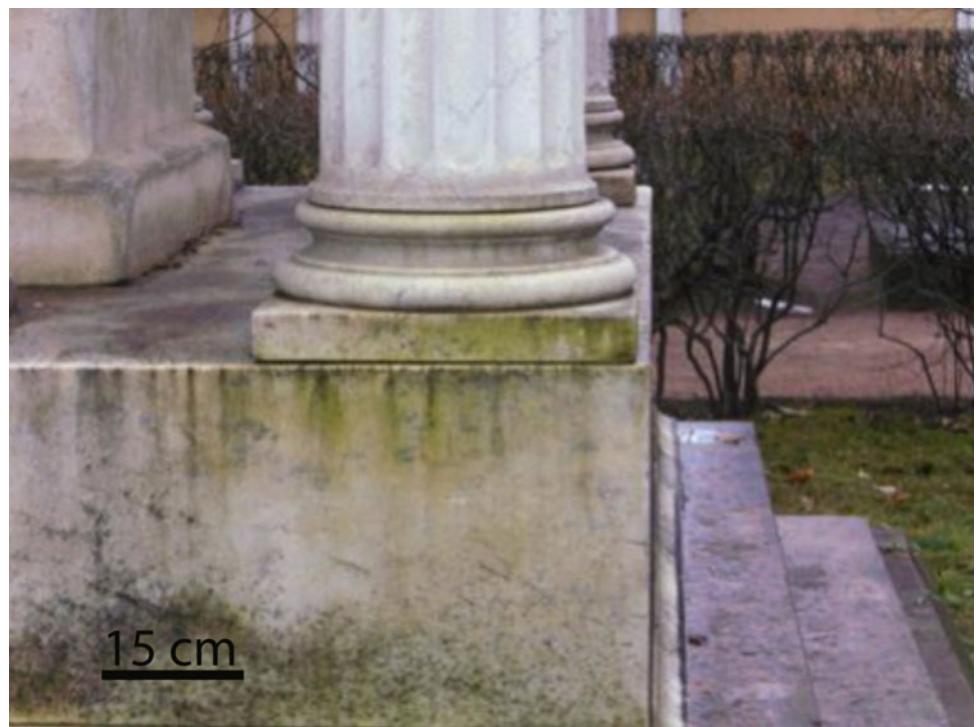
The results of the survey showed that on the surface of the monument to A.I. Kosikovsky here and there biofilms of green color are formed, in which algae dominate (of Chlorophyta division) (Fig. 5.6). Local disintegration of stone is observed on the surface of the sarcophagus due to crumbling. In addition, on marble surface a dark dirt deposition is formed in which microscopic fungi accumulate and develop (Fig. 5.7).

**Fig. 5.6** Biological buildup. The north side of the pedestal. May 2010

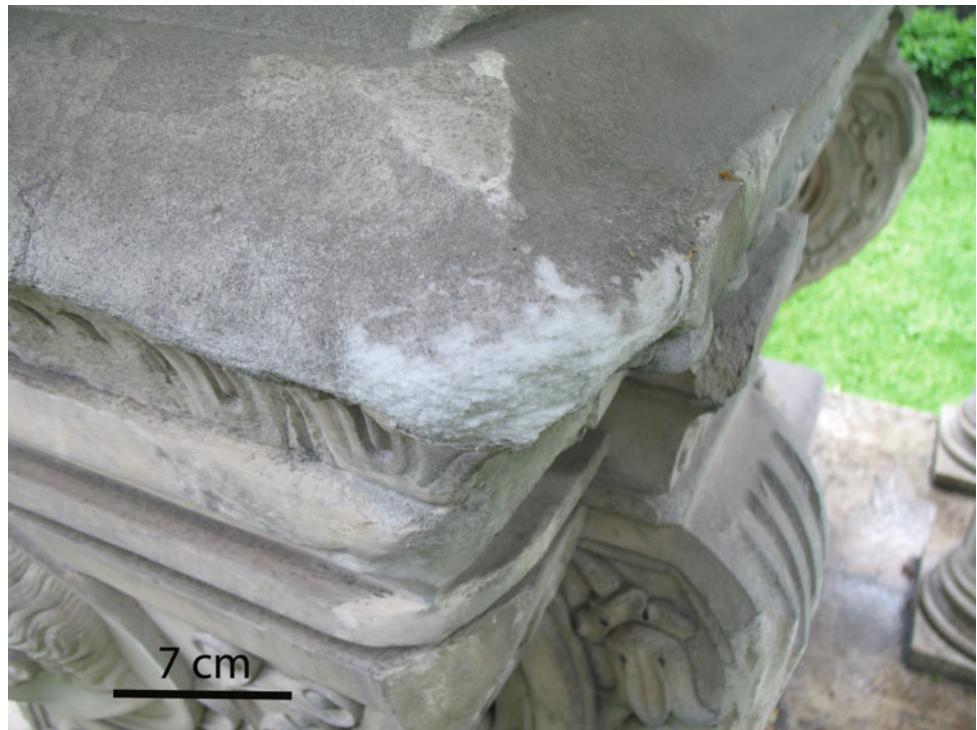
**Fig. 5.7** Roughening and fouling of marble on the lid of the sarcophagus. The eastern side of the monument. May 2010

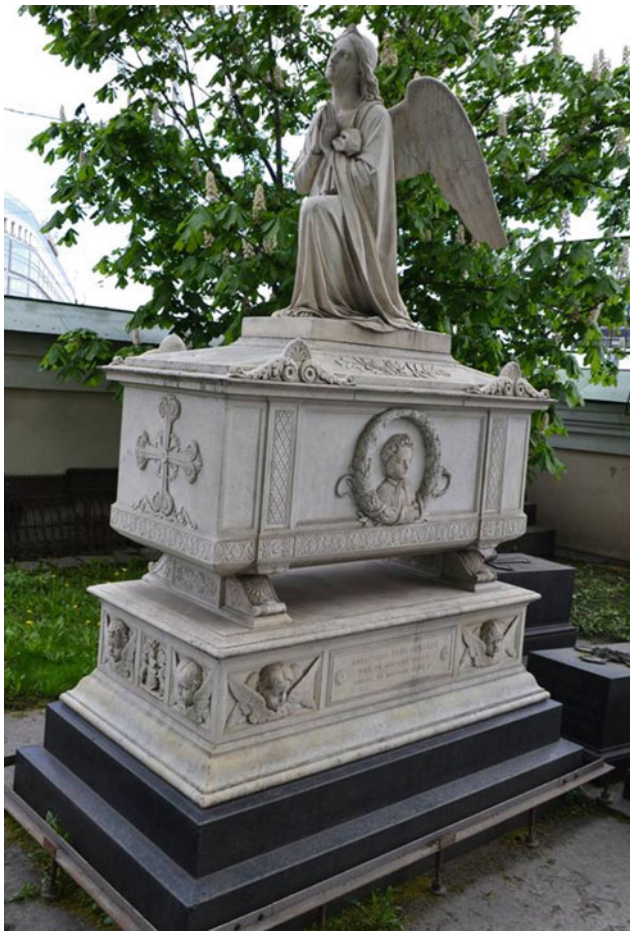
**Fig. 5.8** Monument to E.A. and V.N. Kochubey (view from the south-west side) 2013

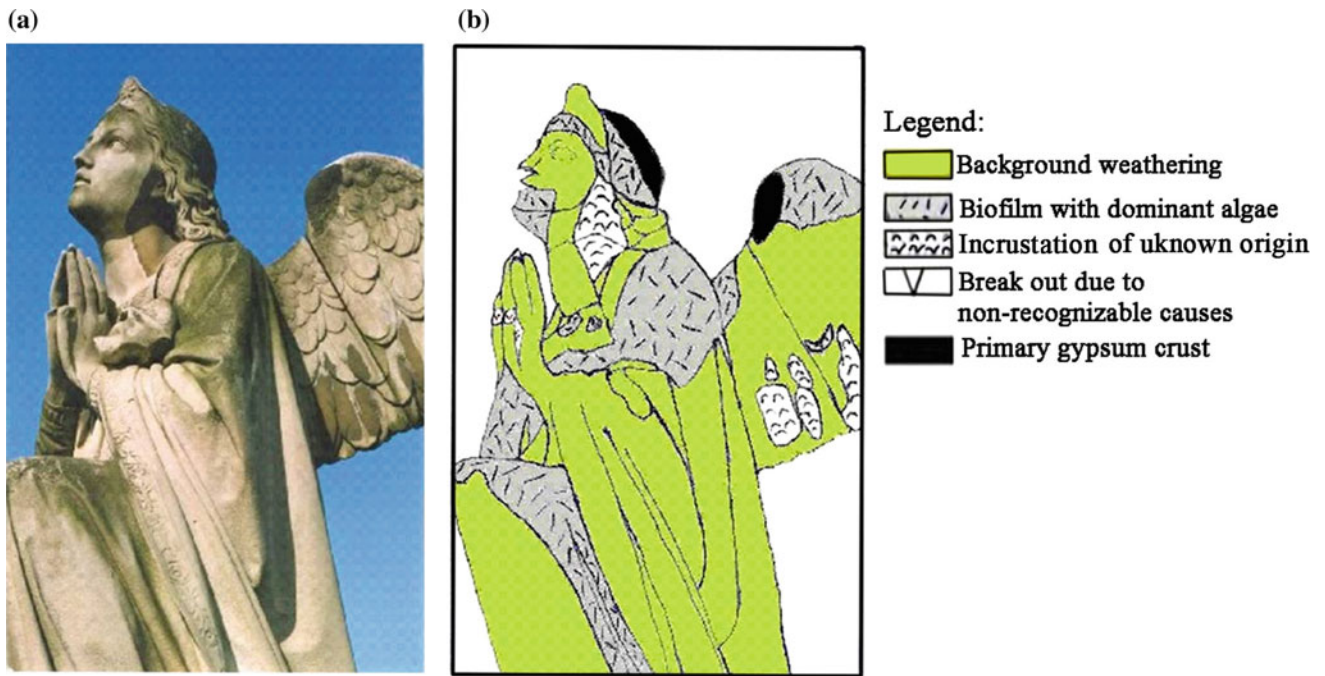
**Fig. 5.9** Fragment of the angel sculpture on the monument to E.A. and V.N. Kochubey (Mironova 2000): **a** photo; **b** map of the types of marble deterioration. Examination of 2002

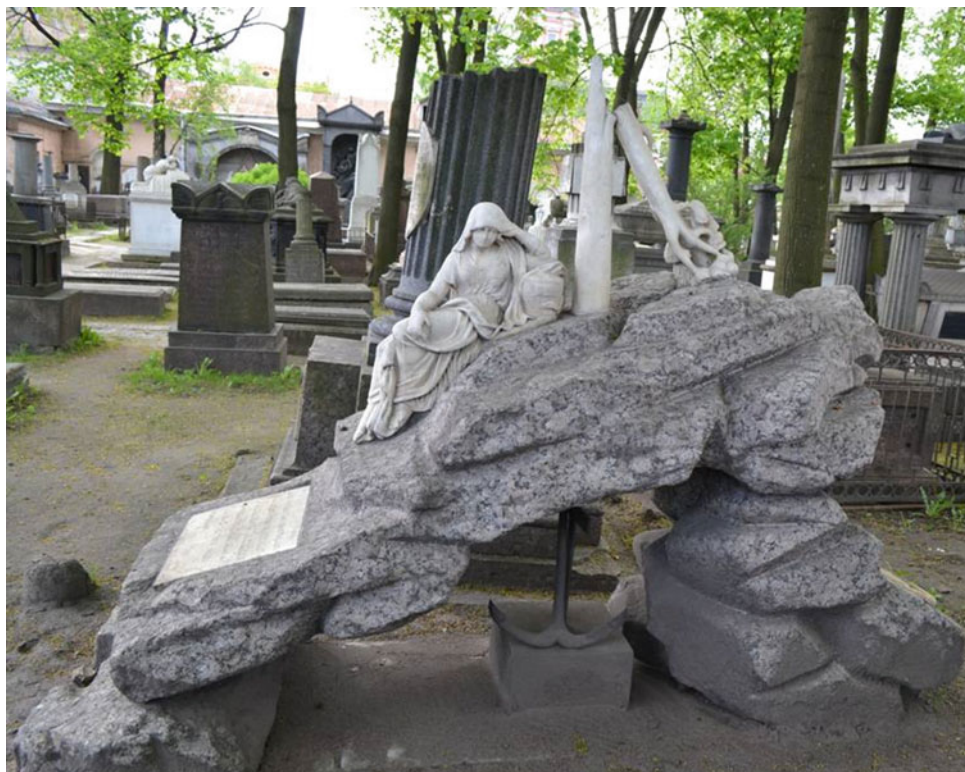
**Fig. 5.16** Monument to A.Ya. Okhotnikov 2013

Restoration of marble was carried out according to the traditional method with the use of modern materials (Loginova 2012), including such measures as structural strengthening of marble, biocidal treatment and conservation (synthetic waxes were used). The ancient monument was transformed (Fig. 5.16). Now, as the restorers recommended, annual monitoring and routine maintenance (stone washing and renewal of the protective coating once every three years) were required to keep it in good shape.

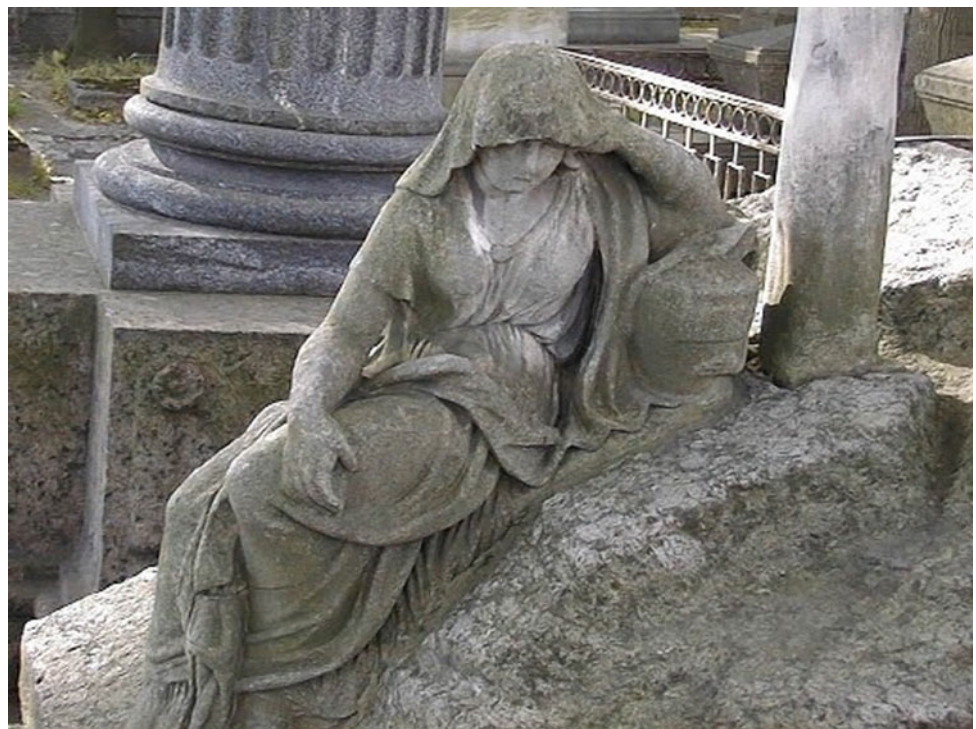
In 2002, N.F. Lepeshkina found extensive stone crumbling, development of colonies of dark-colored fungi (Table 5.3) on the entire surface of the marble sculpture, lichen and algae thalli (Fig. 5.17). On the neck of the sculpture and in the folds of the cloak (under the bent hand), the beginning of black gypsum crust formation was registered. Small fissures were found on the surface of the memorial marble plaques (on the western and eastern sides). The degree of marble deterioration, in general, was 15%.

**Fig. 5.17** Fouling of biological origin, crumbling of marble and black gypsum crust on the figure of the mourner on the monument to A.Ya. Okhotnikov 2002

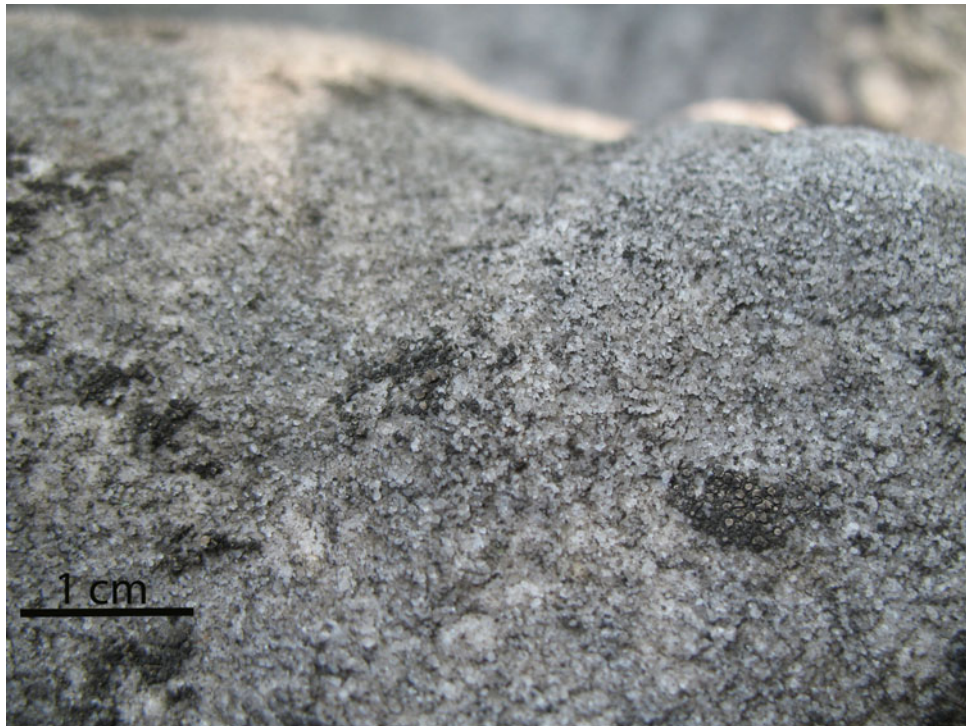
The results of the 2009 expert examination (expert M.S. Zelenskaya) showed that intensive deterioration of the marble sculpture continues (Fig. 5.18a). Stone crumbling, development of colonies of dark-colored fungi, thalli of lichens and algae (Fig. 5.19), formation of gypsum-rich patina. During the mycological examination of the monument, 13 species of micromycetes were identified (Table 5.3), among which dark-colored microscopic fungi dominated. At the same time, their number in the samples was high (from 3500 to 6800 CFU). After the examination, it was again recommended that restoration should be carried out as soon as possible, as well as biocidal treatment of the monument.

**Fig. 5.19** Marble crumbling, microcolonies of dark-colored fungi, thalli of crustose lichens on the monument to A.Ya. Okhotnikov 2009

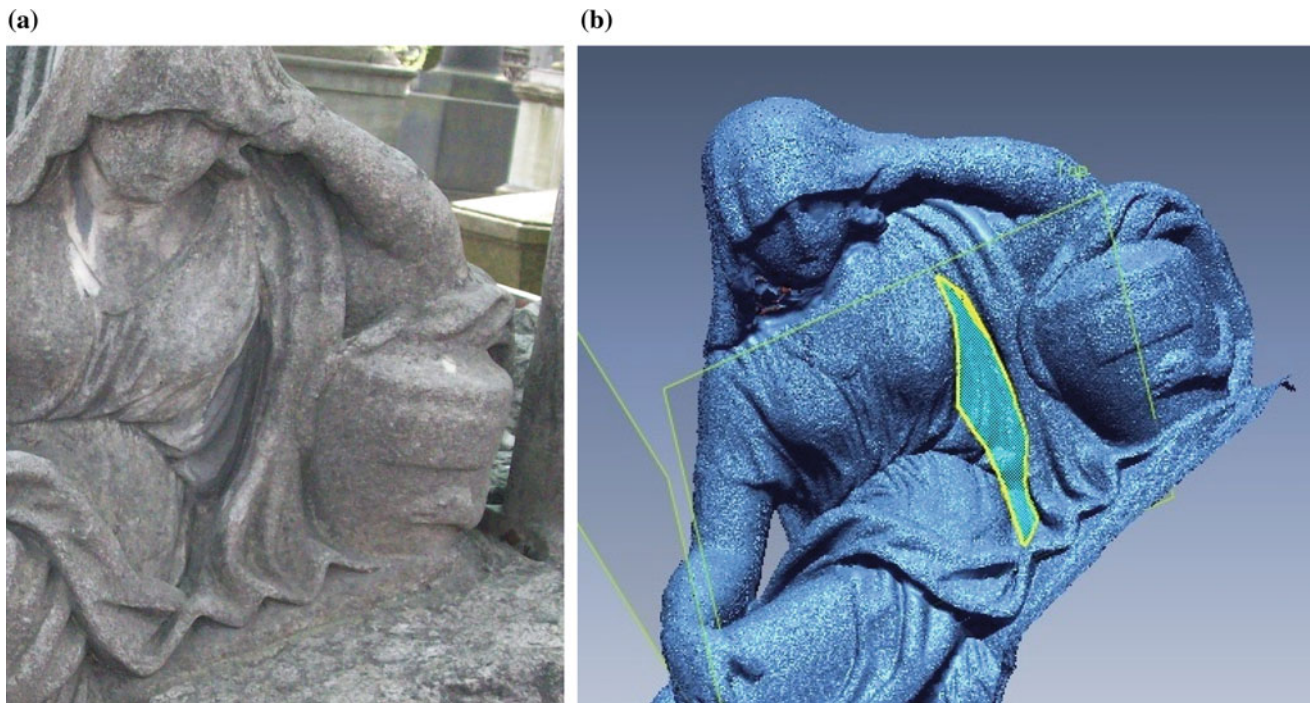
**Fig. 5.20** Fragment of the mourner sculpture with gypsum crust in the folds of the cloak: **a** photograph, **b** electronic 3D-model, on which the area of the gypsum crust is highlighted (Leonova 2012)

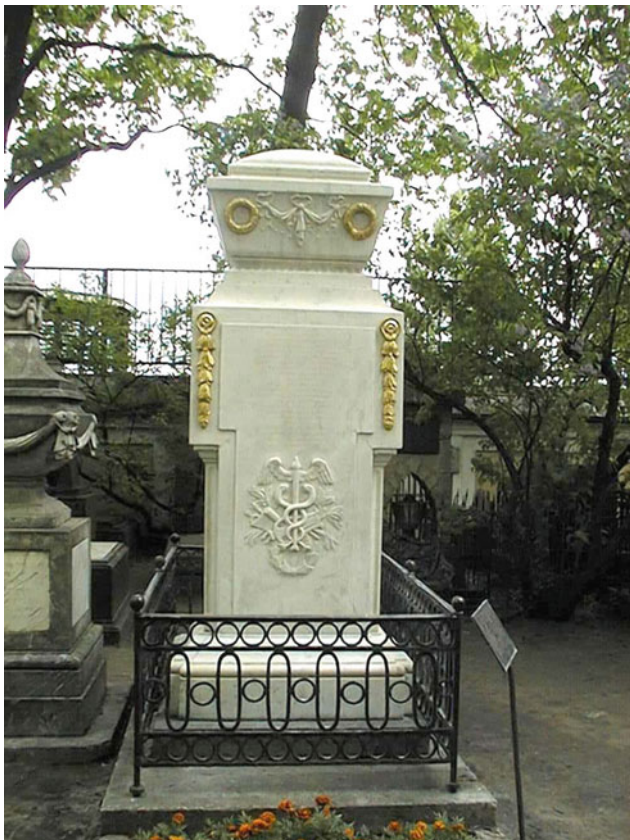
**Fig. 5.24** Monument to M.V. Lomonosov in the Necropolis of the 18th century. The western side 2004

The tombstone of Lomonosov, made, as the author of the drawing emphasized, “in Florentine style”, is a white marble stele topped with an urn in the shape of a sarcophagus (Fig. 5.24). On the stele there is an epitaph: on the west side, in Latin, on the eastern side in Russian:

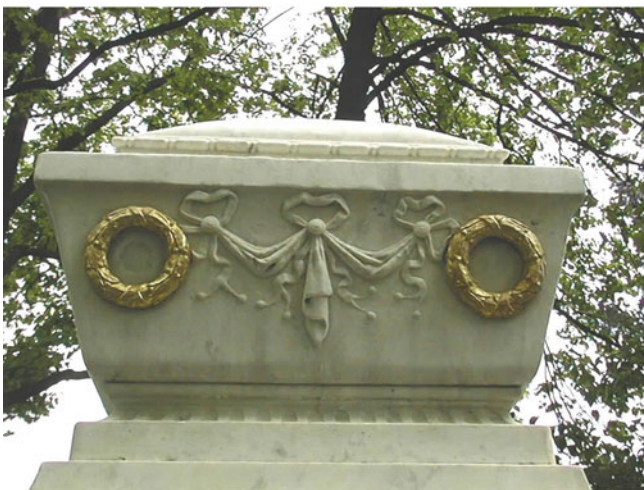
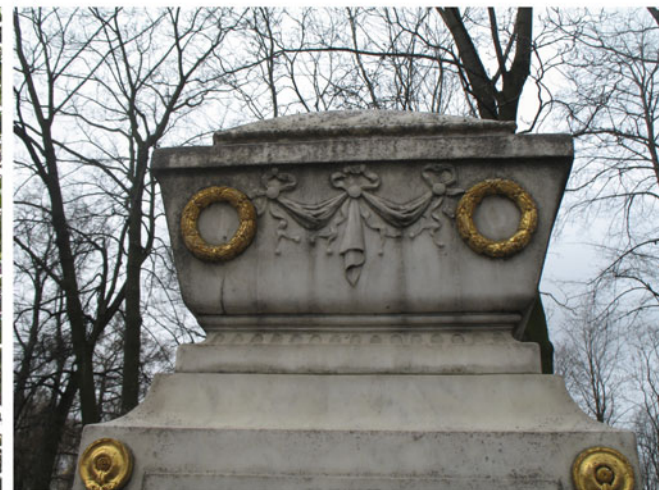
**Fig. 5.25** Mud deposits on the marble surface of M.V. Lomonosov's monument: **a** 2004, **b** 2011

Marble is covered with an uneven layer of airborne contaminants (Fig. 5.25b). On the southern side of the marble stele, rusty streaks from the coins left by the visitors are visible (Fig. 5.26). The surface of marble is seriously contaminated with biogenic formations (Fig. 5.27). The development of colonies of dark-colored fungi (Fig. 5.27a) is observed almost over the entire surface, the sarcophagus being most severely affected. A coat of algae (Fig. 5.27b) covers the lower part of the stele (at the socle) from the north

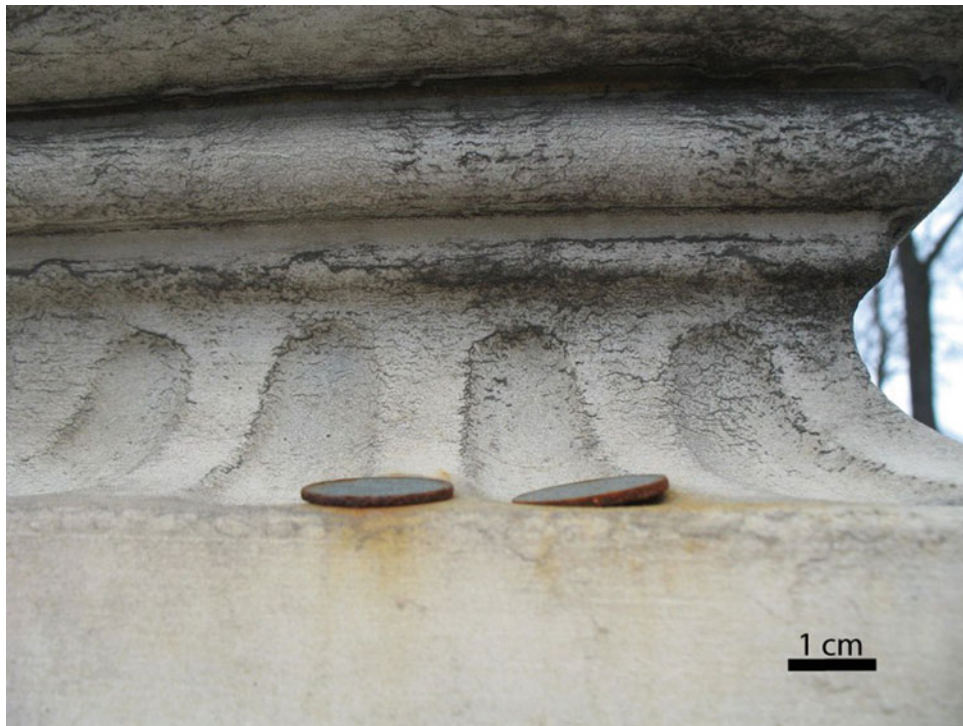
**Fig. 5.26** Mud deposits, biological buildups and rusty streaks from coins on the horizontal and vertical surfaces of the stele under the sarcophagus. South side 2011

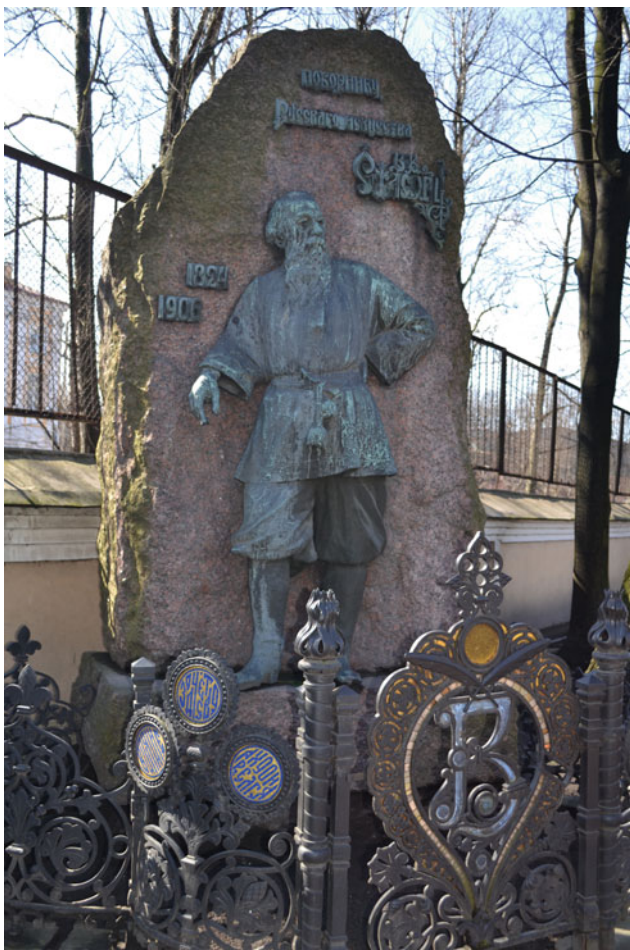
**Fig. 5.30** Monument to V.V. Stasov in the Necropolis of Masters of Arts

surface. The upper colored patina layer is very thin and uneven (Figs. 5.30 and 5.31).

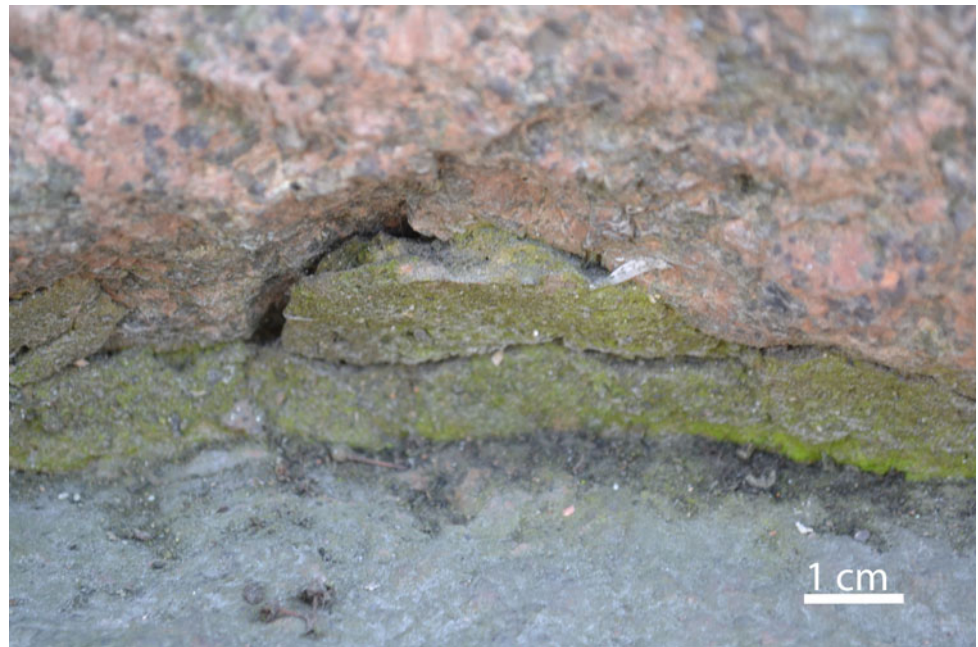
**Fig. 5.32** Organic buildup in the space between the monolith and the pedestal. Aerophilous algae and small turfs of moss develop

algae stains (Chlorophyta Division) (Fig. 5.32, 5.33 and 5.34). These stains cover a significant part of the monolith, although they are more developed on the south side of the monument. It should be noted that green stains are located mainly on the upper half of the granite block, while the lower part of the monument (closer to the ground) is predominantly covered by dark crust (Fig. 5.35). The densest buildups are found where the parts of the monument are joined, and enough room remains for accumulation of mud and biological contaminants.

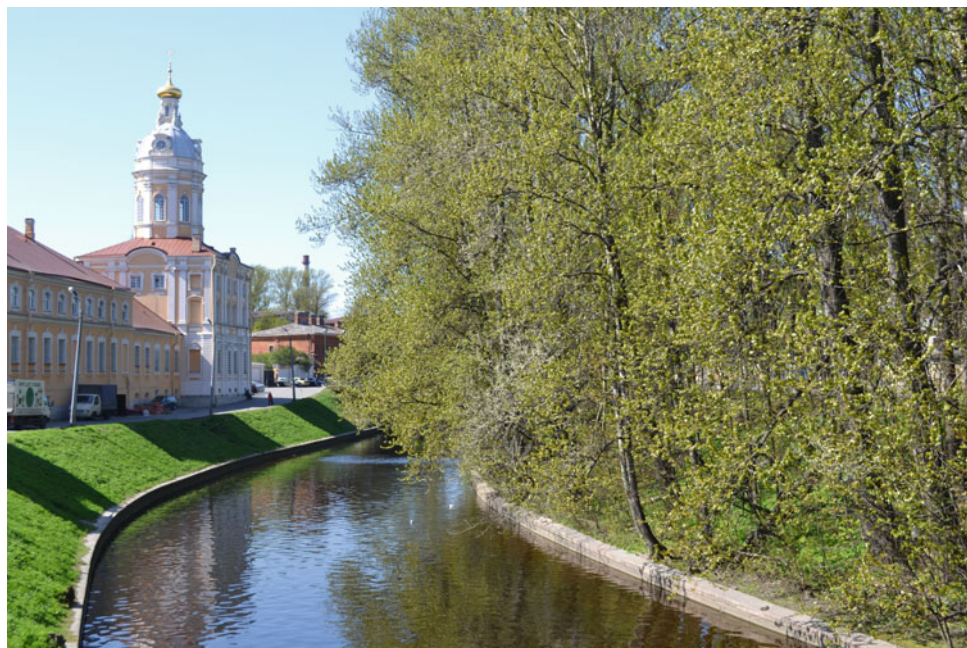
**Fig. 5.36** River Monastyrka, flowing outside the boundary of the Necropolis of Masters of Arts

flowing nearby (Fig. 5.36), under the crowns of trees, resulted plant secretions deposit on the monument surface.

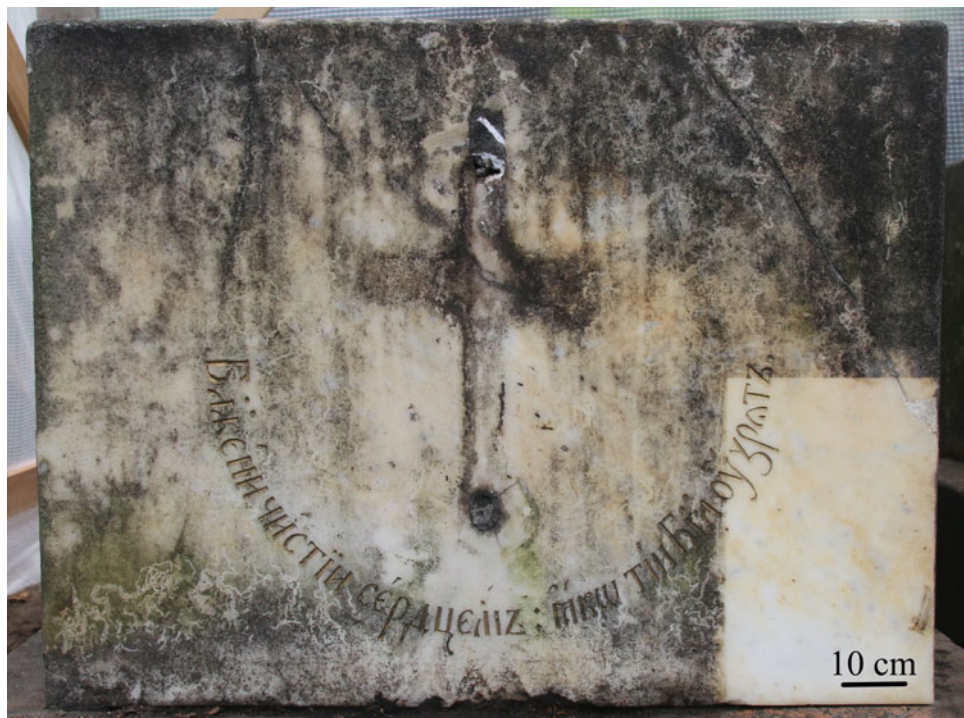
**Fig. 5.45** Mud buildups, algae growths, colonies of dark-colored fungi and cracks on the butt end of the marble tombstone of N.M. Karamzin (June 2016, shows the result of trial cleaning)

On the surface of the tombstones and the metal fence, algae and colonies of dark-colored fungi were found (Fig. 5.45; Table 5.12).

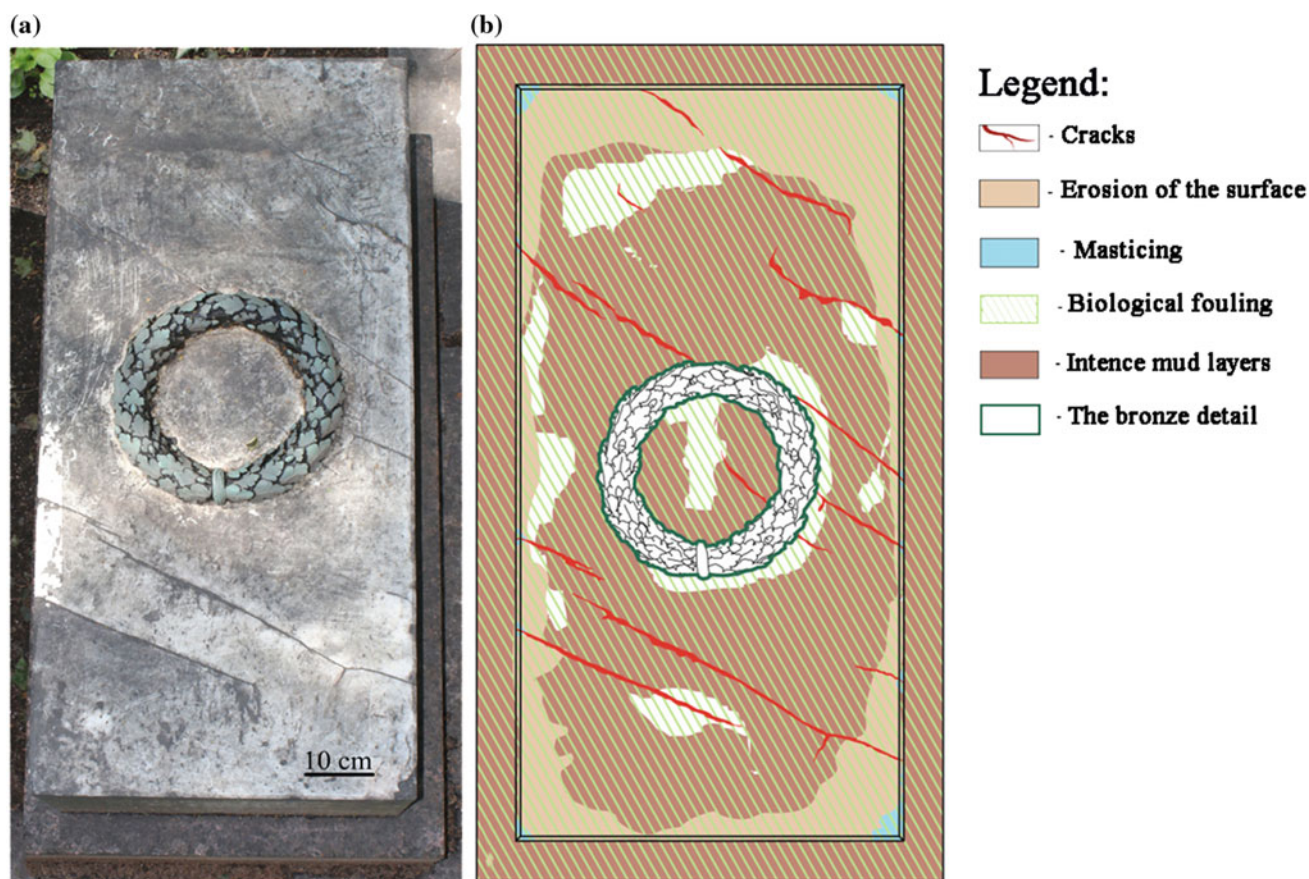
**Fig. 5.46** The tomb of N.M. Karamzin (seen from above) prior to the beginning of restoration (June 2016): **a** photograph, **b** map of the forms of marble deterioration (the signatures on the picture: cracks, erosion of the surface, mastic, biological fouling, intense mud layers, the bronze detail)

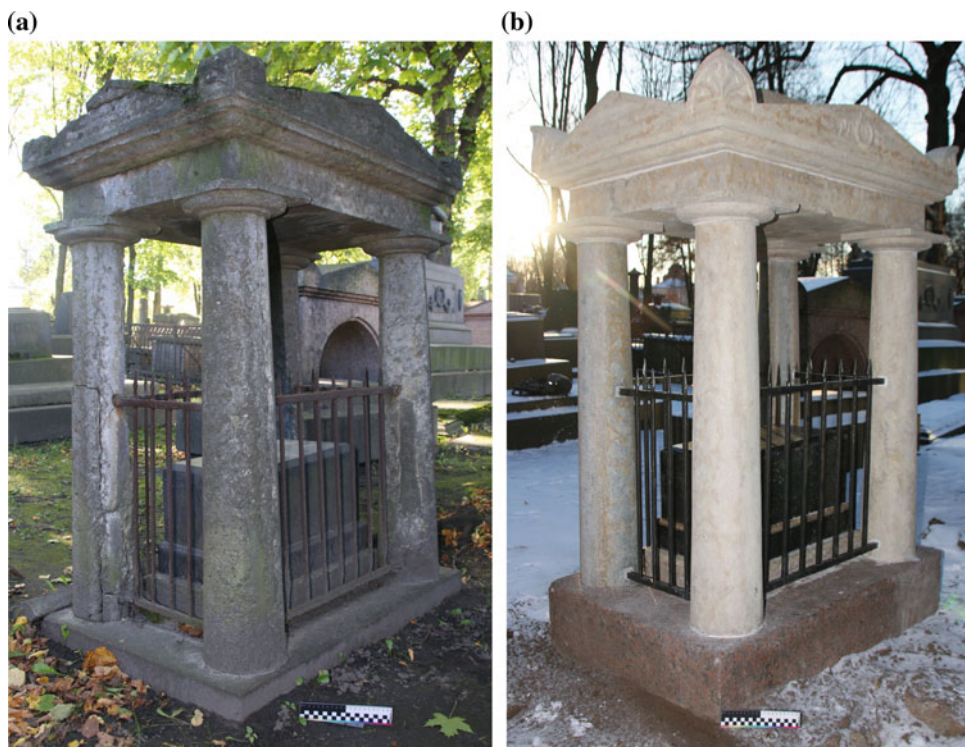
**Fig. 5.52** Monument to A.Ya. Potemkina (view from the north-eastern side) **a** before restoration (September 2016), **b** after restoration (November 2016)

The monument to A.Ya. Potemkina (Fig. 5.52) is made of Putilovo limestone and is a portico on four Doric columns with a helm roof and triangular pediments, decorated with

Seven years later, in the summer of 2016, prior to the restoration, a second examination of the state of the monument was performed (by experts H.V. Shumilova, M.S. Zelenskaya, V.V. Lebedev), which confirmed that the gravestone was in a critical state (Figs. 5.52a, 5.54, and 5.55), and the extent of its deterioration significantly increased.

Restoration of the gravestone of A.Ya. Potemkina was performed in autumn 2016. The monument was dismantled, and all its parts were transported to the restoration workshop. The most labor-consuming work was connected with the restoration of the portico from Putilovo limestone—a material that is usually used for socles and foundations of monuments and rarely for vertical structures. The stone was washed, biological fouling and an extensive black gypsum crust on the ceiling inside removed. The restorers even called it “the queen of crusts” (Fig. 5.56). The further work was related to strengthening of the stone, mastic of chips and cracks and conservation. During the restoration, the lost fragments of acroteria were recreated. It was not possible to save the two columns, which were in extremely poor condition. By decision of the Restoration Council, they were replaced. The new columns were also cut from the Putilovo limestone, which is still mined in the same quarries near the village of Putilovo (Leningrad region, Fig. 2.31).

After the monument was assembled in its historical place in the Necropolis of the 18th century, it was possible to say that the main goal of restoration—to give the monument as much strength as possible and to preserve it for many years—was achieved (Fig. 5.52b).

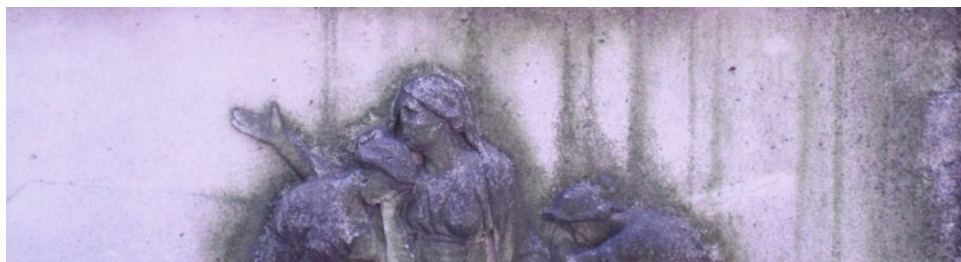
**Fig. 6.3** Marble bas-relief of the monument to N.V. Smirnov with biofilms before biocidal treatment

Using the example of the bas-relief on the monument to N.V. Smirnov in the Necropolis of the 18th century (Fig. 6.3), changes in the biofouled area (after protective treatment) over time were investigated. The estimates of biofouling development were made before cleaning, immediately after cleaning and 1 year after cleaning the monument (Table 6.7).

Biofilm with dominant algae (color yellow): $1.4 \pm 0.08$ Black biofilm with dominance of micromycetes (color brown): $10.9 \pm 0.7$ Clean stone: $87.7 \pm 2.7$

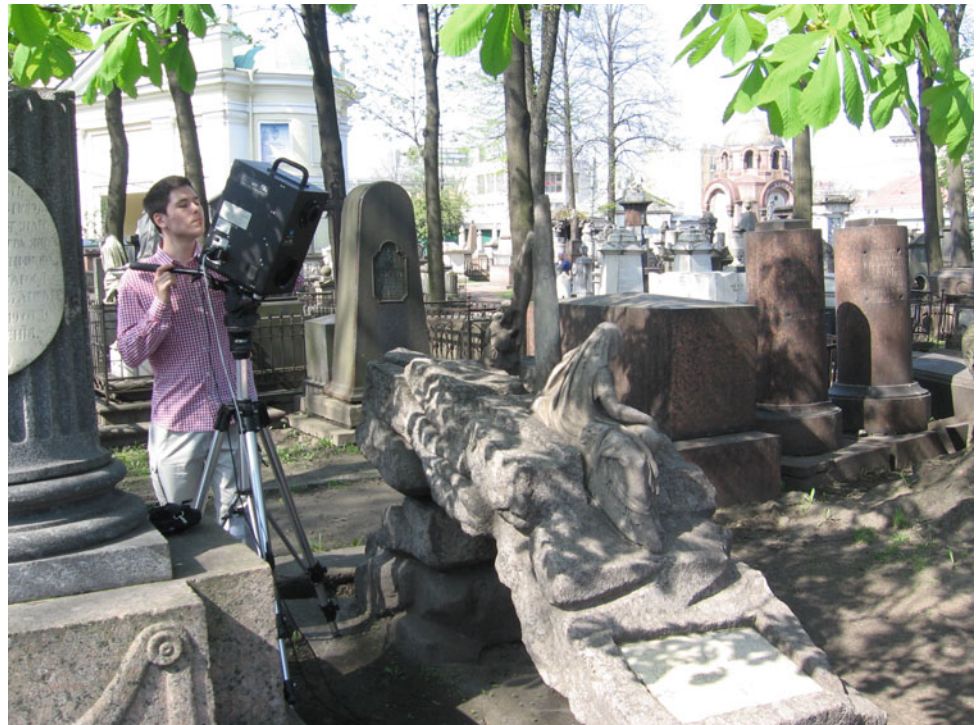
**Fig. 6.4** Laser scanning of the monument to A.Ya. Okhotnikov (2010)

In recent years, laser 3D scanning technology is increasingly being used abroad to monitor exterior monuments (Boochs et al. 2008), but in Russia it has not yet become widespread. Perhaps the only example of its use in this country is scanning of the figure of the mourner on the monument to A.Ya. Okhotnikov in the Necropolis of the 18th century (Fig. 6.4), performed in 2010 by a group of experts from the St. Petersburg “LETI” State Electrotechnical University and the St. Petersburg “Resstroy” Restoration Company.
