Historic Mortars

Advances in Research and Practical
Conservation

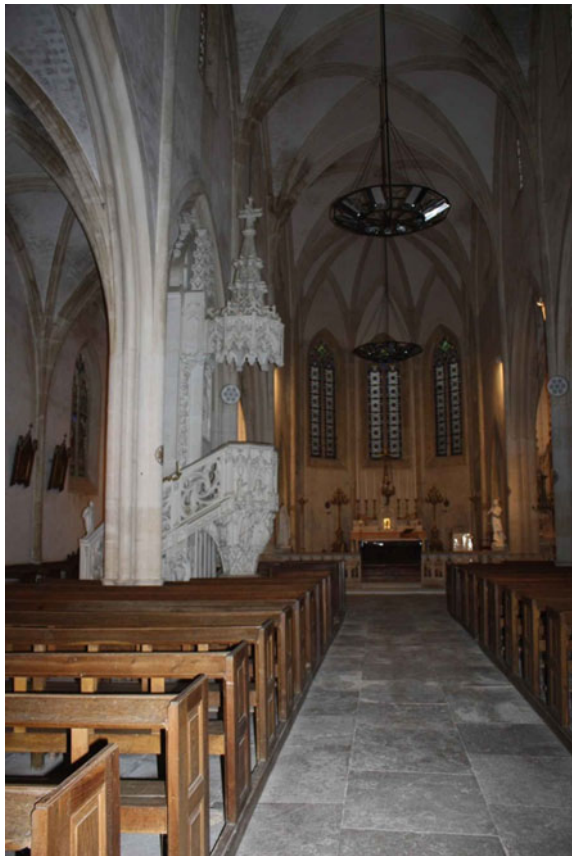
Fig. 1 Vassy church, indoors

The Vassy-lès-Avallon church was built between 1859 and 1862 by the architect Tircuit, at the initiative of the Gariel family, producers of the Vassy cement. Indoors, the walls are covered with an ochre mortar, with a white paint finish (Fig. 1). The arches and the foundations which are made of stone, are coated with an ochre mortar up to the intersecting ribs. Some elements, such as the columns, are also covered with an ochre mortar that can be made out under the white paint. There is no evidence of the implement technology used such as with run-in situ mortar making, or molding marks.

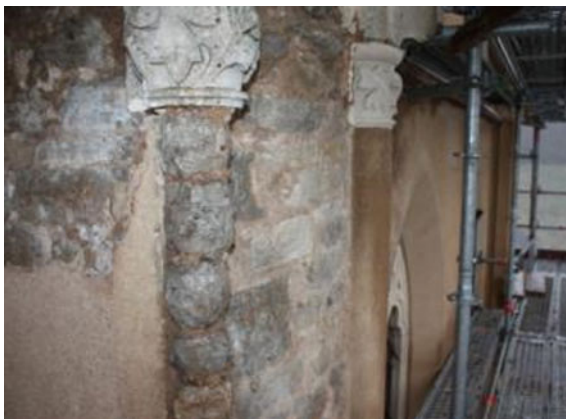
Fig. 4 Stone hook and cornice made of an ochre run-in situ mortar

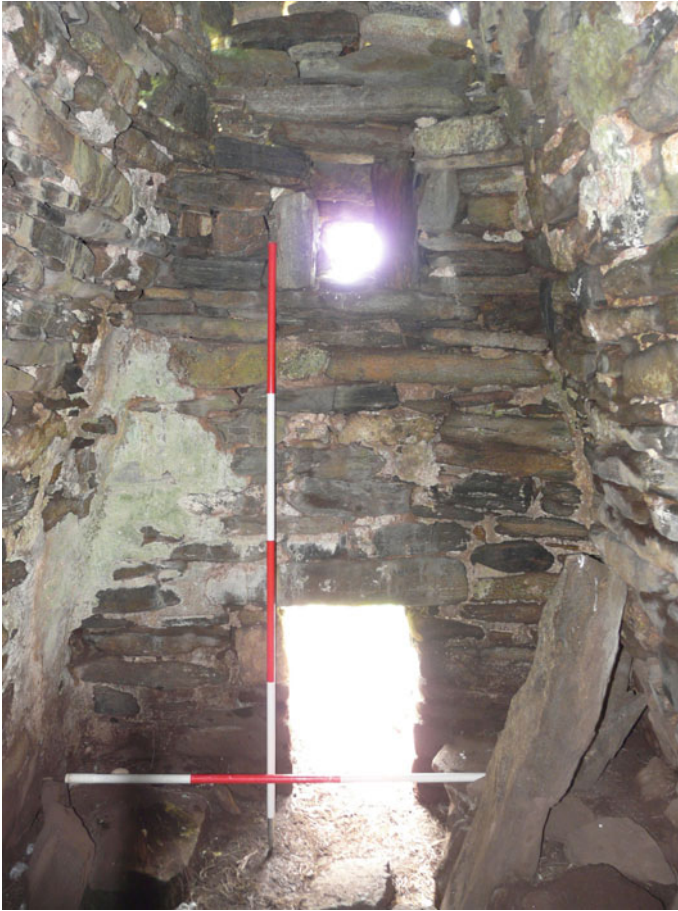
Fig. 2 Corbelled eastern cell, facing west, displaying large patches of multi-layered lime coating. Scale 500 mm (*Photograph M. Thacker*)

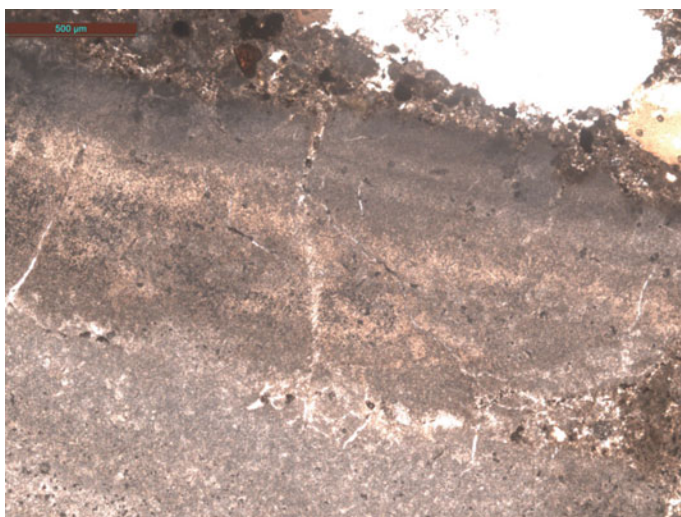
Fig. 4 Thin section of mortar from eastern cell displaying calcined and fractured shell with complete loss of internal microstructure. XPL. Scale bar 500 µm (*Photomicrograph M. Thacker*)

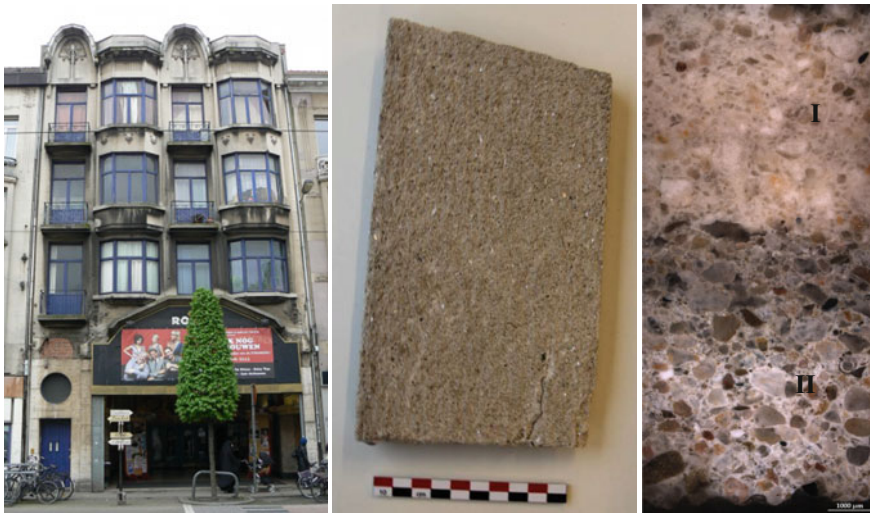
Fig. 1 Historic cinema “De Roma” (1928, north façade), Antwerp (Belgium): upper floors are finished with Terranova (Picture: Y. Govaerts) [left]; Terranova sample from the west façade of “De Roma” (Picture: L. Dekeyser) [middle]; Optical microscopic image of the layered structure of the historic sample: I. Top layer, II. Rendering layer (KIK-IRPA 2011) [right]

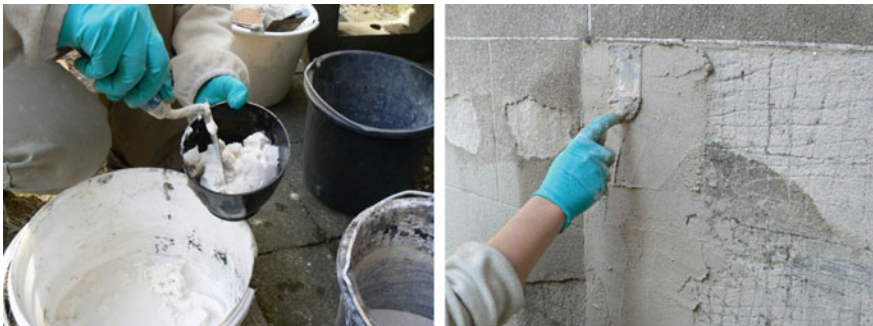
Fig. 8 Final stage to repair damaged exterior stone imitations. The stone imitation render is refabricated and spread onto the façade (Govaerts 2012)

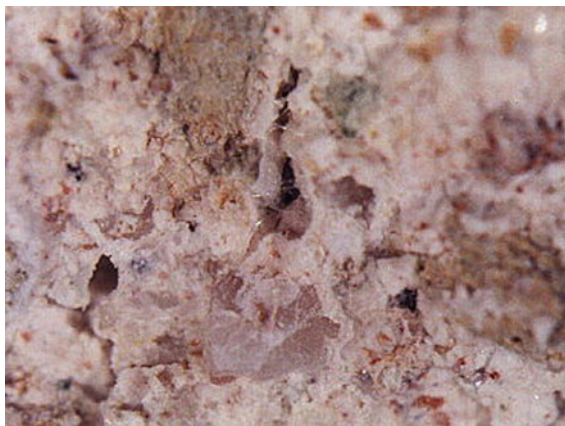
Fig. 1 Salt crystallization into the pores of a structural mortar from Galerius Palace (4th century AD)

functional problems to the structures. According to theories, if the growing crystals exceed the pore size, significant pressures build up on the pore walls resulting in disruption of the structure (Scherer 2004). The low mechanical strength of lime-based mortars making them even more damage prone. Nevertheless, it seems exceptional rare salt crystals to fill the pores and cracks of the structure, since pre-existing cracks especially around the pores can lead the salt solutions away and give small possibility for their high concentration. The presence of fissures around large pores is often met in the structure of lime mortars and their origin is hard to define. Shrinkage phenomena and wet-drying cycles are few of the reasons that can generate cracks on the circumference of pores. Cracks and pores are not often filled with salts (Figs. 1 and 2). The mechanical behavior of the salt crystals is not predictable, as they may be broken or detached easily under favorable conditions.

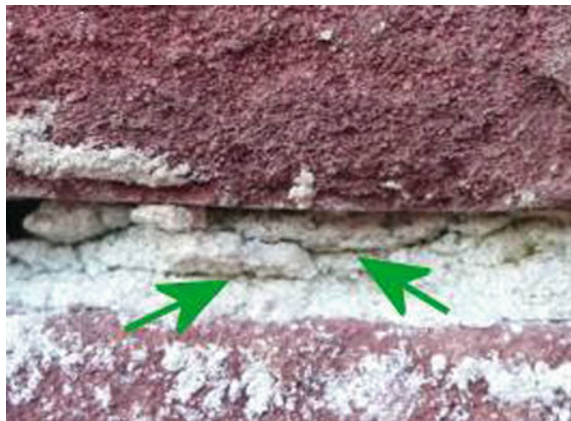
Fig. 1 Horizontal layering (see arrows) in an uncarbonated air lime repointing as a result of freeze-thaw cycling

Related damages in addition to the execution technique may play a role in the further occurrence of freeze thaw damage. For instance: a hollow between repointing and bedding, as a result of insufficient filling of the joint may result in push out by frost (where a period of heavy rain is directly followed by a frost period); other causes of damage may be insufficient depth of the repointing, a V-form instead of a rectangular form of the joint etc.

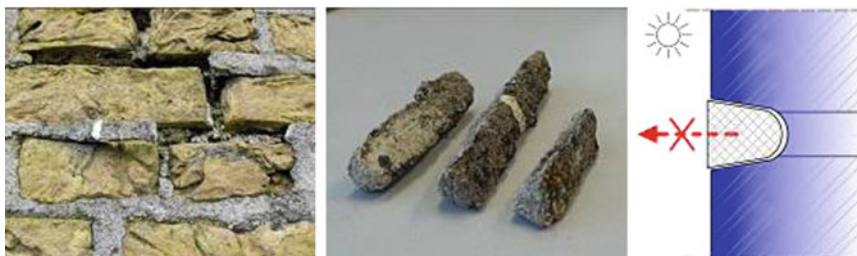
Fig. 4 Detachment of repointing caused, in particular, by thermal deformation enhanced by a wrong cross-sectional form (V-shape instead of rectangular) of the repointing

At meso scale thermal resp. moisture deformation may as well be a serious cause of damage (see Fig. 4). Not only do material properties such as the (linear) thermal respective moisture expansion coefficient play a role in the detachment process, but so does the execution technique in for example the pointing.

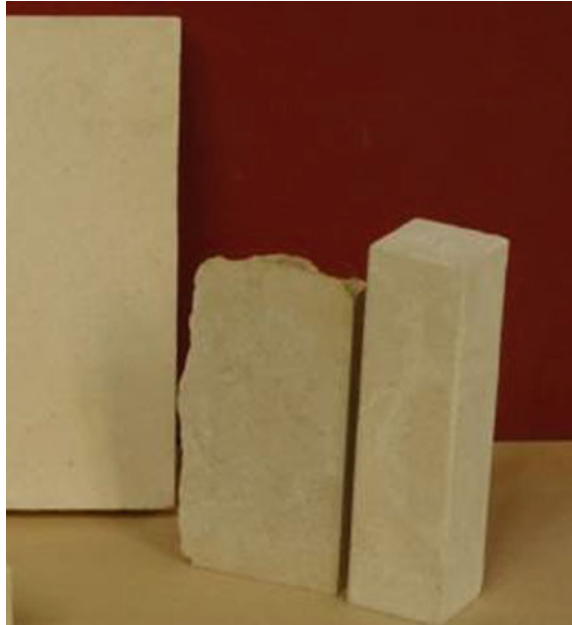
Fig. 4 Comparison between the original Tuffeau de Lincant in the middle and the mortar from the auto-formulation tool on the right

Mortar samples were made based on the recipe provided by the auto-formulation tool. The tool suggested using a mortar made with 44.2 wt% of white cement, 21.06 wt% of yellow sand, 5.75 wt% of green sand, and 29 wt% of water. This large amount of water had to compensate for the white cement's normal resistance, in order to give a final mortar strength in the range of the stone. After 28 days of curing, the samples were tested for their colour and resistance and compared with the values from the stone samples. The stone had following colour values (Y,x,y): 0.58; 0.3378; 0.3625 and the mortar samples had following colour values: 0.65; 0.3353; 0.3558. This colour difference is not distinguishable to the human eye according to Trouvé (1991); in L*a*b*, this would give a colour difference (ΔE^*) of 3.12 (Fig. 4).

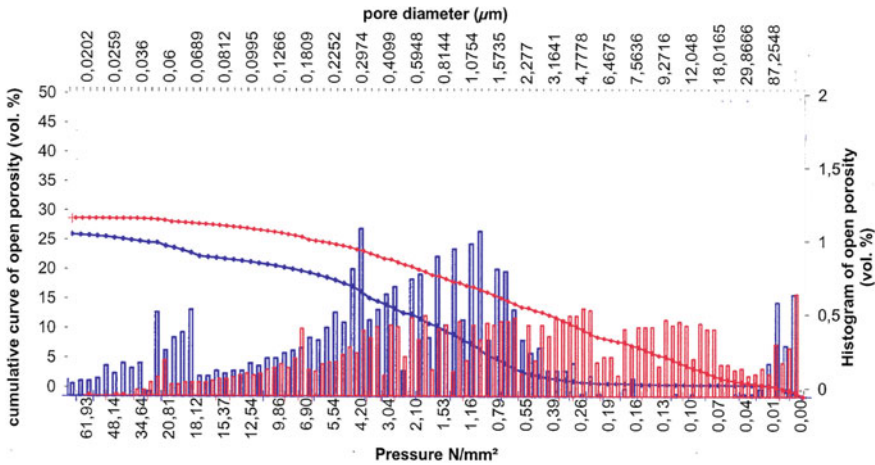
Fig. 8 Pore diameter histogram and cumulative curve of open porosity of the stone (red) and the mortar (blue) (color figure online)

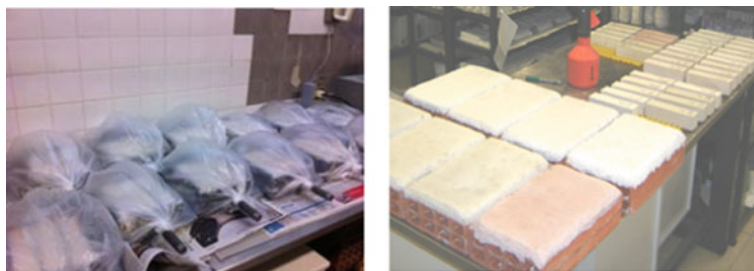
Fig. 2 Prismatic samples inside the moulds and conditioned in polyethylene bags; mortars on brick and prismatic samples at laboratory controlled conditions

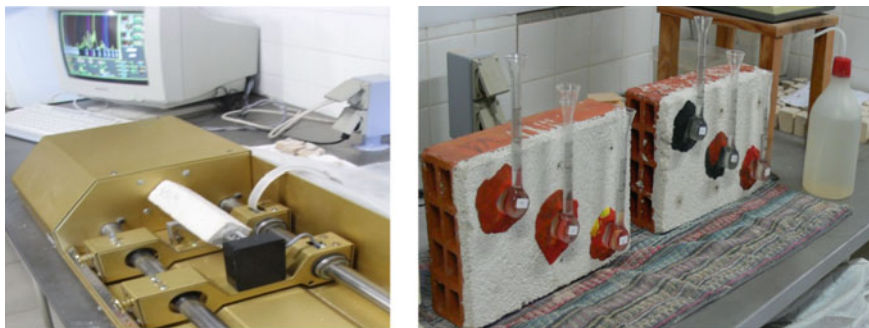
Fig. 3 Tests of dynamic modulus of elasticity and Karsten tubes

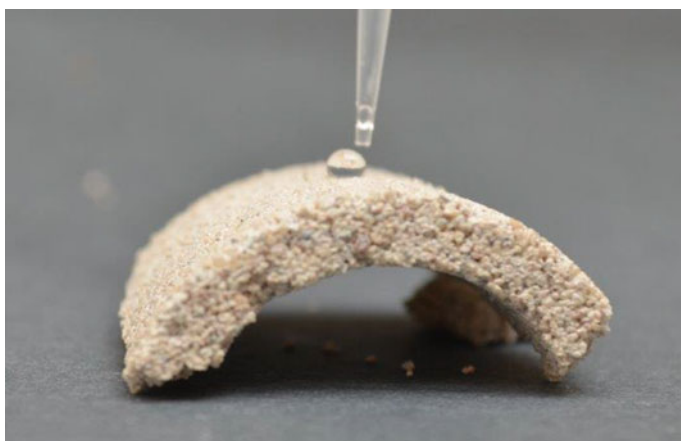
Fig. 5 Test of the water drop absorption rate

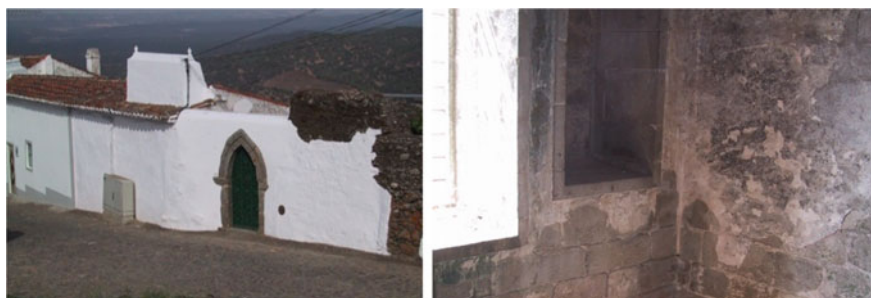
Fig. 1 Whitewashed façade at Terena village, Alentejo, south Portugal (on the left) and a thicker lime coating on stone masonry at Rendufe Monastery, Braga, north Portugal (on the right)

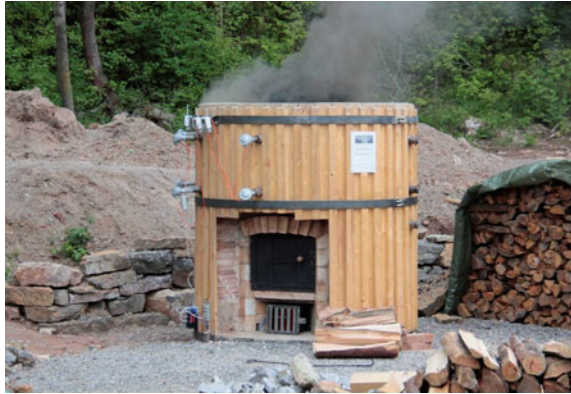
Fig. 1 Prototype of a lime kiln

The experimental lime kiln, shown on Fig. 1, was built to investigate the influences of traditional burning on the quality of lime and for the production and subsequent research of lime binders made with historically used raw materials (Válek 2015). In addition to the research reasons, it was constructed as a prototype enabling small-scale production of lime binders by traditional methods. A single batch wood-fired burning of limestone can be replicated in the kiln—this is what it was designed for—but the kiln can also be used to burn limestone in a mixture with fuel, known as mixed feed burning. Other elements of the design satisfied requirements for the durability of the kiln and ease and safety of operation.

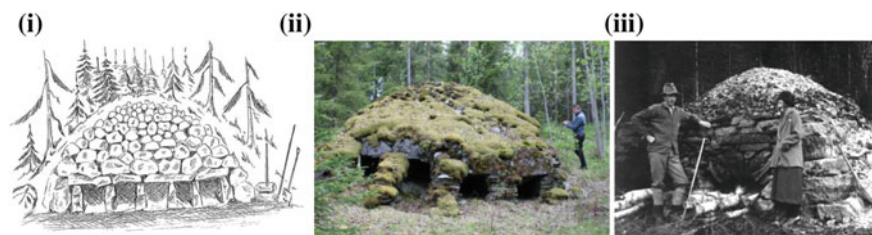
Fig. 2 **i** Illustration of a field kiln of Jämtland model (Åsling 2000). **ii** Unburned field kiln built in the late 19th century still standing in the forests of Åse. Now it is covered with moss but originally the stones were visible and not covered. **iii** Lime kiln from Havsnäs Jämtland in the 1920s

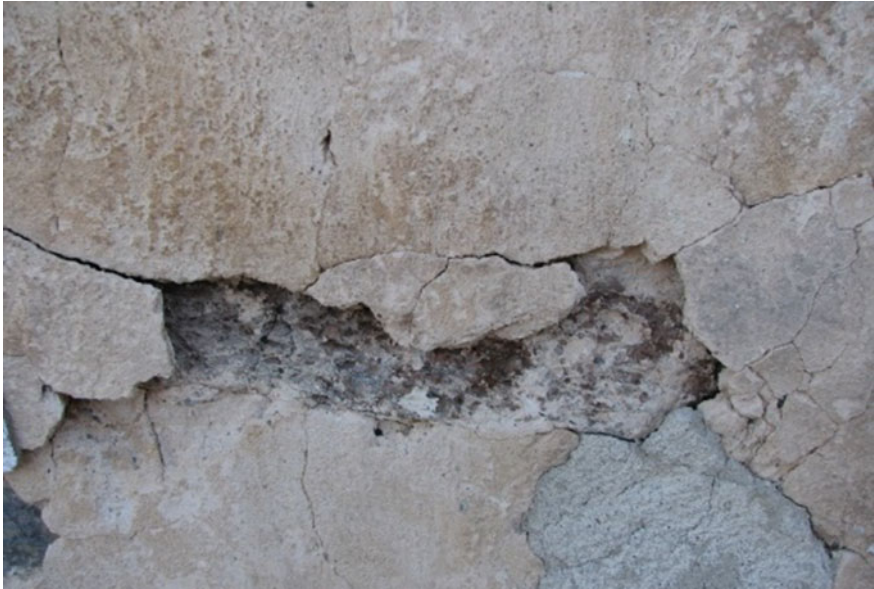
Fig. 4 Old lime mortars in Oviken. The oldest mortars from 17th century are extremely lime rich (20:1 lime/sand by volume) with a yellowish color. What occurs as sand particles to us might be just impurities from the limestone and the slaking process (Balksten and Lindqvist 2016). To reproduce such mortars we need to experiment more with slaking and storing of the specific lime. The surface has traces of lime wash and aging

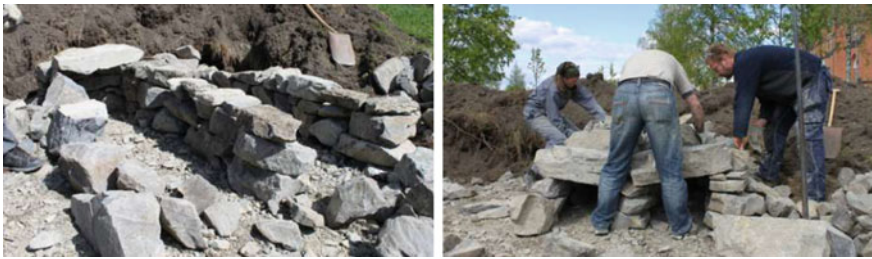
Fig. 7 Field kiln built in 2011. It has two fire places, like some of the kilns found in the region had

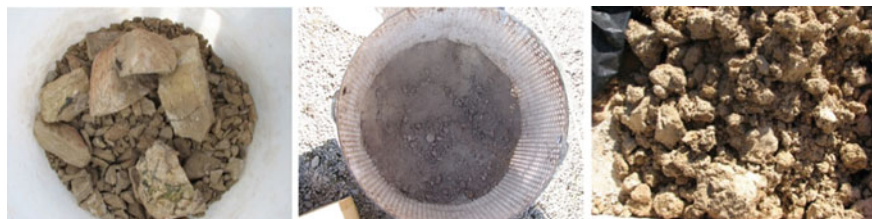
Fig. 10 Burned limestone from Marieby; dry-slaked Näsersjöberg lime in a special constructed steel basket; wet-slaked Marieby lime. The lime from Näsersjöberg is almost a bit purple-grey when it is slaked compared to lime from Marieby that is yellow-brown (Color figure online)

The analysis as well as the practical tests show two very different types of lime after burning, slaking and hardening, see Fig. 10. As always it is essential that the

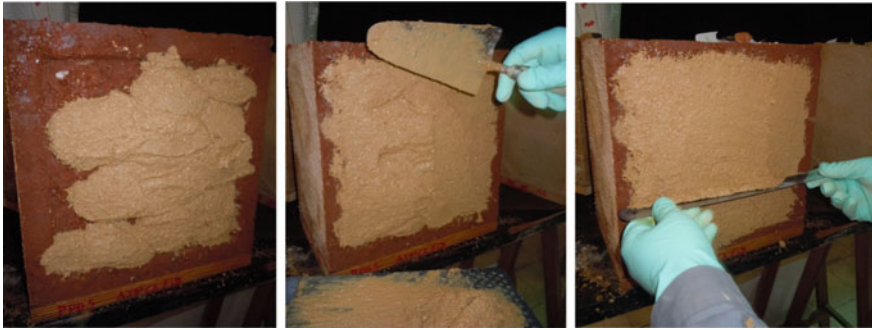
Fig. 3 Application of the mortar MRE_CL15 on a standard superficial defect of the PD rammed earth

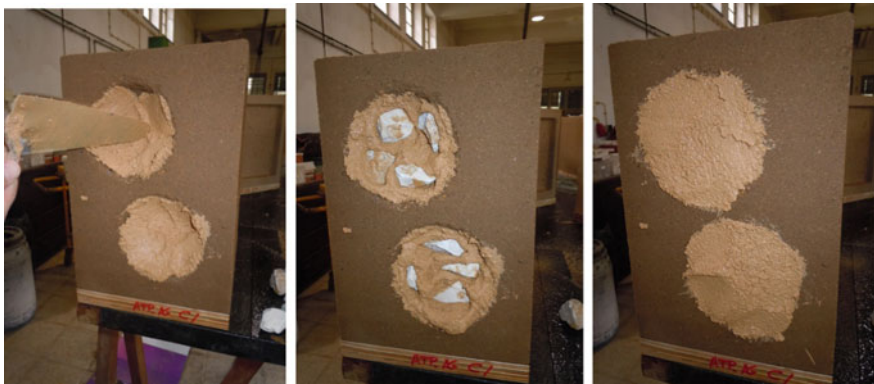
Fig. 4 Application of the mortar MRE on a standard deep voids defect of the Av rammed earth

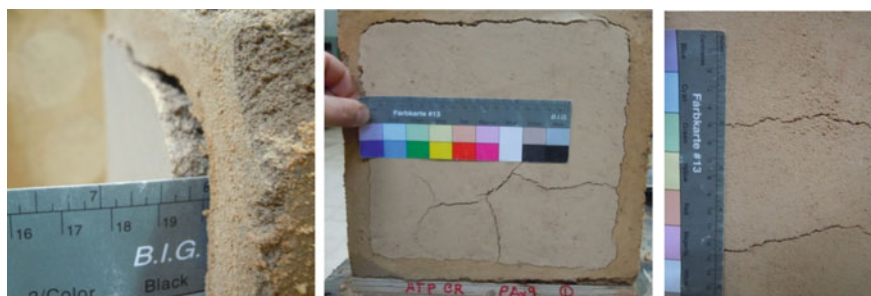
Fig. 5 Mortar MRE_NC15 applied in block BAv on standard superficial defect: left, detachment of the mortar; center, cracks; and right, detail of large cracks
