Lime Burning Tradition in a Field Kiln of the Jämtland Model in Sweden

K. Balksten, C. Persson and J. Eriksson

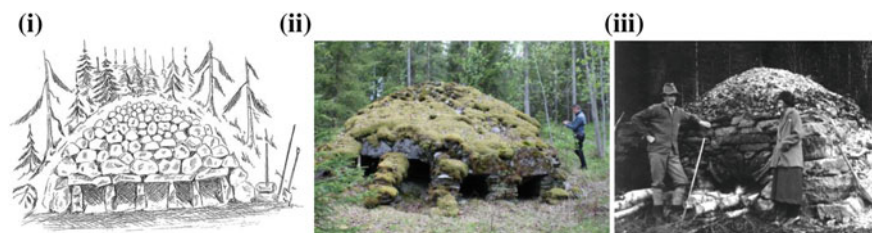
Fig. 2 **i** Illustration of a field kiln of Jämtland model (Åsling 2000). **ii** Unburned field kiln built in the late 19th century still standing in the forests of Åse. Now it is covered with moss but originally the stones were visible and not covered. **iii** Lime kiln from Havsnäs Jämtland in the 1920s

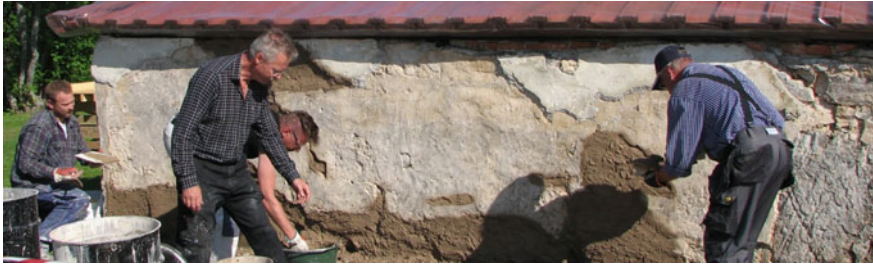
Fig. 3 Mortars are applied with a trowel onto the wall. Old mortars can be distinguished by color and texture, here as the white and yellowish surfaces in the picture

During a workshop in July 2011 the lime was slaked, mixed with sand and used as a mortar for restoring a part of the wall surrounding Oviken old church, see Fig. 3. Both dry slaking and wet slaking methods were used according to a method developed by Eriksson and used for Ordovician lime from south of Sweden

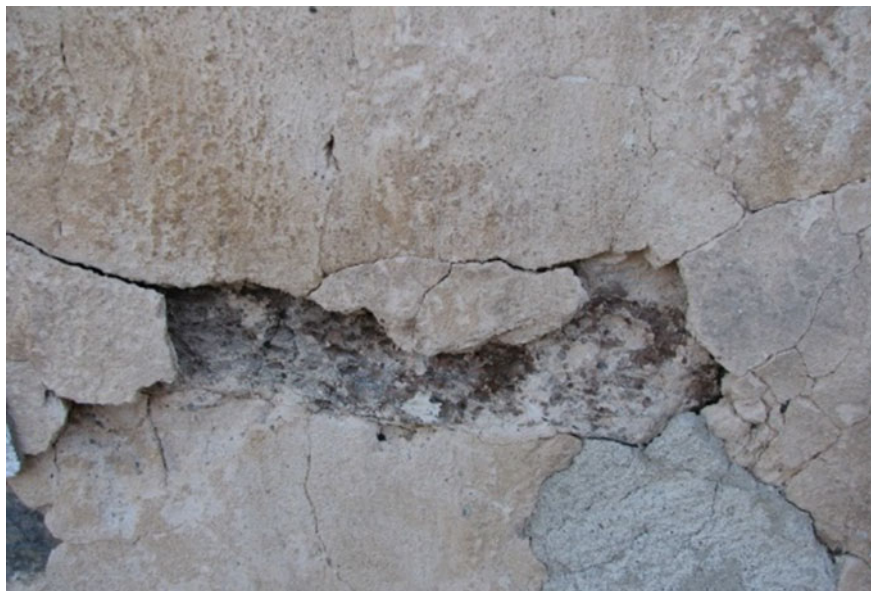
Fig. 4 Old lime mortars in Oviken. The oldest mortars from 17th century are extremely lime rich (20:1 lime/sand by volume) with a yellowish color. What occurs as sand particles to us might be just impurities from the limestone and the slaking process (Balksten and Lindqvist 2016). To reproduce such mortars we need to experiment more with slaking and storing of the specific lime. The surface has traces of lime wash and aging

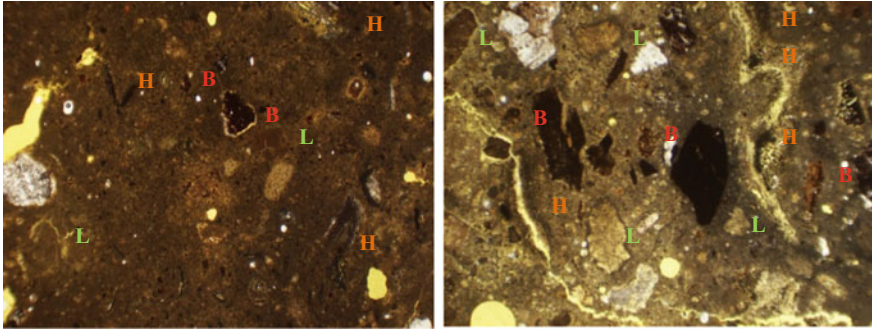
Fig. 6 Examples of thin sections made from old lime mortar samples from the old church wall in Oviken (see Fig. 4) and the church ruin in Sunne, Jämtland. The shown width of each image is equivalent to 4.5 mm. Both of the analyzed mortars are extremely rich in lime, showing almost no sand particles at all. The binder is not pure CaCO_3 , it contains some other elements, or impurities. The thin sections show that the lime contains some darker hydraulic components, marked with H, lime lumps L and burned clay minerals B

took over (Pasch 1826). Thin sections are made from soft yellow colored lime mortar samples which are extremely hard and fat, see Fig. 6. They both contain hydraulic reactions; reference material can be found in Johansson (2006) in analysis made by Jan-Erik Lindqvist and Torbjörn Seir and in Ingham (2011).

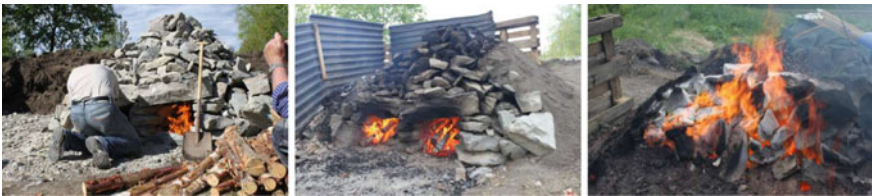
Fig. 8 Lime kiln during the first, second and third day. On the third day the flames started to become blue all over the top of the kiln, giving a signal that the lime was burned long enough

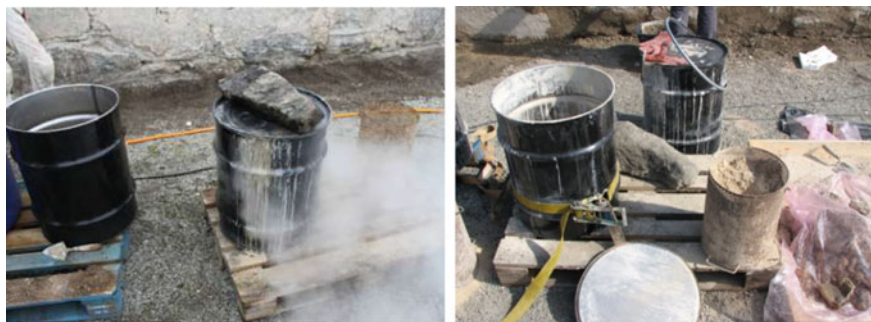
Fig. 9 Lime slaking under pressure in an oil drum

(Eriksson 2015). When being slaked, the burned limestone was placed inside in an oil drum (Eriksson et al. 2012), see Fig. 9, giving the effect that the lime is slaked under a small pressure. When mixing mortars for test surfaces, an electric stirrer specialized for mortar were used. The mortars were then applied being pressed or thrown with a trowel; the more fat mortars had to be pressed while the more lean mortars could be thrown. Their surface texture was made as similar to the old

much water during the wet slaking process, giving mortars with inconsistent and hard-worked qualities when it comes to workability. The amount of water used in wet slaking for similar kinds of limestone is known to cause extended time for the hardening process followed by lower resistance to degradation (Pasch 1826). Traditional wet slaking in Sweden (Sjöbladh and Engeström 1750) means using a larger surplus of water to slake the lime in the open atmosphere to achieve lime putty. In this project this technique was only tried on a few individual stones, but since the limestones of Marieby and Näversjöberg proved to be difficult to slake, the method of slaking under pressure developed by Eriksson (2015) was instead applied, see Fig. 9.

The limestone was put in a steel basket with holes and dipped in water for 18 s until it ceases to bubble. In the wet-slaking method hot water is placed in the drum in which the burned lime is poured into. When dry-slaking, the basket is put inside the empty drum. In both cases a lid is placed on top and a stone is placed on top of the lid in order to create a pressure, which minimizes the loss of energy. This method was created both from practical research and experience by Eriksson (2012), Eriksson et al. (2015).

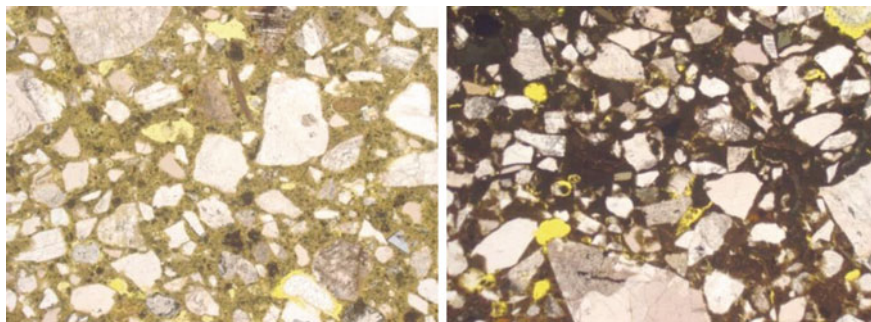
Fig. 11 Thin section of mortar samples made from dry slaked Marieby lime 1:1 and dry slaked Näversjöberg lime 1:1 to sand 0–3 mm. The shown width of the images is equivalent to 2.6 mm. A polarization Microscope, Zeiss TM, was used

The tested mixes were extremely sensitive for too high water content, both when it came to applying the mortar and especially when it came to working the surface structure. All the tested lime mortars would easily bleed lime towards the surface if worked on before they had become stiff. Shrinking cracks occurring in the drying phase had to become visible before the render could be smoothed with a steel trowel with a light hand. The test surfaces showed that it is essential not to be in a hurry when building a render since every layer must be able to harden before another layer can be applied, and every layer must be worked on after it has set (Fig. 11).
