Terranova, a Popular Stone Imitation Cladding: Strategies and Techniques for Restoration

Yves Govaerts, Ann Verdonck, Wendy Meulebroeck and Michael de Bouw

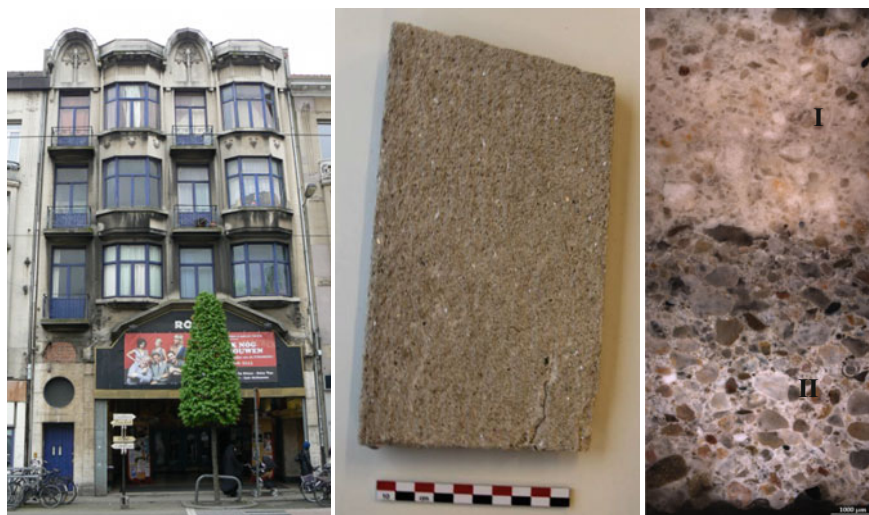
Fig. 1 Historic cinema “De Roma” (1928, north façade), Antwerp (Belgium): upper floors are finished with Terranova (Picture: Y. Govaerts) [left]; Terranova sample from the west façade of “De Roma” (Picture: L. Dekeyser) [middle]; Optical microscopic image of the layered structure of the historic sample: I. Top layer, II. Rendering layer (KIK-IRPA 2011) [right]

A remarkable Terranova application can be found on the art deco façades of *De Roma*, a cinema complex from 1928 in Borgerhout, Antwerp, Belgium (Fig. 1-left). The composition of the façades is based on a rhythm of predominantly straight lines, balconies and bay windows. Uniform shades of the simili-pierre finish generate a striking architectural effect of light and shadows. The material itself performs an important decorative function. As shown in the microscopic image (Fig. 1-right), the mortar is applied in two layers: a rendering layer and top layer, each with a different composition.

Chemical examination (SEM/EDX) of a sample from the west façade of the case study (Fig. 1-middle), performed by the Royal Institute for Cultural Heritage (KIK-IRPA 2011) reveals new information on the ingredients (Figs. 2 and 3). The binder (16.5% hydraulic) consists of calcium, silicon, and a small amount of magnesium, potassium and aluminium (feldspar). Presumably, the binder is a combination of white cement and lime, because non-hydrated hydraulic residues are observed; yet it is hard to identify them by optical microscopy. Note that the composition of historic ‘white cement’ is different from ordinary white coloured cement. ‘White cement’ was known as heavy white lime mixed with about 10% of bright coloured cement (Leduc 1902).

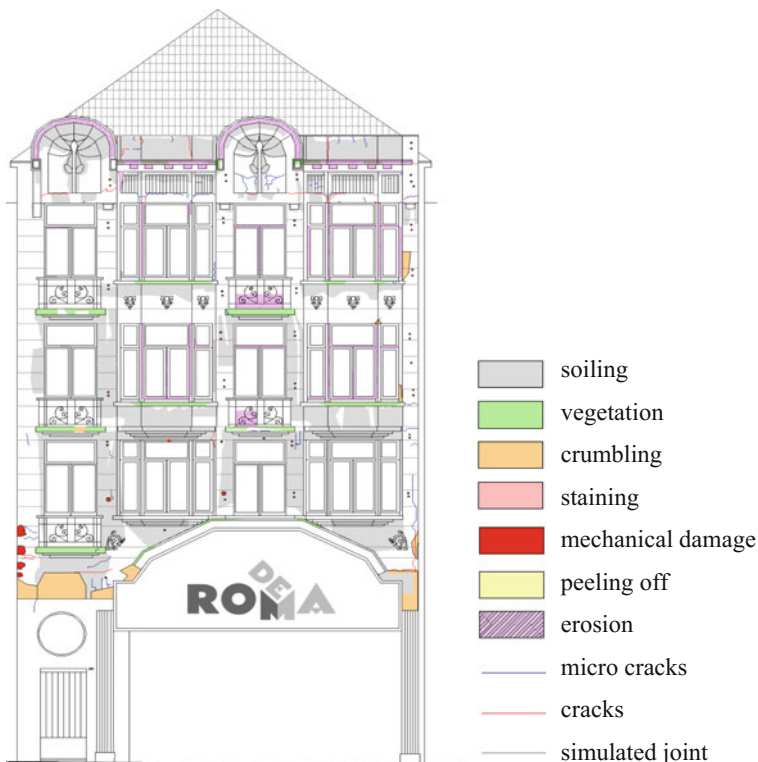
Fig. 5 Damage assessment of the north façade (Govaerts 2012)

In order to effectuate correct conservation strategies, an assessment of damage patterns is required. After all, it is important to have a proper idea of the origins of the problems, because improper treatment may lead to recurring damage. The following paragraphs describe the most important damage typologies that were observed within the case study (Fig. 5) and concentrate on the origins.

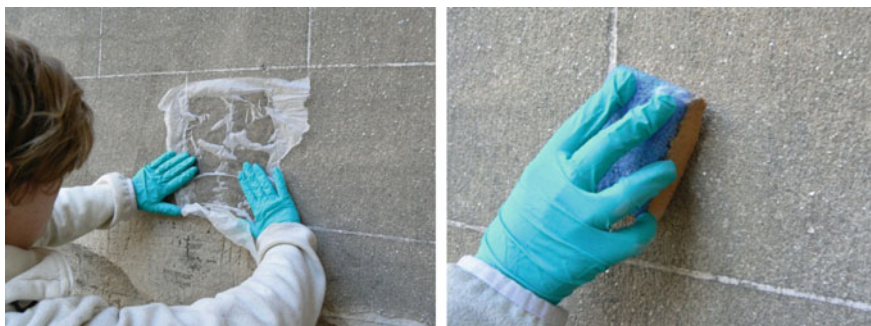
Fig. 6 Two appropriate cleaning methods: Mora cleaning gel covered with Japanese paper [left] and scrubbing with a dry Wishab sponge [right] (Source Govaerts 2012)

Performing test areas with cleaning techniques and a repair mortar is indispensable to establish correct cleaning, consolidation and restoration works. Contemporary cleaning techniques generally rely on hydro pneumatic blasting technology, but because of their potentially abrasive effects, it is useful to try more traditional dry (Wishab sponge) or wet cleaning methods (purifying chemical pastes) (Fig. 6).
