Chapter 5

Hydromorphology of the Lower Drava

Ulrich Schwarz

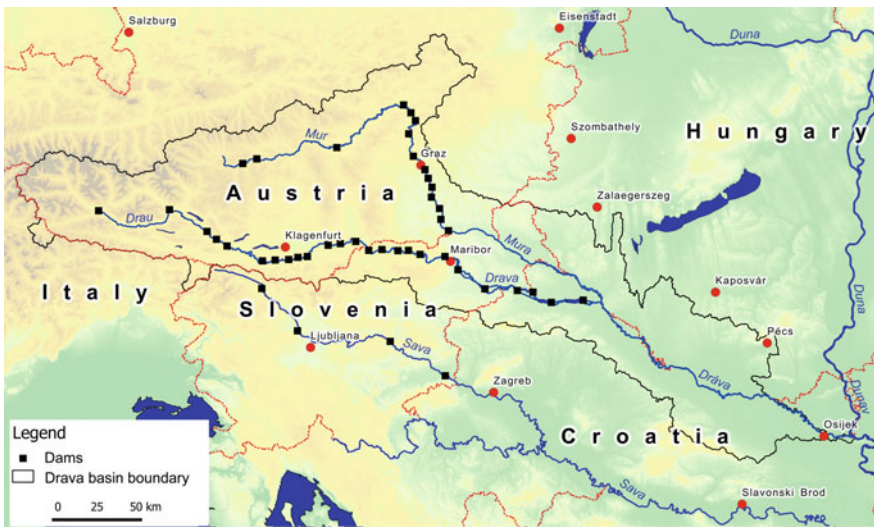
Fig. 5.1 The Drava River Basin covers territories in Italy, Austria, Slovenia, Hungary and Croatia

The Drava-Mura river system with a drainage basin of 40,150 km² (Fig. 5.1) and an average discharge of about 550 m³ s⁻¹ is the third largest in the Danube Basin. It is predominantly influenced by Alpine conditions in the headwaters namely by discharge and sediment budget. Huge gravel deposits dominate in the basins of Graz and Klagenfurt and again downstream the Drava breakthrough in Slovenia accumulated along the foothills expanding downstream to the Mura confluence. Here the river has a strong mountainous (Alpine) character. The relief of the Lower Drava consists mostly of lowlands with Quaternary sediments and loess-mantled terrace systems. The course partly follows geological lineaments (e.g. high banks in Hungary). Also the lower course is dominated by sands and silts and the banks have much lower cohesion than those in the neighboring lower Sava system. Therefore, the lower Drava used to be characterized by strong lateral shifting and meandering under natural conditions.

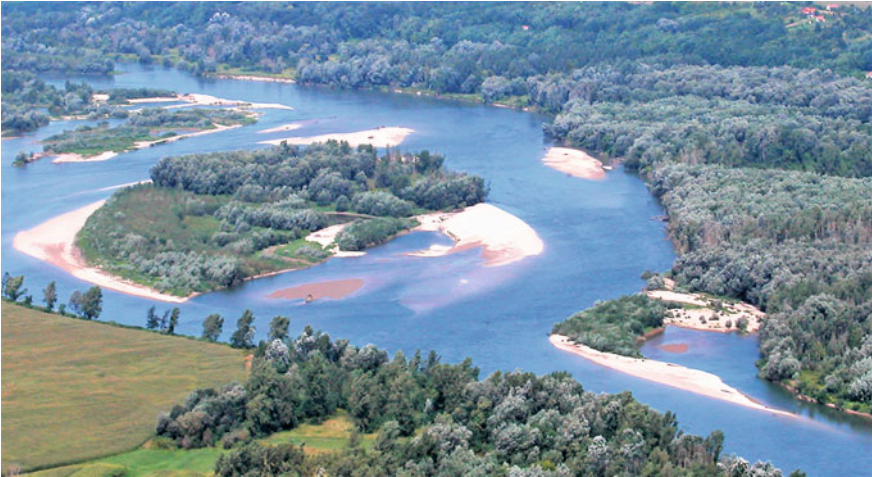
Fig. 5.2 Two examples for reaches serving as potential reference sites. Just 10 rkm downstream of the Mura confluence the anabranching river builds gravel bars and islands (photo by Arno Mohl)

The Drava hosts several stretches with at least near-natural features—here illustrated by two photographs (Figs. 5.2 and 5.3).

- transitional anabranching from the highly dynamic partially braided Drava upstream the Mura confluence to the meandering downstream (D-II, rkm 235–185) and
- meandering large lowland river with sand bed and extensive floodplain (D-III, rkm 185) (Figs. 5.2, 5.3, and 5.4).

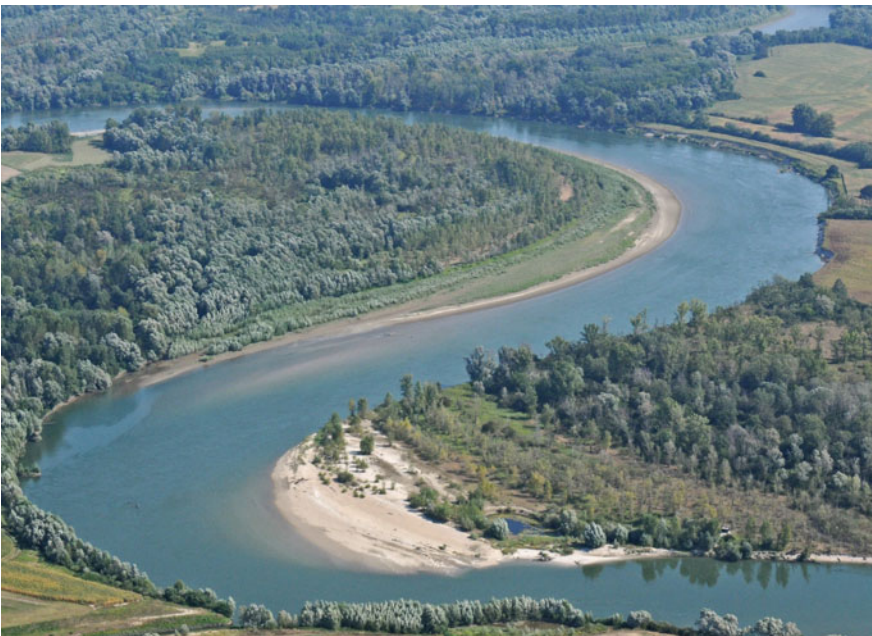
Fig. 5.3 Two examples for reaches serving as potential reference sites. One of the most dynamic meander reaches is at about rkm 180, highlighting the driving force, the lateral shift of river channels: erosion of land on the one side, rejuvenation of habitats on the other side (photo by Darko Grlica)

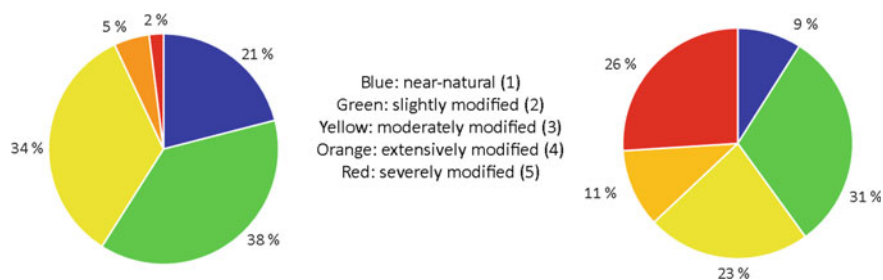
Fig. 5.7 Overall evaluation of the lower Drava (left) and for all rivers in the Drava and Mura river system (right) (Schwarz 2007)

At least a few scattered reaches of the lower Drava (together about 45 km out of 235 km) could be attributed to the best (blue) quality class, showing all features of a near-natural channel in comparison to the reference condition. On the other hand, only about 7% are extensively and severely modified (orange and red classes, see Fig. 5.7). About 38% belong to the quality class 2 (green), indicating a still high potential to provide most of the hydromorphological functions of reference reaches.

The remaining 34% are rated as third (yellow) class, mostly regulated with stabilized banks. The two most significant human pressures are flood protection and hydropower generation (upstream from the studied section) (see Chaps. 9 and 10 in this volume). But for the Lower Drava in particular, the conditions maintained for the nearly non-existing navigation (mean and low water regulations) and the commercial gravel and sand extraction are significant pressures (the latter was considerably reduced since 2010).

half of the river belongs to the first and second class and one third is in the moderately modified class three (see the left pie chart in Fig. 5.7 and the map in Fig. 5.8). This result, excellent in comparison with many other European rivers of similar size, however, should be critically viewed. The long-term processes driven by the chain of hydropower plants upstream alter the sediment balance and hydrological behavior at least for the minor but ecologically important flood events. The impact of continuous sediment deficit (channel incision) in regulated reaches, lowering of groundwater on the one side and disconnection of the active floodplain areas should lead to degradation on the long term. Looking at the catchment scale (right pie chart in Fig. 5.7), the significant alterations due chains of hydropower plants in Austria, Slovenia and Croatia are evident in the 37% ratio in the two poorest classes.

In *Austria* about 20 km of the river length of at least class 3 (yellow) (Fig. 5.7, right pie chart) were affected by hydropower impoundments and turned into the red class (two plants built downstream of Graz on the Mura). On the Upper Drava and Mura, however, several river restoration projects were carried out, not only creating continuity by fish passes, but also improving the morphological situation (e.g. between Lienz and Spittal) and locally on the Upper Mura in Styria. But the length of new impoundments exceed the length of restored river reaches.
