# Factors Contributing to Rockfall Occurrence and the Associated Risk in Rockville, Utah

Carl Jacklitch and Abdul Shakoor

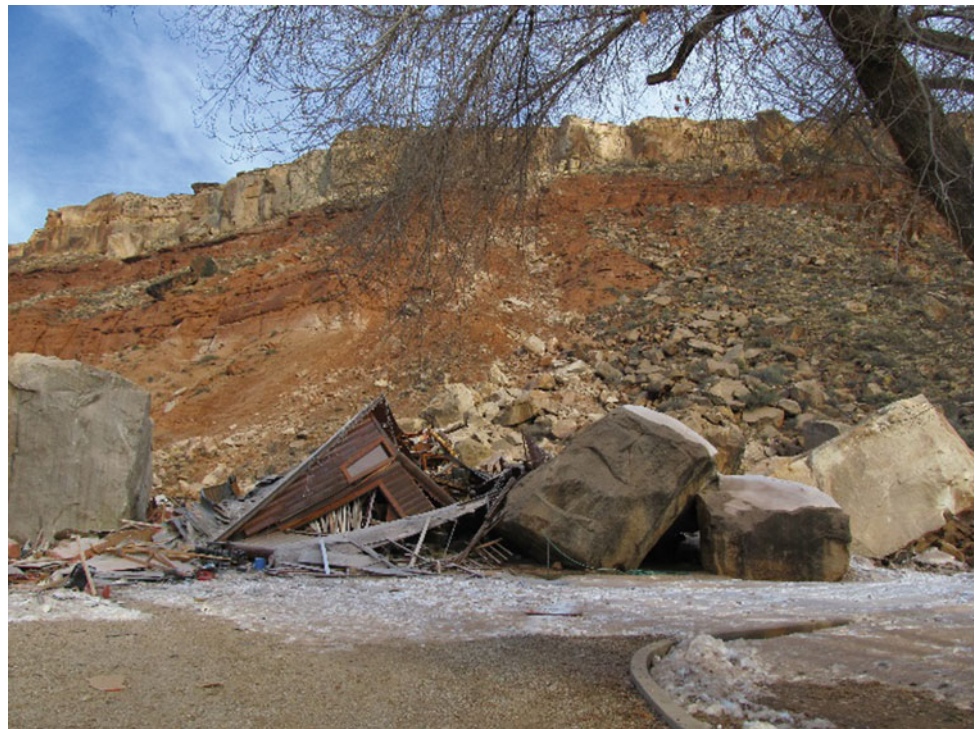
**Fig. 2** The house after the December, 2013 rockfall (Lund et al. 2014)

The town of Rockville in Washington County, Utah (Fig. 1), is known for frequent, large, hazardous rockfalls. There have been at least six large rockfalls within the past 38 years (1976; October, 2001; October, 2002; spring, 2007; February, 2010; November, 2010), with five of the six occurring in the past 14 years (Knudsen 2011). The rockfall on December 12, 2013, destroyed a house (Fig. 2) and resulted in the deaths of its two inhabitants (Dalrymple and Piper 2013; Mabbutt 2013; Lund et al. 2014). The rock mass, weighing approximately 2450 tonne fell from a 122 m high slope.

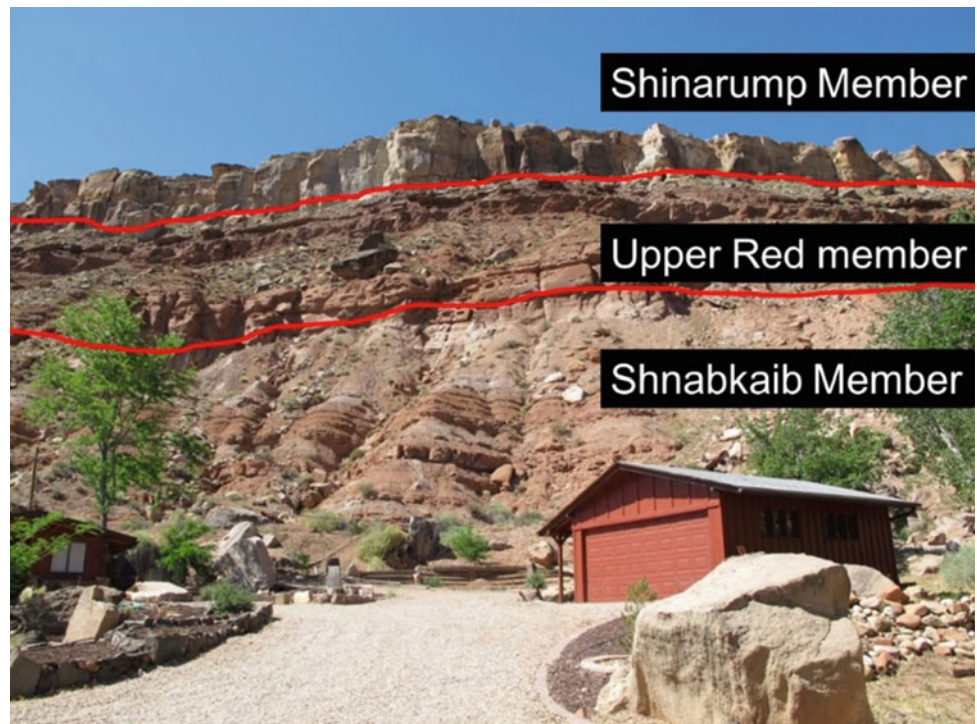
**Fig. 3** An overview of the stratigraphy of Rockville slope near the fatal rockfall site

Most homes in the town of Rockville are located very close to the slope toe (Fig. 3). This obviously increases the risk from rockfalls.

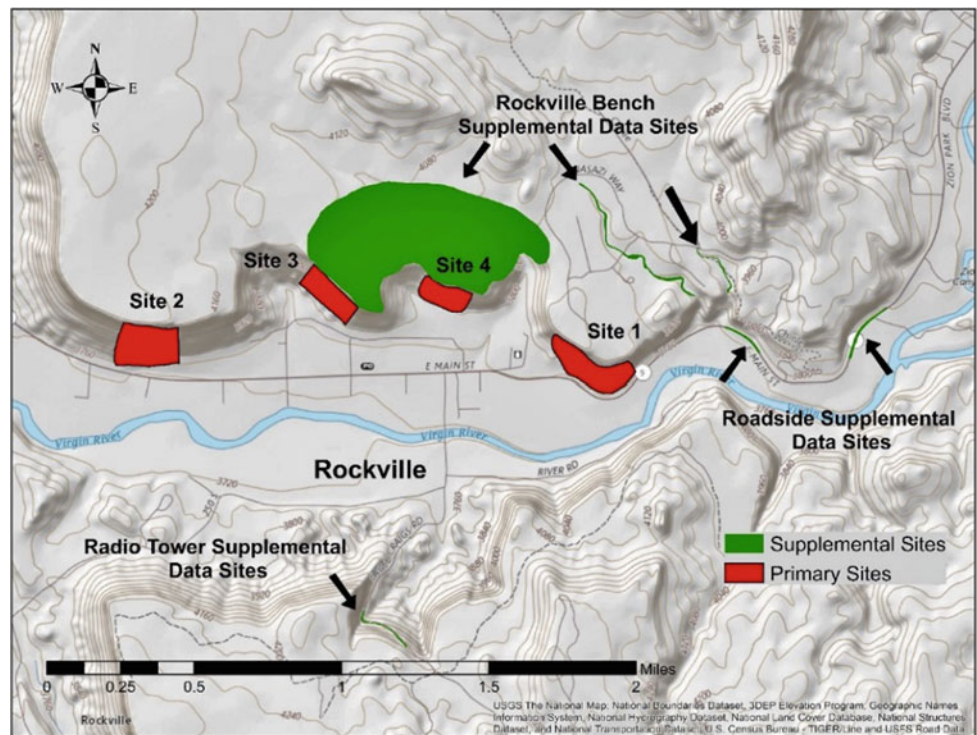
**Fig. 4** Location of the four primary sites and the supplemental data sites on a USGS topographic map overlay (Google Earth). *Note* 1 mile = 1.6 km

We selected four primary sites along the Rockville slope for detailed investigations and several supplementary sites for additional data. Figure 4 shows the locations of the selected

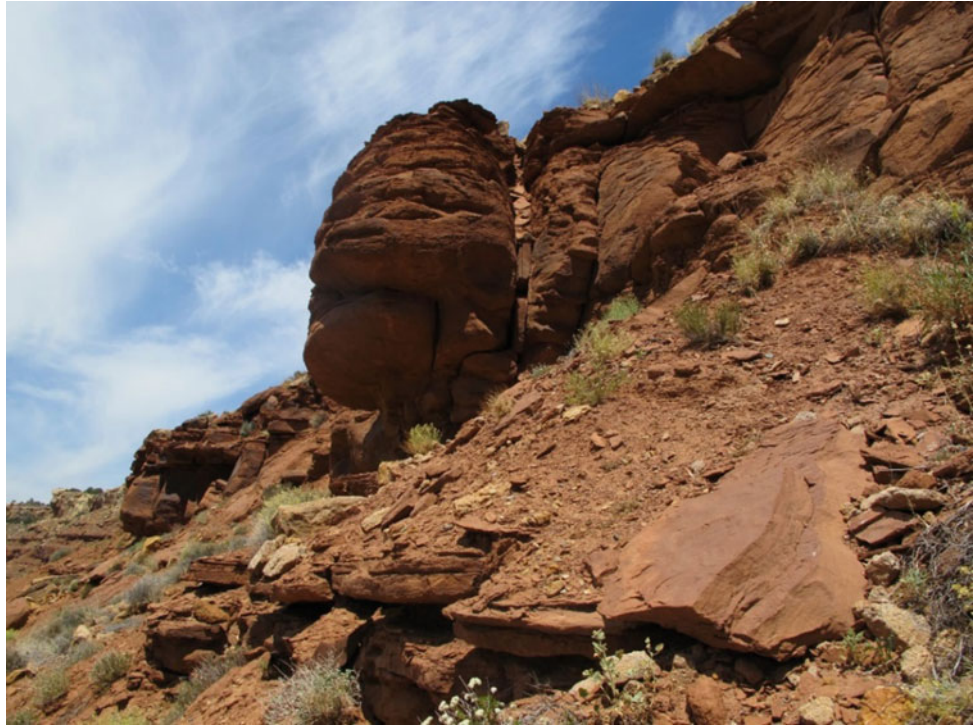
**Fig. 5** Undercutting of the cliff-forming resistant rock unit within the Upper Red member of the Moenkopi Formation by the less resistant slope-forming rock unit at Site 1

difference in slake durability index values between the stronger and weaker rock units within the Moenkopi Formation indicates a high potential for differential weathering and the associated undercutting of stronger rock units by the weaker rock units (Fig. 5). The amount of undercutting between the Shinarump Conglomerate Member and the Moenkopi Formation (Fig. 6) is variable across the study area. The primary factors that contribute to the variability in the potential for undercutting between the two rock units is whether the portion of the Moenkopi Formation unit that is in contact with the Shinarump Conglomerate Member consists of more resistant or less resistant rock, or whether the cream to maroon colored silty mudstone lenses are present (Fig. 7). The silty mudstone lenses that exist beneath the Shinarump Member, throughout the study area, promote differential weathering because of their moderate to low durability ( $Id_2 = 69\%$ ). Within most of the study area, the contact between the Shinarump Conglomerate Member and the Moenkopi Formation is covered with colluvium, protecting it from undercutting. However, the mudstone lenses are not protected by colluvial soil because of continual weathering.

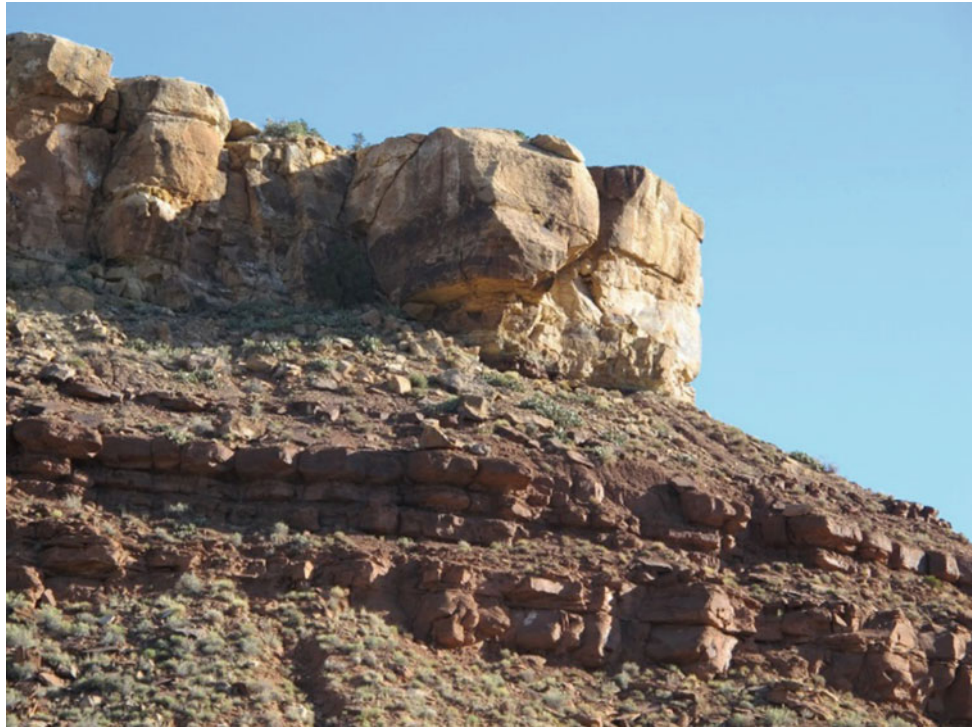
**Fig. 6** Undercutting of the Shinarump Conglomerate Member by the Moenkopi Formation between Site 3 and Site 4, resulting in potentially unstable blocks of the Shinarump Conglomerate Member

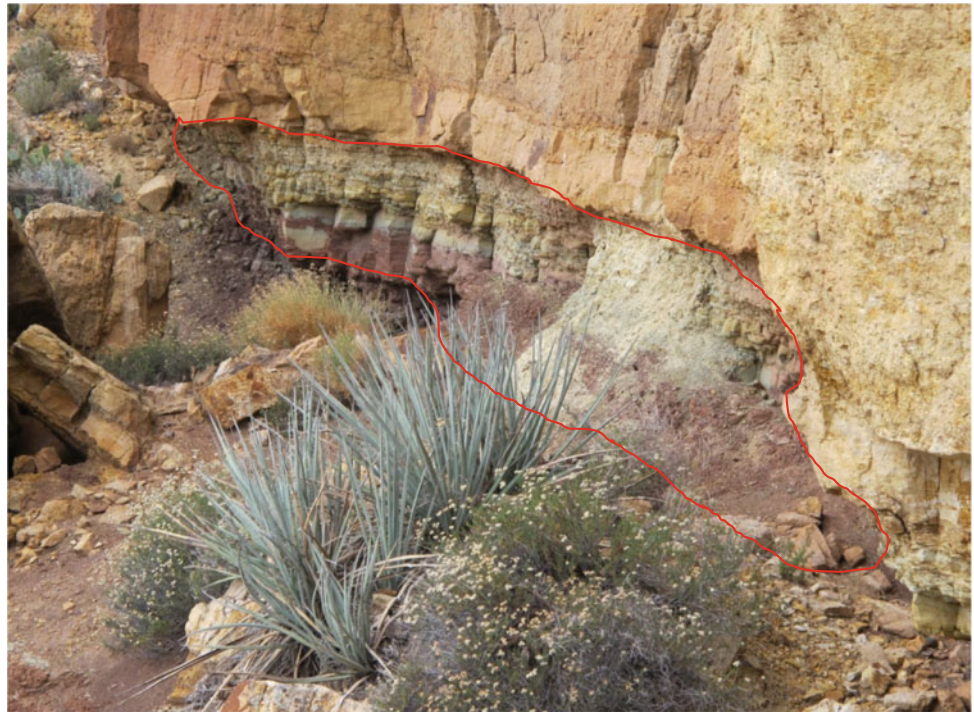
**Fig. 7** One of the lenses of red to gray mudstone that separates the Shinarump Conglomerate Member from the Moenkopi Formation at several locations

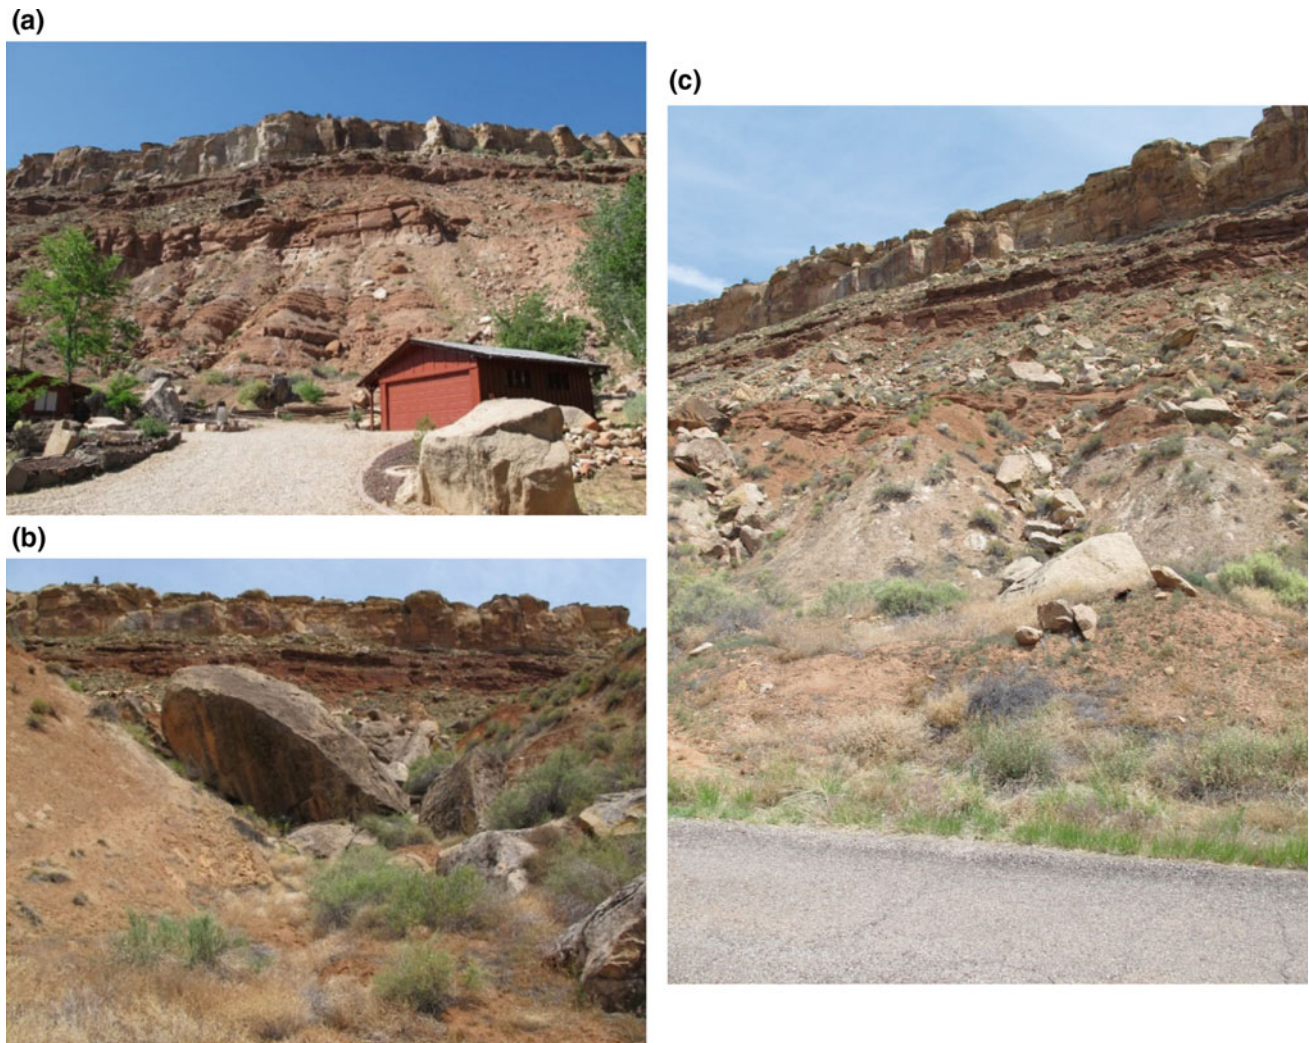
**Fig. 8** a Gullies at Site 2 with varying sizes of rock blocks; b gullies near the base of the slope at Site 3 with large rock blocks; and c a large gully at Site 4 with large rock blocks

While the gullies do not induce rockfalls, they can channelize the rockfalls and debris released from the slope. Therefore, a structure built near the mouth of a gully would have a higher risk of damage from rockfalls. Figure 8 shows examples of gullies at the field sites. Gullies, some of which are fairly deep (>1.8 m), are most prevalent within the western slope, but become less extensive toward the east. This is probably because the Shnabkaib member (the weaker rock unit) is below the ground surface in the eastern portion of the study area.

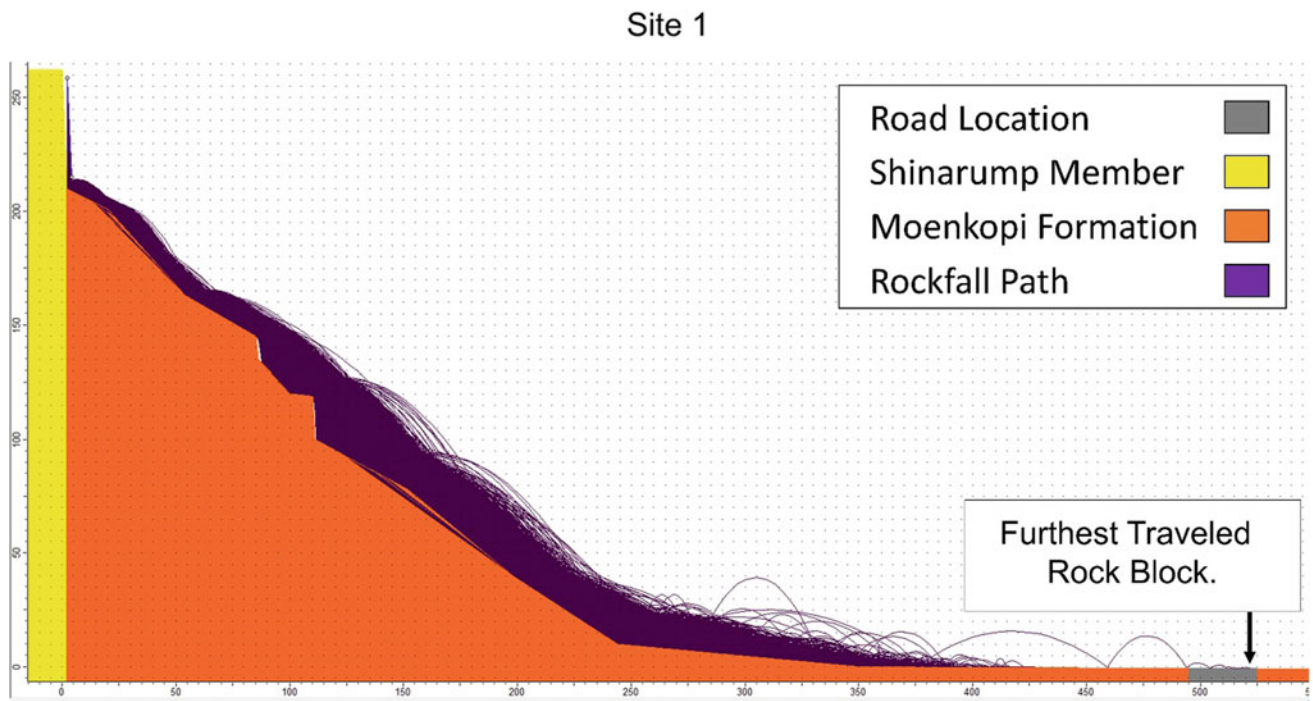
**Fig. 9** Rockfall simulation plot for Site 1 using RocFall software (Rocscience 2015). The rock block weighed 41 kg. After 11,000 simulated rockfalls with variable random block sizes and initiation points along the face of the Shinarump Conglomerate Member, the

furthest rollout distance from the point of release was 159 m. This distance represents the furthest distance a rock block can travel at Site 1 for the various block sizes tested

Using RocFall software (Rocscience 2015), rockfall rollout distances were determined for all four sites. Figure 9 shows an example of such analysis for Site 1. The analysis indicated that the rollout distances for Sites 1, 2, 3, and 4 were 159, 253, 167, and 154 m, respectively. These rollout distances were used to establish the hazardous zones for different portions of the Rockville slope. As long as homes are located within these rollout distances, they are subject to rockfall hazard.
