The Consequences of Pyrite Degradation During Construction—UK Perspective

M. A. Czerewko and J. C. Cripps

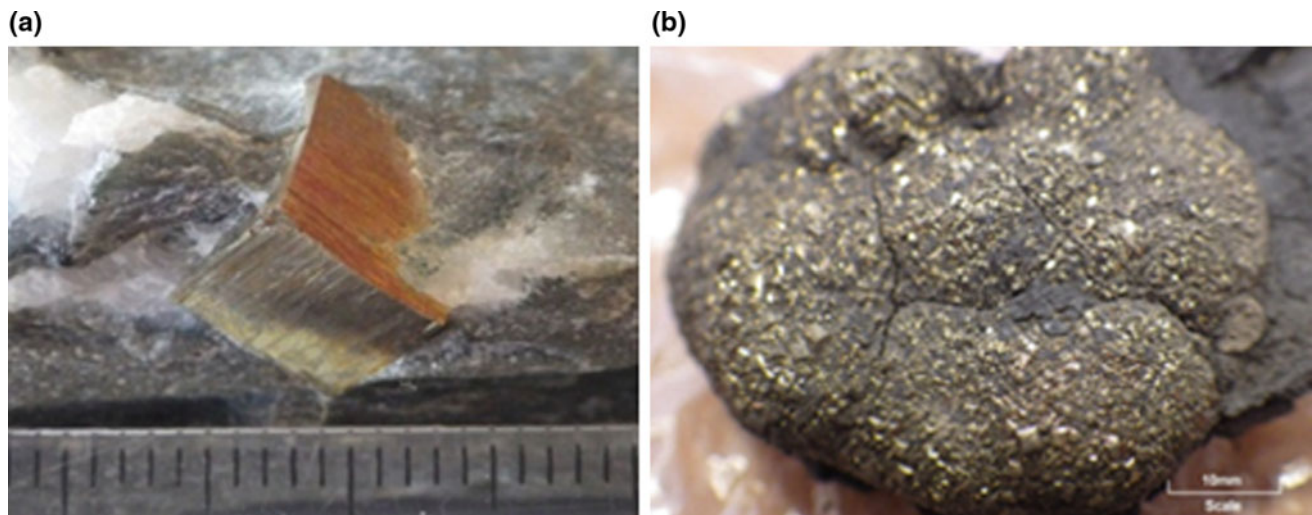
Fig. 1 a Visible striated pyrite cube in Cambrian slate; b Crystalline pyrite nodule in Carboniferous strata

Although macroscopic crystalline pyrite (FeS_2) is easily identified from its appearance as gold coloured cubic crystals or nodular aggregates (Fig. 1), it commonly occurs in unweathered, dark coloured, organic rich over-consolidated clays, mudrocks and argillaceous limestones as scattered microscopic crystals and clusters of microcrystals <1 to 10 microns in size, known as framboids (Fig. 2). Due to small size and black colour the latter are not visible to the naked eye. UK deposits containing pyrite in this form occur in formations from and including the Carboniferous to the Recent, such that as Fig. 3 shows they are very widely distributed. On account of a high specific surface area and lower density (Pugh et al. 1981) which can increase oxidation rate 10 fold, framboidal and microscopic forms of pyrite are susceptible to rapid breakdown when exposed to atmospheric conditions, such that problems during construction are very likely to occur.

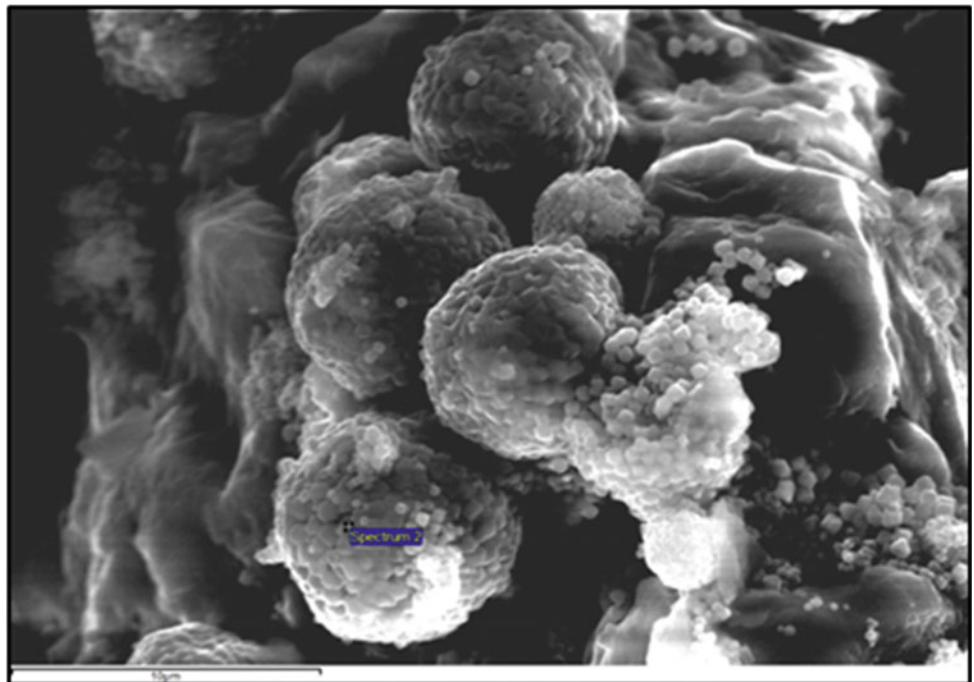
Fig. 2 Pyrite framboids in fresh London Clay (Eocene)

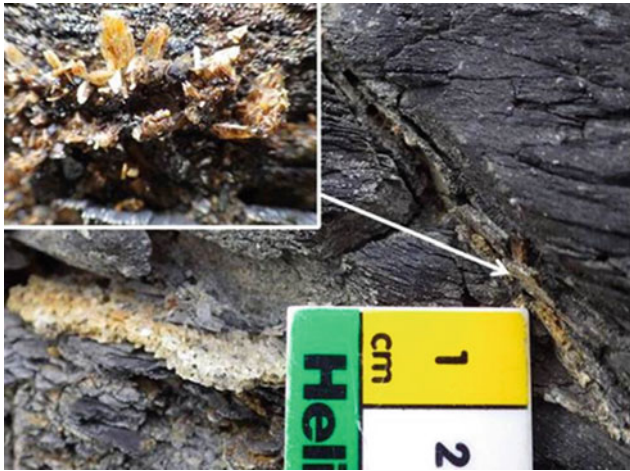
Fig. 4 Selenite growth within joints in Bowland Shale as consequence of pyrite oxidation

pressures of up to 100–500 kPa in confined conditions leading to significant ground stresses with development of differential ground heave (Taylor 1984). Gypsum has low solubility (Deer et al. 1992), a significant factor for ground heave. While calcium and sulfate ions are carried in solution they are mobile and may travel some distance before precipitation occurs. But once gypsum is formed, it is not readily re-dissolved or removed by groundwater, unless acidic (Hawkins and Pinches 1987). The products tend to be precipitated as discrete crystals at fabric and structural interfaces such as joints in rock masses (Fig. 4), or at construction boundaries and in fill (Fig. 5) or at the embankment and subgrade interface (Fig. 6). Volume increases at the

precipitation site can far exceed that caused by pyrite in the immediate vicinity (Cripps et al. 1993) and the growth of selenite crystals by nucleation involves the enlargement of discrete crystals. In indurated rocks this causes widening of cracks and fissures and where sub-horizontal fissility is present it causes vertical heave (Hawkins and Pinches 1987), whereas in clays and compaction mudrocks randomly distributed gypsum crystals produce more uniform heave (Fig. 7).

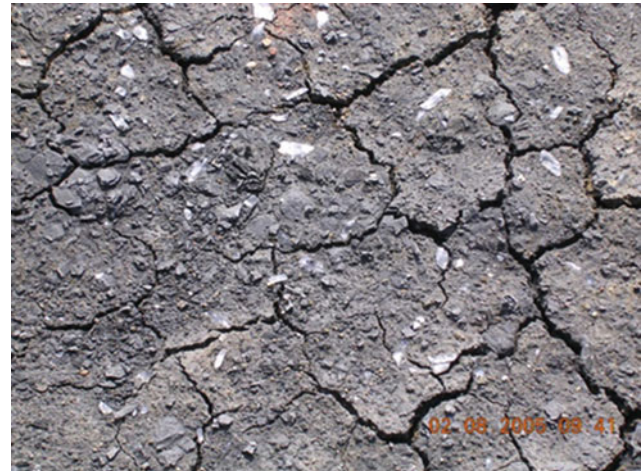
Fig. 6 Rapid deterioration due to pyrite oxidation of highway formation surface showing desiccation and selenite

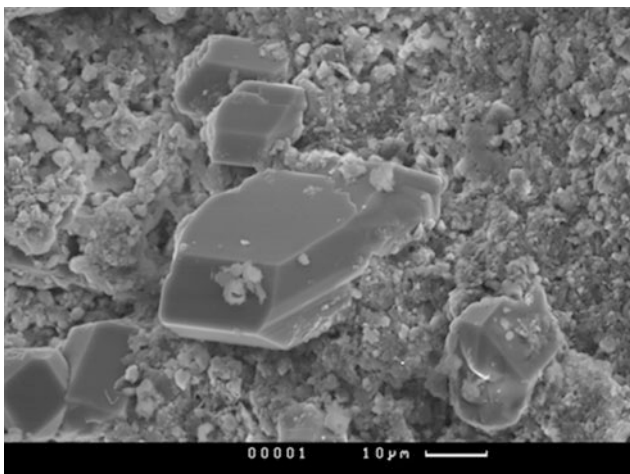
Fig. 5 Selenite growth on cementitious blockwork at the interface between pyritic fill producing ground heave

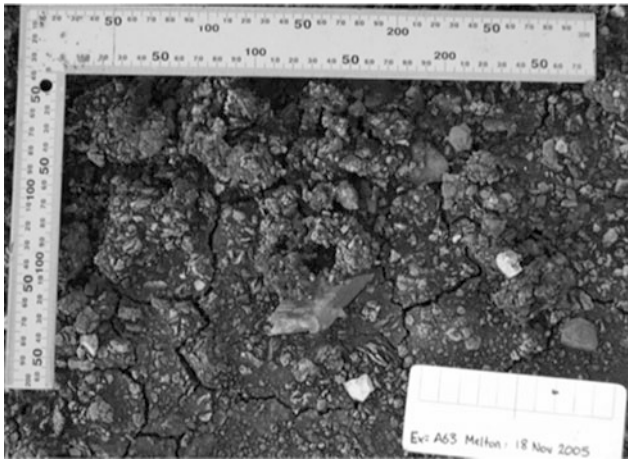
Fig. 8 Reaction at pavement formation level with heave & rapid growth of selenite in Jurassic Ancholme Clay

Due to a lack of appreciation of the potential consequences of pyritic oxidation processes, the need for long-term mitigation measures within the construction design may be missed. Furthermore, early stage signs of reactions may not

be recognised, thus hindering early intervention (Fig. 8). Therefore these issues need to be clearly addressed at preliminary design stages before construction commences.

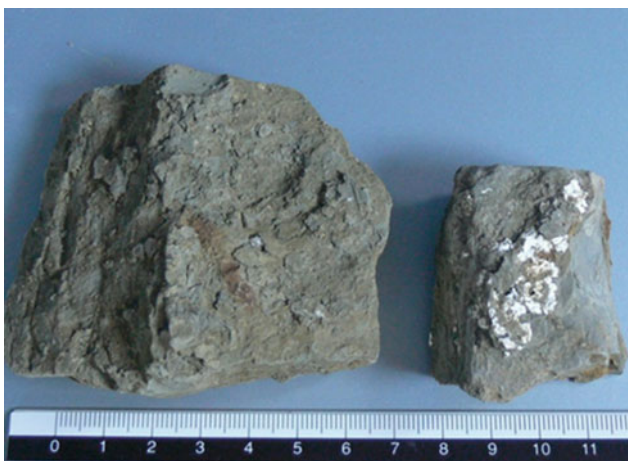
Fig. 9 Oxidation of pyrite forming selenite observed in sample on right during stages of Slake Durability Testing

In the development of highway infrastructure, the potential for deterioration of materials is often overlooked, ignoring the consequences of rapid weathering of materials. Durability testing of material is needed with analysis for sulfate content of the water used and samples observed for precipitated minerals following drying (Fig. 9). Simple weathering exposure observations may also help elucidate the likely behaviour of materials, as seen in Figs. 10a–c (Czerewko et al. 2011). The designer must anticipate the

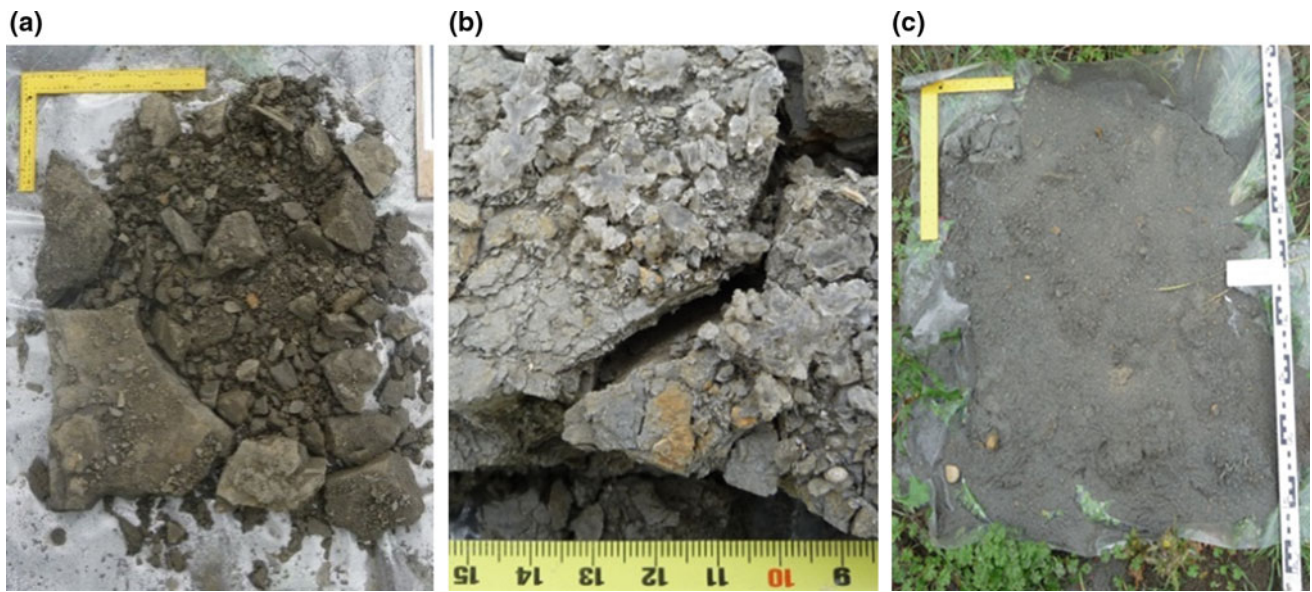
Fig. 10 Blue Lias Mudstone; **a** 1 day after excavation: intact blocks and fragments. **b** Sample 10a after 19 days exposure: evident selenite development. **c** Sample 10a after 41 days exposure: fine soil mass

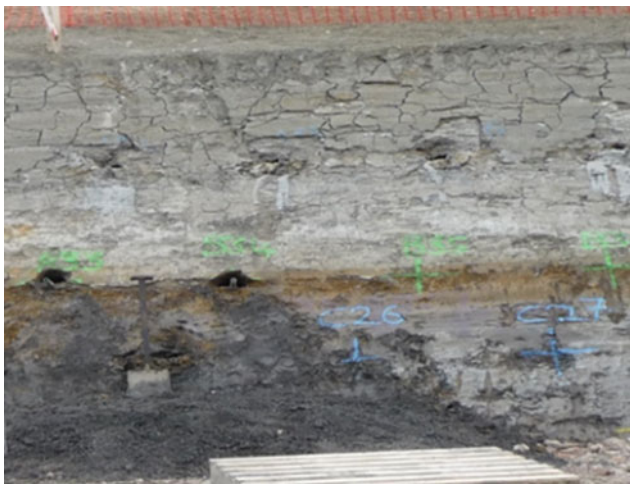
Fig. 11 Colour changes clearly evident in a weathering profile affected by pyrite oxidation seen in Oxford Clay

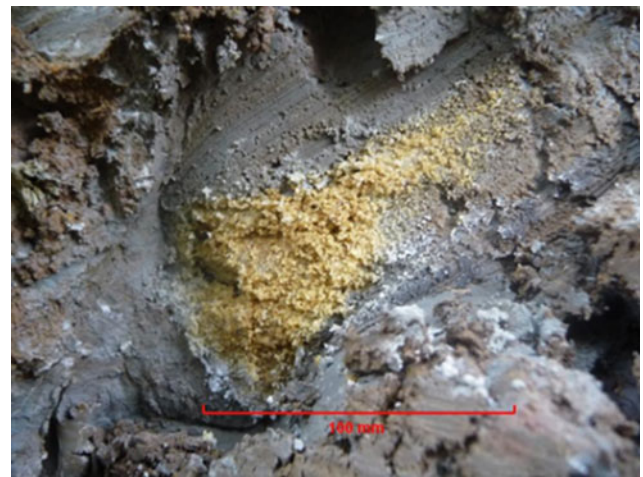
Fig. 12 Saccharoidal selenite with hydrous iron oxide surface staining in weathered Lower Lias Clay

Pyrite is often associated with organic carbon where <0.5% can impart a grey colour in mudstones, siltstones and sandstones. The weathering related change of these grey deposits to shades of brown is often accompanied by precipitation of granular saccharoidal selenite crystals in calcite rich materials, often mistaken for sand (Fig. 12).
