IAEG/AEG Annual Meeting Proceedings, San Francisco, California, 2018— Volume 5

Geologic Hazards: Earthquakes, Land Subsidence,
Coastal Hazards, and Emergency Response

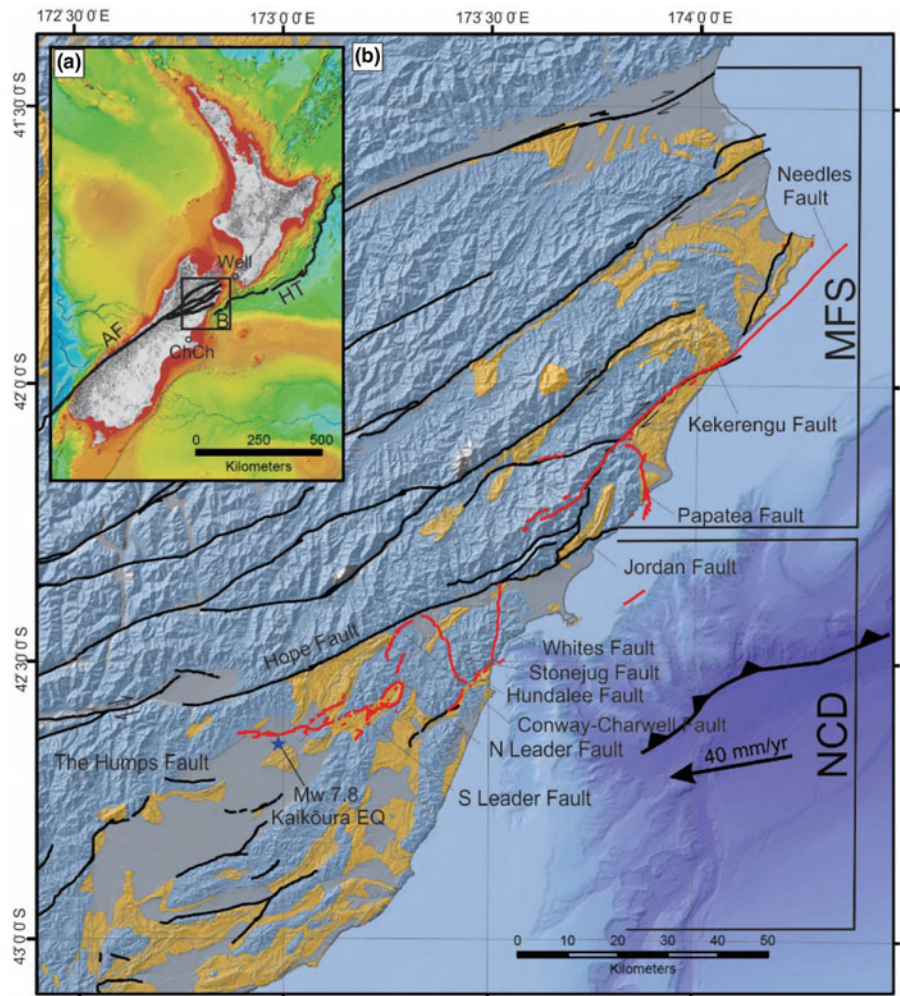
Fig. 1 Top: Fault rupture from the 2016 Kaikōura earthquake. Faults with both primary and secondary surface deformation shown in red. Other active faults shown in black. NCD: North Canterbury Domain; MFS: Marlborough Fault System. Bottom: Detail of the fault rupture in the epicentral region

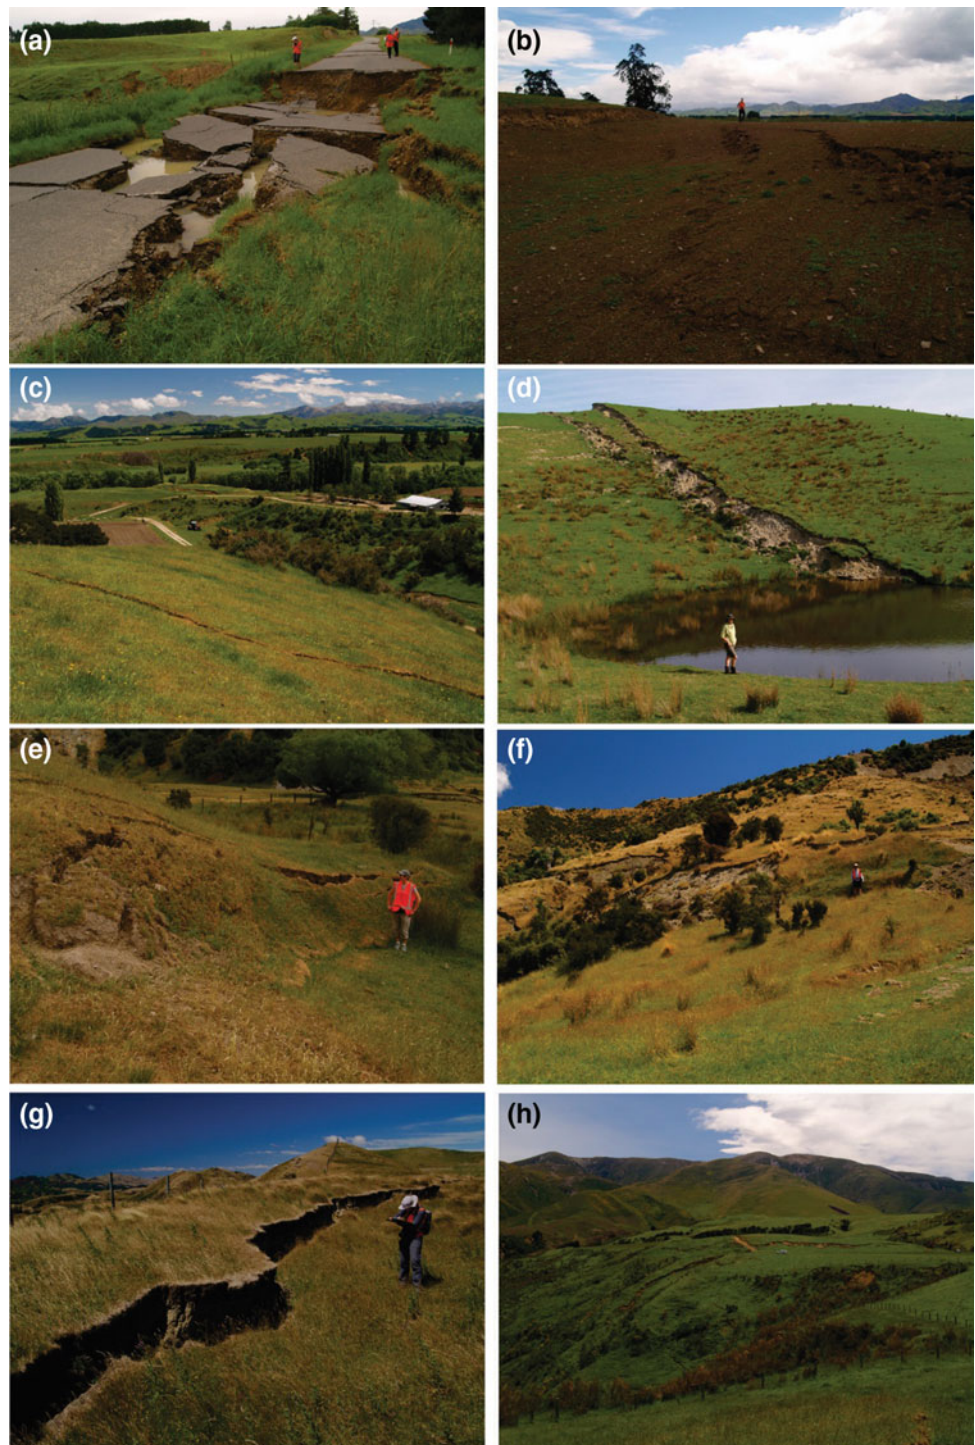
Fig. 2 Examples of differing styles of surface deformation along the Kaikōura earthquake surface rupture in the epicentral region and across the North Canterbury Domain. **a** Fault scarp enhanced by lateral spreading at Leslie Hills Road, Emu Plain. **b** Graben formed at a releasing bend at Hossack Downs. **c** Broad releasing bend at Glenbourne. **d** A normal fault scarp above a blind thrust fault, Woodchester Station. **e** Thrust fault scarp and fault bend warp with extensional cracking in the hanging wall, Woodchester Station. **f** A 4 m high warp and thrust fault scarp on Mount Stewart. **g** Secondary extensional faulting in the hanging wall of a thrust fault section, Mendip Station. **h** Right-lateral strike-slip and extensional dip-slip displacement at the western end of the Conway-Charwell fault, Conway Downs

1980 El Asnam earthquake). This is displayed spectacularly along the South Leader section of the Kaikōura surface rupture. Here the 3.5 m high Waiiau Wall represents secondary normal dip-slip deformation in the hanging wall of a blind, west-dipping reverse fault (Fig. 2d).

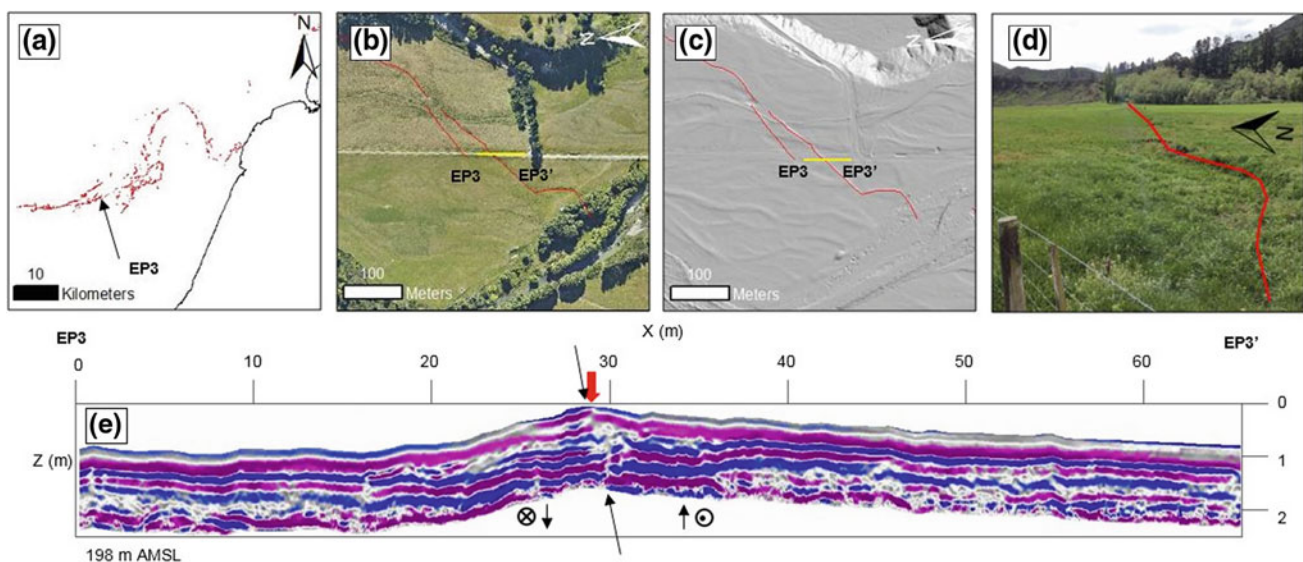
Fig. 4 A GPR profile across a 2016 Kaikōura thrust trace at Glenbourne. The near-surface materials are alluvial sands and gravels. Shallow groundwater and/or the presence of fines has reduced the depth of penetration to 1.5 m. **a** Location of Glenbourne GPR profile.

b Vertical aerial photograph of GPR profile site. Red lines show 2016 surface rupture traces. **c** LiDAR image of the GPR profile site. **d** Field photo showing the low reverse fault scarp at Glenbourne

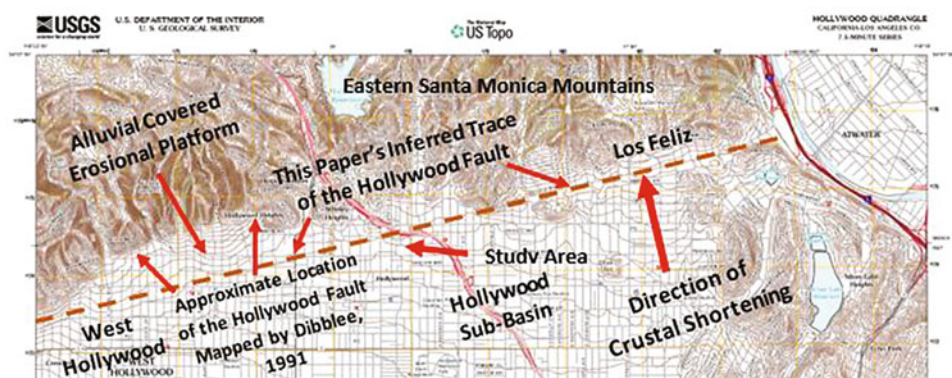
Fig. 4 Suggested trend of the Hollywood Fault following regional geomorphic features and perpendicular to the direction of crustal shortening

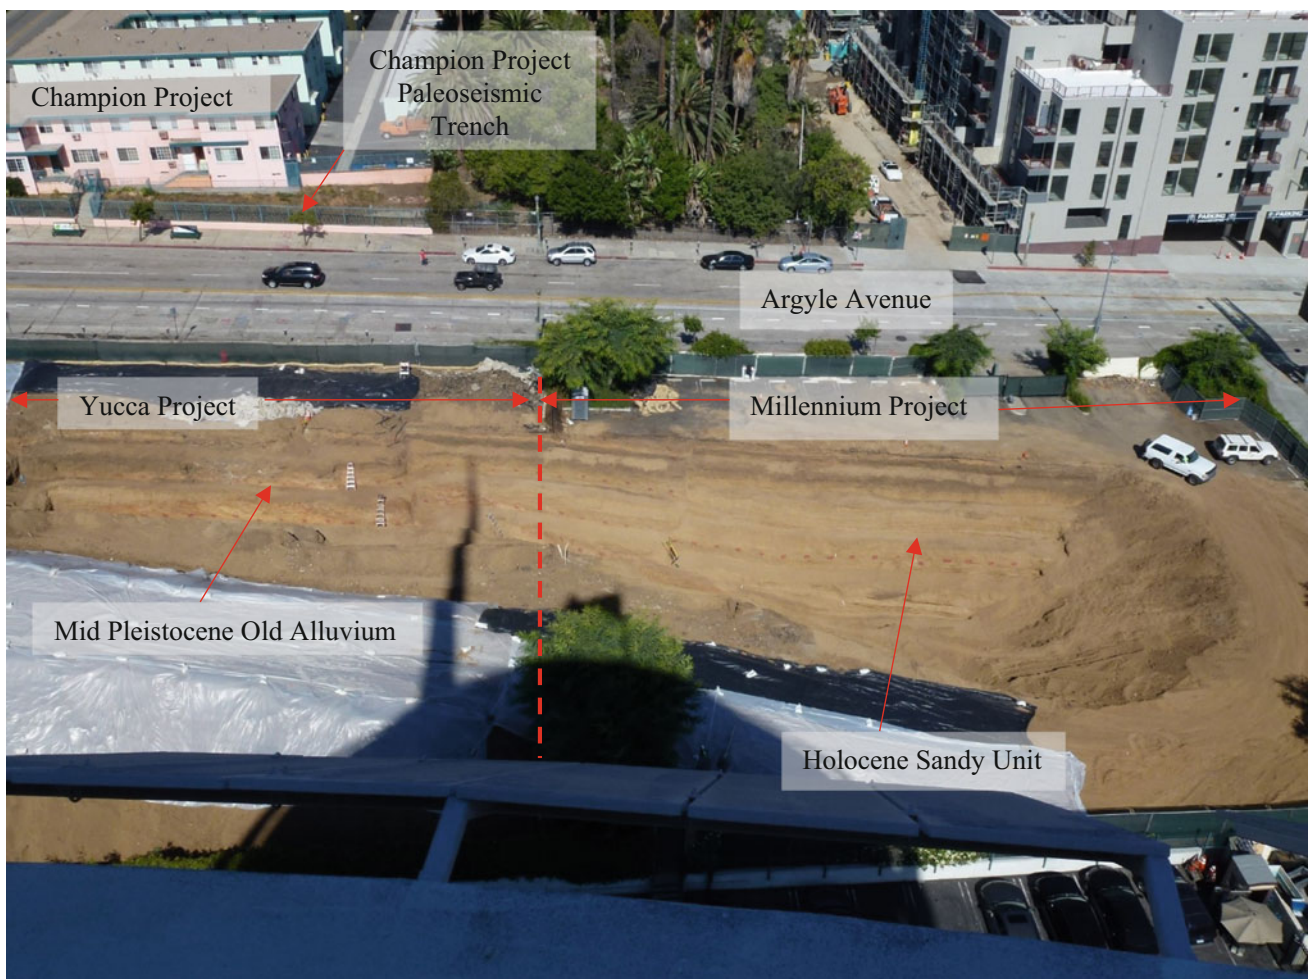
Fig. 5 A typical urban paleoseismic trench across the Yucca and Millennium Projects excavated at the Capitol Records parking lot. The Champion Project paleoseismic trench is shown at the top left corner of the photo. Photo by Steven Kolthoff

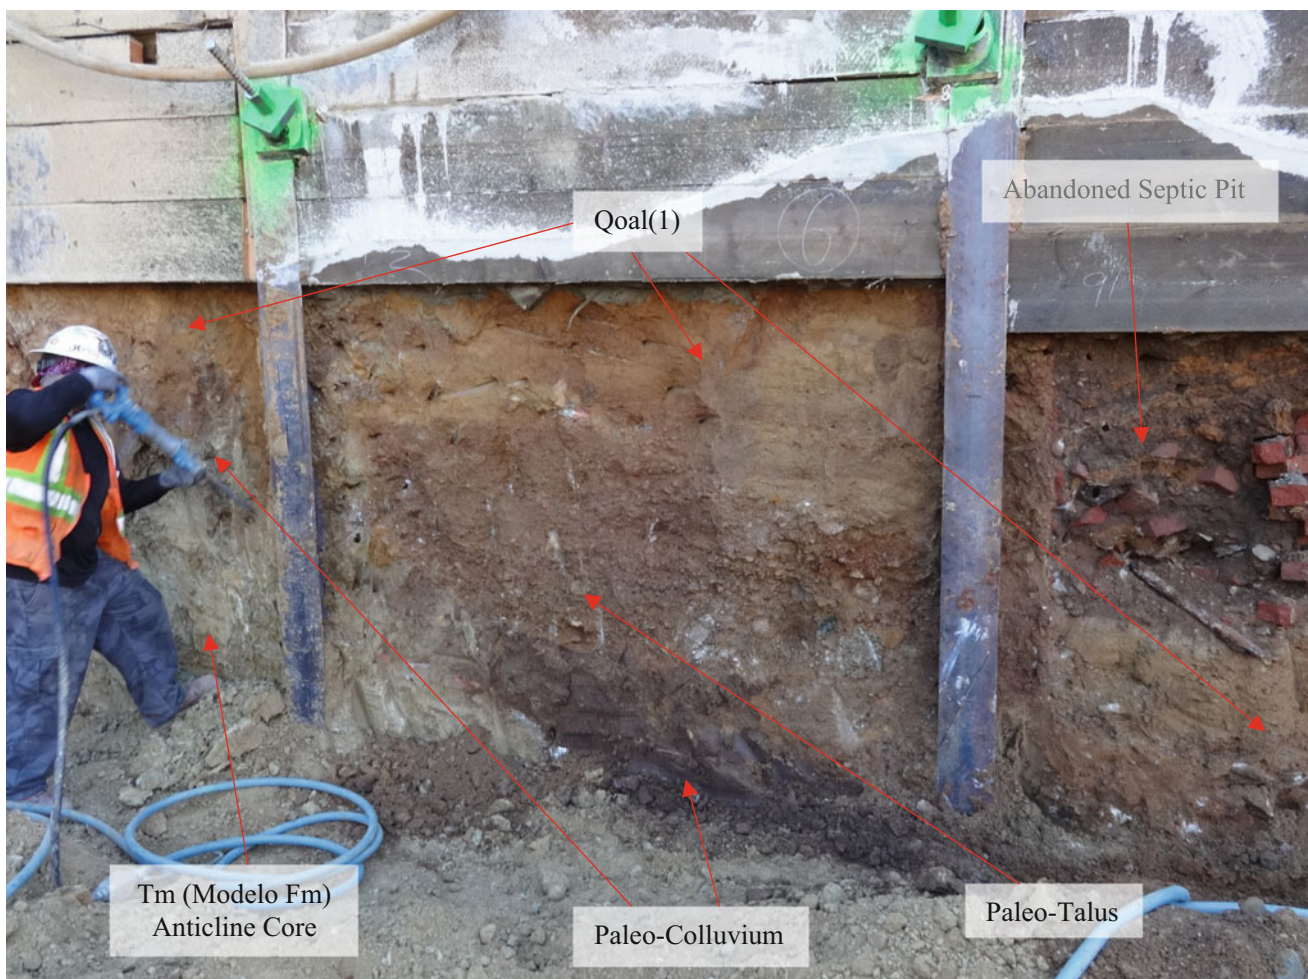
Fig. 7 Excavating the Yucca Project basement bulkhead. See Fig. 6b for a graphic illustration of this exposed section along Argyle Avenue. Photo by Steven Kolthoff

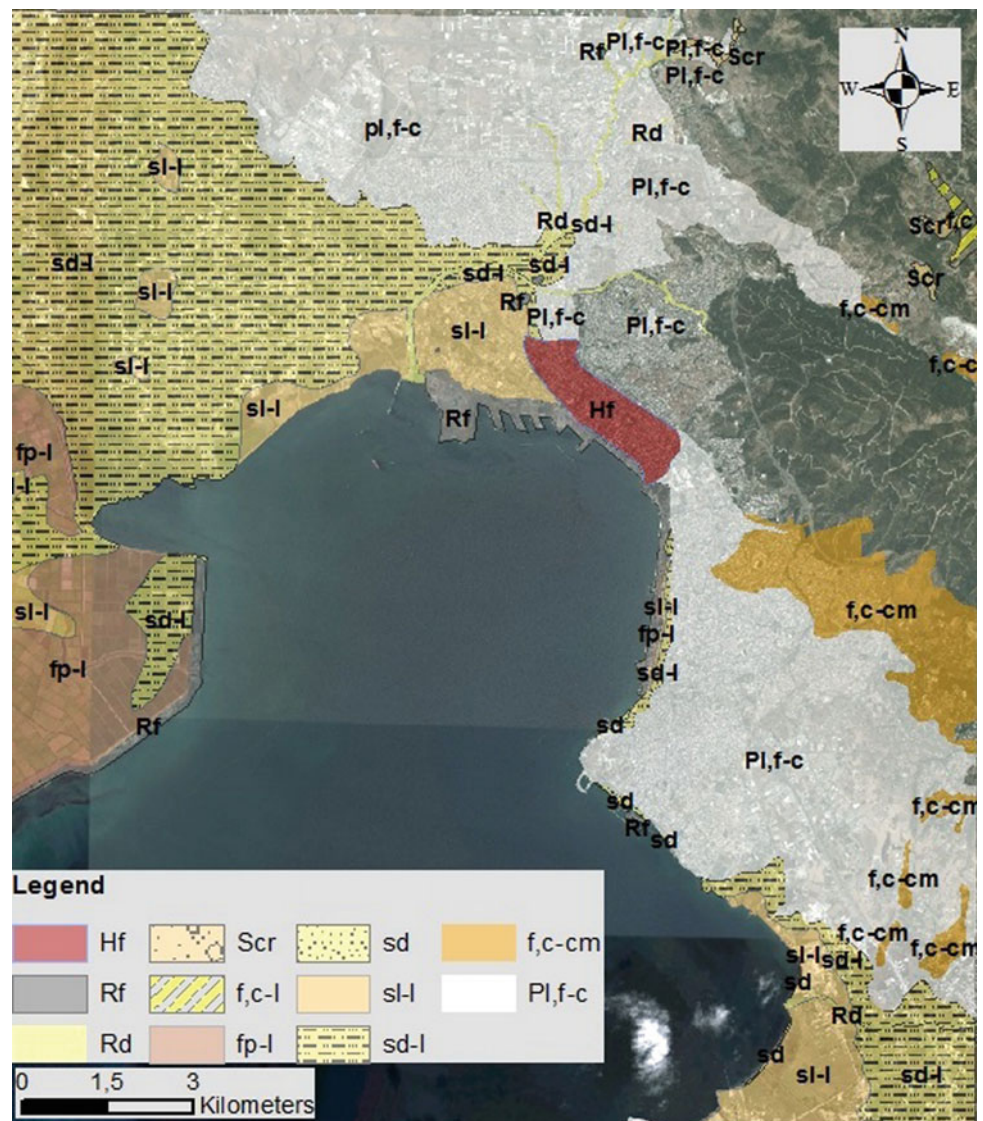
Fig. 1 Engineering geological map of Thessaloniki (modified by Rozos et al. (2004)). Coastal sands (sd), torrential deposits (Rd), inland basins deposits (f,c-l), Quaternary loose sandy deposits (sd-l), Quaternary loose silty deposits (sl-l), Quaternary loose fine deposits with organics (fp-l) Quaternary scree material (Scr) and the Pleistocene cohesive sediments of mixed phases coded as f,c-cm

section, is to analyze and classify these deposits based on their level of susceptibility to liquefaction and to compile a relevant map for the entire urban area of Thessaloniki.

In particular, starting from the younger manmade unit, which is described with the general term of “Artificial fill”, it was decided to classify the area covered by this unit as high susceptible to liquefaction zone. For this classification we took into account the outcome of a research conducted by Anastasiadis et al. (2001) and Senetakis et al. (2008), concluding that soil layers of high potential to liquefaction are encountered at the waterfront of Thessaloniki, and the conclusion of a relevant research by Kiratzi et al. (2014), indicating that likely to liquefaction subsoil layers are encountered in this area. Both analyses were based on data provided by in situ tests (SPT) performed at the waterfront area of the city of Thessaloniki and its suburbs.

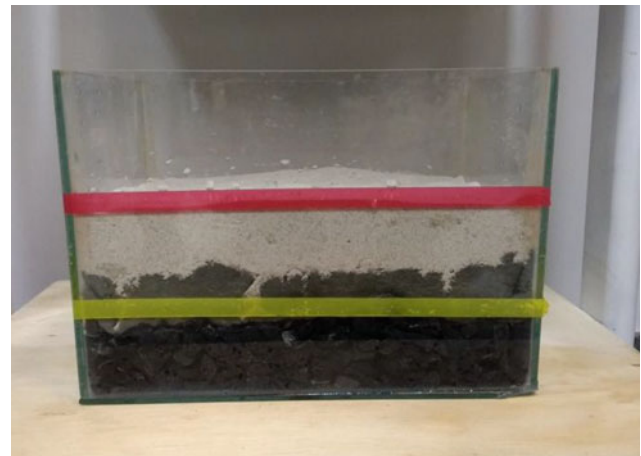
Fig. 2 Layout of materials

The arrangement of materials in the equipment, as shown in Fig. 2, was: gravel 1, the geodrenant mesh, and sand, which was the studied variable.

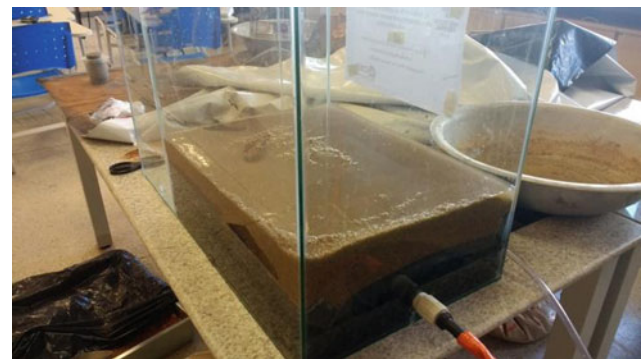
Fig. 4 Apparatus for carrying out the quicksand phenomenon

The small-scale quicksand phenomenon carried out in the laboratory was efficient in presenting the situation in a didactic way. The specimen subjected to the phenomenon was submerged with the application of the upward flow of water. This has proved that sand particles in a constant flow saturated environment lose contact with each other and behave like a fluid.

Figure 4 shows the moment when the water begins to saturate the sand grains.

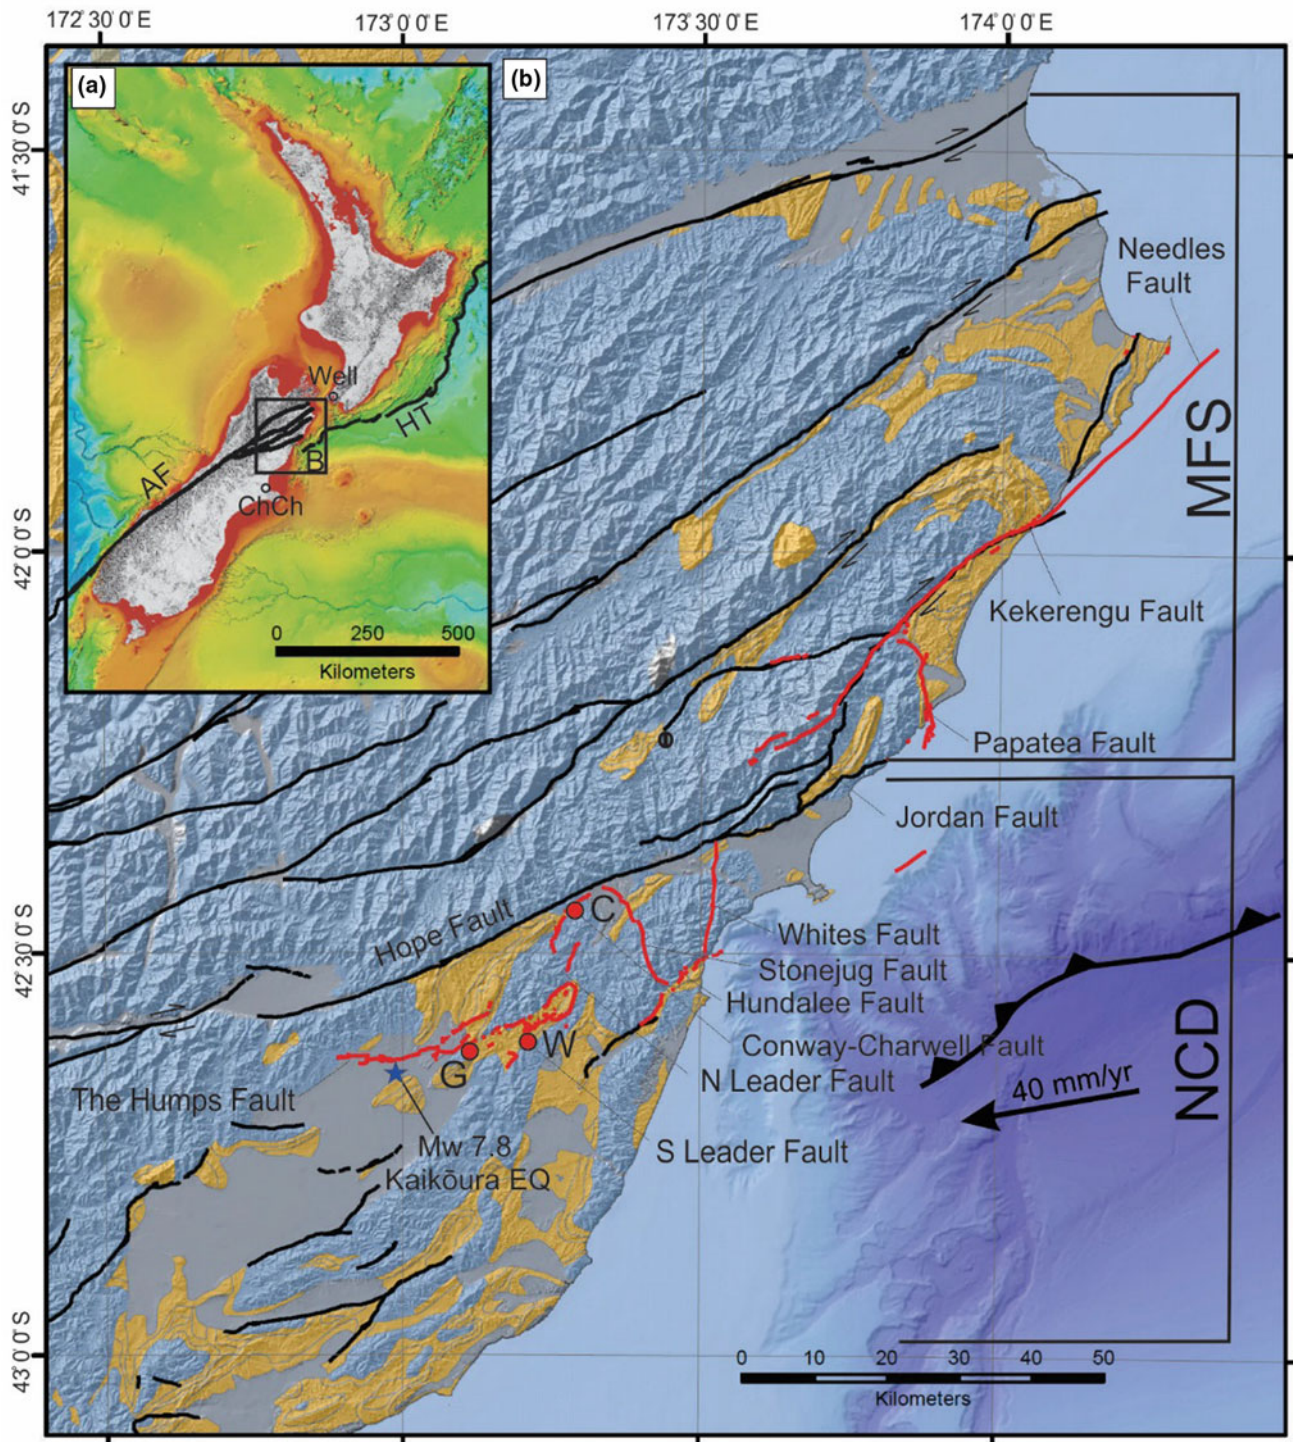
Fig. 1 Surface fault ruptures of the M7.8 Kaikōura earthquake shown in red. Other major active faults shown in black. Locations of landslide study areas discussed in text marked by red circles. C Conway; G Glenbourne; W Woodchester

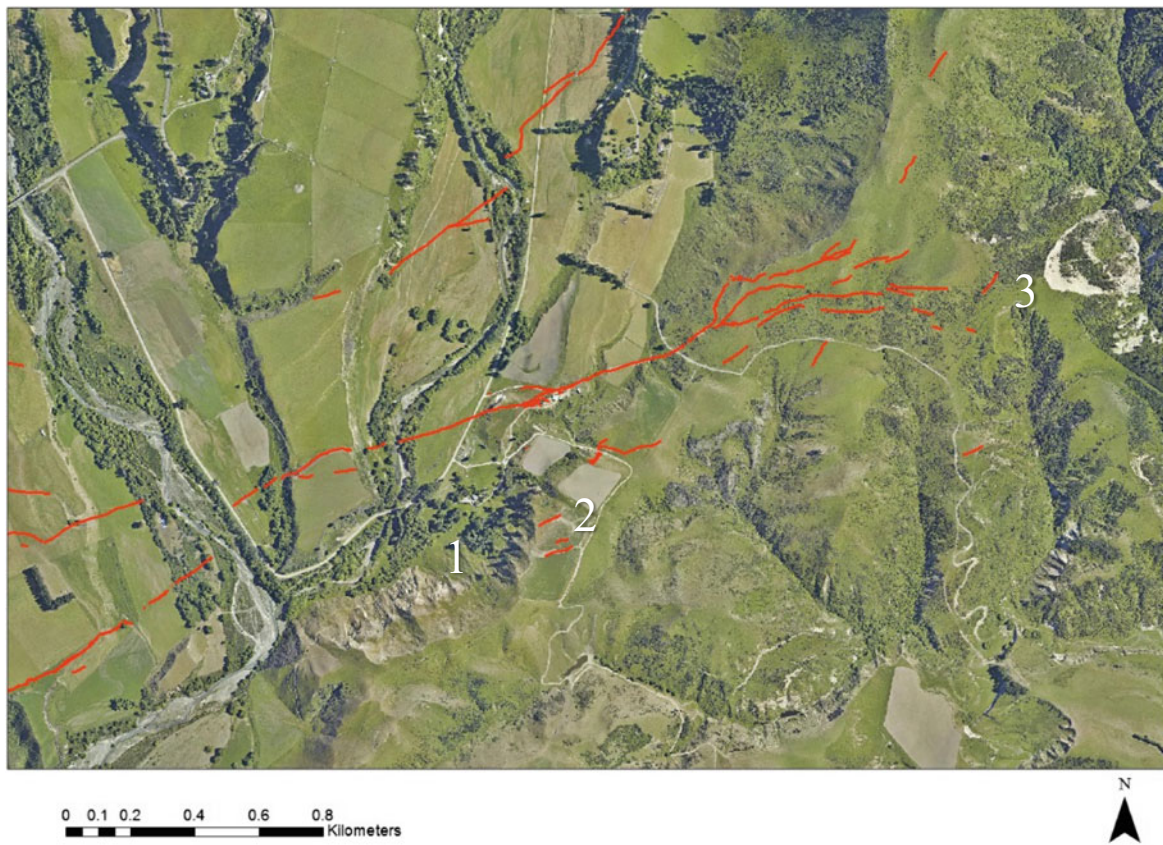
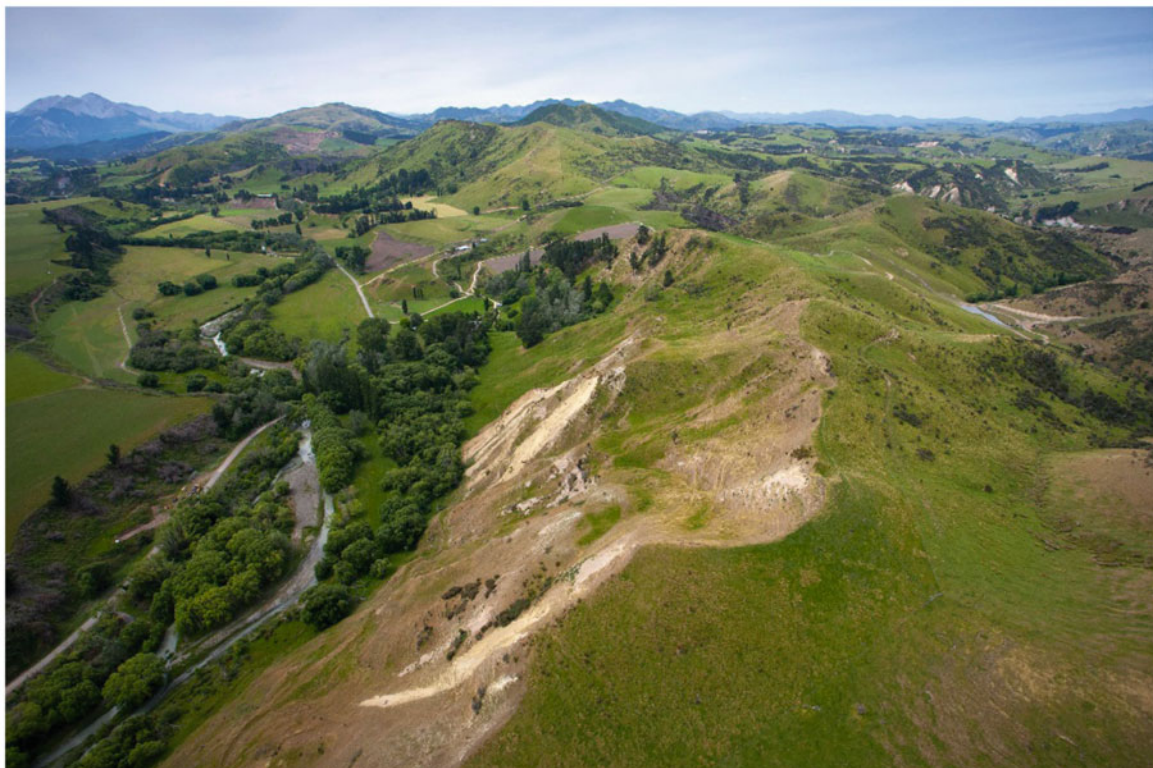
Fig. 4 Landslides and surface rupturing faults at Glenbourne Farm, Hurunui District. Top: Orthophoto showing the fault rupture (red). Areas of major slope movement are numbered. 1: incipient failure, open fissuring and dilated rock mass. Fissures subparallel to the fault traces.

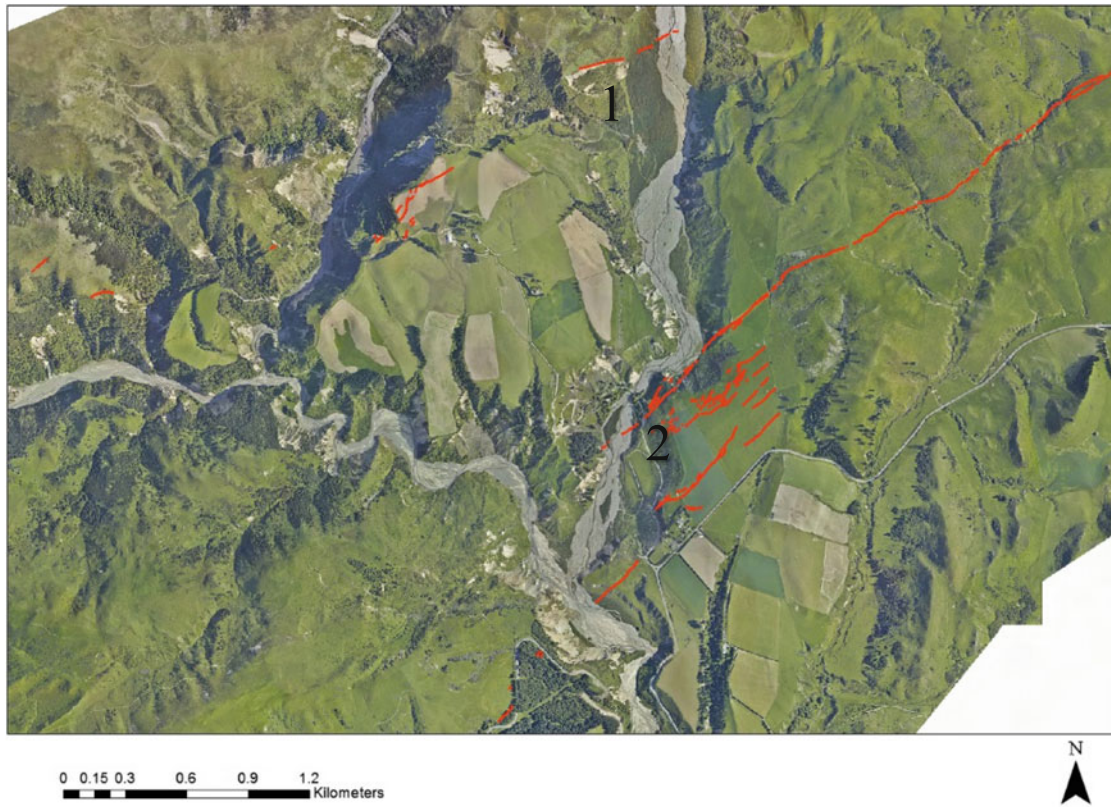
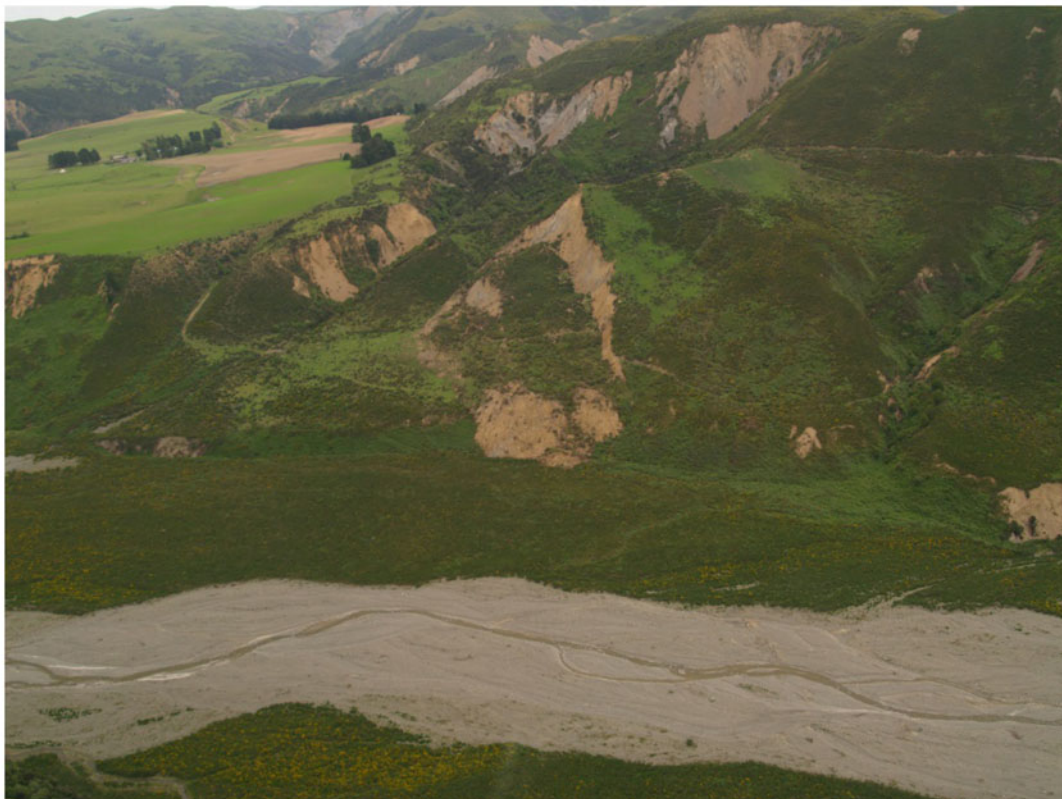
Fig. 5 Landslides and surface rupturing faults at Conway Station. Top: Orthophoto showing the fault rupture (red). Areas of major slope movement are numbered. 1: The Cloudy Range landslide detached along a trace of the Hope fault. No surface faulting was found on the

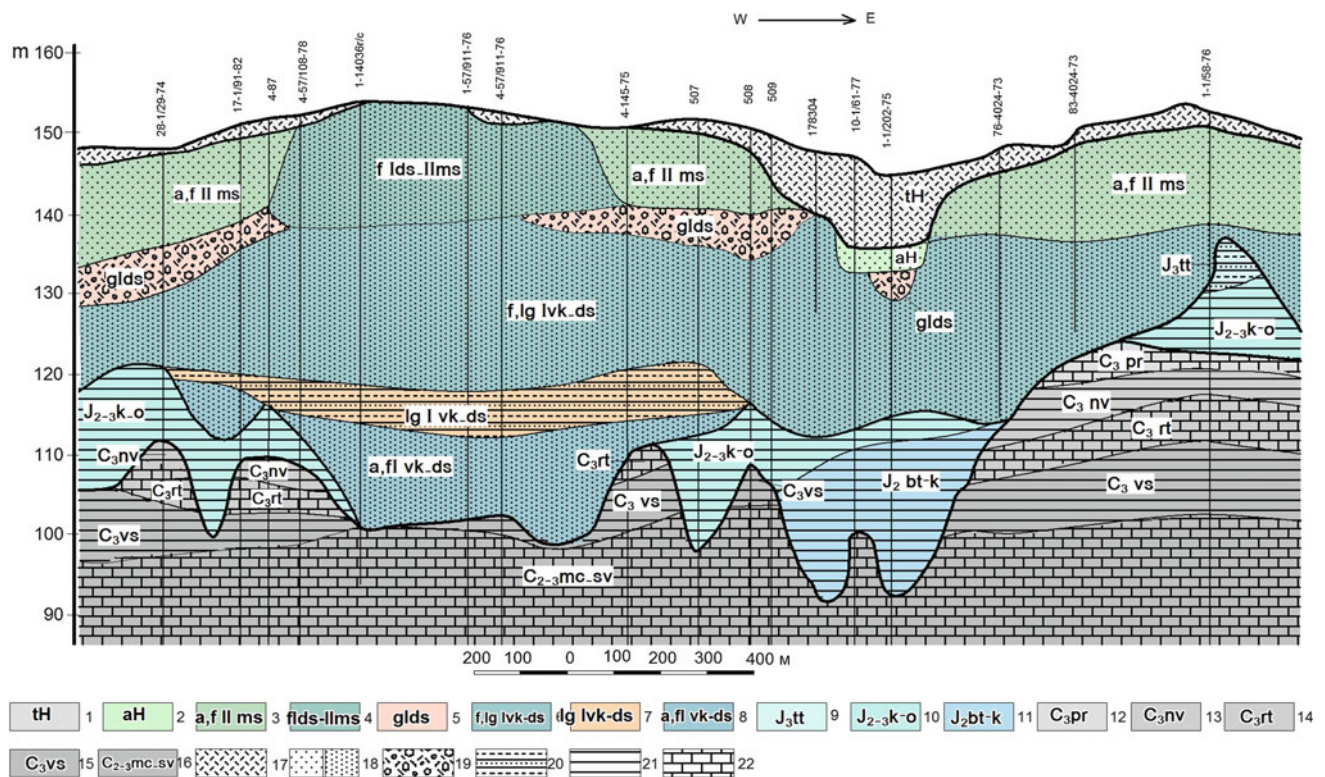
Fig. 1 Geological cross-section in the northwest of Moscow. Holocene: 1—technogenic deposits; 2—alluvial deposits of river channel and flood-plain; Middle Neopleistocene: 3—alluvial-fluvioglacial deposits of the 3rd terrace above the floodplain (Khodynskaya terrace); interglacial deposits of Donskoi-Moskovskii horizons: 4—fluvioglacial deposits of Donskoi horizon; 5—glacial deposits of Donskoi horizon; 6—fluvioglacial and lacustrine-glacial deposits; 7—lacustrine-glacial deposits; 8—alluvial and fluvioglacial deposits. Jurassic system. Upper series: 9—Tithonian stage; Middle-Upper series undivided: 10—

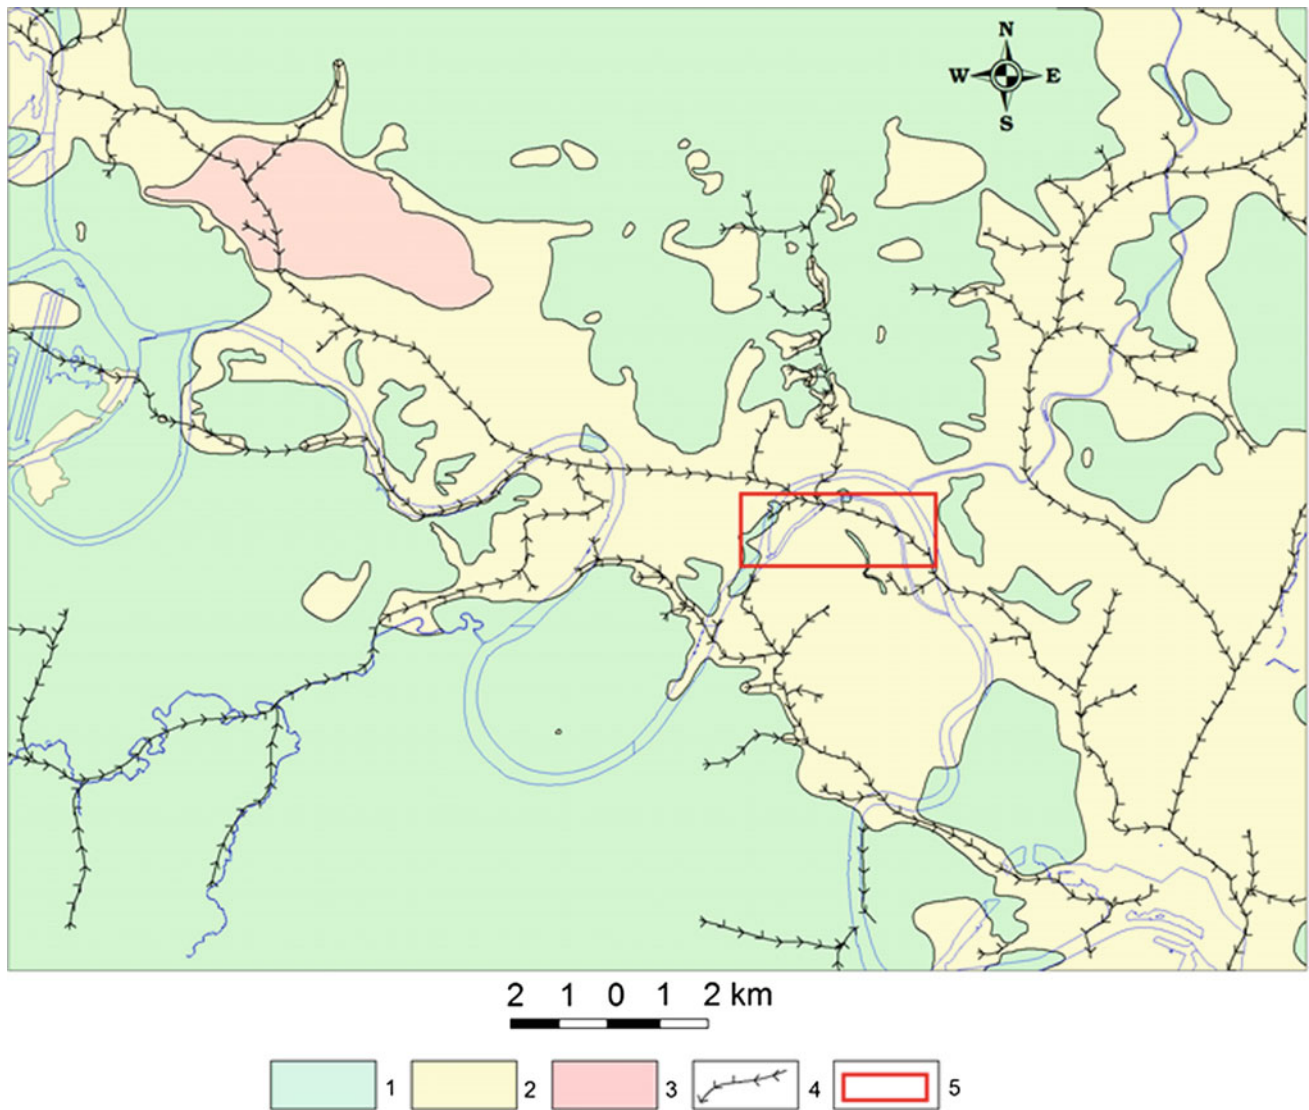
Fig. 3 Fragment of the map of karst-suffosional hazard in Moscow. Designations: hazard categories: 1—nonhazardous, 2—potentially hazardous, 3—hazardous. Other designations: 4—thalwegs of

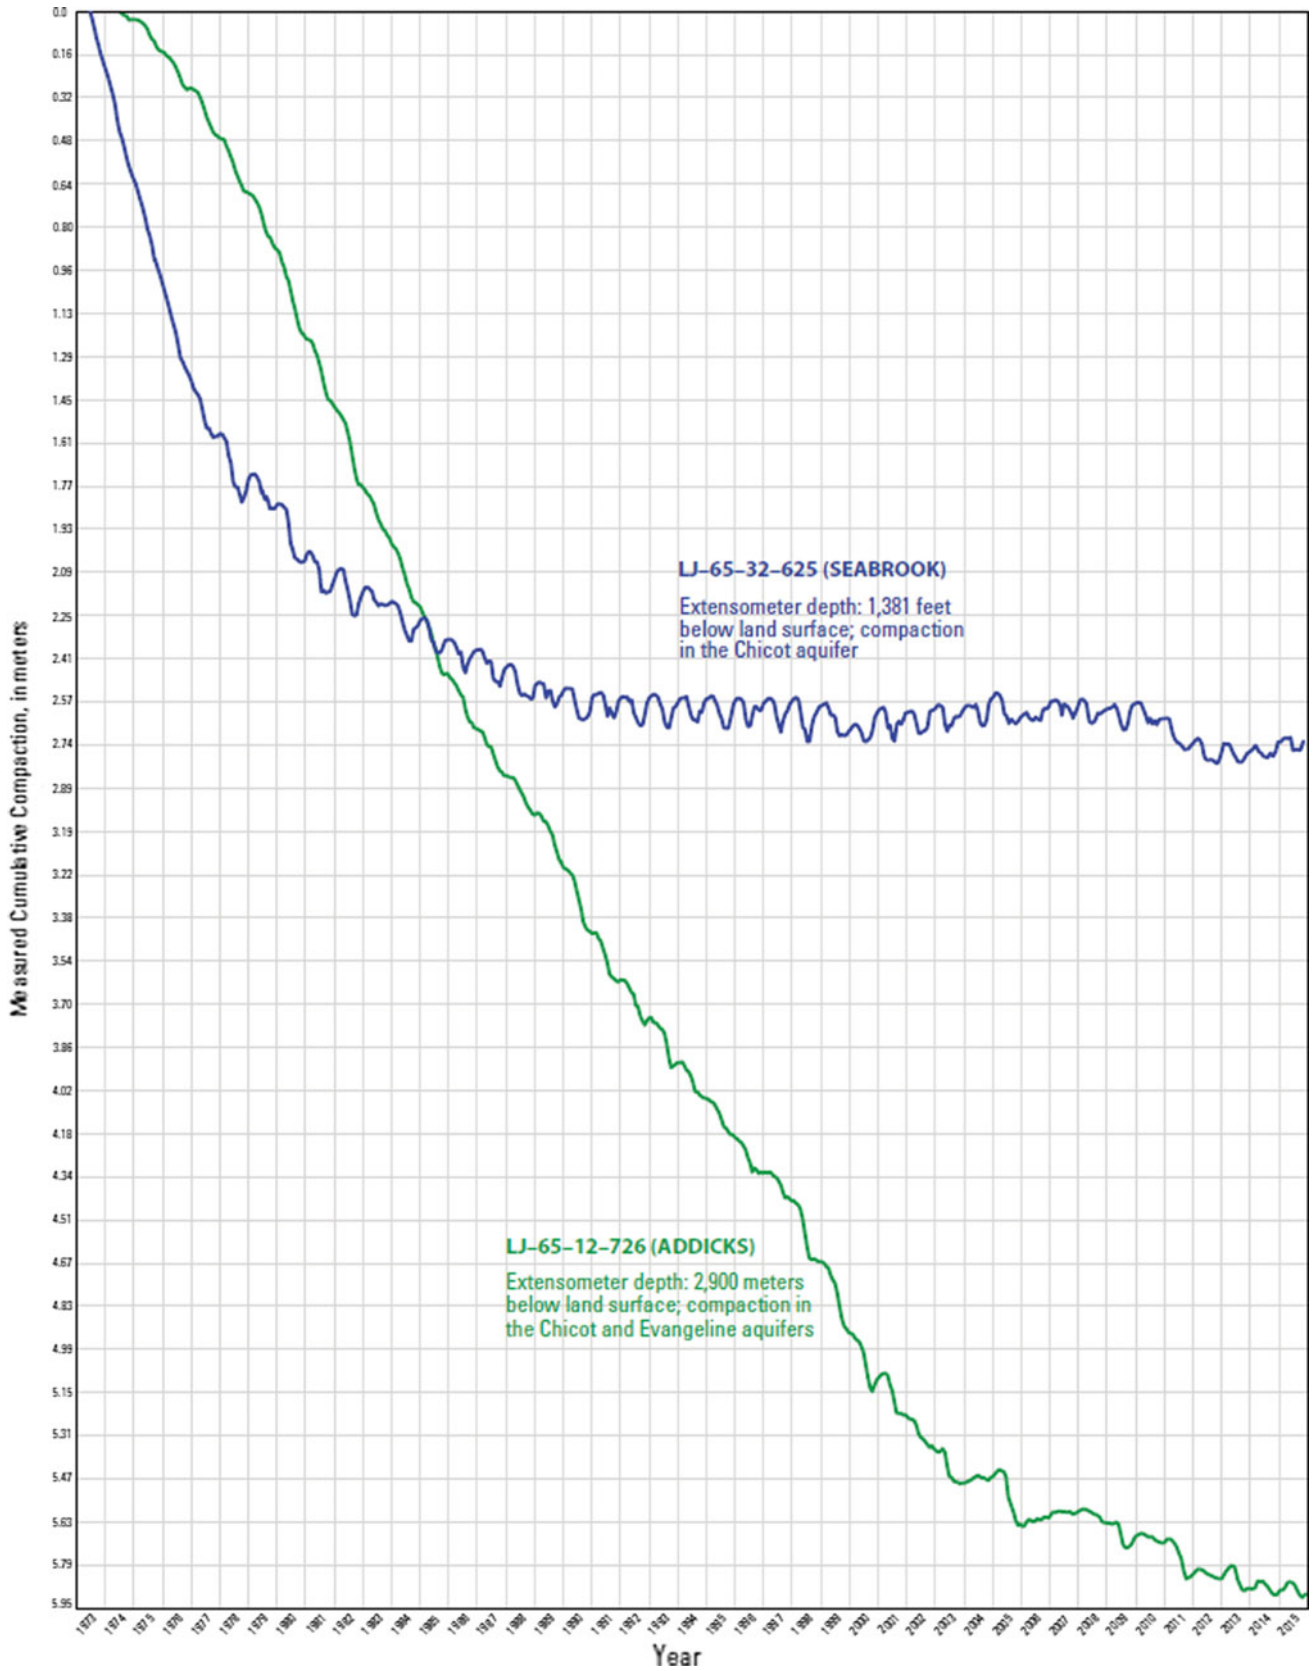
Fig. 9 Cumulative compaction at two borehole extensometer sites in the Harris County

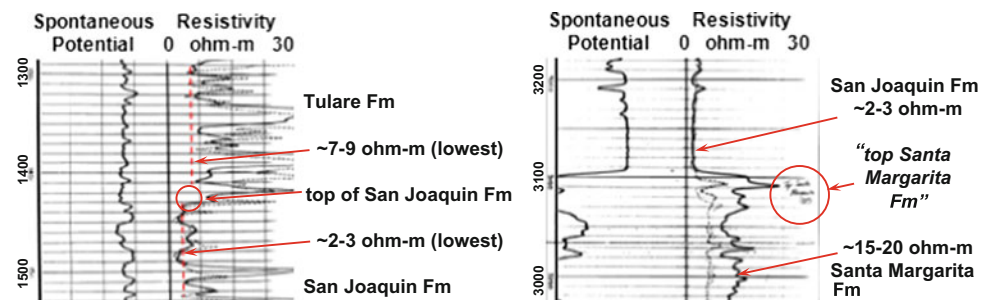
Fig. 5 Well logs (DOGGR 2017) nearest to the Pixley Fissure. Well locations are shown in Fig. 3. Resistivity color coding is similar to Fig. 2. An apparent offset of about 150 ft, downward to the southwest, between Wells 024 and 375, brackets the fissure

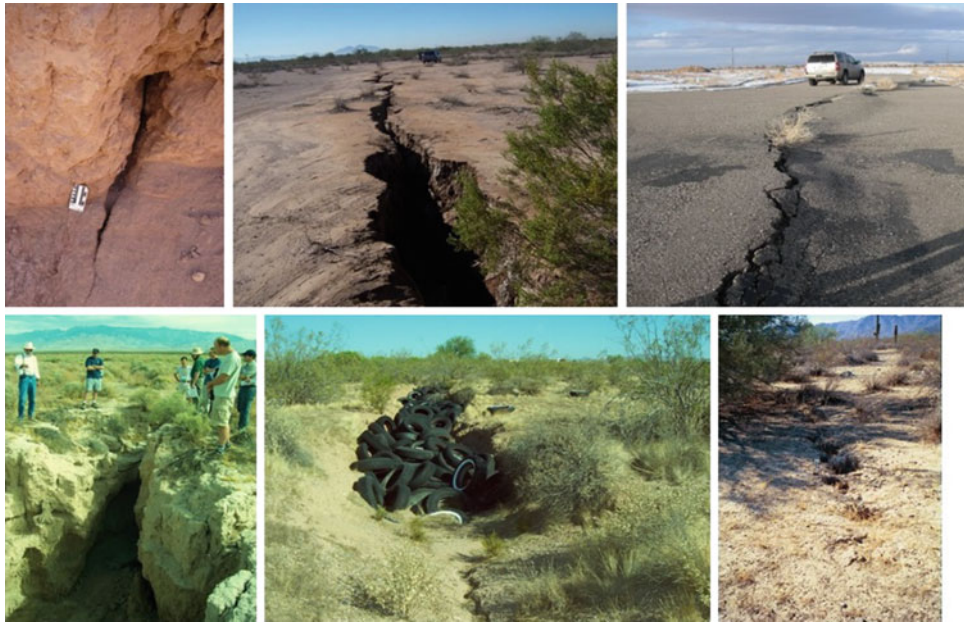
Fig. 1 Examples of earth fissures. Beginning clockwise from the top left: (1) un-eroded incipient earth fissure in bottom of trench excavation at powerline FRS in Central, Arizona, (2) fresh earth fissure gully at Siphon Draw Wash Basin in Central Arizona, (3) earth fissure with

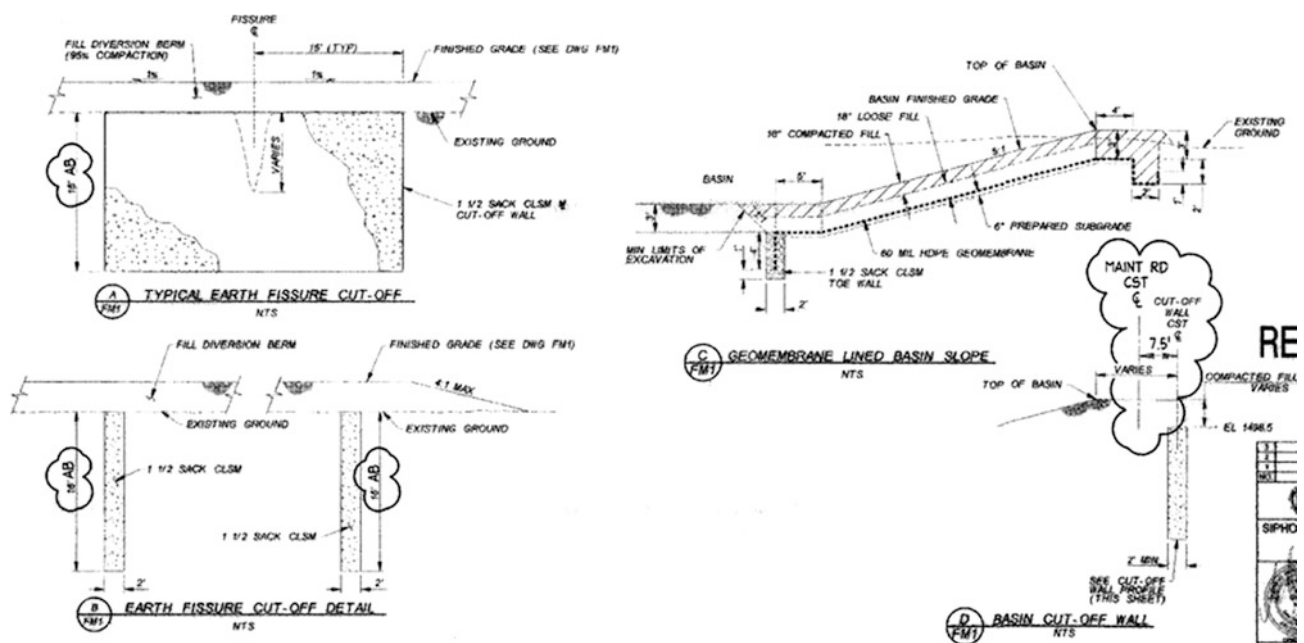
Fig. 2 Design drawings for cut-off wall and geomembrane liner at Siphon Draw Wash Basin in Central Arizona (Ferguson and Rucker 2018)

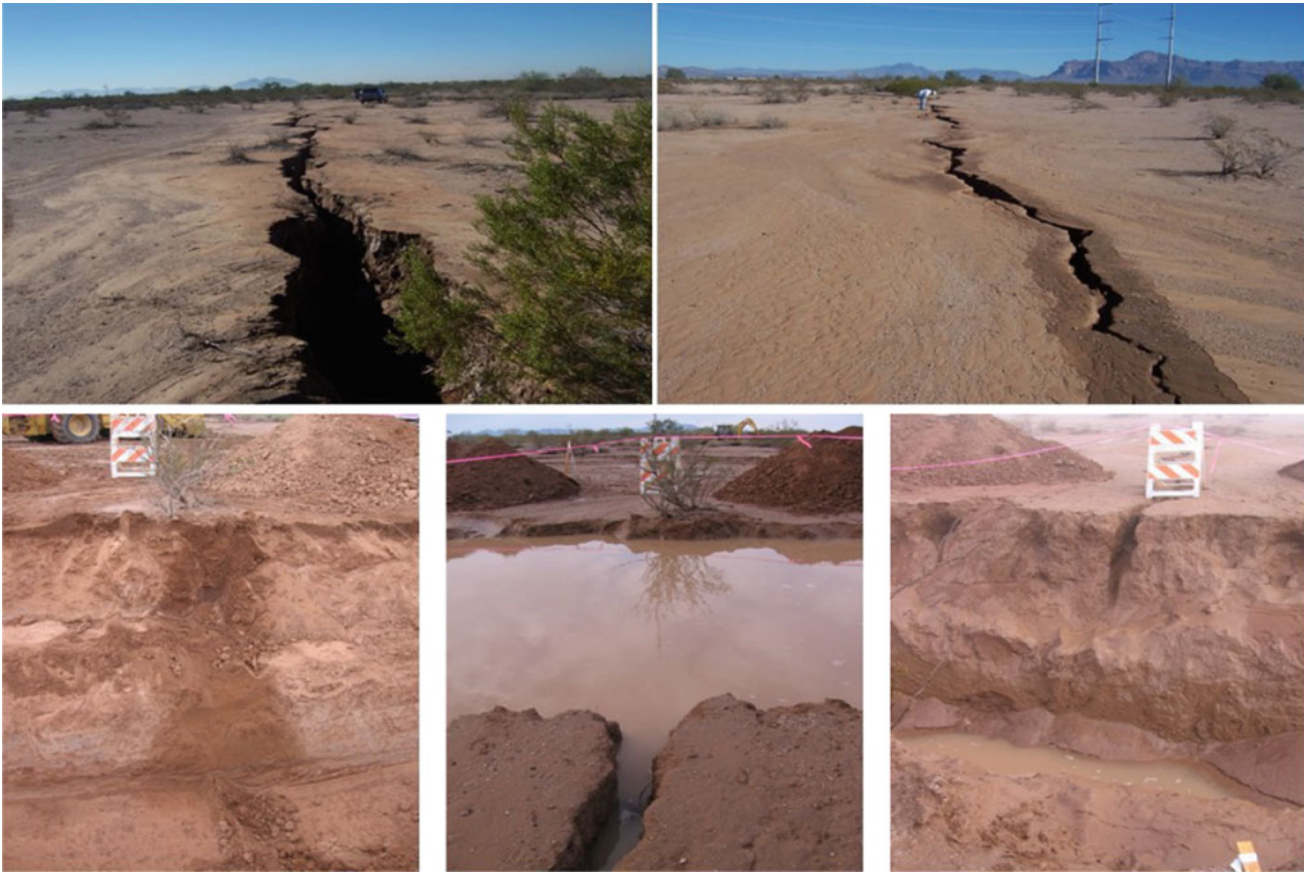
Fig. 2 View of the SWEF prior to construction of the SDW Detention Basin. The upper 2 images show the extension of the earth fissure that occurred overnight as the result of a rain event. The bottom three photos show the trench at the termination of the SWEF. The left image shows
