IAEG/AEG Annual Meeting Proceedings, San Francisco, California, 2018— Volume 5

Geologic Hazards: Earthquakes, Land Subsidence,
Coastal Hazards, and Emergency Response

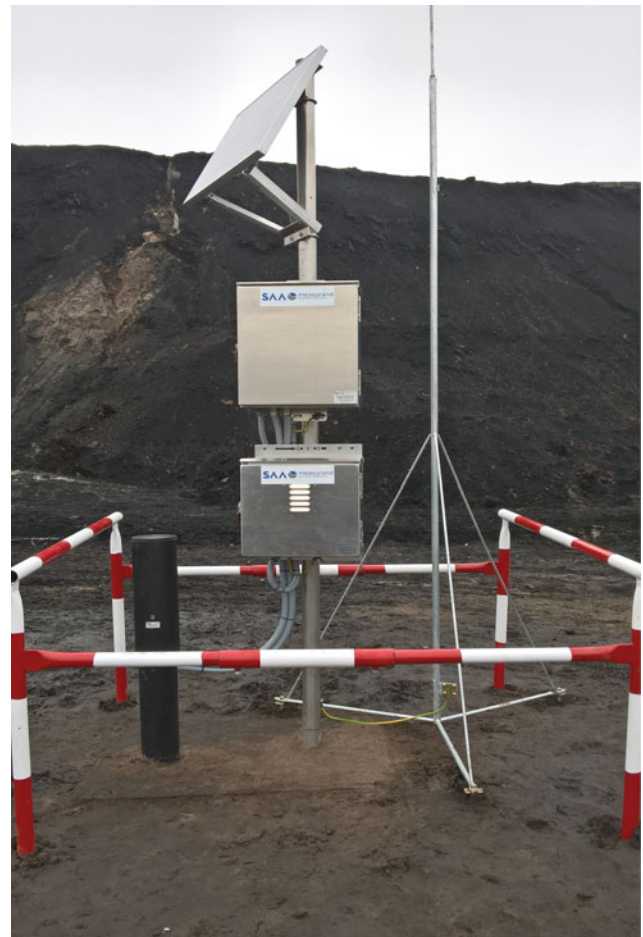
Fig. 2 On-line system in Belchatow Mine

The first nearly real-time system was installed by the author in the Carpathian Mountains near the city of Gorlice in May 2010 as a part of the EU Innovative Economy project. It included three inclinometer field stations to depths of 12–16 m and a weather station. The second nearly real-time inclinometer warning was installed in the Belchatow opencast mine in December 2016 (Fig. 2). That system was installed to a depth of 100 m. Proper calibration of monitoring devices required individually dedicated site investigation and monitoring methods. In this paper monitoring methods in two selected sites and their advantages and limitations are described.

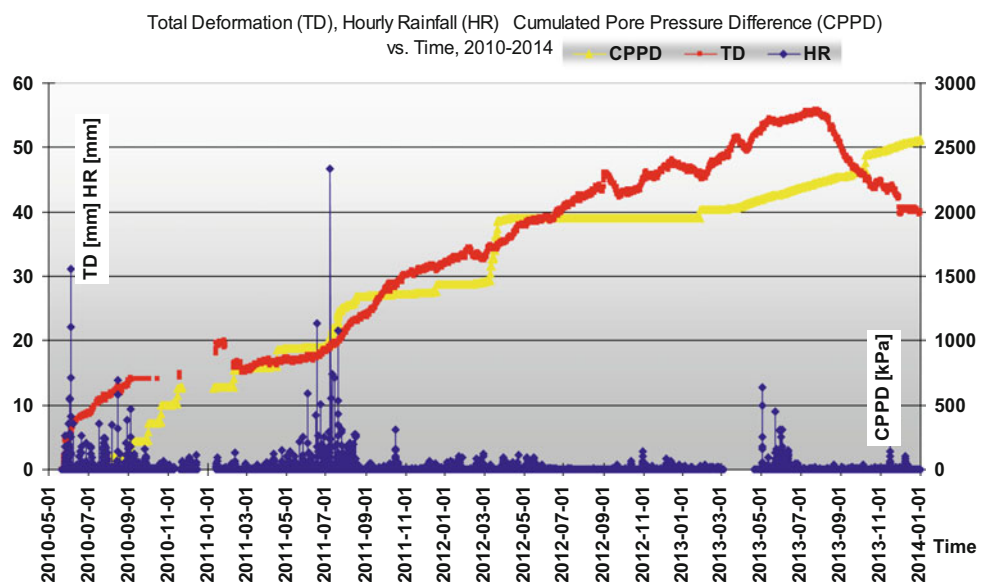
Fig. 5 Hourly rainfalls [mm], pore pressure [kPa] and total deform [mm], Szymbark landslide

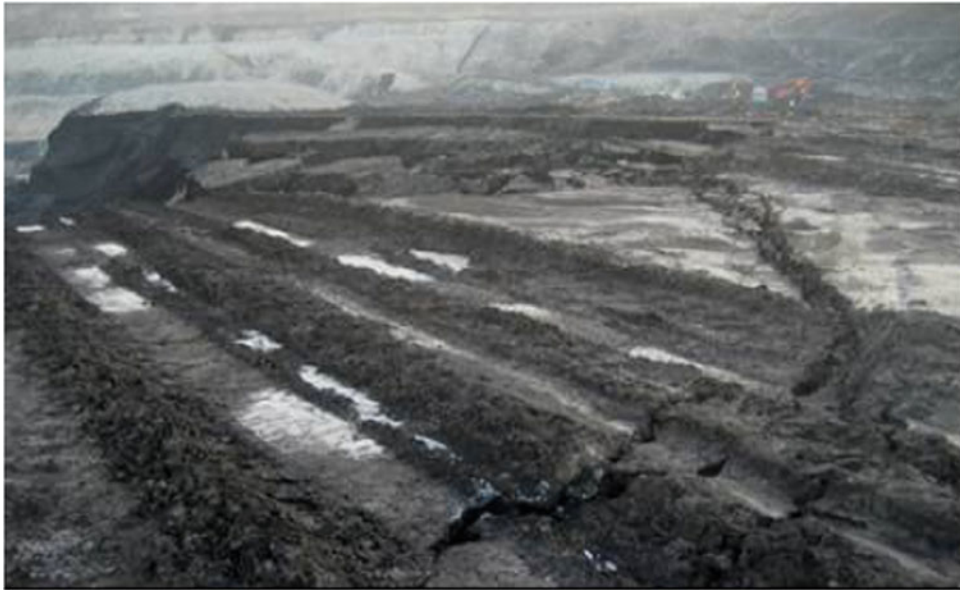
Fig. 6 Landslide at level +42 a.s.l, west slope of Belchatow Mine

The instrumentation was installed in December 2016. A borehole 132 mm in diameter was drilled to the depth of 100 m at the northern part of the west slope at level of +42 m a.s.l in the contact zone of the salt dome (Figs. 6 and 7). Instrumentation included innovative Shape Accelerated Arrays. The system of 200 ground displacement sensors located every 0.5 m, extended to a depth of 100 m is built from rigid segments and includes 3 magnetometers for rotational control. One segment included 3 tilt sensors, measuring a range of $\pm 45^\circ$, with an accuracy of 0.02 mm/m an admissible error of joints of ± 0.250 . Every octet (8 segments) is equipped with a ground temperature sensor. The maximum range of equipment depends on the speed and depth of movements, usually no more than 500 mm. The system is waterproof up to 980 kPa. It was additionally equipped with a VW pore pressure sensor located at a depth of 30 m. The field station included a recorder and GPRS data transmission devices powered by a solar panel. The GPRS

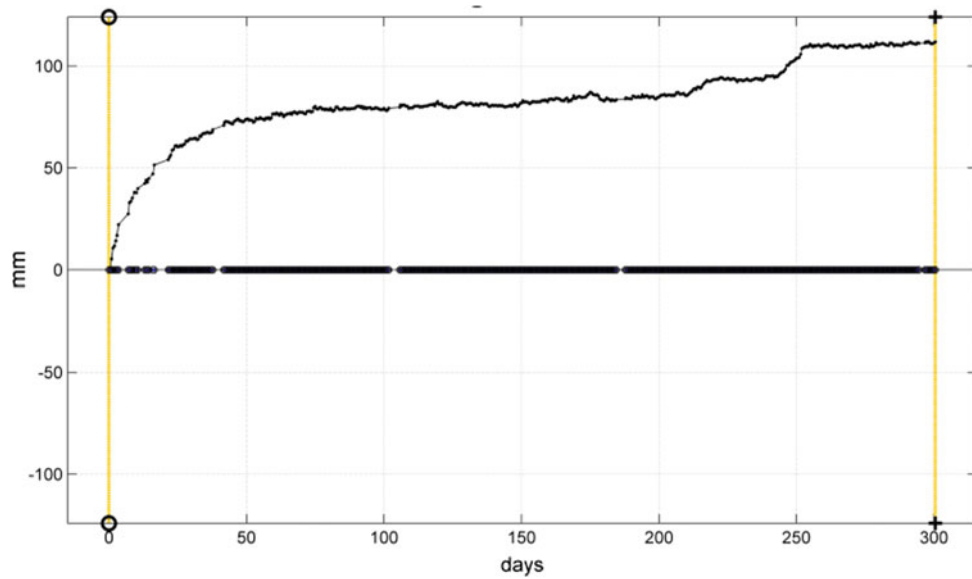
Fig. 8 Monitoring results, magnitude of displacement versus time, Belchatow Mine

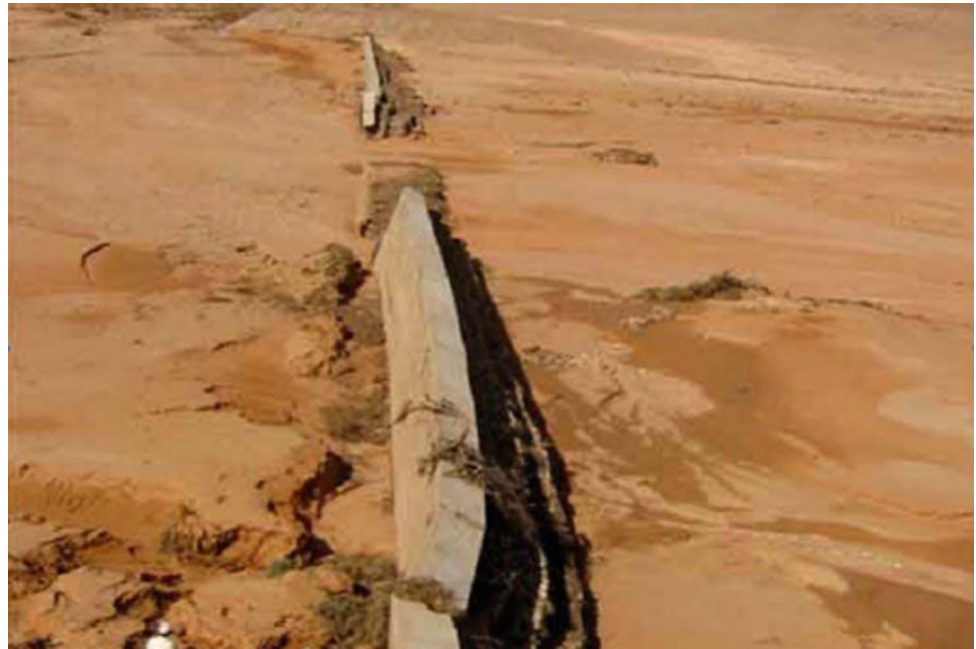
Fig. 6 Flooding M'zab wadi (oct 2008)

for this flood are due to a collapse of a hill reservoir built in 2005 at the wadi Laadhira 20 km from Ghardaïa chief town. In fact, heavy rains have caused water accumulation in 2 km (Figs. 5 and 6). The water pressure provoked a 70 m break in the reservoir dam and the onslaught of nearly $900 \text{ m}^3/\text{s}$ on Ghardaïa city (Alli Azouaou 2009) (Table 3).

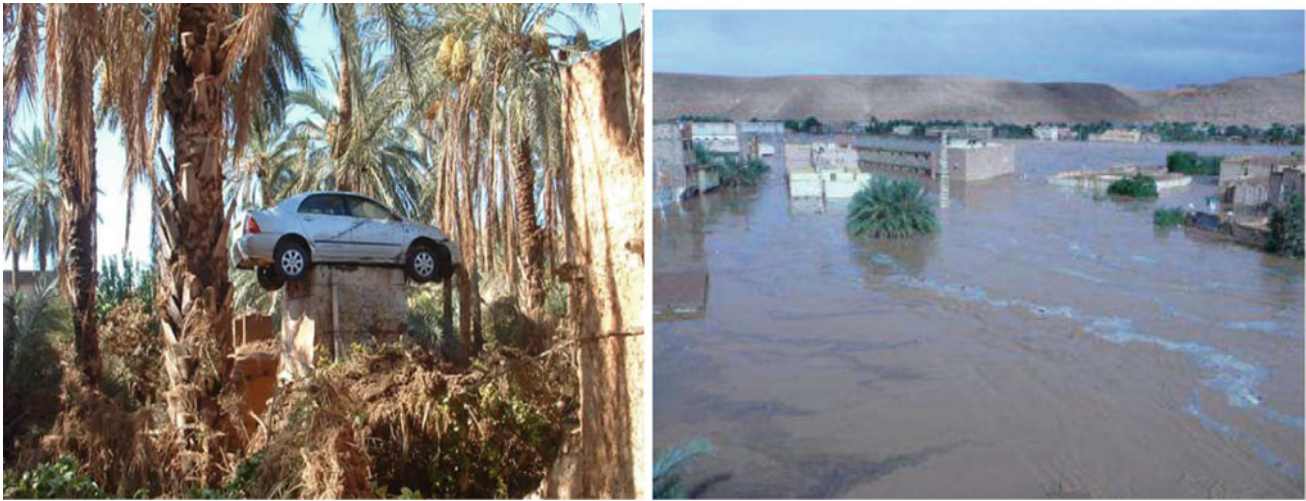
Fig. 8 01 October 2008 flood (<http://observers.france24.com/fr/2008>)

During the flood, many houses located in the Daya Ben Dahoua commune, agricultural lands and roads were damaged (Fig. 8).

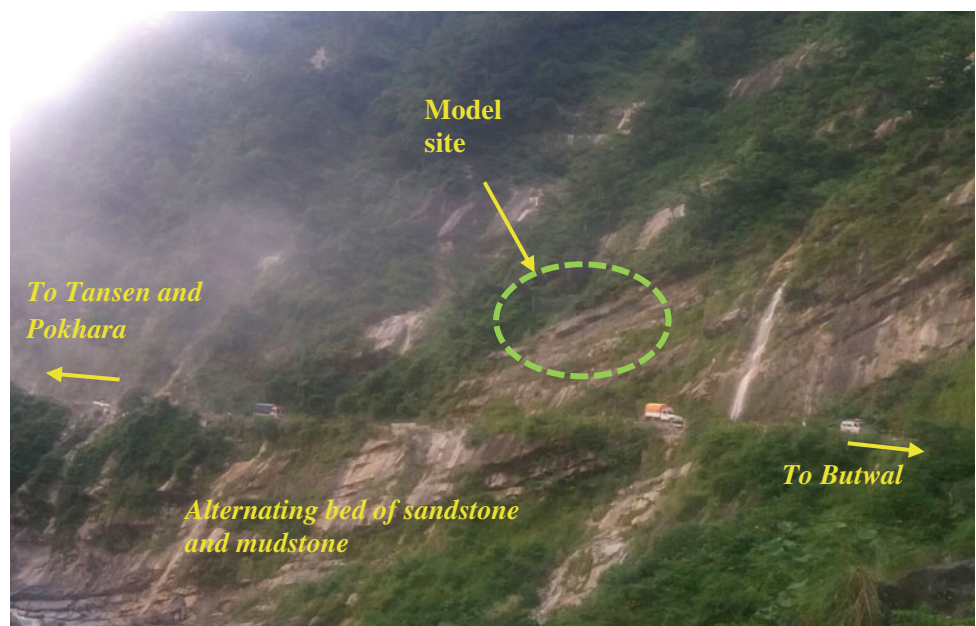
Fig. 2 Model site and surrounding geological settings at the Siddhababa area

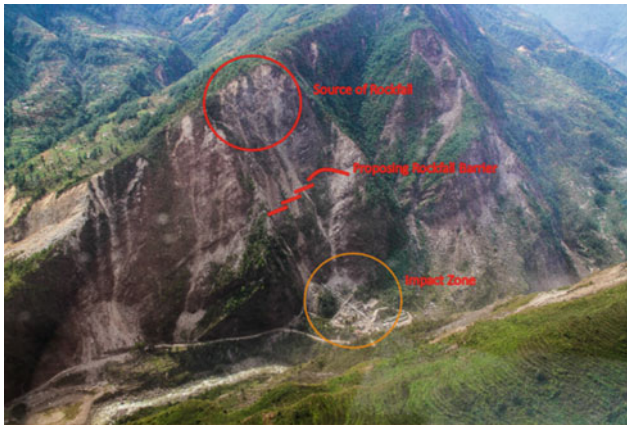
Fig. 3 Rockfall problem in Upper Bhotekoshi Hydropower Project after the Gorkha Earthquake

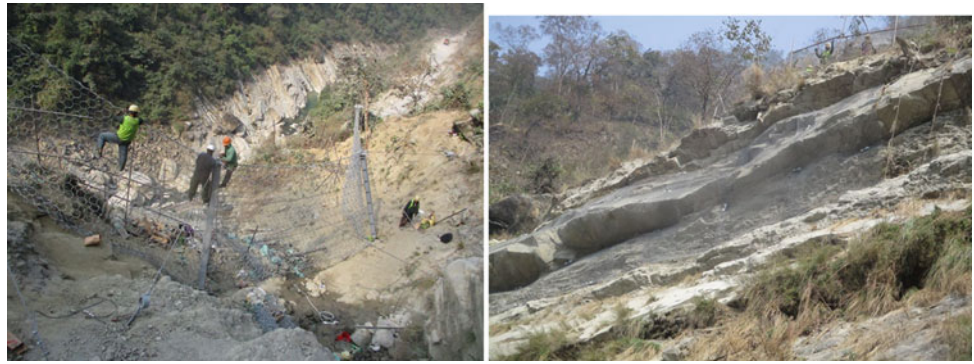
Fig. 4 Model site in Siddhababa. Skilled labors and engineers are installing barriers on left photo and on right photo rock nets installed on hanging sandstone bed

debris, which contributes to further socioeconomic losses in the region. In total, 13 problematic sites for rockfall were identified in the Siddhababa area. Problematic sites were coded as B1 to B13. Out of 13 sites, some part of B8 site was selected for model site installation. In the model site, a rockfall barrier system of 27 m length having maximum

energy level of 1000 kJ is installed along with 120 m² of wire mesh net (Fig. 4). The purpose of model site is to illustrate the function of new technology of rockfall protection system for Nepal. The model site is now performing well and few rock boulders of size up to 1 m³ have been stopped by this barrier.

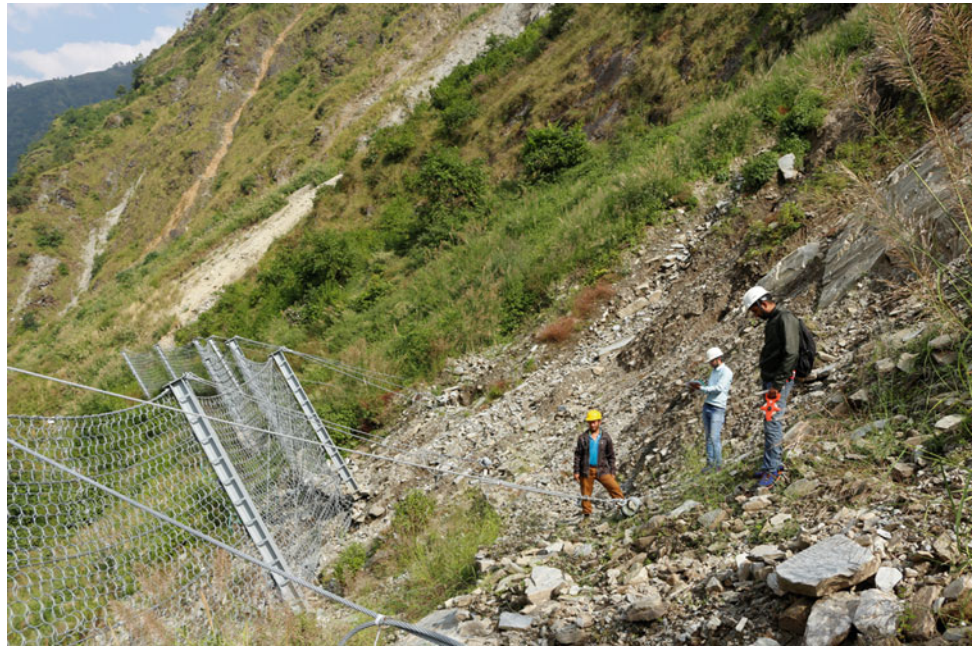
Fig. 6 Already installed rockfall protection barrier on uphill slope of Upper Bhotekoshi Hydropower Project

The Upper Bhotekoshi Hydropower Project is a run-of-the-river hydropower plant in Sindhupalchowk district, Nepal and it is situated at approximately 105 km northeast of Kathmandu. The Powerhouse site lies at latitude $27^{\circ}54'45''$ N and longitude $85^{\circ}55'28''$ E. It was constructed between 1997 and 2000 and power generation started in January 2001. During 2015 Gorkha Earthquake, considerable damage had been observed in the project site. The penstock pipes were hit by the Rockfall and were irreparably damaged. The rocks are highly fractured quartzite and phyllite of the Lesser Himalayan Zone. To design an effective mitigation barrier at this site, rockfall simulations have been performed (Fig. 5) to understand trajectories and impact locations of rockfalls in the project area. There are drastic changes in rockfall scenarios after installation of rockfall barriers. Simulations suggested to a 3000 kJ system are necessary for optimum protection (Fig. 6).

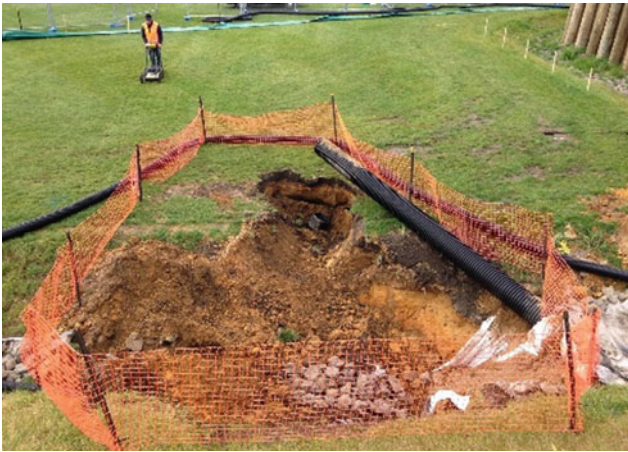
Fig. 4 Sinkhole observed in the playfield of the school. GPR survey underway

Following the site walkover, a GPR survey was undertaken in an attempt to identify cavities in the area (Fig. 4). Whilst some potential anomalies were initially identified, subsequent hand augers aimed at ground-truthing the GPR did not find any cavities or soft spots.

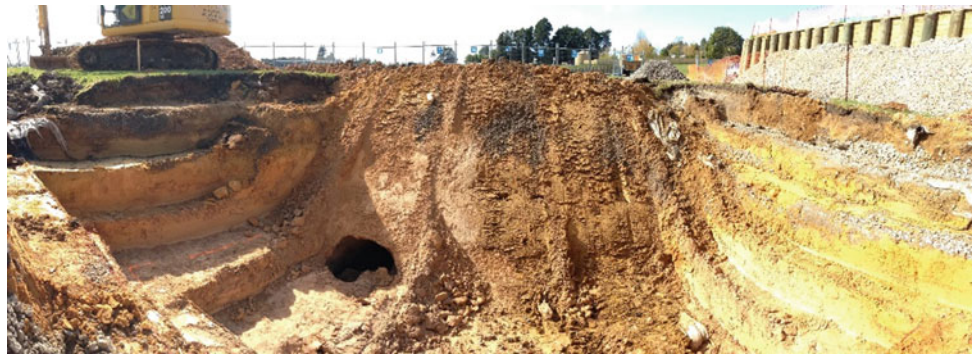
Fig. 7 800 mm thick granular filter layer installed at the base of the excavation

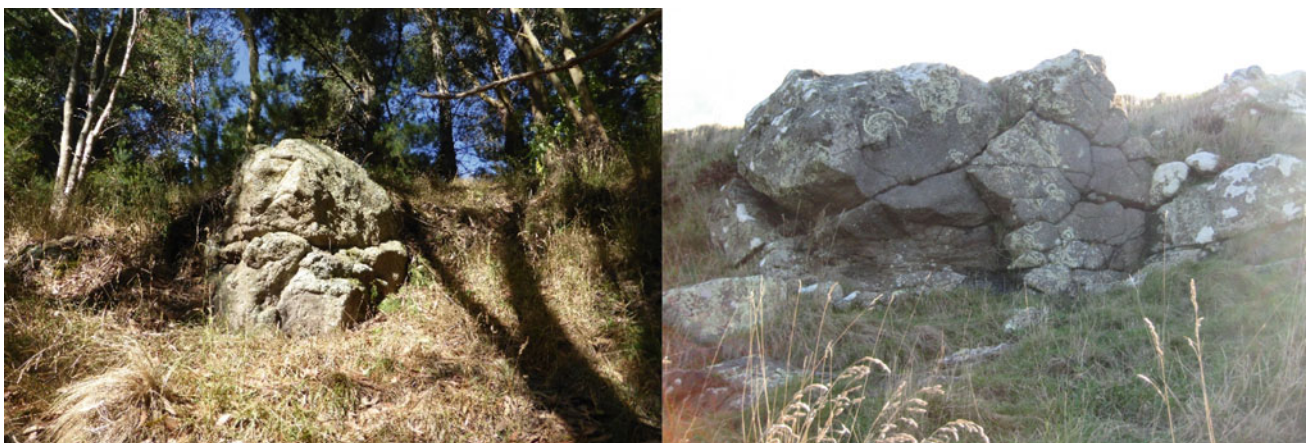
Fig. 2 Discrete rockfall source outcrops mapped in area identified as continuous cliff bands by the area-wide assessment

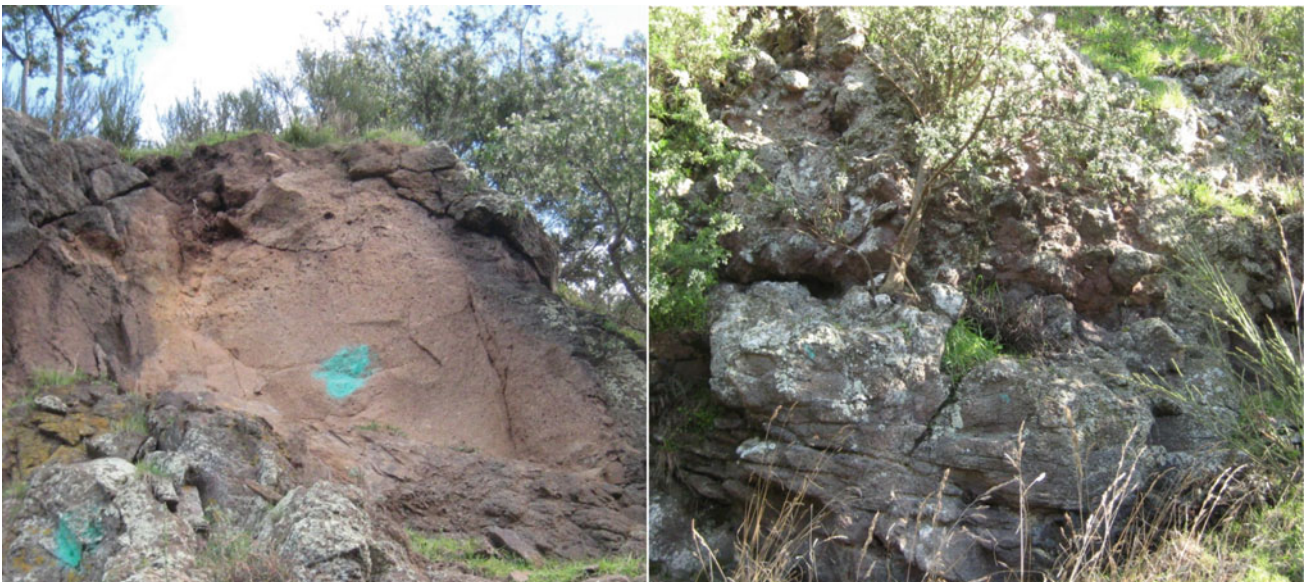
Fig. 3 Blocky trachyte (left) and basalt flow (right) rockfall sources

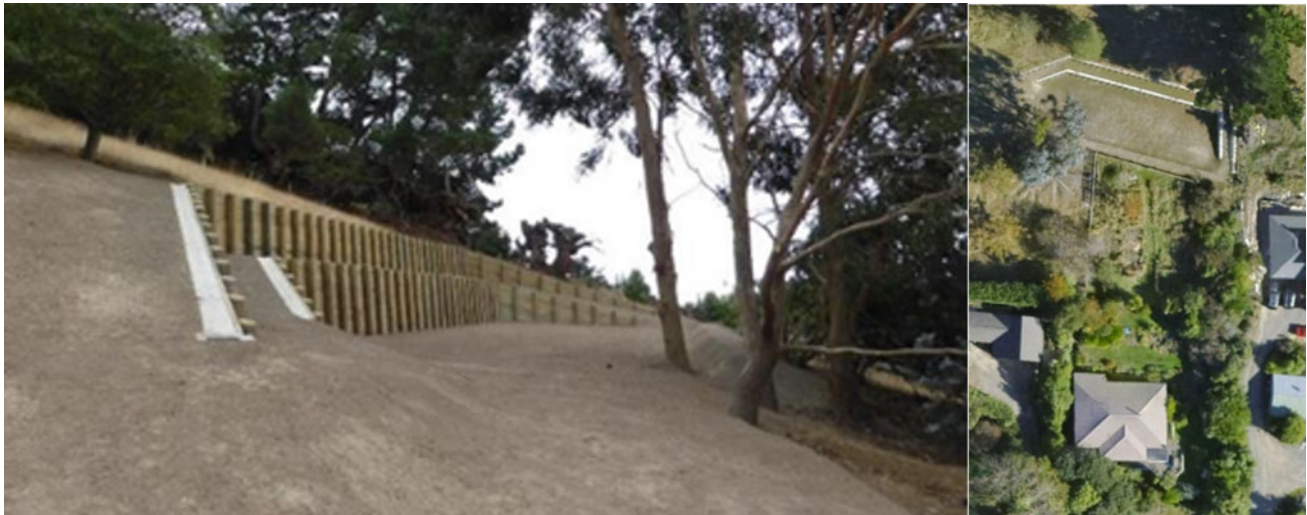
Fig. 5 Terrace and berm RPS on Avoca Valley Road. The image on the right is a Google Earth image of property and terrace upslope

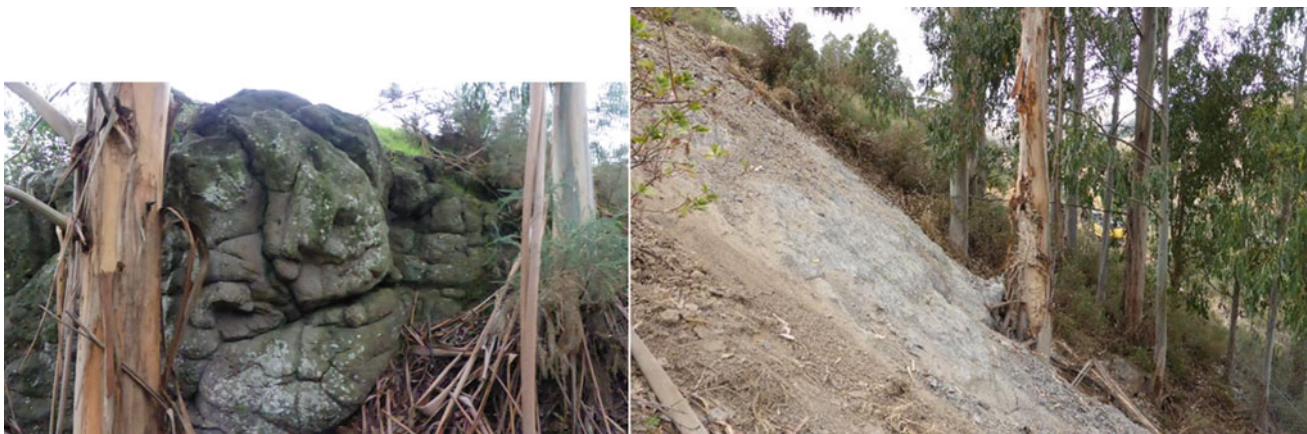
Fig. 7 Discrete rockfall source before (left) and after (right) removal of source

The rock sources were subsequently removed by milling (cutting) them back to an angle approaching the natural grade (Fig. 7). This treatment rendered the outcrops to be non-credible sources of rockfall, therefore reducing the risk to the properties.

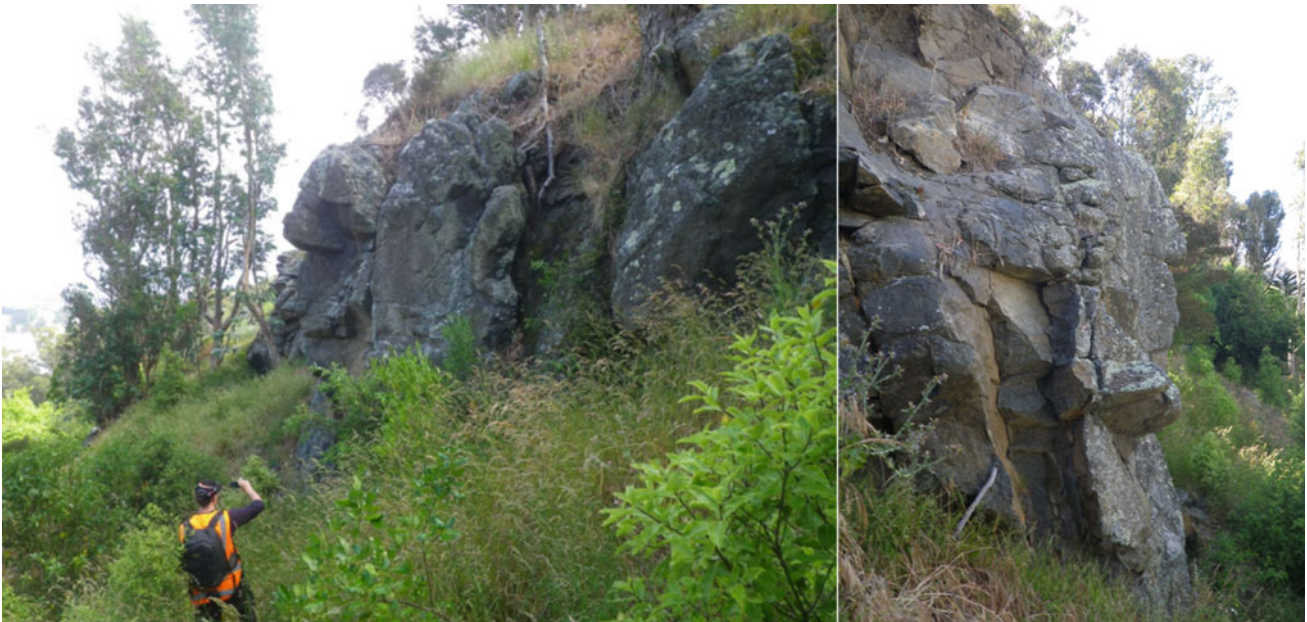
Fig. 9 Photograph of rockfall source cliff bands in Heathcote Valley

A site-specific geotechnical assessment of a series of adjacent properties was carried out to characterize the geological conditions, to identify rockfall source zones presenting a hazard, and to undertake analyses to assess the risk of fatalities caused by rockfall across the properties. Mapping showed cliff bands up to 6 m high occur within the upper portion of the slope (Fig. 9), and further isolated rocky outcrops are situated above the cliff on the grassy slope extending towards the crest some 180 m in elevation.

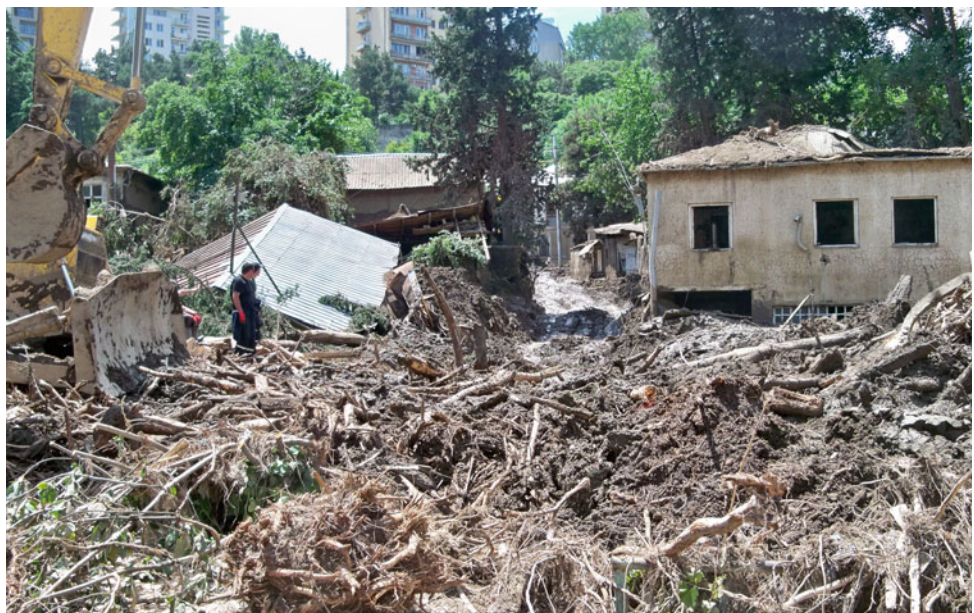
Fig. 2 Debrisflow disaster in riv. Vere Basin (Tbilisi)

northern slope of the Lesser Caucasus (Trialeti anticline), which are created in syncretic synergism of landslide-erosion processes triggering multifactorial agents. In the monoclinic structure of the north side is formed the river Vere basin (with asymmetric morphology), the area of which amounts 196 km², and the depth of the erosion cut in arête zone is 350–400 m (Figs. 1 and 2).
