Conservation Efforts on the Middle Phrygian Gate Complex at Gordion, Turkey

Abstract. The Early Phrygians constructed the fortress city of Gordion (modern day Turkey), ca. 950–800 BCE. Gordion is renowned as the seat of the most famous Phrygian king, Midas of the Golden Touch, and also where Alexander the Great cut the Gordian knot (333 BCE). Although the ancient site was discovered in the late 1800s, it was not until the 1950s that large-scale excavations were begun by the University of Pennsylvania. Excavations showed that in the 8th century the Phrygians buried the Early Phrygian city with clay fill and rubble packing that formed the base for the new citadel fortifications and the Middle Phrygian Gate Complex guarding the city. Since the Gate Complex was first exposed in the 1950s, faces of the excavated rubble masonry have been subjected to environmental and weathering effects. More recently, sections had spalled off and left several large stone blocks of the Middle Phrygian wall resting above in imminent danger of collapse. In 2016, a site conservation project was undertaken to preserve portions of the Middle Phrygian architecture and stabilize the remains of the rubble mason

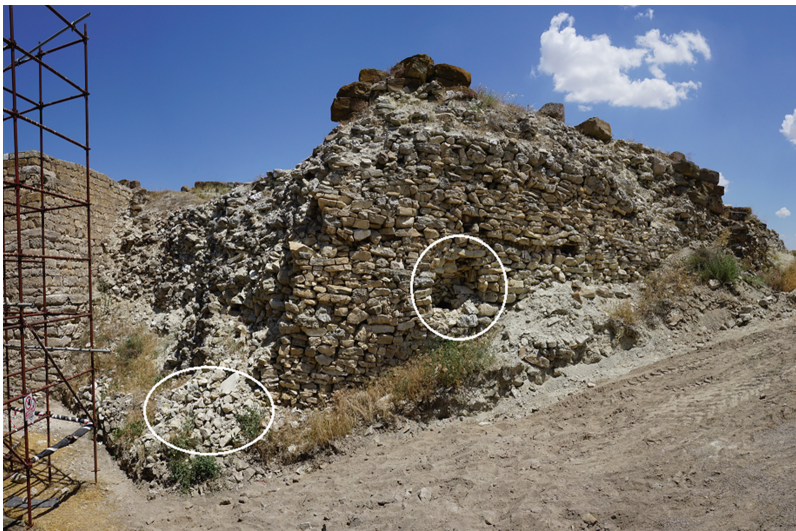
During excavations in the 1950s, a large quantity of the Middle Phrygian stone packing was removed, leaving a 5 m high semi-stable pile of rubble masonry that still supported several fragmentary walls of the North Court of the Middle Phrygian Gate. The rubble had been eroding steadily for 60 years, gradually becoming far looser and more dangerous. During the winter between 2015 and 2016, many stones fell from the main exposed rubble masonry face which meant that several large stone blocks weighing approximately 600 kg each- at the south interior corner of the North Court of the Middle Phrygian Gate that were resting on this rubble- were in imminent danger of collapse (see Fig. 4). It was crucial to submit the proposals and obtain the permit quickly since the work season lasts only two months at Gordion. Also, material testing and investigation on the rubble masonry necessitated permission from the Historic Preservation Commission and additional funding, both of which were not readily available for this unexpected condition. Mathematical modelling of the rubble masonry failure under such circumstances was extremely difficult, if not impossible. Furthermore, any solution had to be cost-effective and quick to implement in such a remote site.

Fig. 4. Spalls of 2015 winter highlighted with circles and the MP Wall stones resting precariously above

The Gordion team submitted several proposals for the stabilization of the area, including (a) cutting back the slope of the rubble fill along the west portion; (b) installing a gabion wall system along the vertical south face; (c) installing a bracing wall made of a steel frame and wire net along the west portion of the rubble and south face of the fill; (d) encasing the rubble fill and the MP Wall stones with a wire mesh and steel strands to tie them into the ground above and away from the walkway and

(e) a hybrid of features of (a) through (d). Ankara's Historic Preservation Commission approved a hybrid approach that did not require the addition of any modern materials such as steel mesh, cables, or beams, but would stabilize the rubble and minimize the possibility of wall collapse and injury to visitors at the site as described below. It would be inexpensive in comparison to the other options and produce an aesthetically appealing outcome. Before stabilization efforts began, the extant state of the Middle Phrygian wall and rubble was fully documented. The conservation work, which lasted two weeks, consisted of three tasks (see Fig. 5): to stabilize the Middle Phrygian rubble fill by trimming the southwest corner to a 45° angle, presumed to be the angle of repose for the structured rubble fill; to move the existing Middle Phrygian wall stones to their new location in the northeast corner using a mobile crane; and to trim the south face to a 45° angle by creating multiple rubble steps, or benching (see Fig. 6).

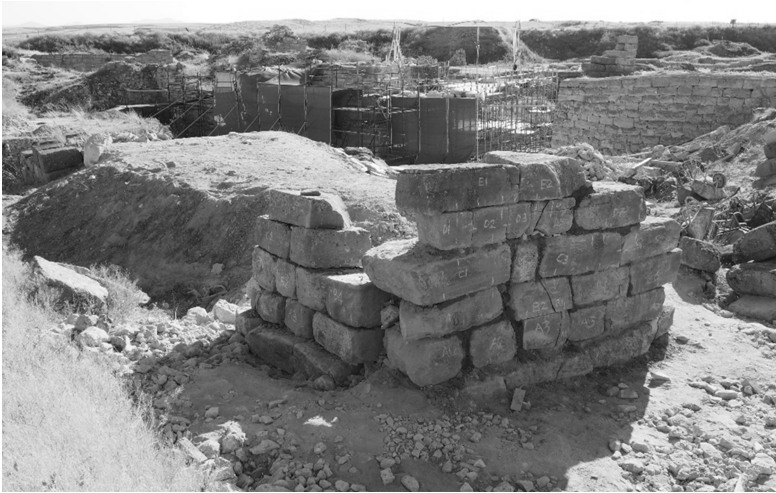
Fig. 7. Reconstructed wall

Moving the corner wall from the south to the north side required the preparation of a new foundation prior to its reconstruction. Before the stones were moved, all of them were marked and numbered, enabling the reconstruction of the wall as close to its original configuration as possible. The blocks were then reassembled in their original positions, but rearranged to create an outside corner of the massive building rather than the original corner of the interior room. The east-west wall was reconstructed running east-west as before, while the alignment of the north-south wall was changed 180° to

face the visitor circuit, so that its original exterior face remained exterior. The east-west wall was preserved to a maximum height of 2.03 m and a maximum length of 3.43 m; the north-west wall was preserved to a maximum height of 1.51 m and length of 2.37 m (see Fig. 7). The total number of stone blocks removed from this wall corner was 36; eight of them were foundation stones originally set within the rubble during the Middle Phrygian period and therefore not visible in antiquity. An interesting feature of wall construction that became clear only during its dismantling was the extensive use of mud mortar between both the stones and the courses. Such mud mortar is lacking in Early Phrygian wall construction and apparently a new feature of Middle Phrygian engineering. To reduplicate the original construction technique, mud mortar was used during the reconstruction, which made it easier to move the blocks into their place; it also prevented any stress concentration that would cause cracking of the stones.
