House on a Bunker by Architect R. Romke de Vries: From Military Accommodation to Residential Refinement

Abstract. The construction of houses on bunkers is not uncommon in post-war Holland, yet this project in The Hague, conceived by architect R. Romke de Vries between 1951 and 1955, sticks out as a pioneering design. A large concrete bunker was reused as an artificial rock foundation for the construction of a new house that was commissioned by contractor Jan van Kampen. In close collaboration with his client, Romke de Vries managed to create a remarkable synergy between both old and new constructions, interior design and garden layout, bringing together many of his previously published innovative design strategies for the post-war home interior. All fittings and furnishings were profoundly detailed and painted in a remarkable colour scheme. This essay is dealing with innovative residential issues by architect Romke de Vries with special attention to technical approaches, the colour scheme and the interaction between architect and client/contractor. This study also addresses objectives of basic comfort standards, improvement of the energetic performances, efficient approach of the

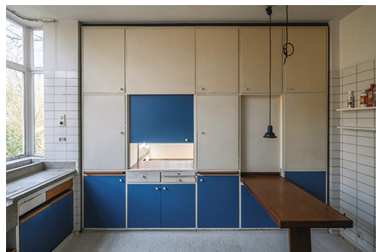
Fig. 4. Fixed furniture between the kitchen and the dining room (© Ossip van Duivenbode, 2017)

The many detailed drawings prove that the layout, construction, material and colour scheme of the house were fully developed. Fixed furniture was customized, resulting in a prominent ensemble that has remained intact to this day (see Fig. 4). The interior and exterior finishing combines raw materials with smooth surfaces. External materials are handmade rusty brown bricks with brushed joints and exposed concrete, steel windows fixed to Afzelia posts and timber roof construction with suspended plaster ceilings and glass quilt insulation (see Fig. 5). Except for some face brickwork, tiled or timber walls and glass mosaics, all interior surfaces were plastered and painted in unique colour schemes. Kitchen and bathroom floors were originally finished with Colovinyl, the hall and corridors were paved with Norwegian slates (*Alta quartzite*) and all other floors with reddish *Kambala* (*Iroko*) hardwood. Romke de Vries also designed the garden layout but the planting was developed by Mrs. Van Kampen [10].

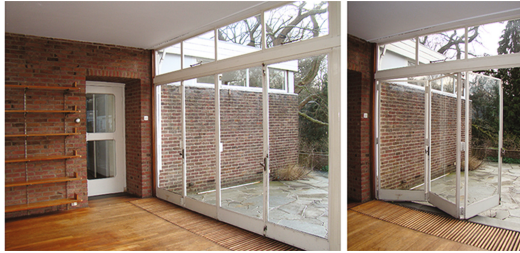
Fig. 5. Living room with raw materials, smooth surfaces and steel window frames (© Ann Verdonck)

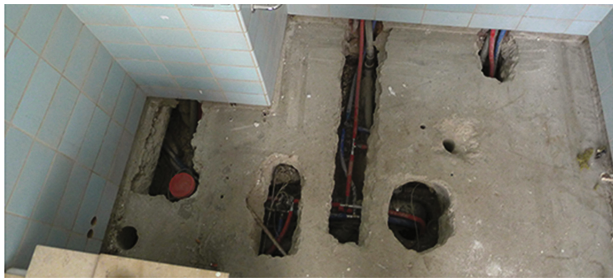
Fig. 7. New pipework from different rooms is bundled under the bathroom floor, where the contemporary vinyl finish is replaced. (© Steven van der Goes)

The design of a new piping system posed a major challenge since every single connection asked for a different solution. Irreversible demolition work was minimised by using modern flexible pipes, concealed in cavities of the existing built-in furniture and beam and block flooring. In order to lead the new pipes through the thick concrete roof of the bunker, boreholes were drilled, hidden under cupboards and vinyl flooring (see Figs. 6 and 7). This approach made it possible to dismantle the central heating pipes from the 1970's outside the bunker walls.

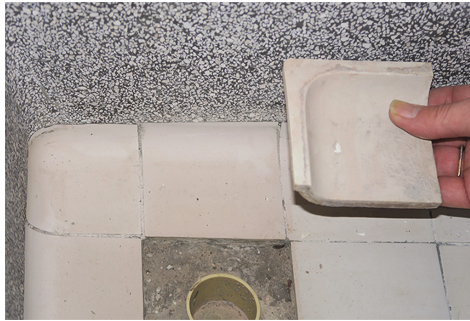
Fig. 9. Reconstruction of the ceramic sink tiles

Considerable time and effort was spent on restoring the exceptionally well-preserved interior. Substantial non-original additions and alterations to the initial design were limited to the removal of Colovynyl tiles and the addition of easily dismountable pinewood panelling in two of the bedrooms. More importantly, successive paint works significantly changed the remarkable colour scheme (Fig. 9).
