Chapter 14

Seismic Behavior of Slopes and Embankments

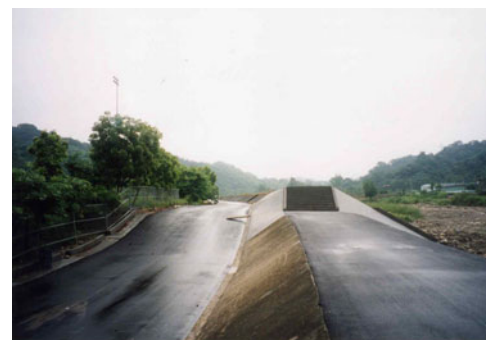
Fig. 14.3 Repaired shape of dike in Wufeng

The quick restoration in Fig. 14.3 makes an important point that the restoration of earth structure is much easier and quick than that of steel or concrete structures. This issue will play an important role in the

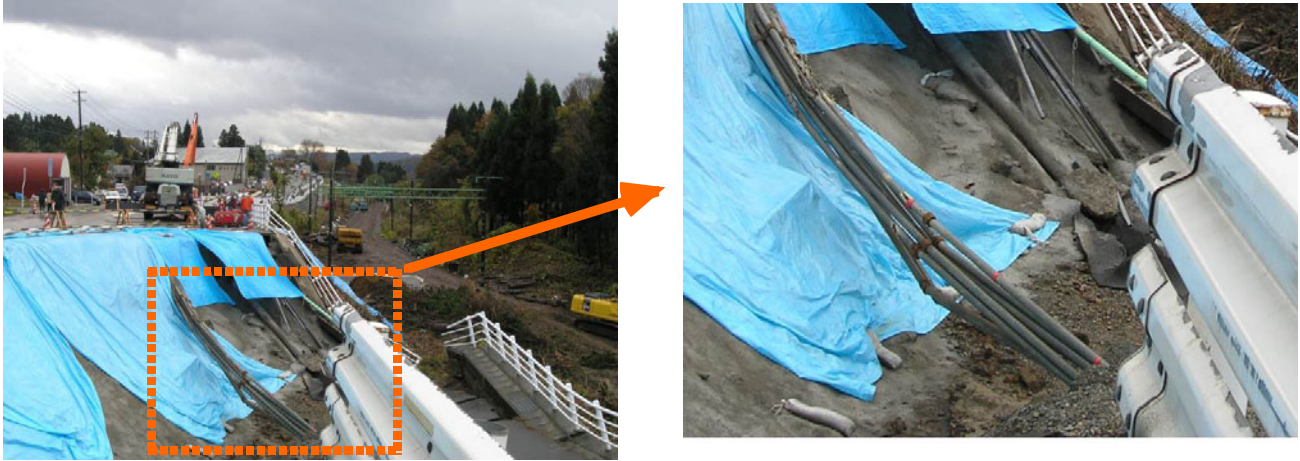
Fig. 14.4 Effects of collapse of road embankment on embedded lifelines

Failure of an embankment may trigger additional problems. Fig. 14.4 shows a case of road embankment during the 2004 Niigata-Chuetsu earthquake (see Fig. 14.24 as well). The large displacement of a road fill destroyed many embedded pipelines. It is important that this site was situated upon a small valley, suggesting the potential instability of embankment upon such a small geology; see also Fig. 14.43.

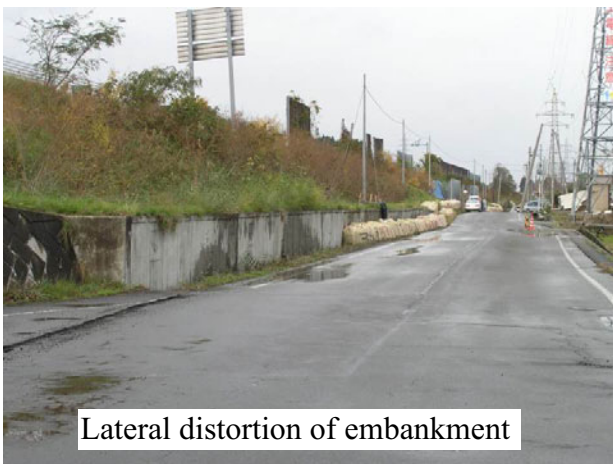
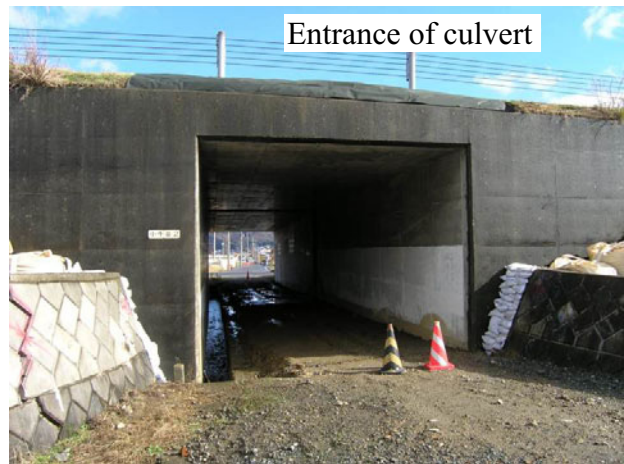
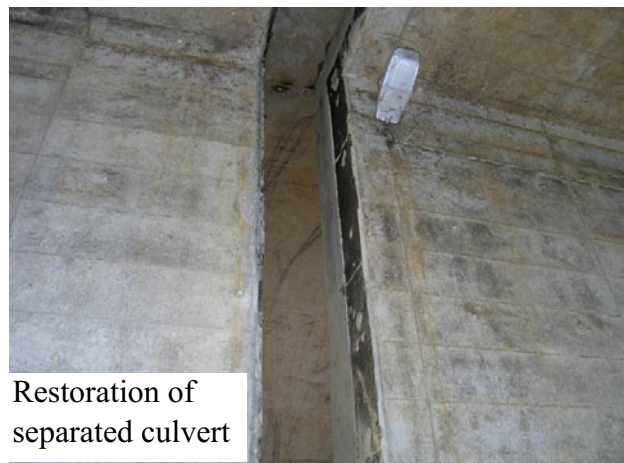
Fig. 14.5 Distortion of embedded structure due to deformation of highway embankment

Another example is demonstrated in Fig. 14.5. A highway embankment deformed in the horizontal direction and an embedded underpass concrete structure (culvert) was separated into two pieces. The separation was restored by placing steel plates. Thus, the stability of an embankment has to be discussed from the viewpoint of interaction with embedded facilities.

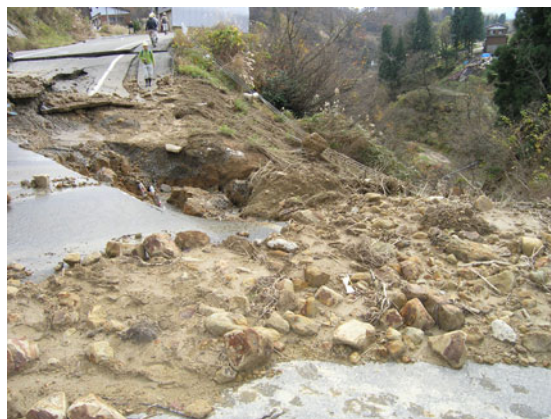
Fig. 14.9 Failure of road embankment during the 2004 Niigata-Chuetsu earthquake

Figure 14.9 illustrates a failure of a road embankment during the 2004 Niigata-Chuetsu earthquake. Situated upon a small valley, the failed earth is overtopped by stream water. This failure was probably caused by a combination of two reasons, which are elevated water table in the fill as well as the weak stream deposit

that was not fully removed during construction. Thus, an embankment constructed upon a stream (集水地形) needs special care such as drainage and reinforcement at the toe of a slope.

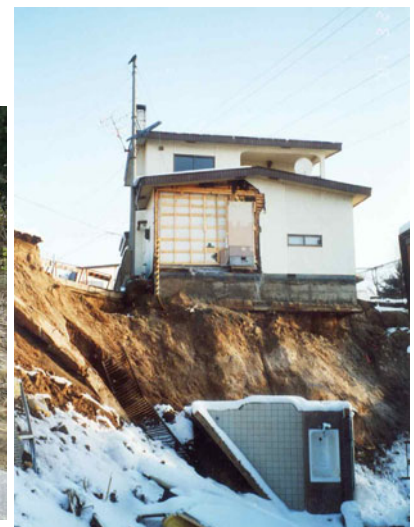
Fig. 14.10 Slip failure of fill part in cut-and-fill area (Midoriga-oka in Kushiro)

Many land development projects in hilly areas employ cut-and-fill construction to achieve a level ground surface. The interface between cut and fill can form a slip plane. Figure 14.10 indicates a sliding failure of this kind. During the 1993 Kushiro-Oki earthquake, only the bathroom of this house, which was situated upon a fill fell down, while the remaining part of the same house was intact.

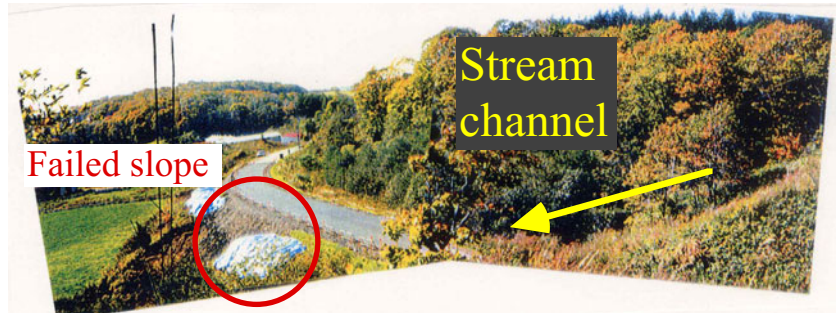
Fig. 14.6 Surface sliding of road embankment at Nakachambetsu site in 1994

Figure 14.6 manifests a development of a shallow slip plane (Type-1 failure in Sect. 14.1). Placed upon a small stream channel, this fill failed during the 1994 Hokkaido-Toho-Oki earthquake.

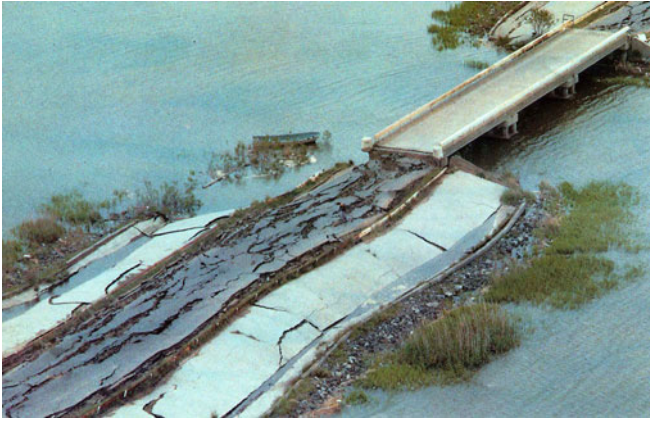
Fig. 14.11 Slump failure of road embankment due to subsoil liquefaction (Akita Sakigake Newspaper)

Slumping (Type 3 in Sect. 14.1) is another important kind of failure of an embankment. The 1983 Nihonkai-Chubu earthquake caused liquefaction in subsoil under Gomyoko Bridge (五明光橋) site on the western side of Hachiro-gata (八郎潟) Lake. Figure 14.11 shows that slumping of the fill resting upon soft lake deposit produced many cracks at the surface pavement. These longitudinal cracks suggest that the fill spread laterally. Figure 14.12 demonstrates an example failure of a road embankment at Chiebunnai Bridge (智恵文内橋) during the 1994 Hokkaido-Toho-Oki earthquake. This fill was constructed on a deposit of a small stream. Thus, an embankment resting upon soft soil deposit is vulnerable to earthquake-induced failure.

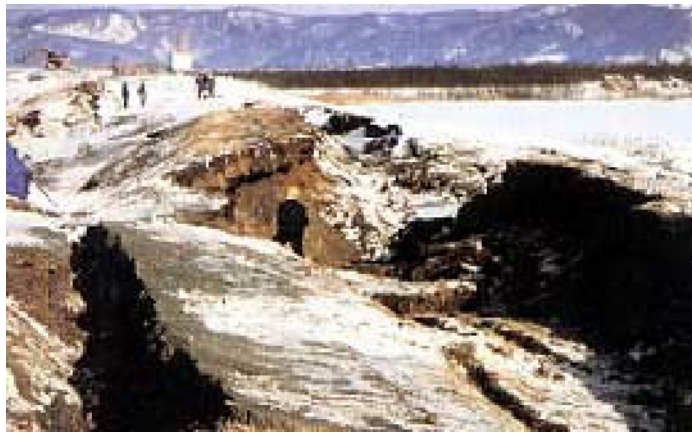
Fig. 14.13 Damaged shape of Tokachi riverdike in 1993 (Ministry of Construction)

Figure 14.13 illustrates a damaged shape of the Tokachi river dike (十勝川堤防) during the 1993 Kushiro-Oki earthquake. Note that the center of the dike subsided more than the lateral slopes. Since an evidence of liquefaction (sand boil) was found here although the foundation soil was unliquefiable peat, the source of liquefaction was discussed. Sasaki (1998) stated that the original sandy body of the dike subsided into peat, expanded in its volume (loosening) and became liquefiable. For more details, refer to Sect. 17.4. Since this site took five months to repair, the conventional philosophy of quick repair before flooding comes did not function. Hence, a need of seismic resistance of important river dikes was recognized for the first time. Figure 14.14 shows a classical record of Nagara River dike which was destroyed by the 1891 Nobi earthquake. The longitudinal cracks suggest the tensile deformation of the dike in the lateral direction (Type 3 in Fig. 14.1). See in this figure the falling of railway bridge (Kansai Line) as well. It is very important that the stability of foundation soil significantly affects the stability of an overlying embankment. Figure 14.15 illustrates a case of Chan Dam in Gujarat Province of India which was destroyed by an earthquake in 2001. Although the dam body was compacted in accordance with the regulation, not much attention was paid to the natural deposit under the dam body. The subsoil liquefied when earthquake occurred, and its large distortion destroyed the dam body. It is interesting that the heaving at the end of the distortion zone was visible at the time of the author's site visit.

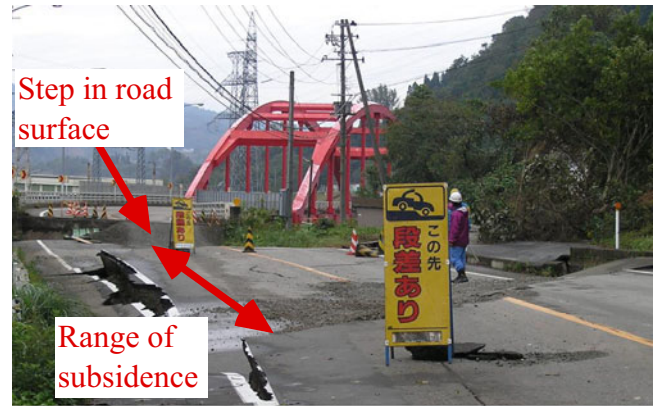
Fig. 14.16 Bridge out of service due to subsidence of approach embankment (Minami Yamabe Bridge of Ojiya City, 2004 Niigata-Chuetsu earthquake)

Densification of road embankment due to strong shaking results in subsidence. If this occurs near an abutment of a bridge, the road transportation is stopped (Fig. 14.16) and even an emergency traffic is prevented. Thus, although the main body of a bridge is of good seismic design, its function is stopped by the soil part.

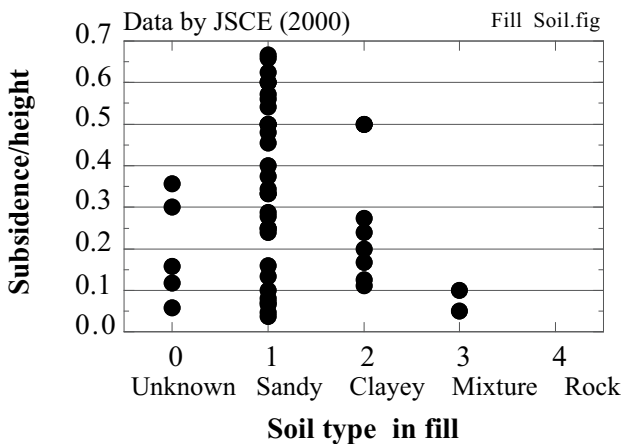
Fig. 14.18 Effects of soil type in embankment on extent of subsidence (JSCE, 2000)

Figure 14.18 illustrates the magnitude of subsidence (subsidence/height ratio) changing with the type of soil in the embankment. It is found that sandy fill material can induce significant subsidence. Furthermore, Fig. 14.19 examines the effects of soil type in foundation on the extent of subsidence. Again, sandy foundation can cause large subsidence. These findings are probably related to excess pore water pressure development and consequent liquefaction either in fill or in foundation. It is important in Fig. 14.19 that clayey (or peaty) foundation soil might generate significant subsidence as well.

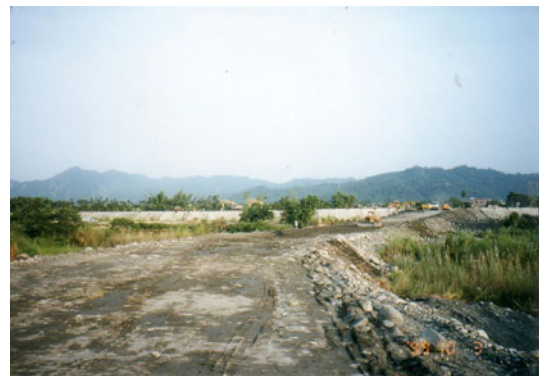
Fig. 14.22 Quick construction of temporary road embankment after collapse of bridge (1999, Taiwan)

It should be stressed that performance of geotechnical structures is different from those of steel and concrete structures. Even if the factor of safety is far less than unity, the situation may still be different from what is called total collapse. The most important feature is the quick restoration. A typical example was presented in the restoration of damaged dike in Taiwan (Fig. 14.3). Figure 14.21 illustrates a total collapse of an important bridge in Taiwan at the time of the 1999 ChiChi earthquake. When the author visited the site two weeks after the quake, a temporary road had already been constructed by earth fill (Fig. 14.22). Figure 14.23 manifests a similar example of river dike restoration after the 2003 Tokachi-oki earthquake.

3. There is not a clear idea on how to determine the allowable deformation. From the viewpoint of limit state design, it is not evident what kind of limit state is appropriate for geotechnical earthquake design; serviceability, restoration, or ultimate failure. If somebody says that 50 cm is the allowable limit, what about 55cm? What is the reason to insist on 50 cm? Most probably, the allowable limit is related to risk to human life, damage cost, pause period of expected service, influence to region/nation, time for restoration, and others. It is important to take into account the situations in Figs. 14.22, 14.23, and 14.25.

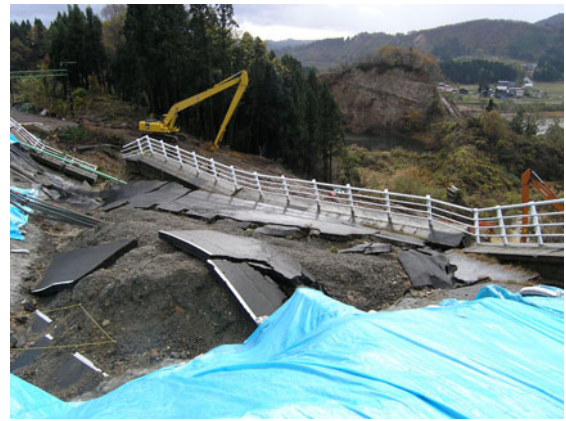
Fig. 14.24 Significant subsidence of road embankment resting on small valley topography caused by 2004 Niigata-Chuetsu earthquake

Quick restoration and construction are important and unique feature of geotechnical structures. The total collapse of a road embankment in Fig. 14.24 appears to be too significant to be allowed. The seismic stability of this part of road embankment was bad because it was placed many decades ago on soft valley deposits. From the viewpoint of oil pipeline and communication lifelines which were embedded in this embankment, this collapse was certainly not allowable. From the viewpoint of road, in contrast, this case may still be allowable. Fig. 14.25 shows the reason; a detour road was constructed next to this collapsed fill within a few days after the quake. Hence, the road traffic was not stopped for many days.

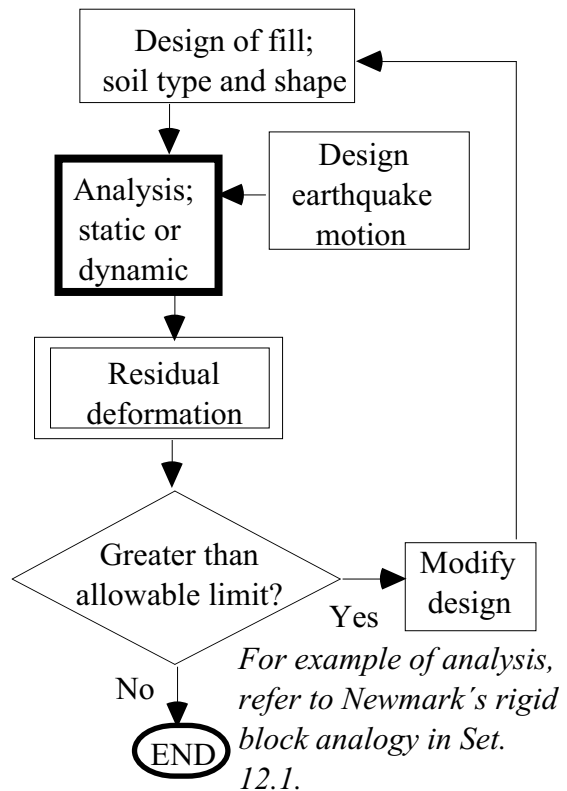
Fig. 14.26 Flow of seismic design based on allowable deformation

The future principle in seismic design will allow the factor of safety to be less than unity and maintain the residual deformation within an allowable extent (Fig. 14.26). Since the seismic load is not of a static nature as (14.1) hypothesizes, its effect lasts for a short time (Sect. 5.12), and does not cause an infinite magnitude of deformation even if the factor of safety is less than unity.

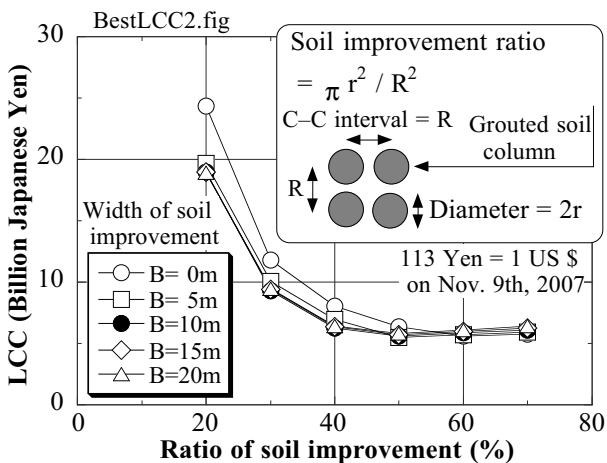
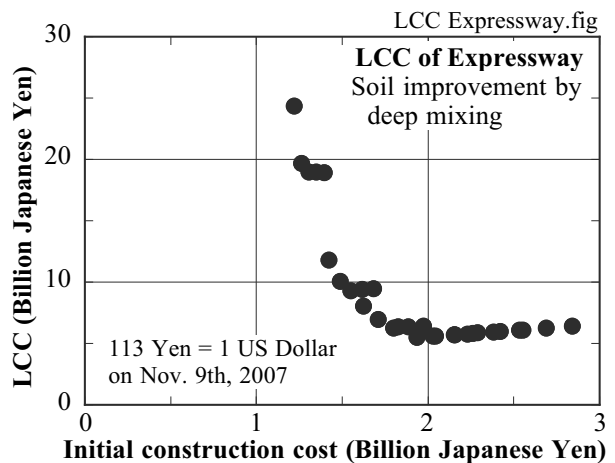
Fig. 14.42 Minimum LCC of expressway embankment

(a) Variation of LCC with extent of soil improvement

(b) Change of LCC with initial construction cost

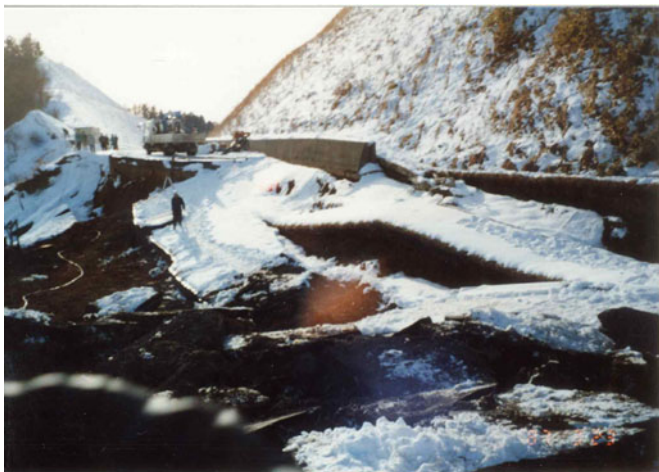
Fig. 14.43 Failed shape of Itoizawa road embankment in 1993

The 1993 Kushiro-Oki earthquake triggered a failure of an important road embankment at Itoizawa site (糸魚沢) between Akkeshi (厚岸) and Nemuro (根室) in Hokkaido. This road was situated along the foot of hills which faced a marsh (swamp) of soft stream deposit. Figure 14.43 indicates the failed shape of the road embankment. This failure occurred at a place where the road crossed the exit of a small stream into the marsh (Fig. 14.44). Thus, an embankment resting on soft soil collected much water from a valley behind and failed easily upon shaking. The slope stability of the embankment had been improved before the quake by placing berms (腹付け盛土 on left and right sides of Fig. 14.45) at the bottom of the fill. This was however insufficient on the embankment resting on softer subsoil.

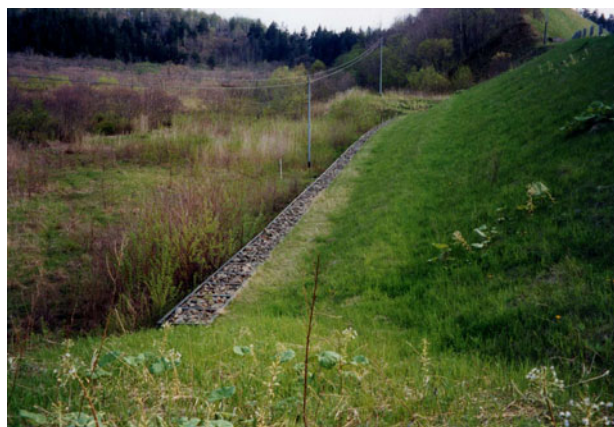
Fig. 14.46 Repaired toe of road embankment in Itoizawa (photo by T. Honda)

The damaged fill was restored by constructing reinforced earth fill (soil with geogrids, plastic sheets, geotextiles, etc) while installing more water drainage pipes and replacing the base soft soil by gravels. Gravel gabions were placed at the toe of the slope for better shear strength and drainage (Fig. 14.46).

Note that the slope toe is the place where stress concentrates and shear strain becomes greater than in other part of the fill. Together with the effects of drainage from inside the new embankment, consequently, no damage occurred here upon the 1994 Hokkaido-Toho-Oki earthquake.

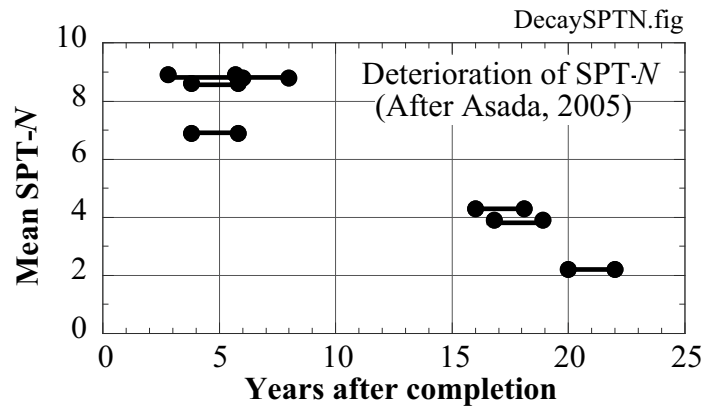
Fig. 14.47 Deterioration of fill material with time (after Asada, 2005)

In addition to reinforcement, the type of fill materials has to be considered. Asada (2005) compared SPT- N values in residential fills which were affected during the 1978 Miyagiken-oki earthquake around Sendai City. While N values exhibit substantial variation within each site, the mean value in Fig. 14.47 clearly decreases with years after completion of filling. This infers that the filled geomaterials were affected by ground water and disintegrated with time (slaking of such materials as mudstone). This is in contrast with a common idea that soil increases its rigidity with time (ageing: Sect. 10.12).
