Fawu Wang · Tonglu Li (Eds)

Landslide Disaster Mitigation in Three Gorges Reservoir, China

Geo-hazard Initiation and Assessment in the Three Gorges Reservoir

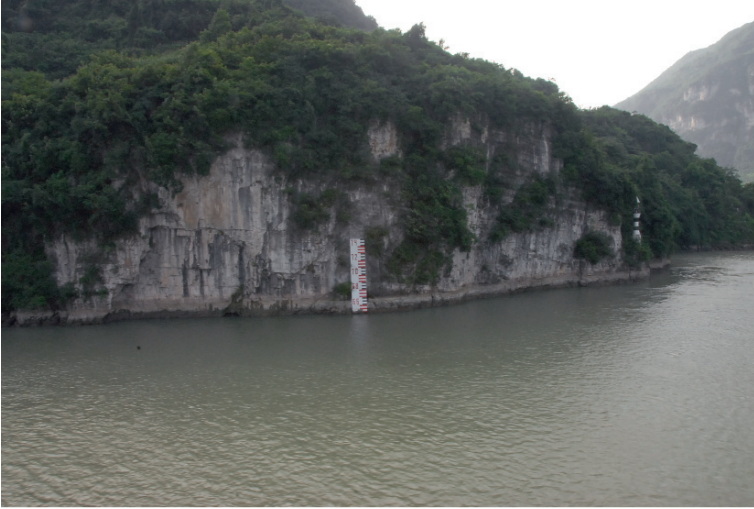
Photo 1 (Xiling Gorge eastern part) The end of the eastern part of Xiling Gorge. The cliff is formed by limestone. The measurement shows the water level of the downstream area of the Three Gorges at 65 m a.s.l

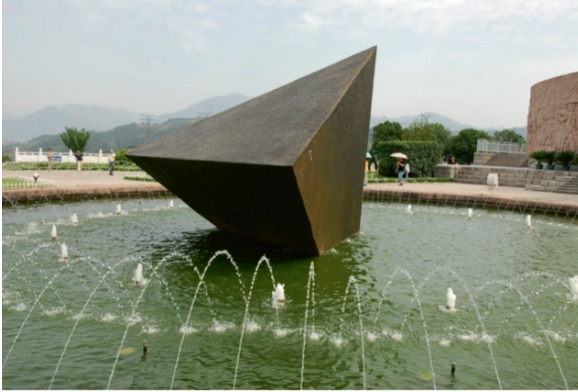
Photo 9 (Three Gorges dam) This wedge, now located at the dam visitor's center, was used to stop the river flow at the initial stage of the dam construction

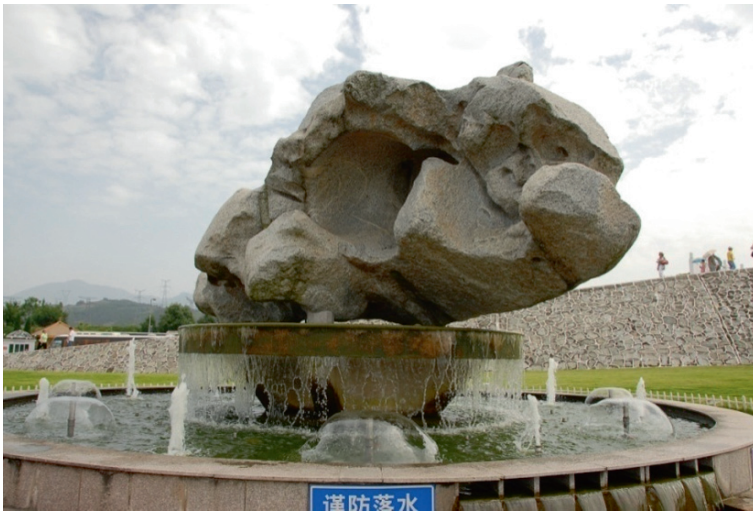
Photo 10 (Three Gorges dam) A chunk of bedrock taken from the river bed at the dam site of the Three Gorges dam is displayed at the visitor's center

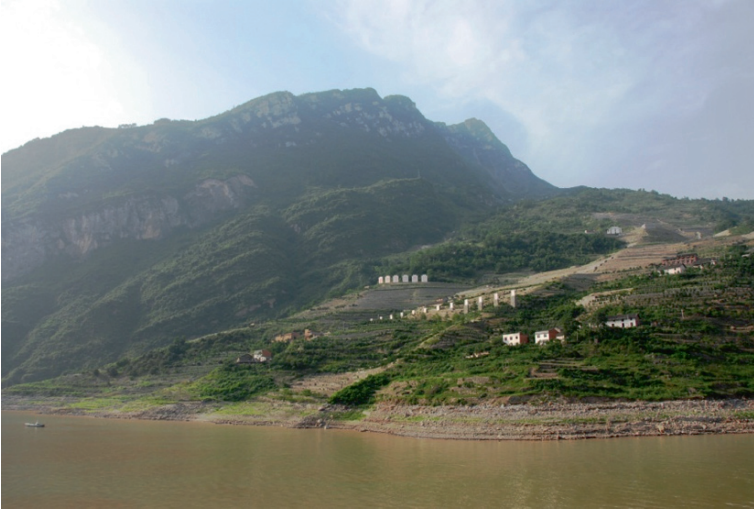
Photo 13 (Xiling Gorge western part) The site of the Xintan landslide that occurred in 1985. Because of the successful failure prediction based on monitoring, no one was killed by the large-scale landslide. It has been preserved as a visitor’s site for geo-hazard education, after the gradation was performed

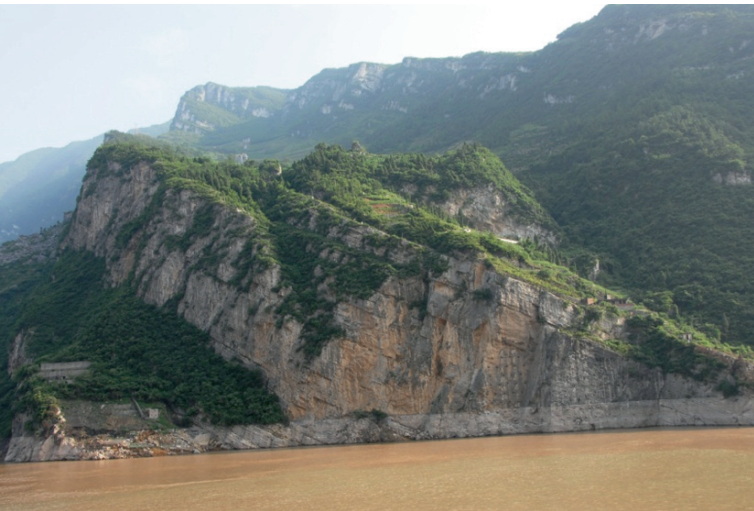
Photo 14 (Xiling Gorge western part) The Lianziya potential dangerous limestone cliff. It is located on the opposite bank of the Xintan landslide. Countermeasure works such as anchors were applied to reinforce the part near the river. This area is the narrowest part of the Three Gorges

The special geological condition brings up the topic of the Lianziya dangerous rockmass, which is well known as it is on the opposite bank the Xintan landslide, located in the Xiling Gorge area. Meanwhile, there are plenty of dangerous rockmasses distributed, that are of different size. After an overall investigation in 2006

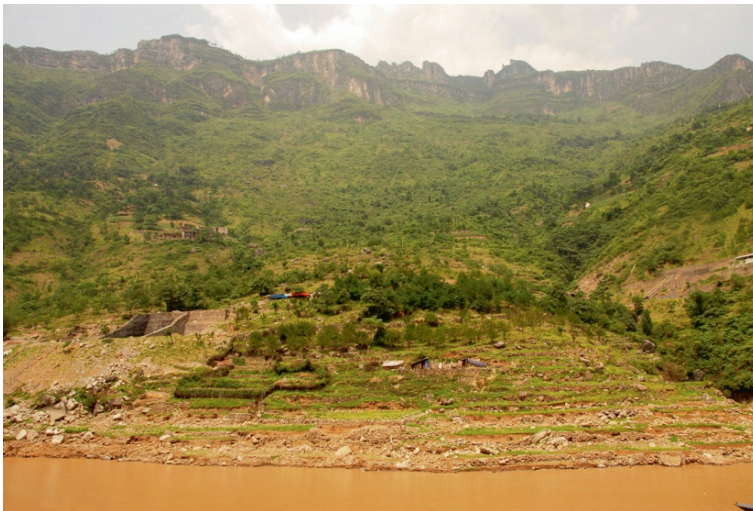
Photo 18 Landslide formed by colluvium from the limestone cliff, located in the far mountain, between Wu Gorge and Qutang Gorge

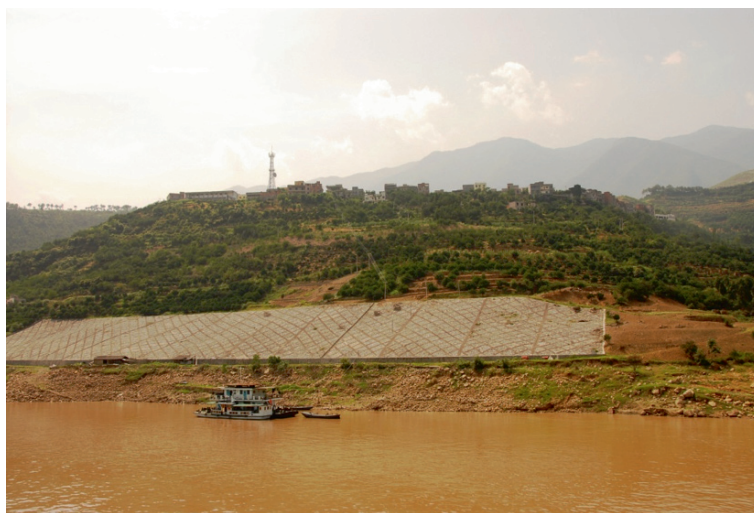
Photo 20 Countermeasure works applied to the landslide between Wu Gorge and Qutang Gorge

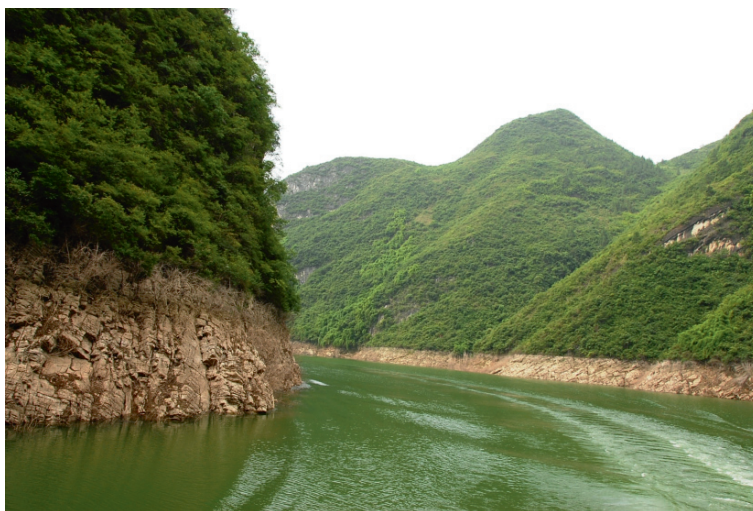
Photo 23 The green water in Shenlongxi stream, a tributary of the Yangtze. The exposed zone without green was formed by washing of the previously increased water level of the reservoir

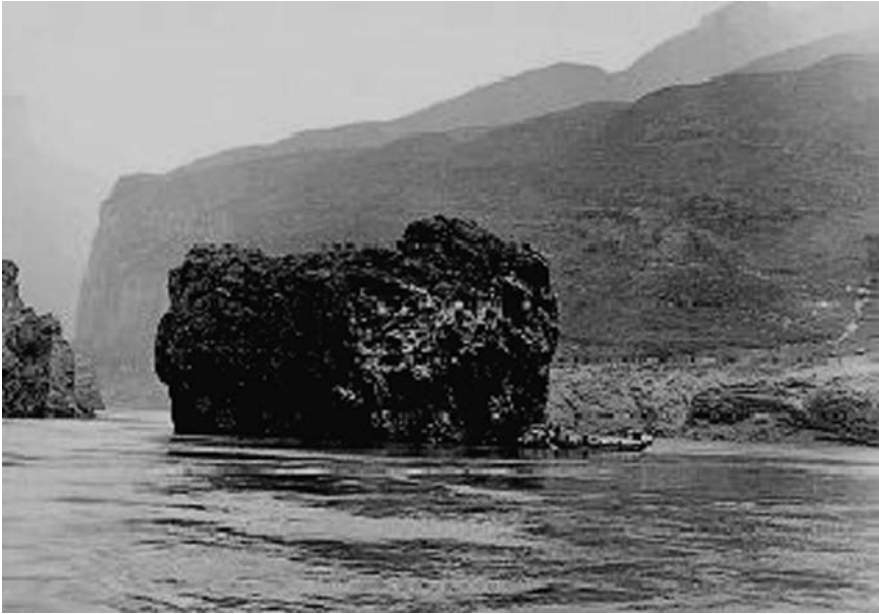
Fig. 1.7 Rock fall trace in Qutangxia Gorge – “Yanyudui,” a huge stone (from Zhangzudao, photographed in 1956)

5. *Collapse relic-Yanyudui*: “Yanyudui” was always a huge stone in the Qutangxia Gorge of the Yangtze River, which was 30 m long, 20 m wide, and 40 m high. It was blown up by 20 tons of dynamite to remove the barrier in the winter of 1958. “Yanyudui” was a typical collapse relic, which showed that huge landslides and collapses had always taken place in Qutangxia (Fig. 1.7).

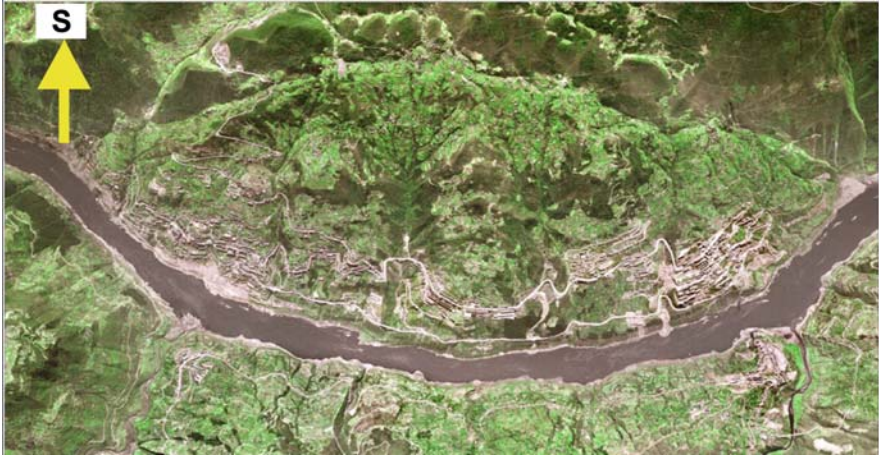
Fig. 1.10 Aerial map of the Badong large slope (from China Aero Geophysical Survey & Remote Sensing Center for Land and Resources (AGRS), 2003.4)

- (2) The Badong big slope is a fan-shaped slope where the strike is nearly east–west and the incline is north. There are a series of deep and big gullies in the slope area, and the gullies pass through the slope from south to north and enter into the Yangtze River. The whole area was cut into five slope units, forming widths of from 1.3 to 1.7 km, the distribution being nearly south–north (Fig. 1.10).

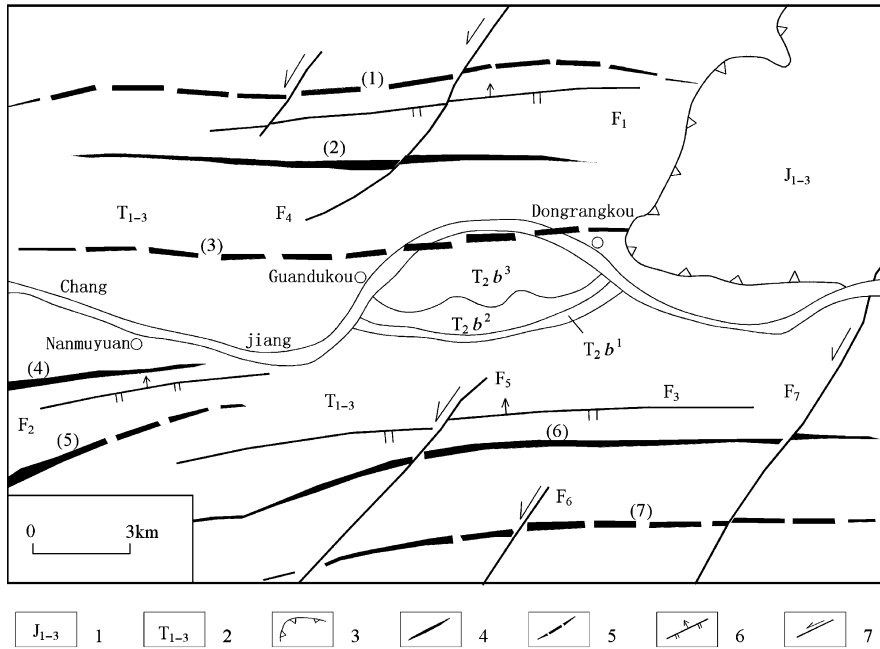
Fig. 1.11 Areal structure sketch of Badong slope in the Three Gorges of the Yangtze River. 1 – Jurassic System; 2 – Triassic System; 3 – continental deposit (Zigui) basin; 4 – anticline structure axis; 5 – syncline structure axis; 6 – reversed fault; 7 – shift fault. (1) – Huofeng syncline; (2) – Xiaogaoshan anticline; (3) – Guangdukou syncline; (4) – Nanmuyuan anticline; (5) – Duping syncline; (6) – Baifuping anticline; (7) – Fengcuiya syncline; F₁ – Guangyintang fault; F₂ – Bingshuijing fault; F₃ – Maluchi fault; F₄ – Gongqiao fault; F₅ – Yeluchi fault; F₆ – Meiziya fault; F₇ – Niukou fault

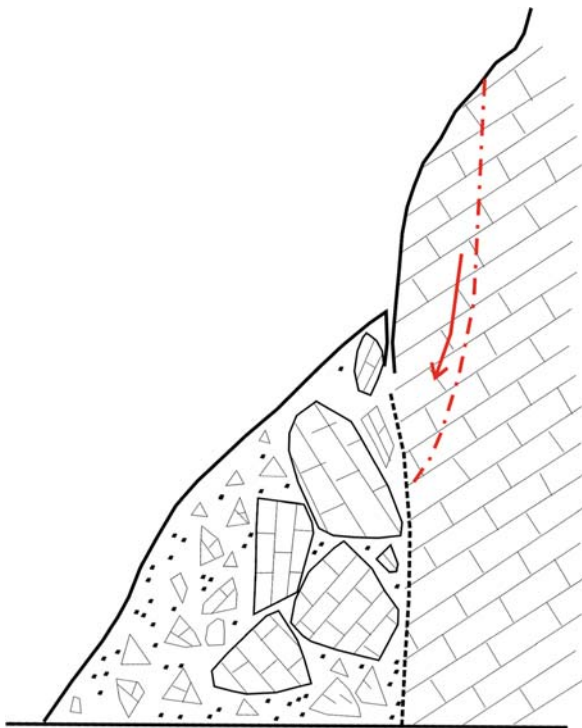
Fig. 1.14 Surface layer weathering model

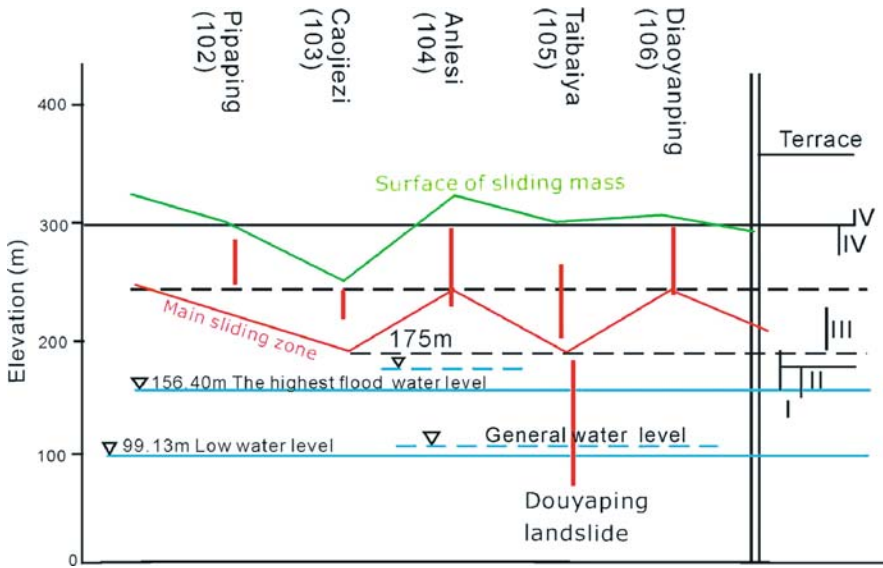
Fig. 2.3 Profile of sliding surface elevation of the old landslides in Wanxian city

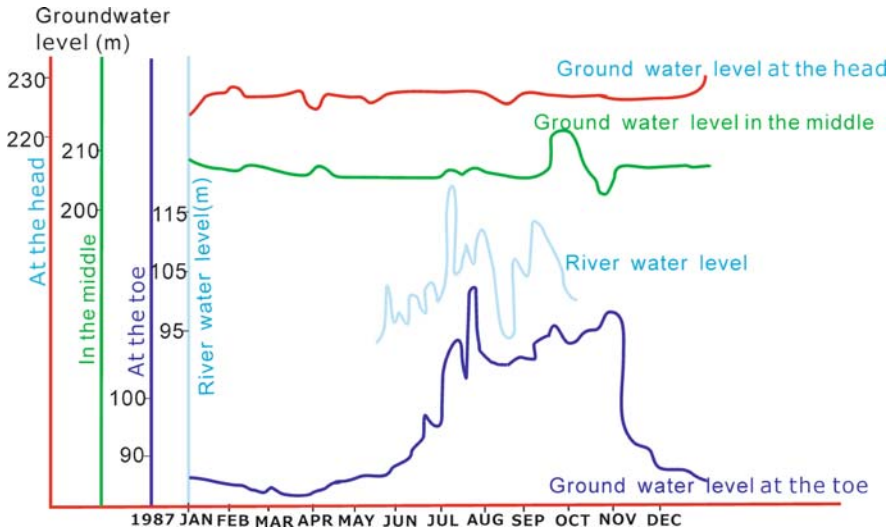
Fig. 2.12 Relationship between ground water level changes in the Jipazi landslide and the river level in 1987

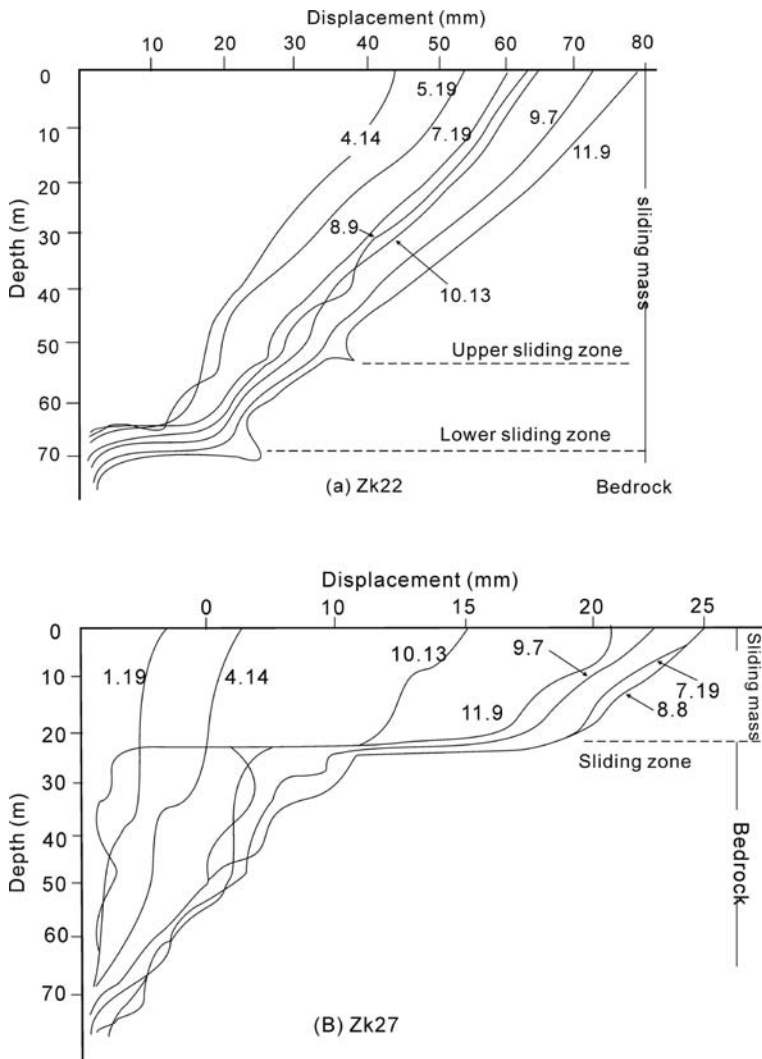
Fig. 2.16 The curves of displacement verses depth measured by borehole inclinometers in the Huanglashi landslide

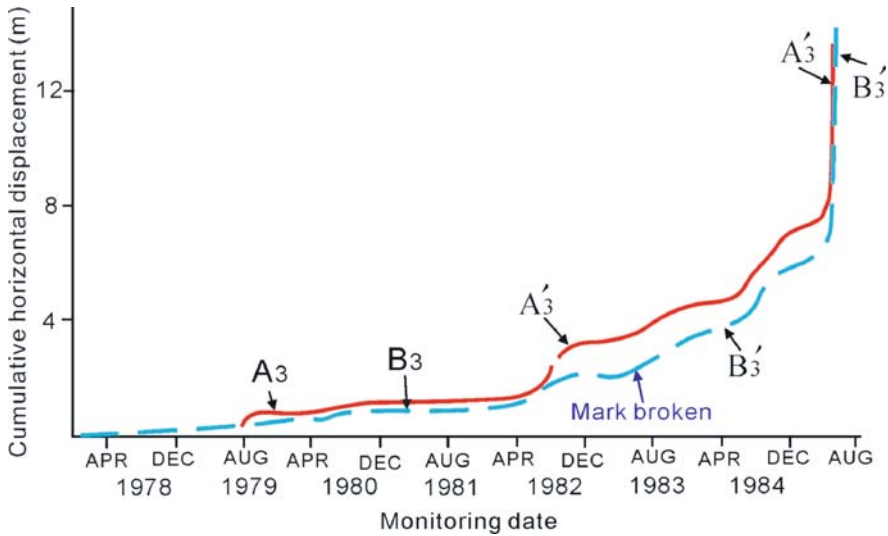
Fig. 2.17 Cumulative horizontal displacement curves on the observation lines A3-A3' and B3-B3' for the Xintan landslide

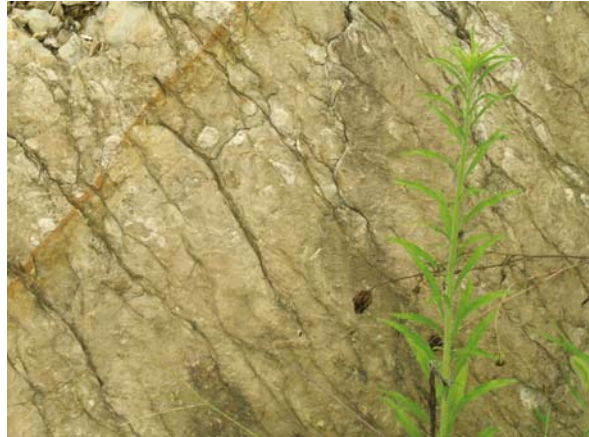
Fig. 3.3 Cleavage of muddy pelmicrite of the 3rd section of Badong formation

(3) *Cleavage structure*: Emphasis is given to outdoor and indoor observations and research of the 3rd section, and the result shows gradual and fluctuating development of cleavage instead of a straight and flat face (Fig. 3.3), and the cleavage domain looks like a narrow and long lens. The thickness of the cleavage domain of a dark celadon muddy stratum ranges from nearly 1 to 5 mm; for more careful observation, this stratum is differentiable to several strata (muddy) of less thickness, sandwiched by thin layer of white and fine crystal calcite in the form of a multilayer pie. To observe this stratum under a microscope, the multilayer structure is clear, among which the muddy pelmicrite observed in the open is fine sericite flakes arrayed in a given direction, and the fine crystal calcite stratum develops vertical to the rock wall, with joints vaguely visible at the center (Fig. 3.4).

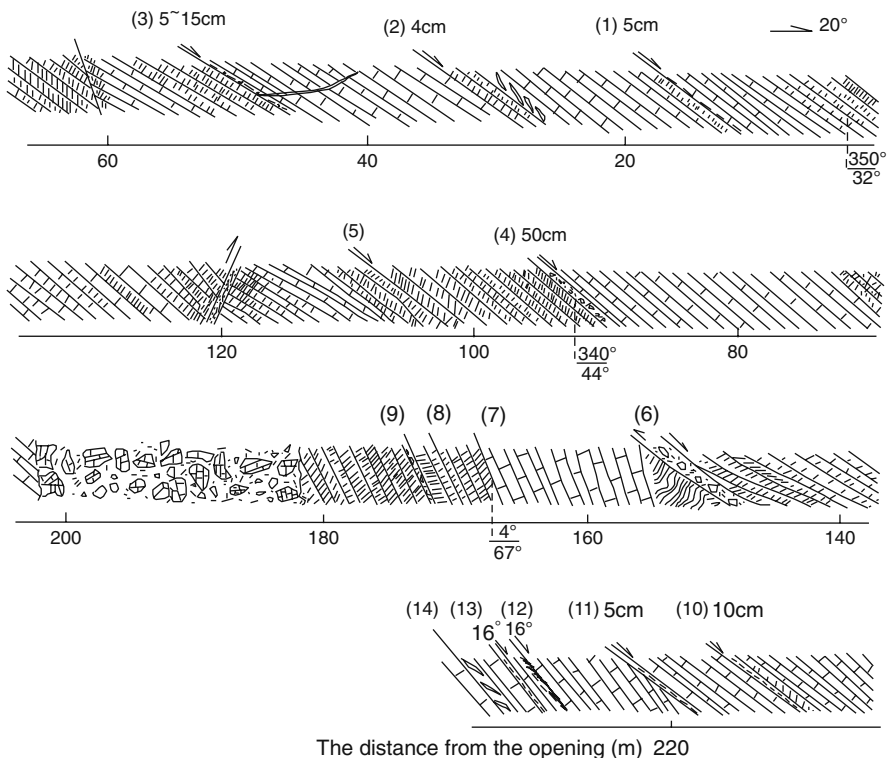
Fig. 3.7 Measured section of the water diversion tunnel on Xirang slope

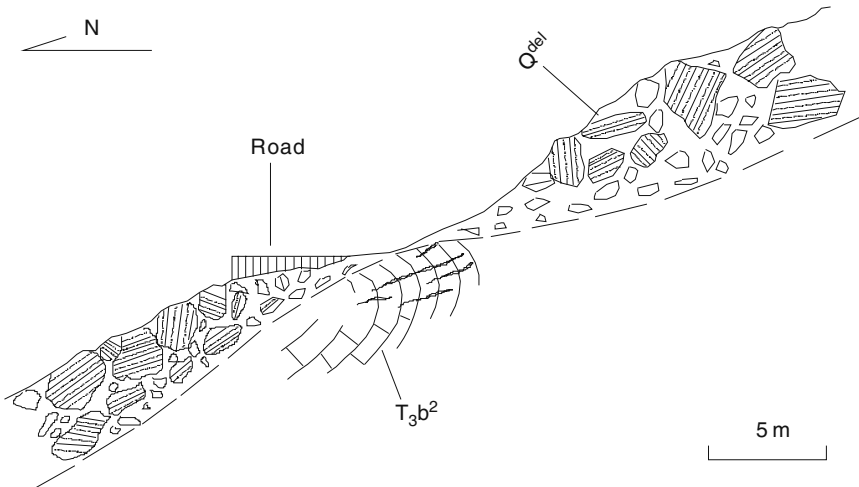
Fig. 3.13 Asymmetric fold and shearing slippage of Sandaogou of the Huangtupo landslide

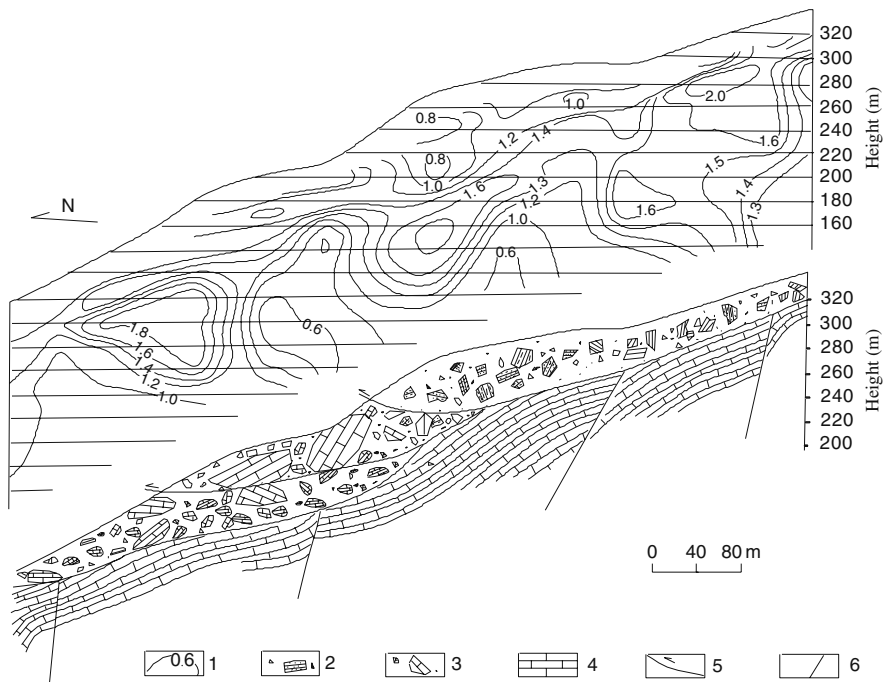
Fig. 3.15 Resistance ratio section (*above*) and geological explanation (*below*) of the Huangtupo landslide. 1 – ratio contour; 2 – stone blocks composed by muddy siltstone and silty mudstone of the 2nd section of the Badong formation; 3 – stone blocks of muddy pelmicrite of the 3rd section of the Badong formation; 4 – pelmicrite; 5 – sliding plane; 6 – fault

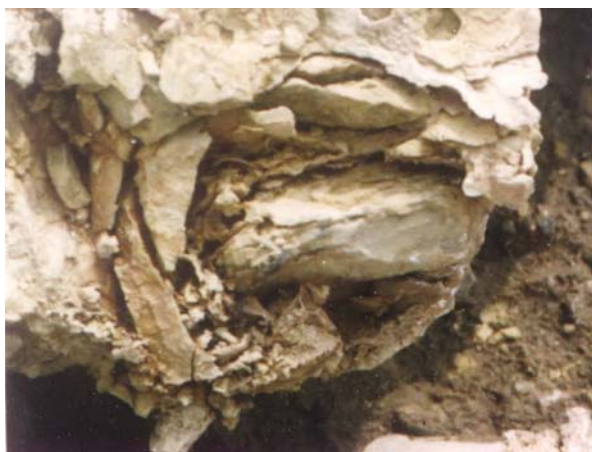
Fig. 3.17 Breccias at the shearing outlet in the front edge of the Huangtupo landslide, a shredded cabbage pattern occurs as a result of strong pressure, in the riverfront, 300 m to the east of Sidaogou

The breccias or muddy breccias zone of large size in the front edge of the Huangtupo landslide (riverfront) is compatible to the loose deposition zone, certainly the outcome of the shearing outlet. Nevertheless, Huangtupo landslide is not formed overnight; instead, it is an outcome of multiple stages, characterized by loss of stability.

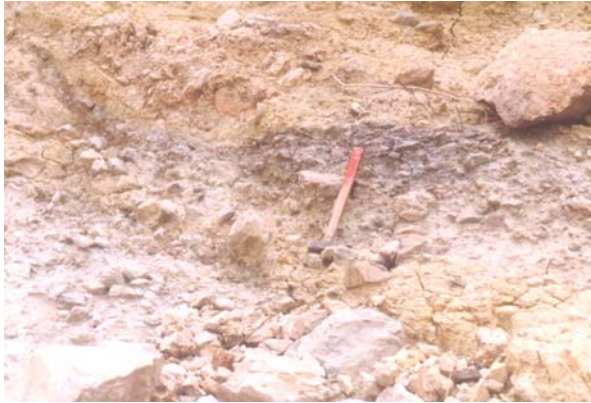
Fig. 3.18 Landslide zone in the front flank of the Huangtupo landslide, in the riverfront, 200 m to the west of Erdaogou

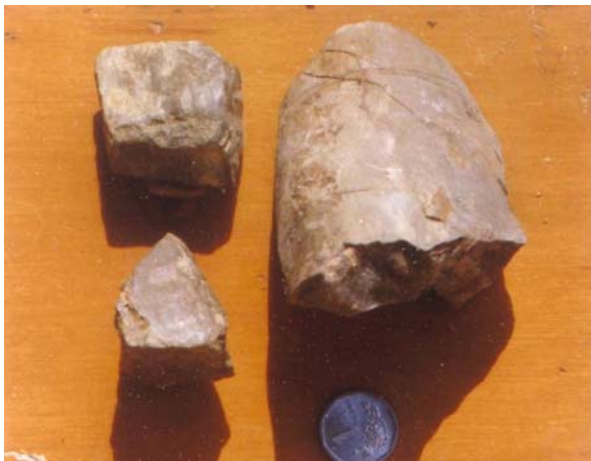
Fig. 3.19 Rounding and polish of breccias in the front flank landslide of the Huangtupo landslide, on the riverfront, 200 m to the west of Erdaogou

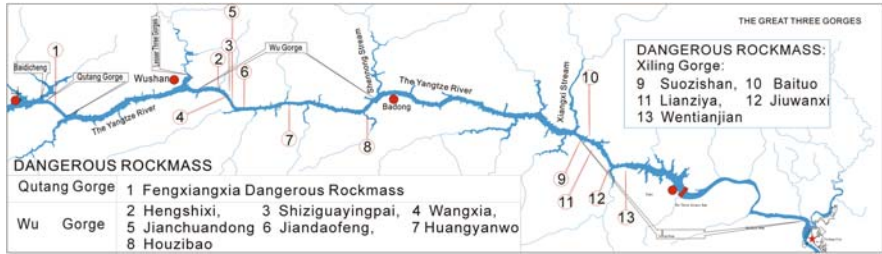
Fig. 4.4 Regional map showing the locality of the important dangerous rockmasses in the Great Three Gorges River valley

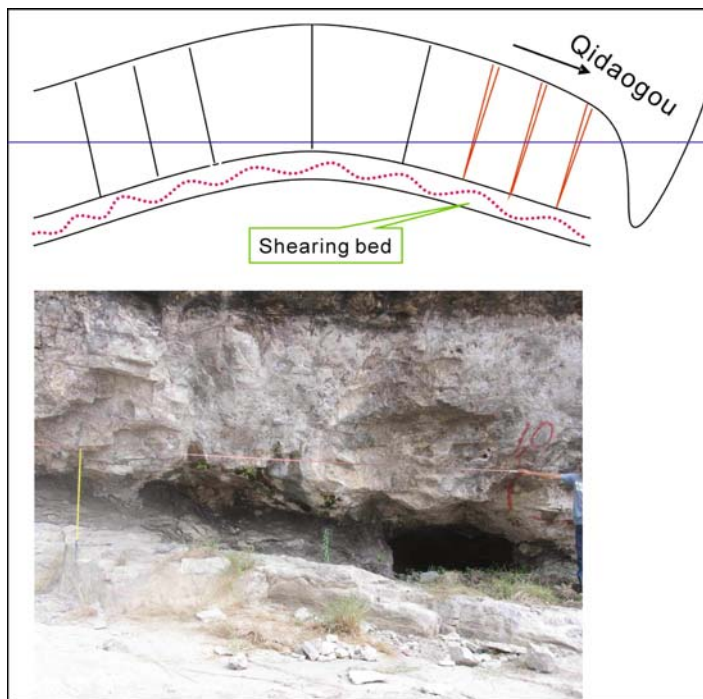
Fig. 4.5 Creep-tense mode of dangerous rockmass in Fengxiangxia Gorge and its underlying large cutting belt between layers (the scale in figure is 1.5 m)

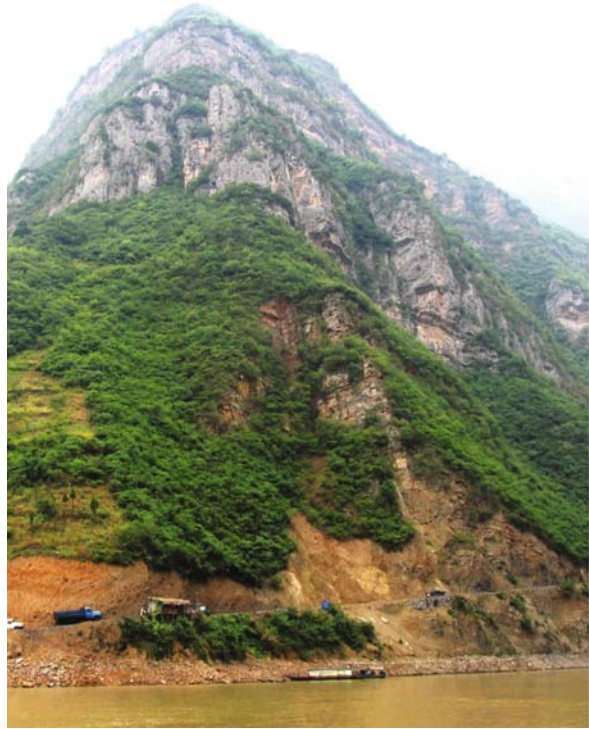
Fig. 4.6 The Hengshixi dangerous rockmass

The Hengshixi dangerous rockmass in Wu Gorge is located on the right bank of the entrance of Hengshixi brook at the north bank of Wu Gorge, is configured in the northwest wing of Hengshixi anticline, and consists of M1# dangerous rockmass on the top and M2# dangerous rockmass at the bottom (Fig. 4.6).

The M2# dangerous rockmass is composed of the Silurian Shamao Formation sandstone, limestone and weak sand shale underneath, and the near rock layer is generally toward the NW with an angle between 25° and 35°. The rockmass is broken, and it is broken structurally. Due to the effects of cutting the slope to build a simple road, the right side of the dangerous rockmass had already collapsed during this process, and a triangular free face was formed. Meanwhile, the localities toward the east and Hengshixi Brook are also free faces. The rear of the dangerous rockmass is a beveled formation with the sheared breakage of Hengshixi Brook (or almost parallel), and it is controlled by the underlying rockmass that contains the

broken structure and the shearing joint. The M2# dangerous rockmass is 25 m long, 12 m wide, 117 m high, and is 31,800 m³ in total volume. Currently the dangerous rockmass is creeping and will constitute a huge threat to the coal mine wharf and vessels in the surrounding area, so a further study on its formation origins is necessary in order to make an evaluation of its stability, and subsequent reasonable disposal plan for the possibility of problems.

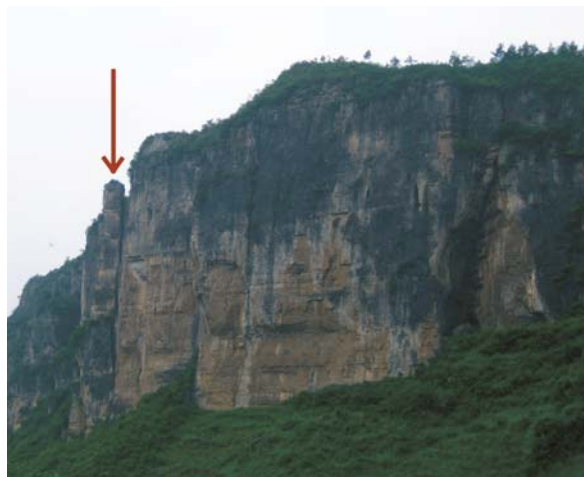
Fig. 4.8 Tongxincun dangerous rockmass

This dangerous rockmass is located on a slope with an elevation of between 1,100 and 1,250 m, the slope root is a flat slope within its 30 m, the slope gradient is 30°, but the top is almost a 90° cliff. In the last 10 days of July, 1999, the dangerous rockmass in this slope happened to deform severely. There are six large fractures that exist in the slope, and a dangerous rockmass cluster with the dimensions of 230 m in length, 50 m in width, and 115 m high was formed, and its total volume is about 1.32 million m³. The fracture in the free face of the rockmass widened about 20 cm in 1 week, and the dangerous rockmass that is separated from the mother rock is around 8.6 m long, 15 m wide, and 75 m high with a total volume of 1,000 m³

(Fig. 4.8). There are subsiding pits at the top that have a diameter of roughly 10 m (Fig. 4.9). After collecting statistics on the fracture in the cliffs of several rockmass, it was found that two groups of advantageous joints grow inside the rockmass, i.e., $90\text{--}100^\circ \angle 80\text{--}85^\circ$, $165\text{--}174^\circ \angle 75\text{--}82^\circ$. The two groups of joints are vertical with each other and form the boundaries of steep cliffs and dangerous rockmasses. Its damage mechanism is the subsiding-bevel lifting mechanism together with human excavation activities. This dangerous rockmass constitutes a huge threat to the local residents, the mineral company, and the sea route.

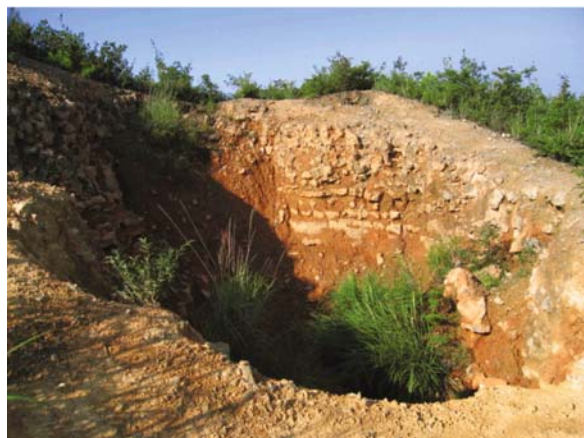
Fig. 4.9 Subsiding pit on the top of the dangerous rockmass

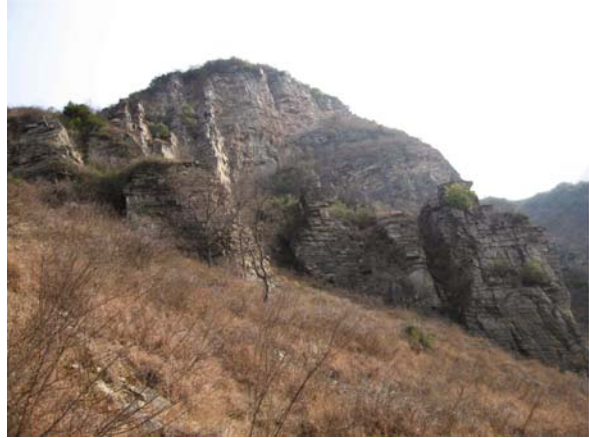
Fig. 4.10 Liaojiaping dangerous rocks group

core of Hengshixi anticline. On the east side of the Liaojiaping slope, there is gutter-like topography, and in the west, it is a gulch formed by Laoshucuo fault, so that it forms a protruding ridge (Fig. 4.10) with three free-face sides around it. From the bottom to the top of the slope, the composition is sandstone, siltstone, and mudstone of Silurian Shamao Formation (Ss), quartz sandstone of Devonian Yuntaiguan Formation (Dy), and silicon dolomitic limestone of Carbonic Dapu Formation (Cd), in which the siltstone and mudstone of Silurian Shamao Formation (Ss) and Devonian siltstone (Dy) are weakly interbedded. Under the constraint of lithology, the slope looks like a cascade as a whole, because of the influence of “plough type” (the top is steep, but the bottom is flat) Laoshucuo fault, the attitude of the Silurian Shamao Formation (Ss) at the bottom is still $340^{\circ} \angle 30^{\circ}$, but normally $130^{\circ} \angle 15^{\circ}$ for the terrain on the top, whereas the overall attitude is $130^{\circ} \angle 5^{\circ}$ for the steep rockmass where the terrain is flat.

shoulder section of the dangerous rockmass or above occurs after the layer and the joint cracks to form a slope in a cascading shape; the SE side contour underneath the shoulder section of dangerous rockmass is a wide unloading fracture (Fig. 4.10, L1), which makes the dangerous rockmass separate from the SE side of the mountain; the NW side of the dangerous rockmass in Jianchuandong is a vertical steep cliff (Fig. 4.13).

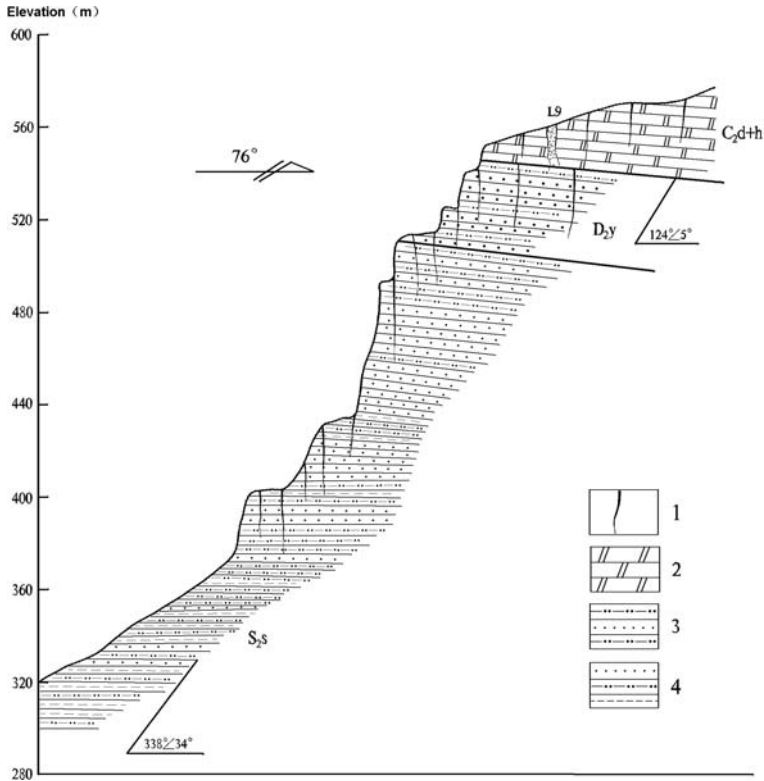
Fig. 4.11 Section plane of Liaojiaping slope 1 – fissures; 2 – dolomite; 3 – sandstone; 4 – siltstone mudstone

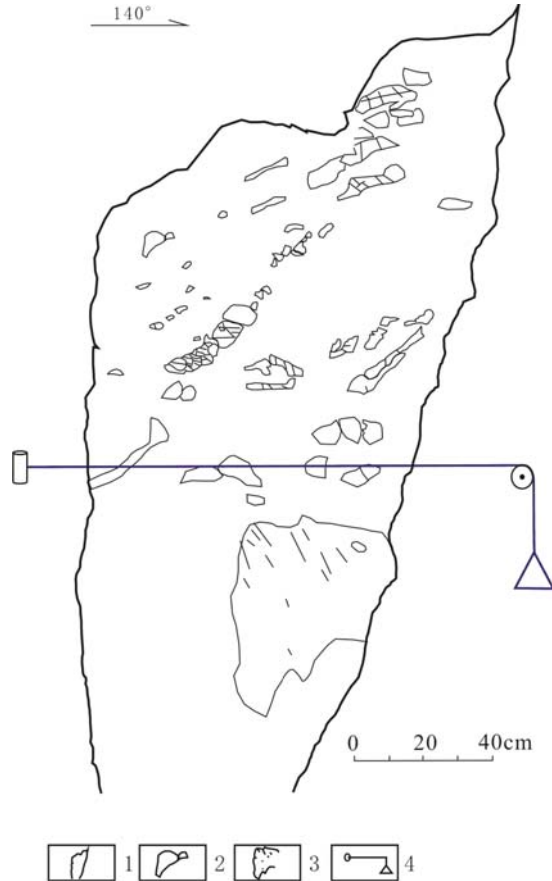
Fig. 4.14 Fracture packing of 2# extensive sense. 1 – fracture shape, 2 – stone fragment, 3 – the scratch on the earth surface after splitting fragment, 4 – extensive sense

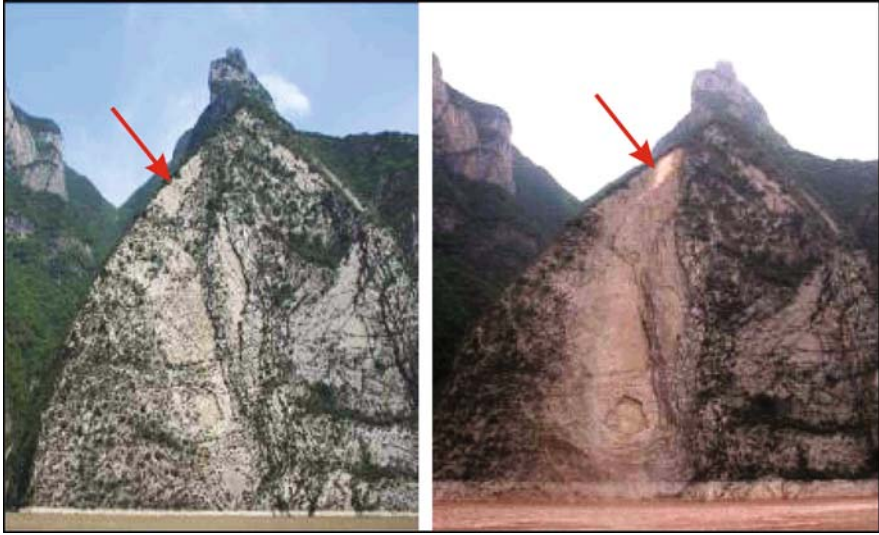
Fig. 4.17 Comparison of the situation before and after the rockfall occurred in Jiandaofeng area in Wu Gorge in 2007. **Left:** Before rockfall (taken in 2006); **Right:** After rockfall (taken in 2007)

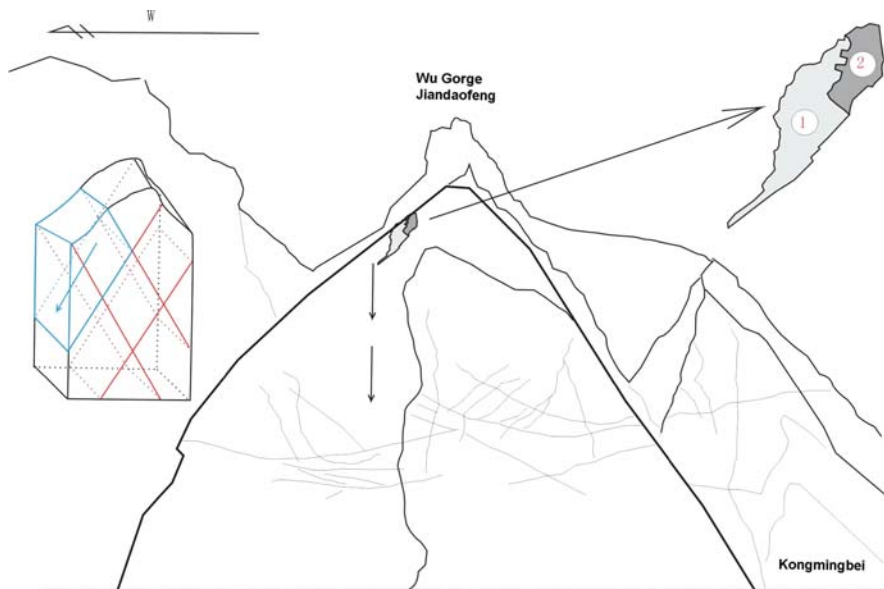
Fig. 4.18 Trace and collapsing mechanism of rockfall occurred at the top of the triangular surface of Jiandaofeng

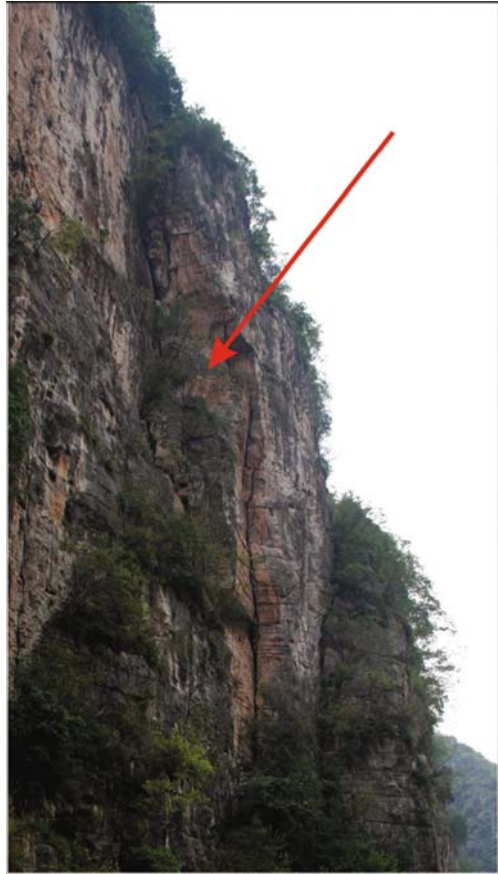
Fig. 4.19 An isolated dangerous rockmass in Huangyanwo

The fracture in the cliff at 400 m in this section extends extensively, the vertical, through and large fracture of two groups and horizontal terrain surface cuts the rockmass into single and thin erect wall shape (Figs. 4.19 and 4.20), and there are three places where the top hangs in the air since the below rockmass collapsed. These single and thin “rock walls” will possibly collapse or fall down. Additionally, the river in this section is narrow, all of which makes ships terrified.

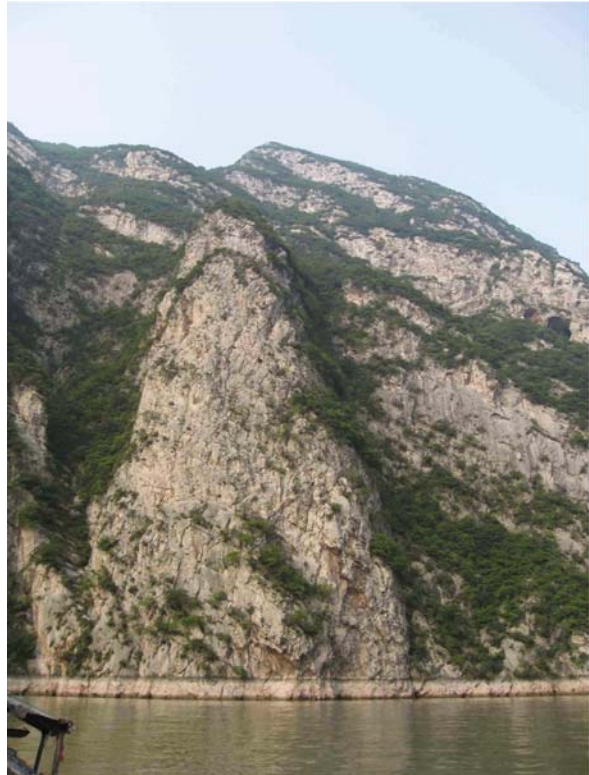
Fig. 4.23 Photograph of the front of Suozishan Mountain

long, 15–20 m wide roughly, now it is higher about 100 m than water surface; the whole height is around 200 m before the impoundment of water, and it looks like a shuttle attached to the mountain (Figs. 4.23 and 4.24). In view of the reflection of local fishermen, the rear boundary opens 3 m. The projection drawing of the structure level (Fig. 4.25) shows that there are plenty of advantageous attitudes in the rockmass, as the rockmass there is broken. Most of the cut crannies are ones with an attitude of $80^\circ \angle 80^\circ$ (nearly parallel to the joint of Yangtze River), $178^\circ \angle 70^\circ$ (nearly vertical to layer mechanism), and $314^\circ \angle 31^\circ$, and the blocks that are cut are of $1 \times 1 \times 0.7 \text{ m}^3$ in size. Though most of the dangerous rockmass will be submerged by water after impoundment, the gravel and ground swell caused by loss of stability cannot be ignored.

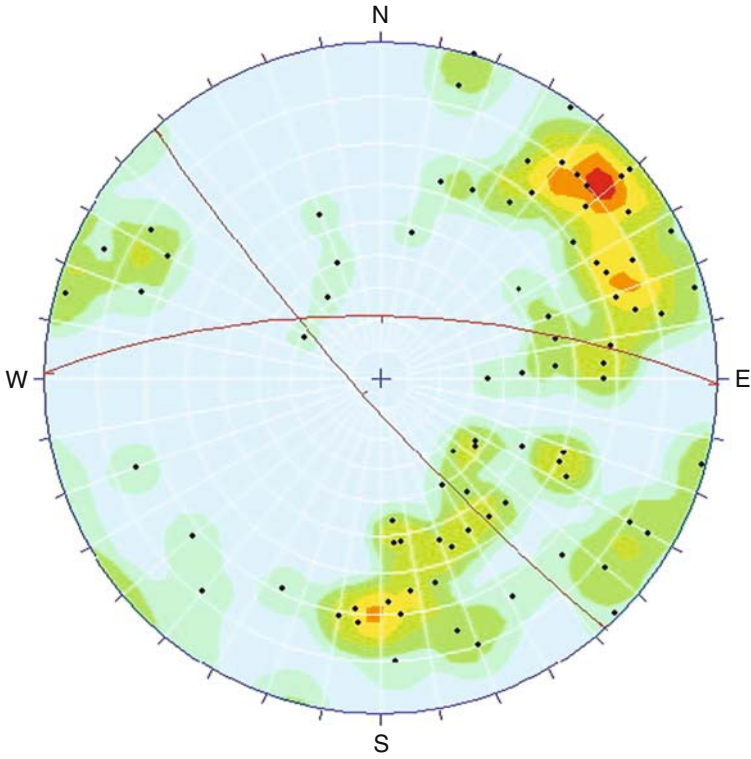
Fig. 4.25 Density map of joint poles of Suozishan Mountain

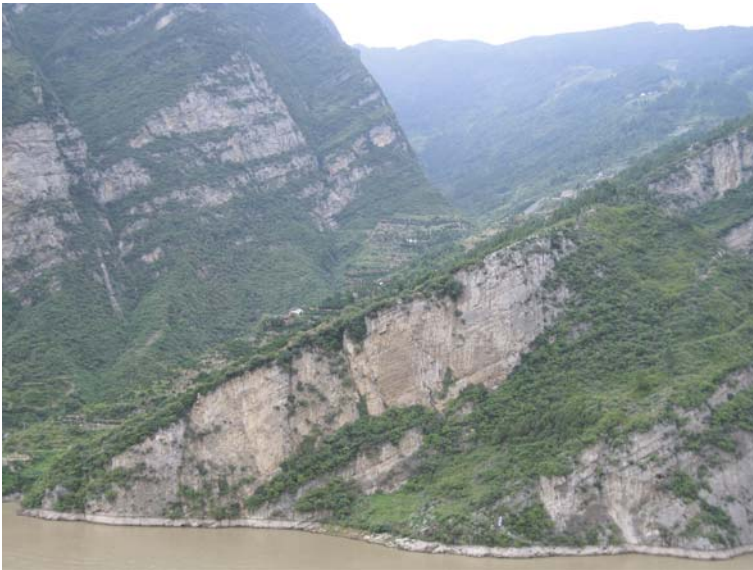
Fig. 4.26 Photograph of the front of the Baituo dangerous rockmass

Maokou Formation and Gufeng Formation, lying in waves, of a coarse nature. The average distance of large joints is 5 m, and the average distance of small joints is 2 m; the rockmass has a rather complete structure and is a thick broken block structure (Fig. 4.26). The locality is the anticline at the west wing of Huangling, and it is jointed with the east wing of Zigui basin. In the east side, there is the NNE-trending Jiuwanxi rupture at 8 km, the near side is the Xintan landslide, and the opposite side is the Lianziya dangerous rockmass. The stratum is a monocline structure, and the lay attitude is $305^{\circ} \angle 30^{\circ}$.

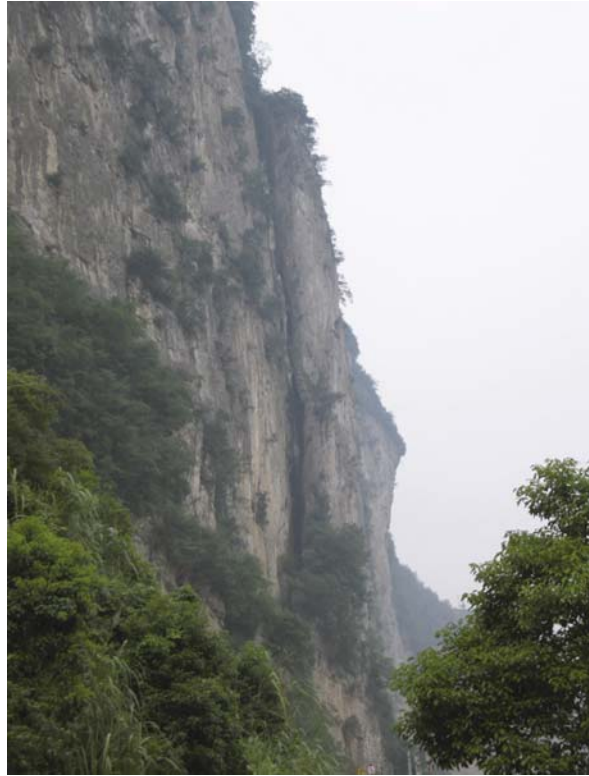
Fig. 4.29 Sketch of the Wentianjian dangerous rockmass

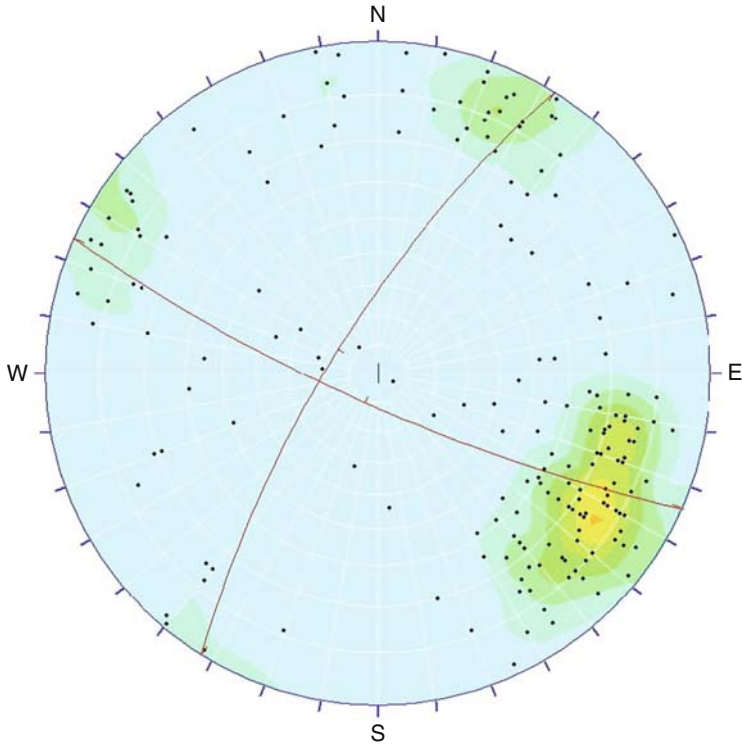
Fig. 4.30 Density map of joint poles of the Wentianjian dangerous rockmass

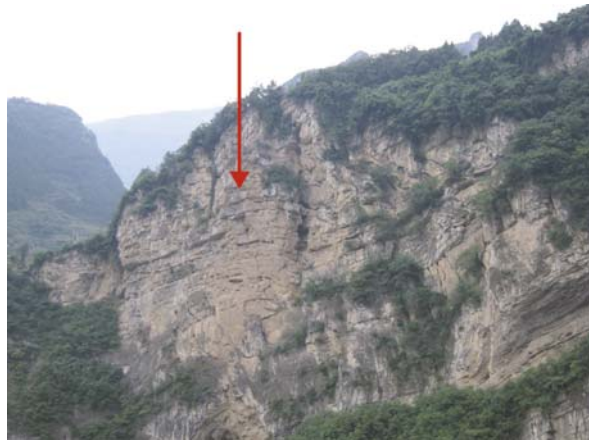
Fig. 4.32 The Jiuwanxi dangerous rockmass

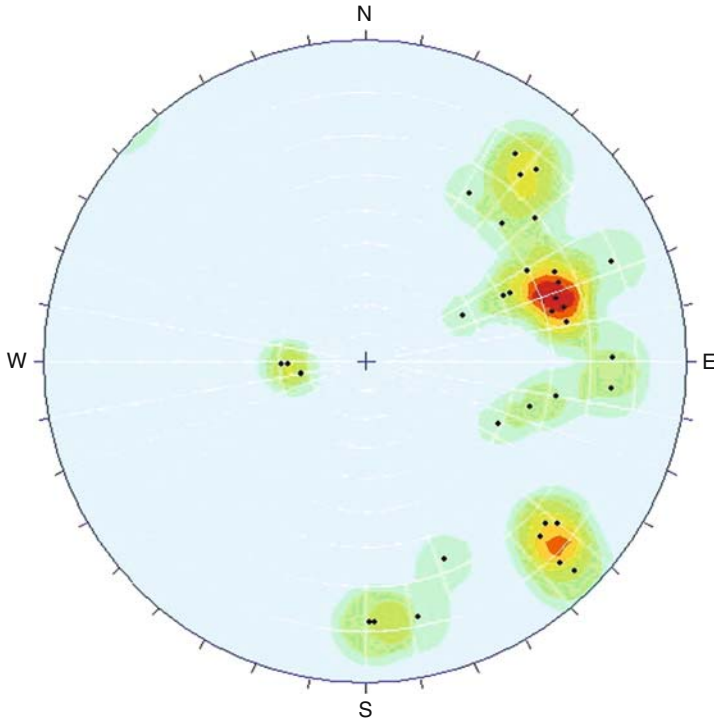
Fig. 4.33 Density map of joint poles of the Jiuwanxi dangerous rockmass

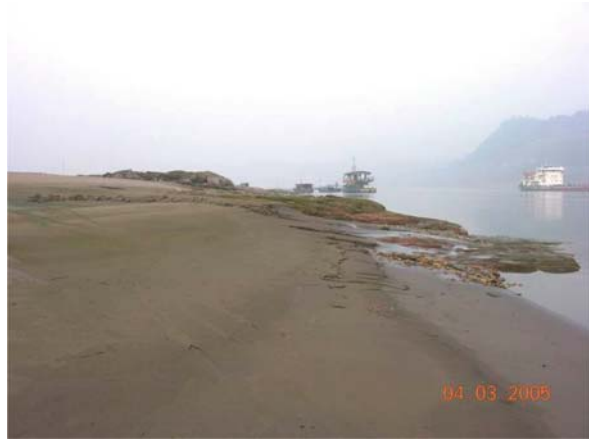
Fig. 5.1 Wash and abrasion collapse

Wash and abrasion refers to the reservoir bank condition of slow recession caused by the wash and erosion of external agencies like current and wave movement inside the reservoir (Tang et al. 2006a; 2006b). This type of bank collapse, with general distribution in Three Gorges reservoir area, mainly originates in bank slopes of gentle incline, intensely weathered granite sand slopes and an intensely weathered redbed belt (Table 5.1a). The reservoir bank reformation is slow and lasting, and the reformation scale is limited. Figure 5.1 is a case in point.

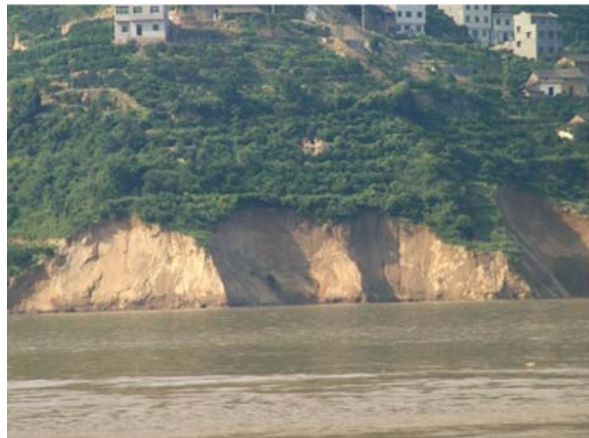
Fig. 5.2 Toe-erosion collapses (Huang et al. 2005)

usually occurs on the fairly slanting slopes (with gradient 30° – 60° and fairly good stability) composed of thick sandy soil, silty soil, and silty clay (Wushan's loess-like soil) (Fig. 5.2).

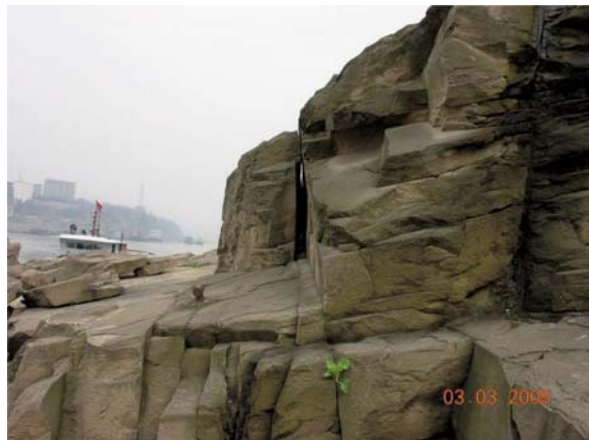
Fig. 5.3 Rock break-off and slides

- (1) *Block break-off and slides*: When the instability-generating joint fissures exist inside the rock slope, the rock blocks collapse as a result of the loss of strength of the fissures and the action of external agencies like reservoir current and wind-driven waves.
