Fawu Wang · Tonglu Li (Eds)

Landslide Disaster Mitigation in Three Gorges Reservoir, China

Geo-hazard Initiation and Assessment in the Three Gorges Reservoir

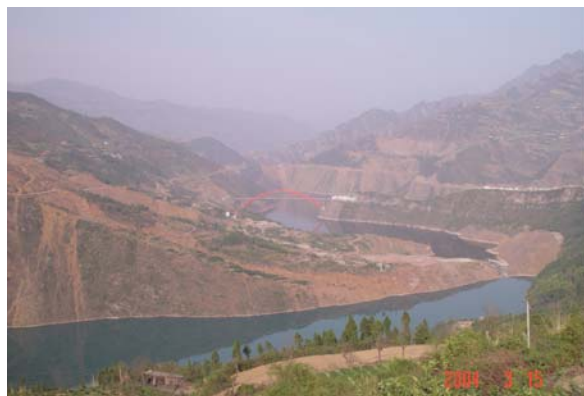
Fig. 8.2 View of the Qianjiangping landslide from the upstream side of Qinggan-he River (taken by F.W. Wang, March 15, 2004)

move so rapidly. It was the wave caused by the rapid sliding that killed the fishermen on their boats. A water trace left on the red bridge (shown in Fig. 8.2) detected after the landslide indicated that the highest level of the wave was about 30 m above the water level of 135 m.

landslide occurred. The landslide release surface was along a bedding plane in the bedrock (Fig. 8.2). Factory buildings on the sliding mass still remained standing after sliding for about 250 m (Fig. 8.3). However, because serious cracks developed in the buildings, they could not be used again and were demolished and the building materials were recycled (compare with Fig. 8.2). Standing trees on the sliding mass in the middle of the landslide (Fig. 8.4) indicate that the angle of the sliding surface remained constant and no rotation occurred. The exposed sliding surface at the upper part was very planar and subparallel to the sandstone bedrock strata (Fig. 8.5). All of these phenomena show that the sliding mass slid along a planar sliding surface. When the sliding mass entered Qinggan-he River, the dip direction of the strata was changed to N45°W, which is opposite to the original dip direction of S45°E. The dip angle is about 5° in the bed of Qinggan-he River (Fig. 8.6). The deposits at

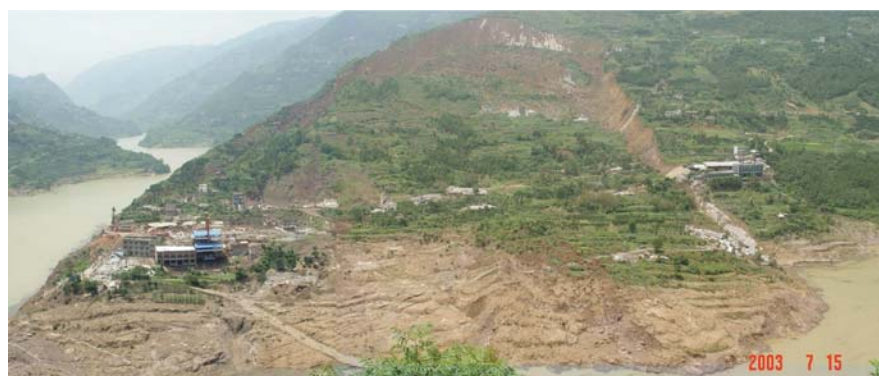
Fig. 8.3 Front-on view of the Qianjiangping landslide (taken by Y.M. Zhang, July 15, 2003)

Figures 8.2 and 8.3 are photographs of the landslide taken from the upstream side and front of the landslide, respectively. The landslide had a tongue-shaped plan, with a length of 1,200 m and a width of 1,000 m. It moved about 250 m in the main sliding direction of S45°E. The average thickness of the sliding mass was about 20 m, thinner in the upper part and thicker at the lower part. The total volume was estimated to be more than 20 million m³. The elevation of the main scarp was 450 m, and the elevation of the Qinggan-he River water level was 135 m when the

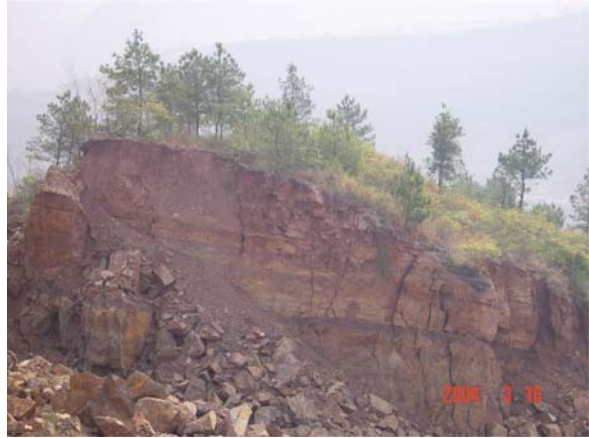
Fig. 8.4 View of the unrotated trees on the sliding mass in the middle of the Qianjiangping landslide

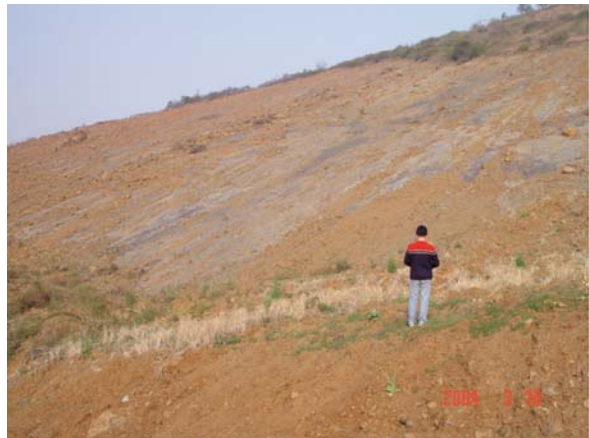
Fig. 8.5 The exposed planar sliding surface, which is also a sandstone bedding plane (there is a damaged rice paddy in front of the person)

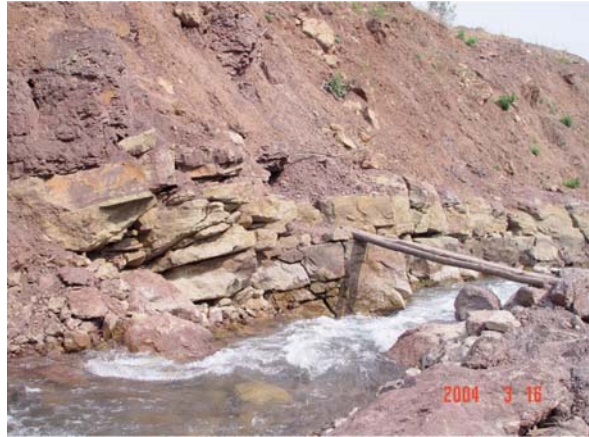
Fig. 8.6 View of the reversed dip direction of the sandstone beside Qinggan-he River (taken by F.W. Wang, March 16, 2004)

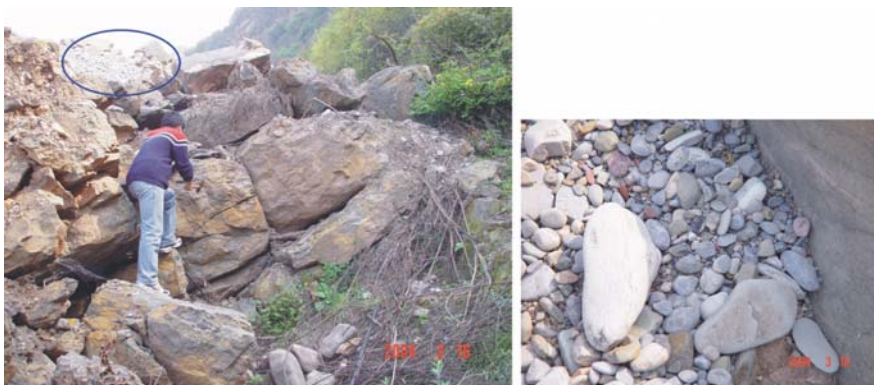
Fig. 8.7 Gravels displaced from the bed of Qinggan-he River and deposited in the toe of the landslide deposit (circled in photograph). Note that the sandstone dip direction is reversed and the dip angle has become steeper compared with Figs. 8.4 and 8.5)

the distal landslide margin contain white gravel with clasts up to 100 mm or so in diameter. The dip angle of the sandstone bedding at the distal margin is steeper than 30° (Fig. 8.7).

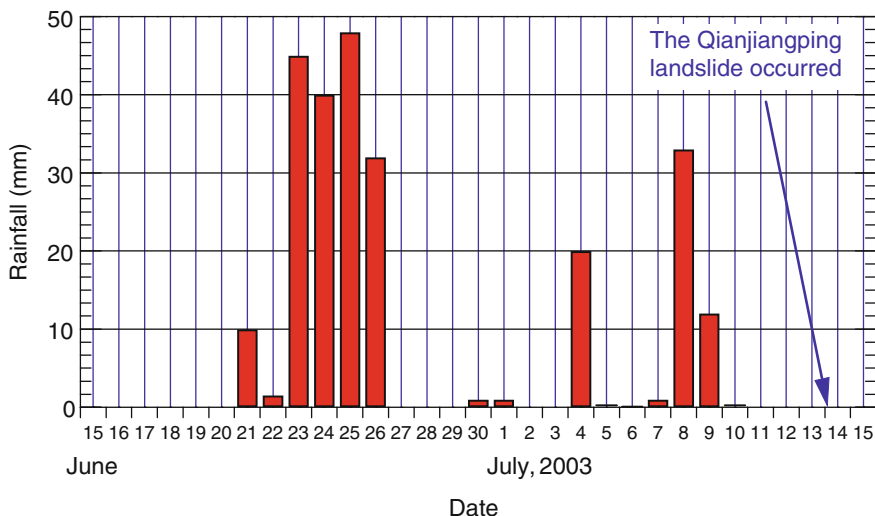
Fig. 8.11 Precipitation data monitored in Yichang city, 70 km from the landslide

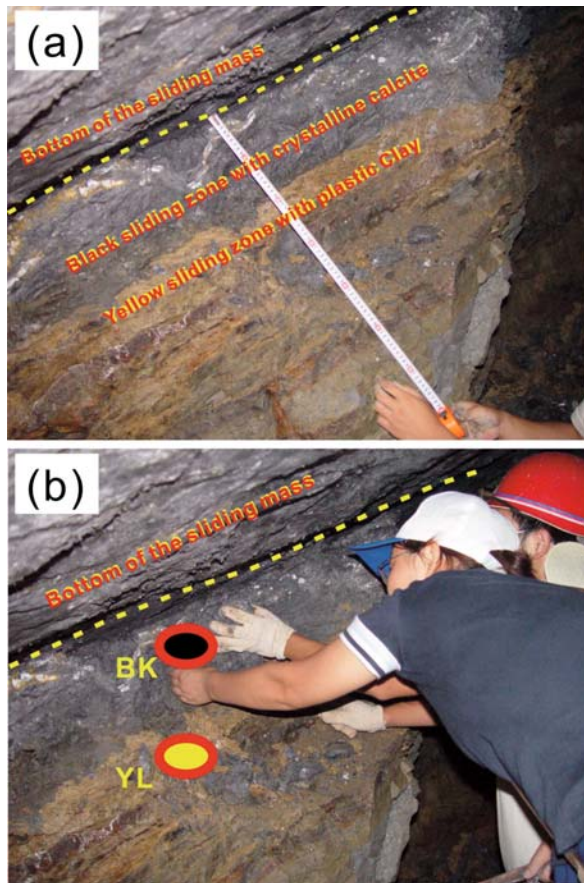
Fig. 8.14 Photograph of the sliding zone in a horizontal investigation tunnel. (a) Under the bottom of the sliding mass, the sliding zone can be observed to consist of two layers. The upper layer is black and includes crystallized calcite, and the lower layer is yellow plastic clay with a high water content. (b) Sampling from the black silt (BK sample) and yellow clay (YL sample) layers of the sliding zone

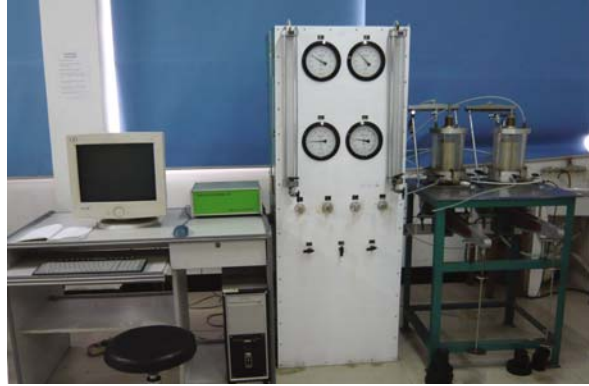
Fig. 10.2 Photograph of unsaturated soil creep apparatus

size $\Phi = 6.18 \text{ cm} \times 12.5 \text{ cm}$; the confining pressure $\sigma_3 = 0\text{--}600 \text{ kPa}$; the pore water pressure $u_w = -30\text{--}600 \text{ kPa}$; the pore air pressure $u_a = 0\text{--}600 \text{ kPa}$; the axial force $F = 6 \text{ kN}$; the axial deformation $\Delta L = 0\text{--}25 \text{ mm}$; the externally measured volume variation of the test sample $\Delta V = 0\text{--}50 \text{ cm}^3$.

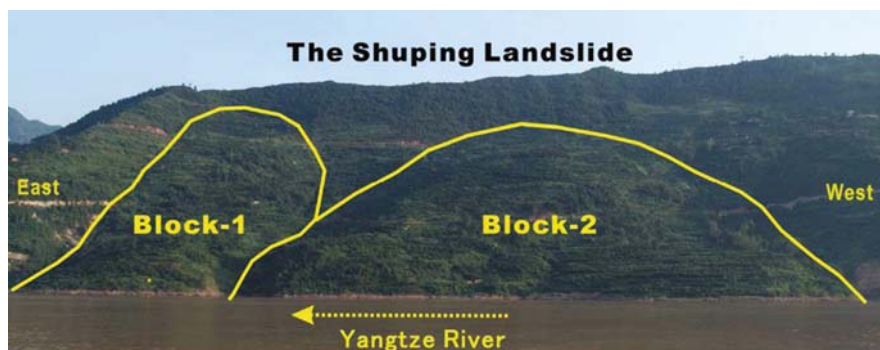
Fig. 11.2 A photograph of the Shuping landslide facing the main stream of the Yangtze River (taken from the opposite bank, facing south)

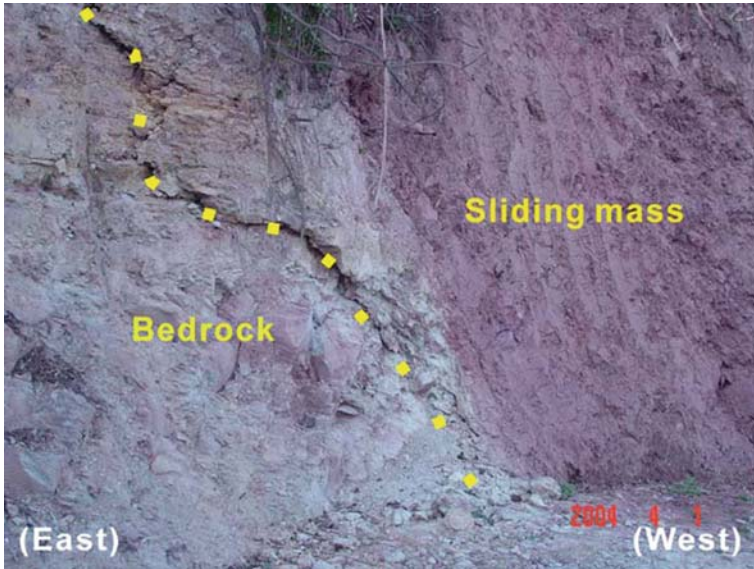
Fig. 11.4 Crack at the right boundary of Block-1 outcropped at a local roadside

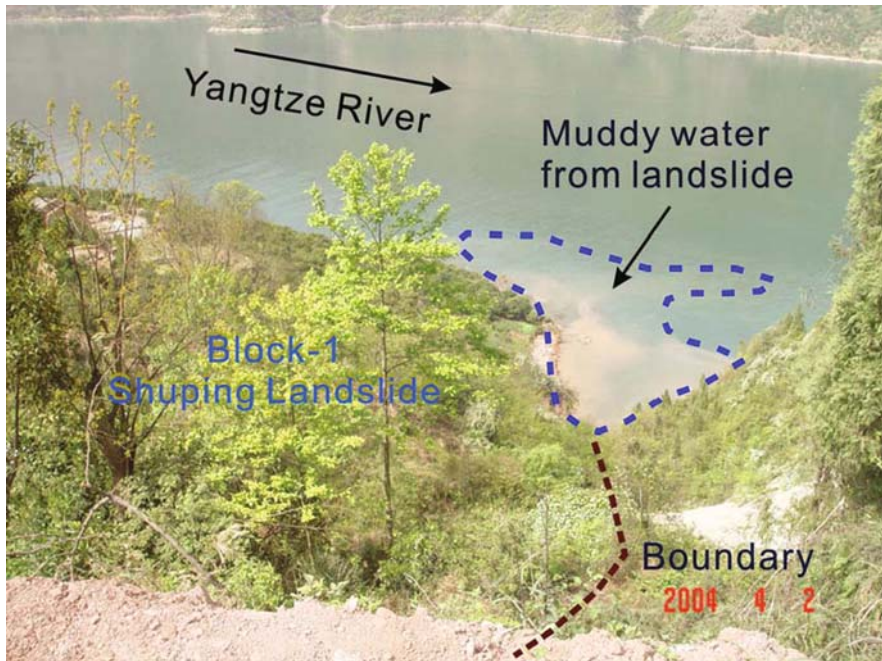
Fig. 11.5 The phenomenon of muddy water coming from Block-1 of the landslide (photo taken on April 2, 2004)

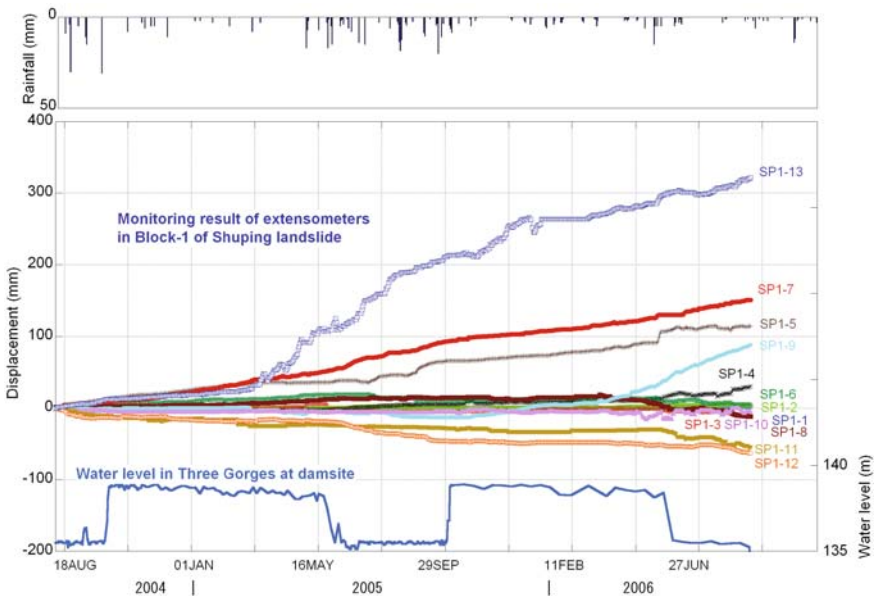
Fig. 11.9 Monitoring results with the drum extensometers for the period from August 2004 to August 2006 in Block-1 of the Shuping landslide. Rainfall for the period and the water level in the Three Gorges Reservoir are also shown

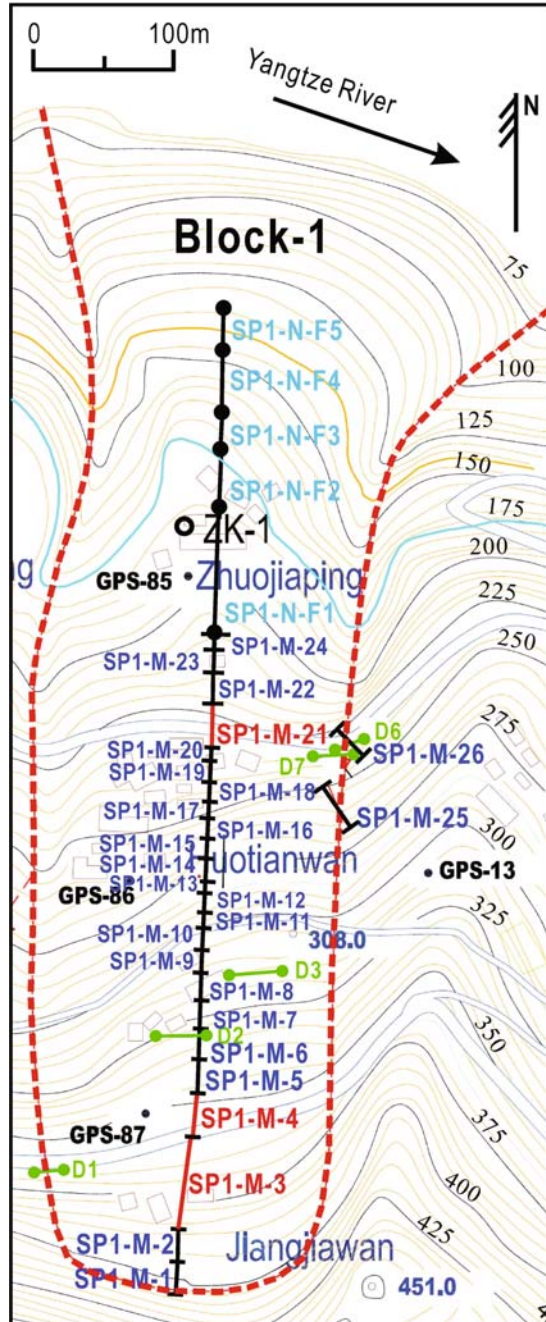
Fig. 11.15 Monitoring results with the continuous monitoring line from August 2007 to May 2008

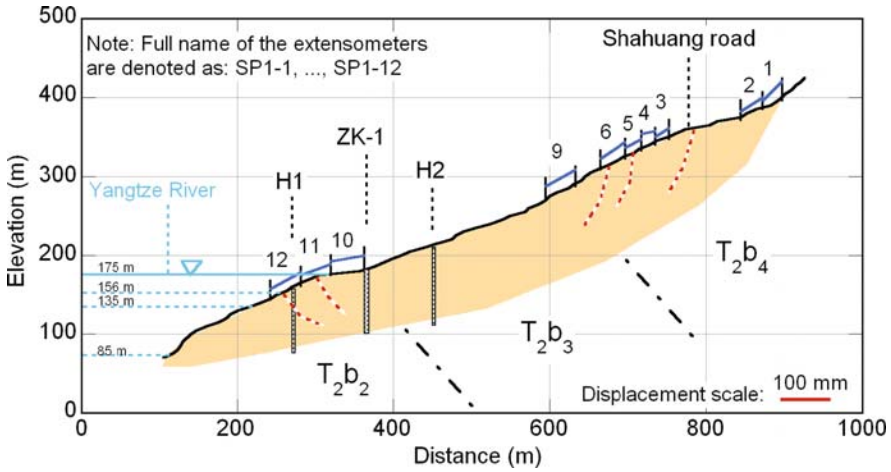
Fig. 11.16 Estimated deforming style of Block-1 of the Shuping landslide based on the monitoring results from August 2004 to July 2006 and the surveying results on the cracks distributing in the slope surface

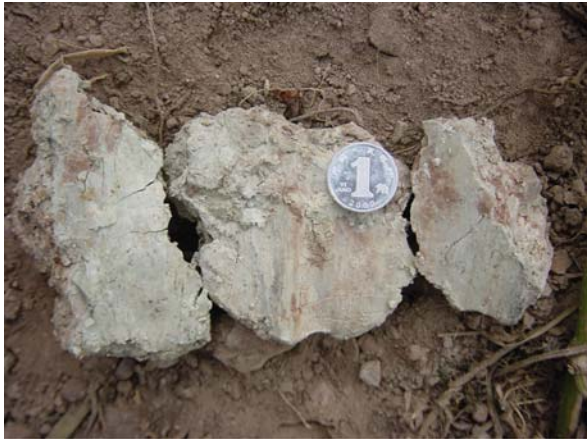
Fig. 12.6 The slip surface of Y1 slip zone

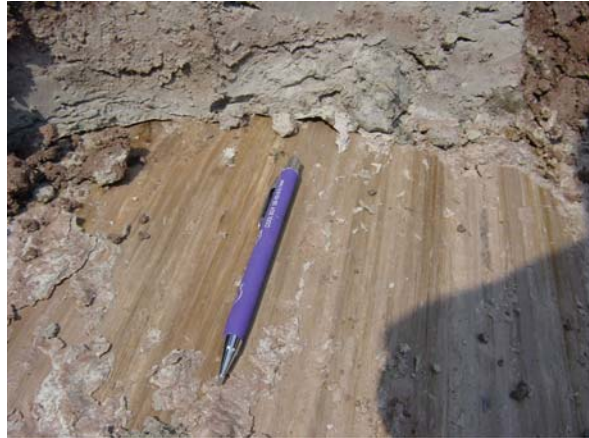
Fig. 12.7 The striations of Y2 slip zone of the Anlesi landslide (the sliding direction is 102°)

direction shown by striations is 100° . The second slip zone (Y2) is at the top of the profile, about 241 m in altitude. The slip zone is composed of grey white clay and gravels with 10–15 cm in thickness. The grey white clay has great stickiness and high water content. The gravels are mainly made of white mudstone. The shape of the gravels is subangular or angular. The grain size of the gravels is generally about 0.5–2.0 cm in diameter, the largest up to 3 cm and the smallest may be less than 0.1 cm. The overlying soil is Quaternary yellow clay, and the underlying rock is silty mudstone (Fig. 12.5b). The sliding surface and striations can be seen clearly at the bottom of the white clay (Fig. 12.7), and the direction of the striations is 102° . These macroscopic features indicate that the two layers of slip zones formed from white mudstones by the effect of the tectonic compressive stress.

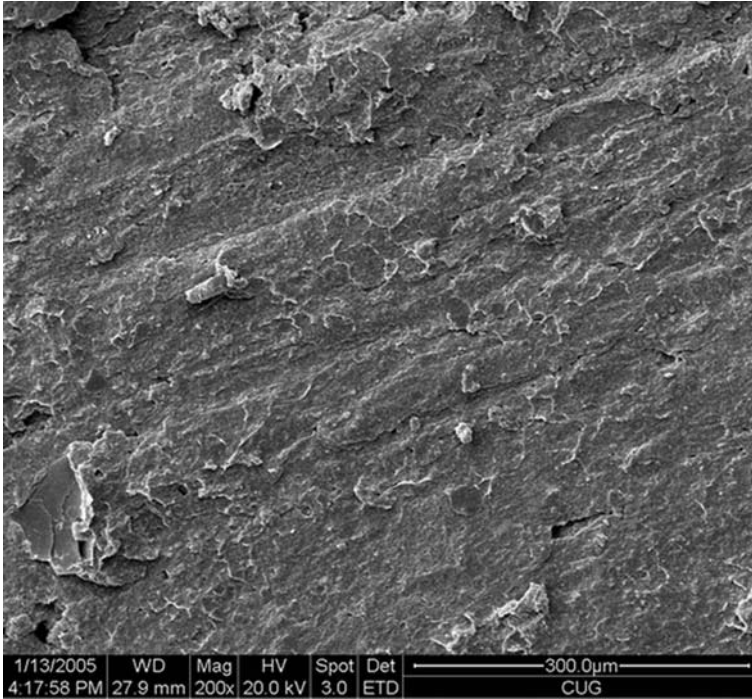
Fig. 12.10 The microstriations of Y1 sliding surface

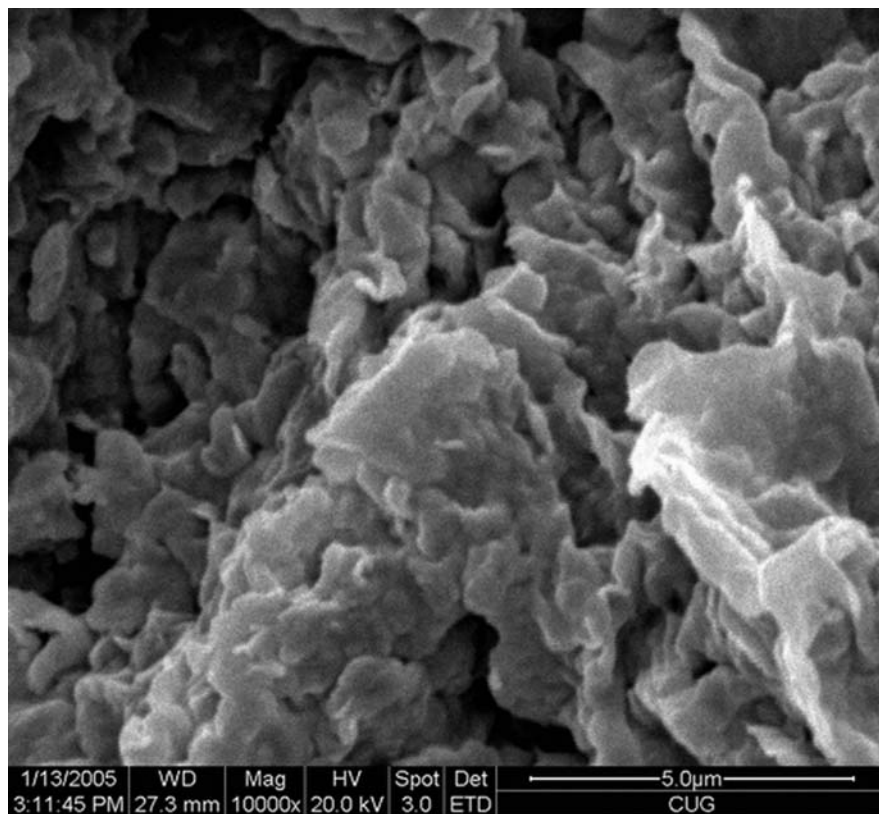
Fig. 12.11 The sheet crystal structure of the clay mineral of Y1 slip zone

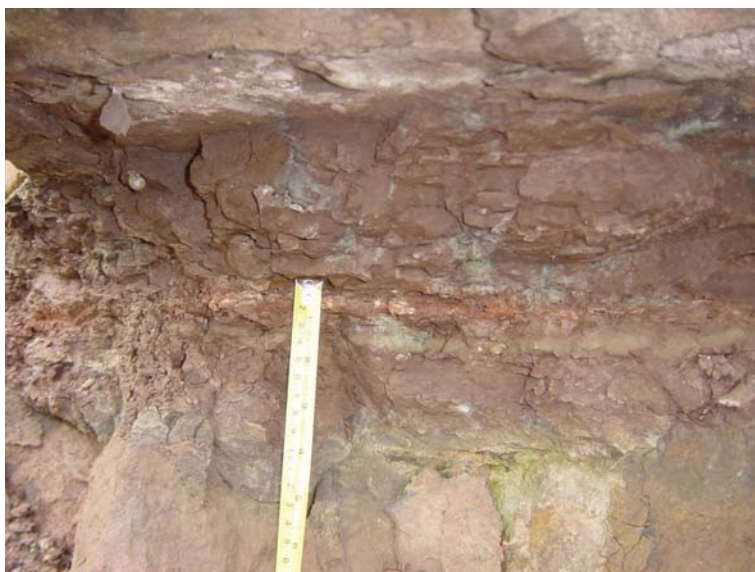
Fig. 12.16 A shear surface in an incompetent bed near Jianchayuan, Wanzhou

The study area is located at the core of the Wanzhou syncline (Fig. 12.2). Strongly squeezed by the tectonic stress in the SN and NWW–SSE direction, great shear displacement took place between the layers. The J_2s strata are stable, nearly horizontal in the Wanzhou area. Shear joints are well developed in the strata, and small-scale shearing surfaces (Fig. 12.16) in incompetent beds can be seen in the field. The scanning electron micrographs show that the grey white incompetent beds located 276.2 m high at the north side of Shalong Road, Sanwan pool (Fig. 12.17), are mainly composed of montmorillonite, illite, quartz, feldspar, and so on and in which exist

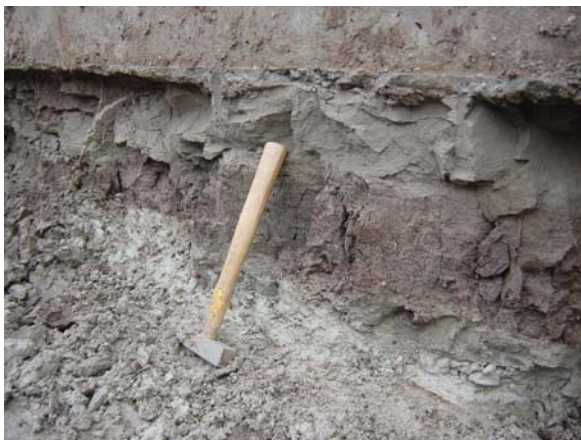
Fig. 12.17 An incompetent bed at the north side of Shalong Road, Sanwan pool, Wanzhou

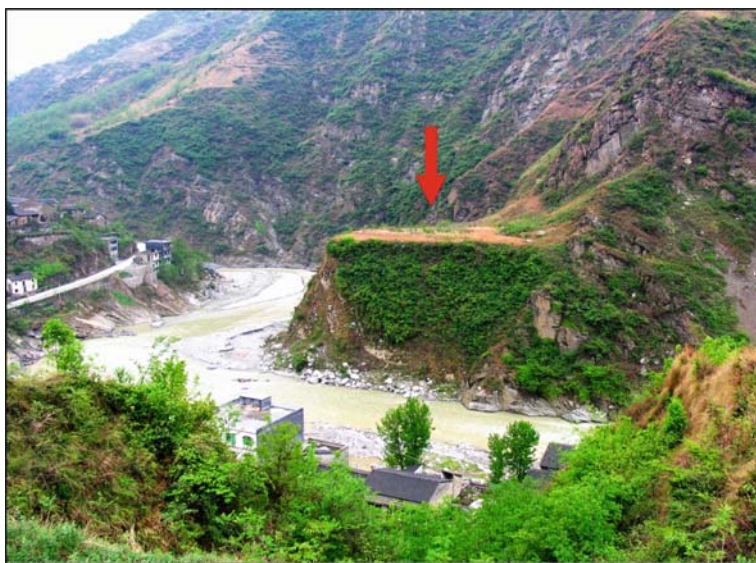
Fig. 13.3 Triangular-shaped dam residual once formed by the Bailuxi mud-rock flow stands on the right bank of the Daninghe River. *Arrow* indicates the top which is about 25 m above the water

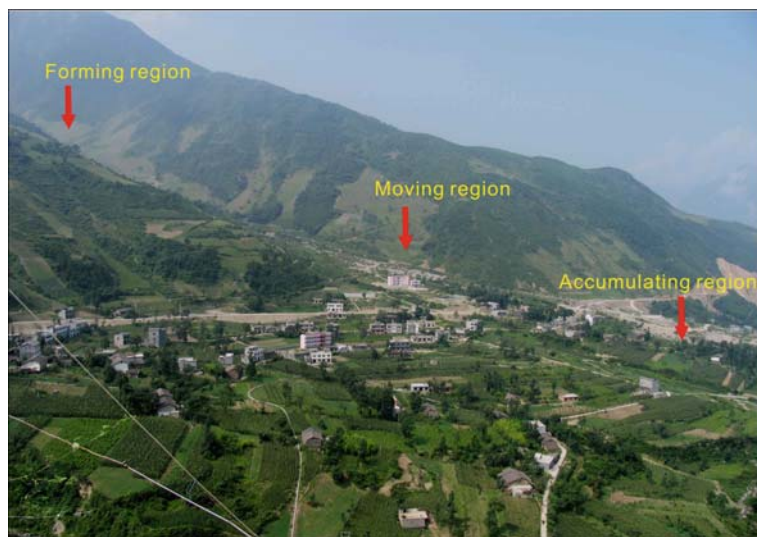
Fig. 13.4 View of Yangjiawan River mud-rock flow region

In the area around the mountain exit of the Yangjiawan branch channel, the right bank of the branch channel is a tongue-shaped mud-rock flow deposit with a width of almost 200 m, and it is 5–10 m higher than the normal water level of the Yangjiawan branch, which is now the deposit in the natural quarry, used for building road and houses for local people. For years, there has never been any large-sized flood or mud-rock flow that can reach these places. However, in view of the deposit composite and structure, the tongue-shaped deposit is a part of the moving and accumulated area of the Yangjiawan branch mud-rock flow. But since flat land for construction is in shortage in the mountainous area, the local inhabitants built the Villager Committee building and charity house for the old, on the tongue-shaped deposit. These two brick and concrete structures were built in 2004. The newly built Wushi high-level road goes across the mountain exit of the Yangjiawan channel valley after its original construction plan was changed. The bridge is at a higher level, 2–4 m over the riverbed, and the span of the bridge is 15 m. The bridge piers are located inside

the deposit, among which the right bank piers are located in the channel bed, which prevents the Yangjiawan branch channel from releasing floodwaters. All these structures are under a direct threat of a Yangjiawan mud-rock flow (Fig. 13.4).

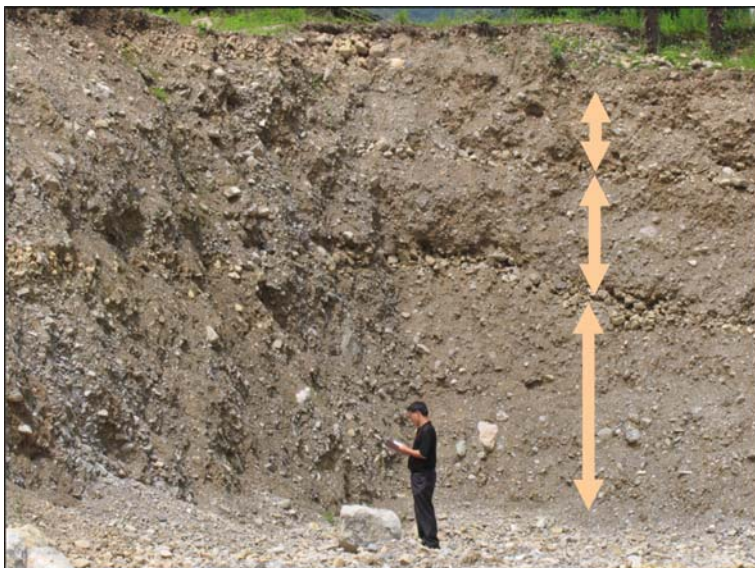
Fig. 13.5 Part of the section showing the structure of the Yangjiawan mud-rock flow deposits. Each layer was made up of a thinner coarse layer and a normal one (the man is about 1.7 m tall)

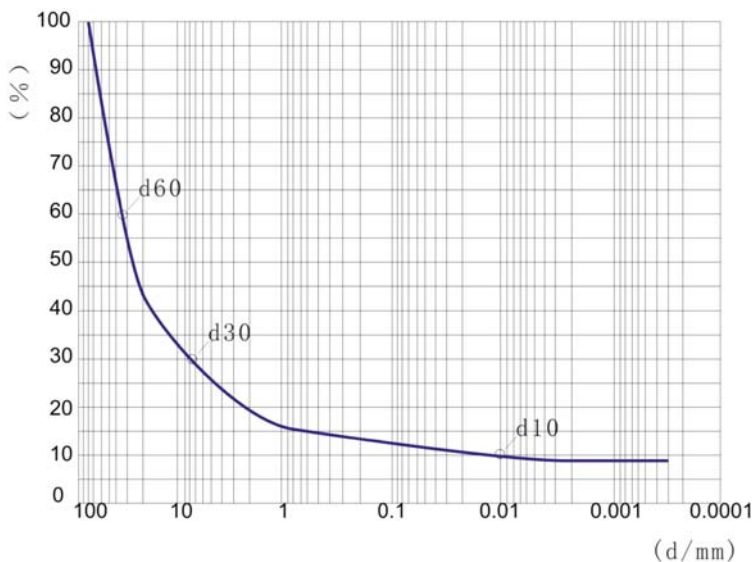
Fig. 13.6 Grain-size accumulation curve of the Yangjiawan mud-rock flow deposits (d/mm means the grain size in diameter and the unit is mm)

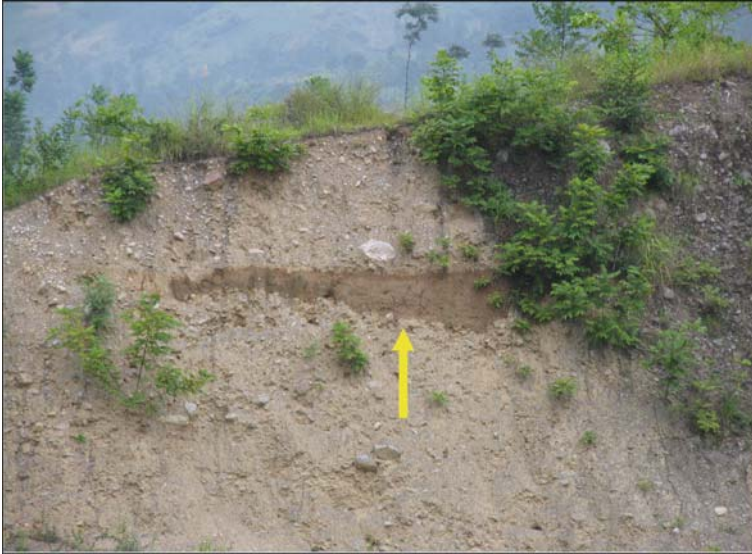
Fig. 13.7 Farmers rice paddy buried by the mud-rock flow that occurred historically

The farmland soil is 24–50 cm thick and spotty in its distribution. It exists over the section and is used for various activities. The soil layer is of a light brown color externally and is black on the interior (Fig. 13.7).

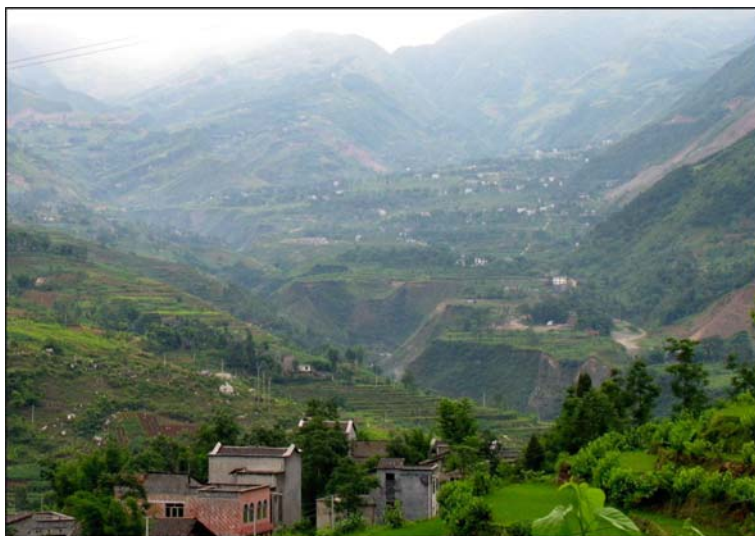
Fig. 13.8 Triangle-shaped accumulated area of the mud-rock flow of the upper branch valley of the Bailuxi River at the confluence with the Yangjiawan. It is the biggest and the most dangerous mud-rock flow region

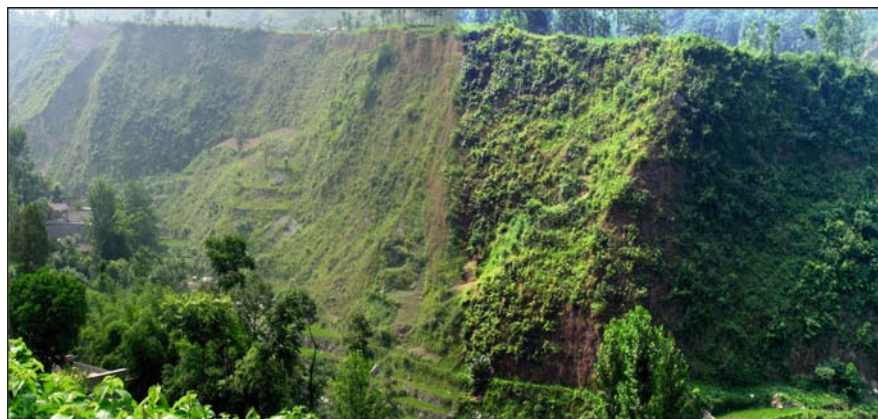
Fig. 13.9 High steep slope on the lower part of the left bank of the Bailuxi River

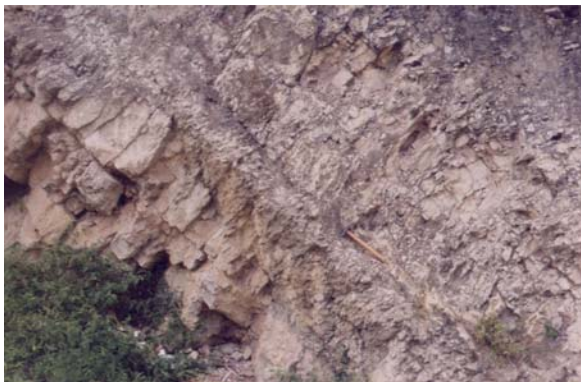
Fig. 15.5 Beds with development of cleavage and toppling of cleavage slices, a detail of Fig. 15.4. Right is to the north

Fig. 15.4 Cross-section showing toppling deposits resulting from cleavage in the pelitic limestone (the third member of the Badong group) at the east edge of the Huangtupo slope. The square is the position described in Fig. 15.5

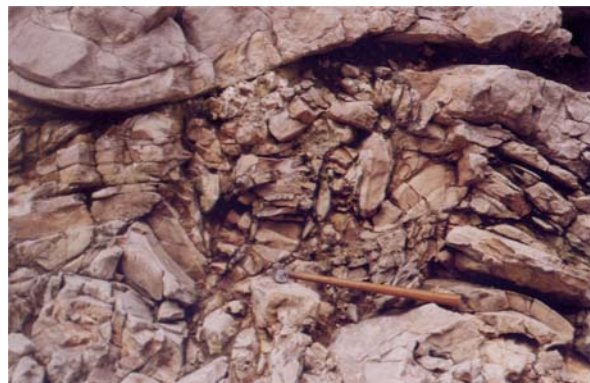
Fig. 15.9 A detail of Fig. 15.8, showing a sliding surface (in the *upper part* of the photograph) accompanied by asymmetric and overturned folds beneath the surface. The right is to the north

Near the axes of the Guandukou syncline, the bedding dips gently and the structure is simple except within the Huangtupo slope. Along the bank of the Yangtze River at Huangtupo, overturned and asymmetric knee-like folds and lower angle faults dipping into the slope are commonly developed (see Figs. 15.8, 15.9, 15.10 and 15.12). Fold axes are sub-horizontal and their direction is E–W; axial surfaces dip into the slope. The asymmetric folds indicate that the rock mass has undergone movement to the north (downslope).

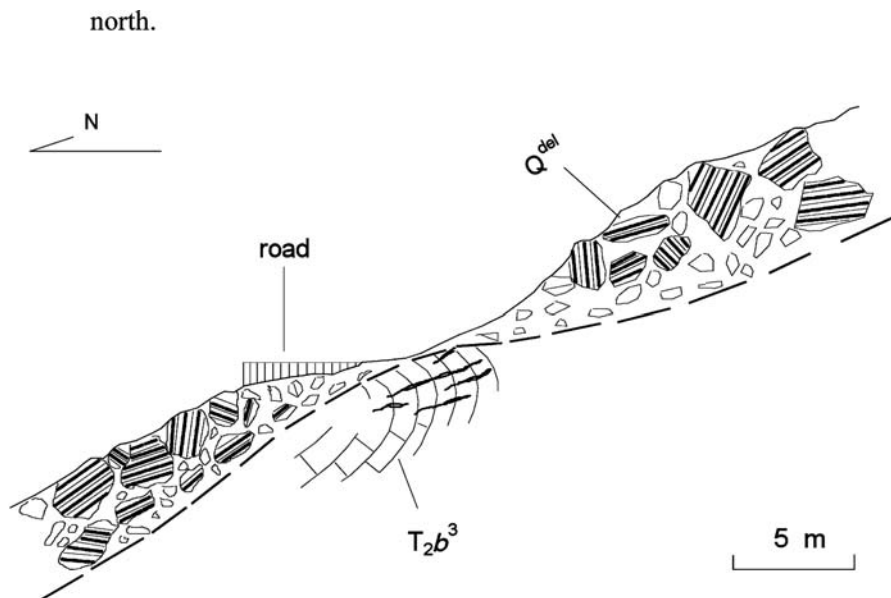
Fig. 15.10 A reversed fold beneath the Huangtupo debris accumulation in the upper reach of ravine 3. Q^{del} is the debris accumulation; T_2b^3 is the third member of the Badong group; *black lines* in the axial part of the fold indicate openings (cracks)

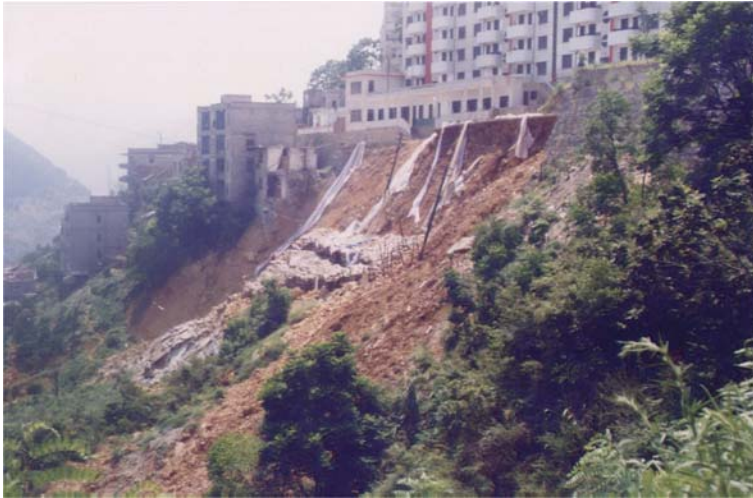
Fig. 15.14 Erdaogou landslide occurred on June 10, 1995. Note it developed in the debris accumulation. View is from the northwest

Two smaller landslides, Erdaogou and Sandaogou, occurred on the surface of the Huangtupo slide in 1995 (see Fig. 15.11). One of these landslides, which was 90 m wide, 100 m long, 5–13 m thick, and had a volume of $6.7 \times 10^4 \text{ m}^3$, slid on the right slope of the ravine 2 on June 10 (Erdaogou landslide, see Figs. 15.14 and 15.15). It occurred as a reactivation of a small part of the preexisting Huangtupo landslide. The debris accumulation, which originated from T_2b^3 , supplied the material for the sliding. Municipal waste and drainage at the back of the landslide were the direct triggering forces. Though this recent slide occurred on the surface of the Huangtupo landslide, there is no evidence to relate it to possible reactivation of the entire landslide. Instead, the process represented only local modification of the Huangtupo landslide mainly due to human activities.

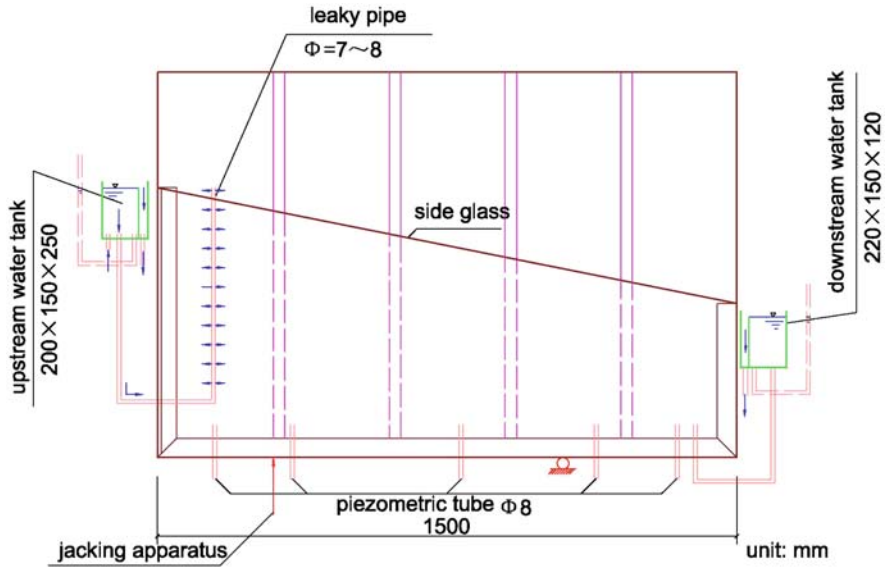
Fig. 16.7 Sketch of the test system

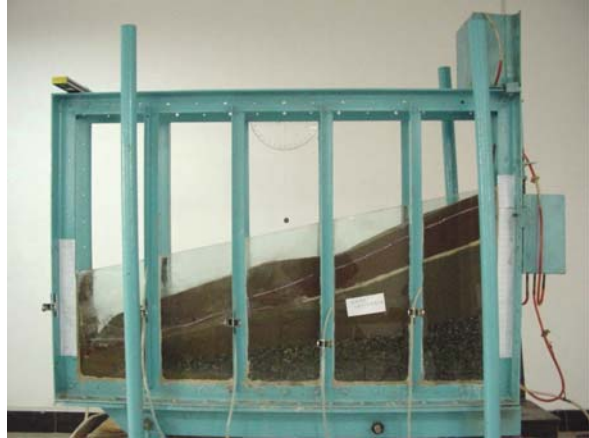
Fig. 16.8 Photograph of the test system

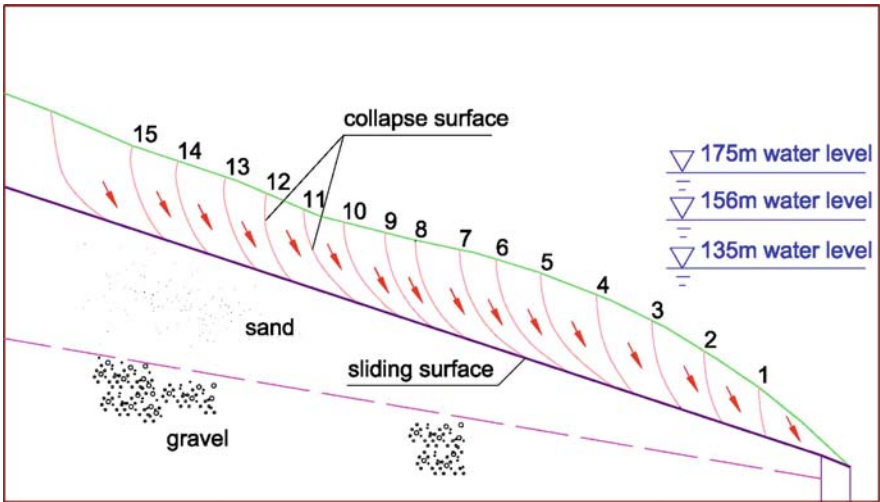
Fig. 16.11 The development of the failure process

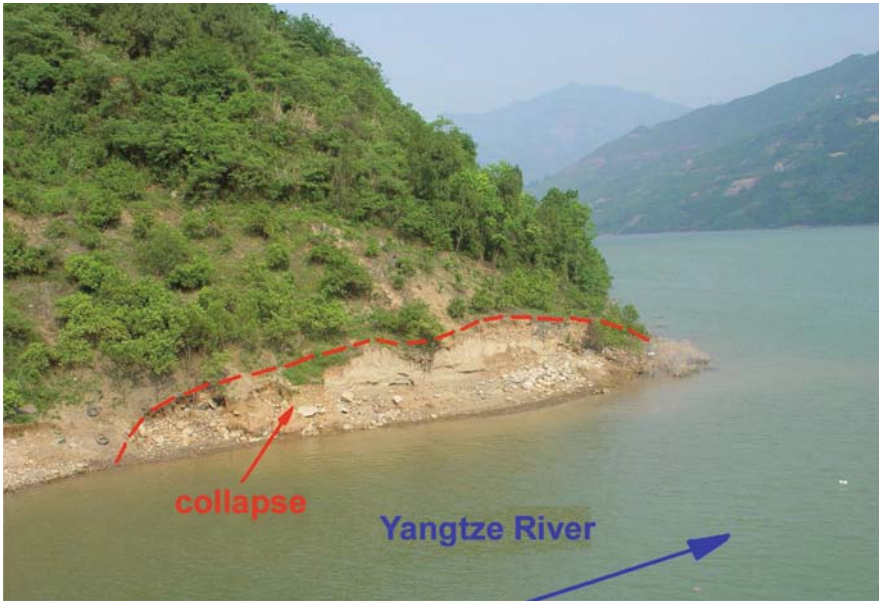
Fig. 16.12 Partial collapse of the landslide after the 135 m water level impoundment

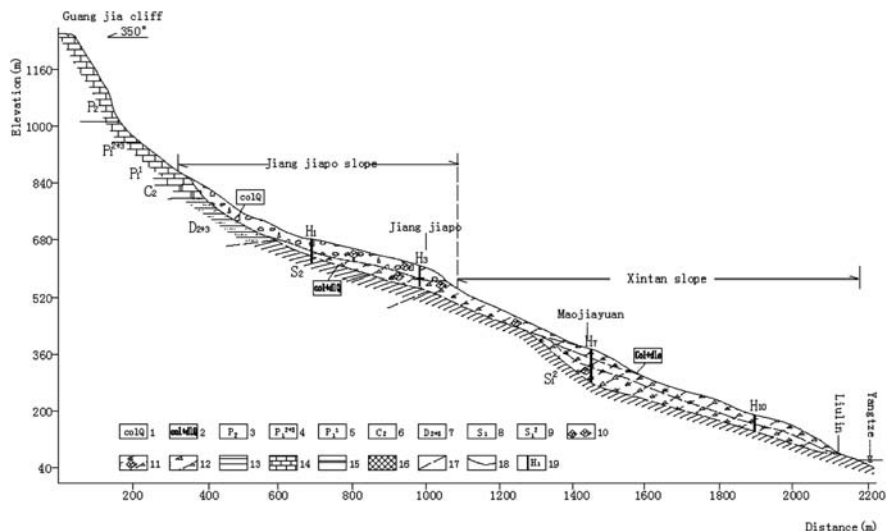
Fig. 17.4 Longitudinal geological section of the slope. 1 – Quaternary colluvium; 2 – colluvium and slope wash; 3 – upper Permian; 4 – Qixia–Maokou formation, lower Permian; 5 – Ma’anshan formation, lower Permian; 6 – Huanglong formation, middle carboniferous; 7 – upper-middle Devonian; 8 – Shamao formation, lower Silurian; 9 – Luoreping formation, lower Silurian; 10 – limestone blocks; 11 – limestone block-debris with soil; 12 – limestone–sandstone debris with soil; 13 – shale; 14 – limestone; 15 – coal seam; 16 – sandstone; 17 – lithological contact; 18 – speculative slip plane; 19 – borehole with number

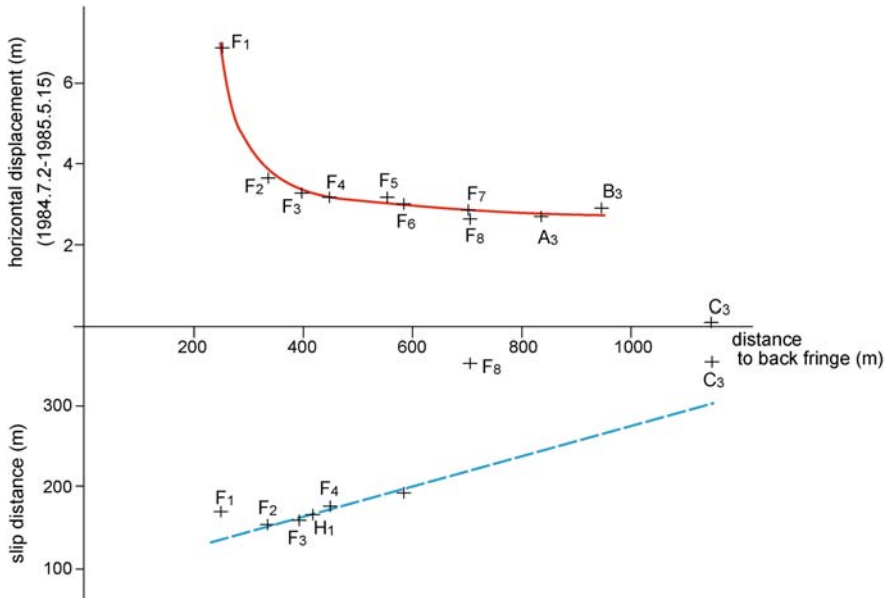
Fig. 17.6 The displacements of reference marks before and after the slide

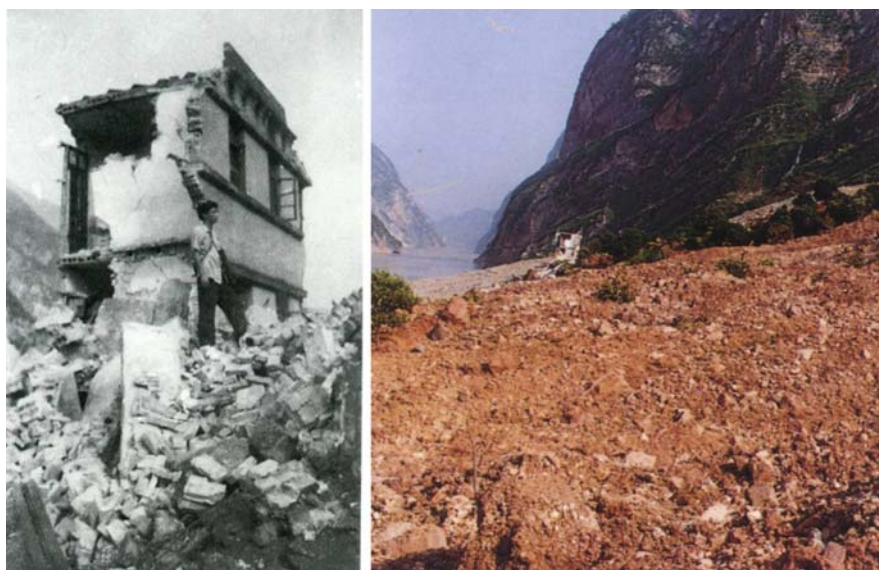
Fig. 18.4 Buildings destroyed by the landslide (Office building of the Rock Fall Survey Department of Xiling Gorge, Hubei Province)

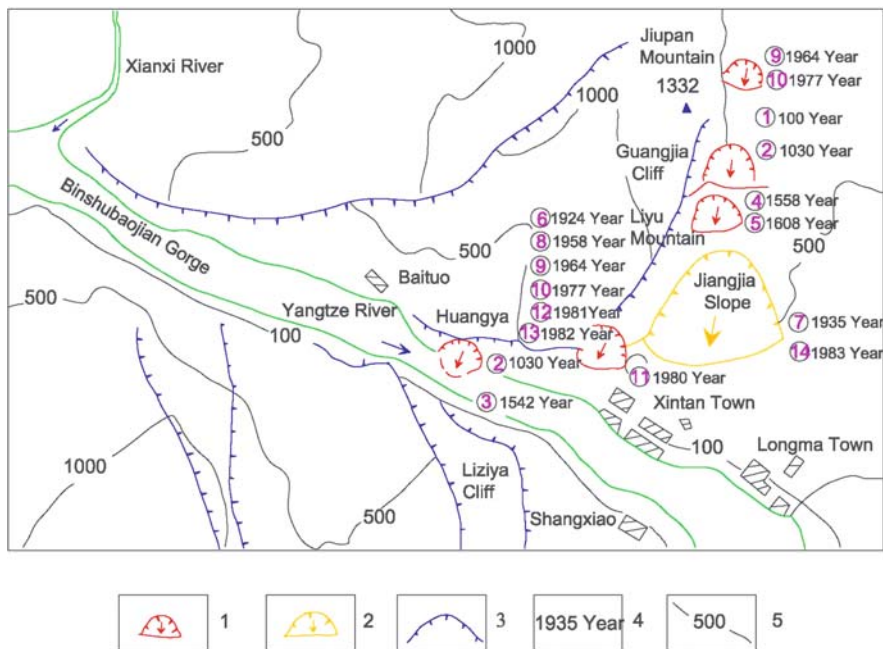
Fig. 18.8 Developmental history of landslides and rock falls in the Xintan area. 1 – falling; 2 – landslide; 3 – scarp; 4 – time of landslide and rock fall; 5 – contour and elevation

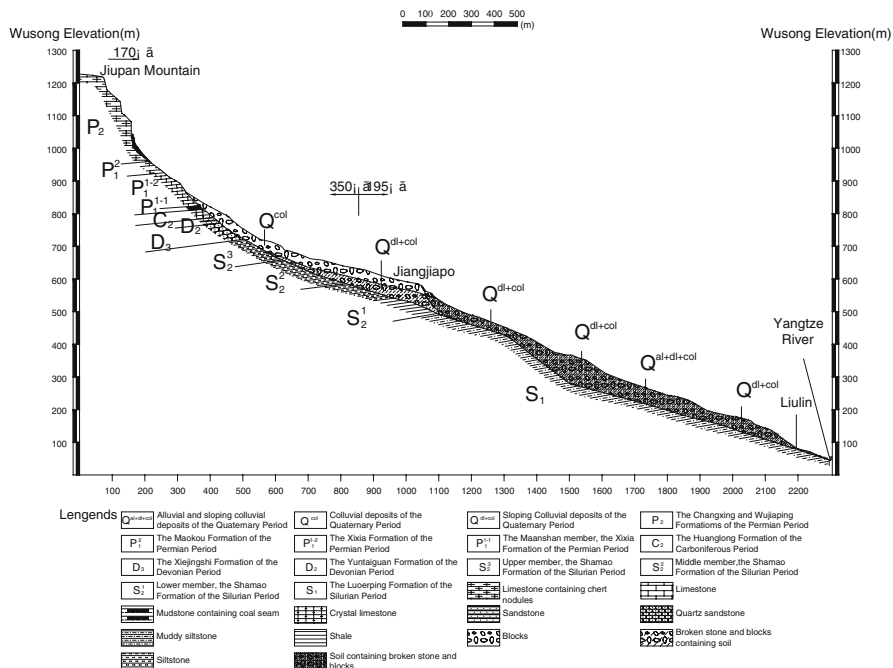
Fig. 19.3 Engineering geological profile of the Xintan landslide (rockfall investigation office of the Xiling Gorge in Hubei Province 1983)

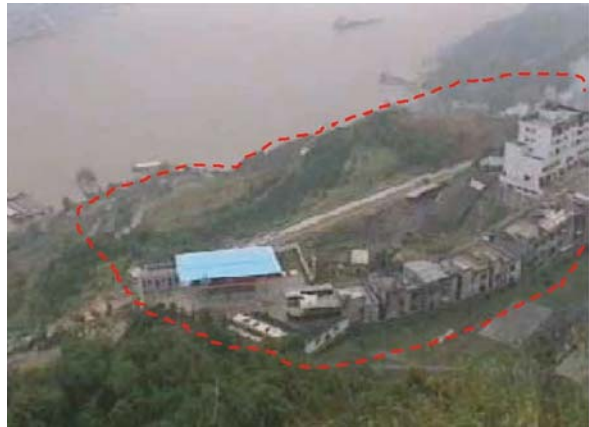
Fig. 20.2 Photograph of the Muzishu landslide (Dashed red line indicates landslide boundary)

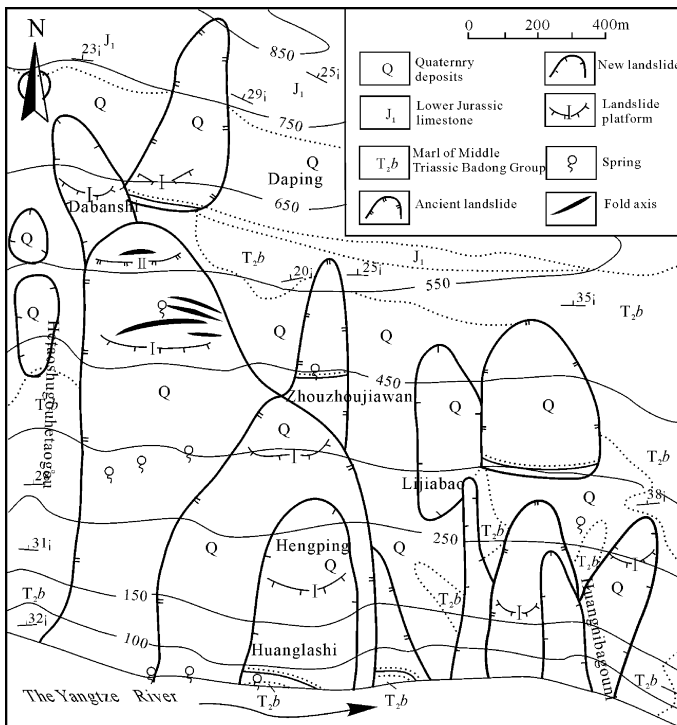
Fig. 21.2 A sketch map of the Huanglashi landslide trace pattern

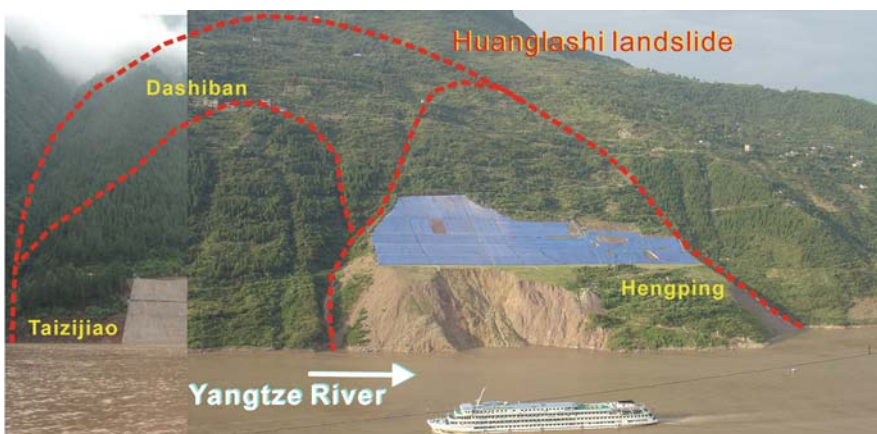
Fig. 22.1 Full view of the Huanglashi landslide

The Huanglashi landslide is a landslide group distributing from the east to the west between Lijiabao and Benlongxi, and forming a longitudinal extended concave formation. The back margin of the main scarp is at 836 m asl, the frontal margin at the toe is at 66 m asl where it is under the reservoir of the Yangtze River. The landslide is 260 m wide at the top, 820 m wide where it is close to the river, and 1,500 m long, covering an area of 1.15 km². The thickness is 8–100 m and the total volume is about 22.8 million m³. Based on the origin, failure mechanism, shape and material composition, the landslides group is divided into the Hengping tangential landslide, Dashiban and Taizijiao colluvium landslides (Figs. 22.1, 22.2, and 22.3) (Bao 1993).

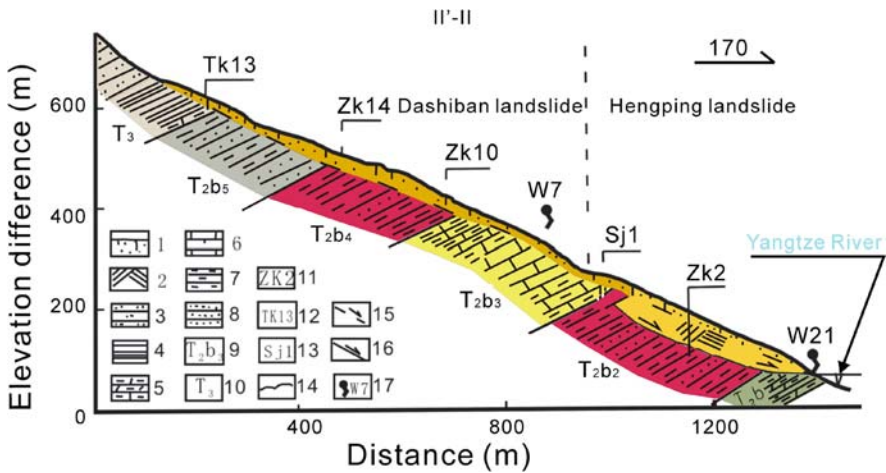
Fig. 22.3 Geological cross section of the Huanglashi landslide. 1 – gravelly soil; 2 – cataclasite by landslide; 3 – gray white quartz sandstone; 4 – gray shale; 5 – marlite; 6 – marlite and limestone; 7 – aubergine mudstone; 8 – aubergine silt and fine sandstone; 9 – code of Badong group stratum; 10 – code of Xiangxi group stratum; 11 – number of drilling; 12 – number of open test pit; 13 – number of shaft; 14 – ground crack; 15 – speculate sliding surface; 16 – sliding surface; 17 – number of spring water
