Fawu Wang · Tonglu Li (Eds)

Landslide Disaster Mitigation in Three Gorges Reservoir, China

Geo-hazard Initiation and Assessment in the Three Gorges Reservoir

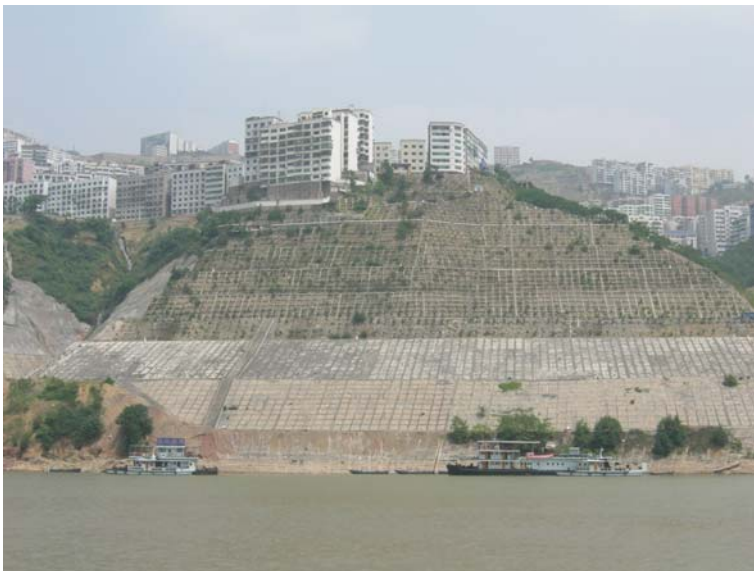
Fig. 24.6 Front view of the Yuhuange landslide in Wushan County

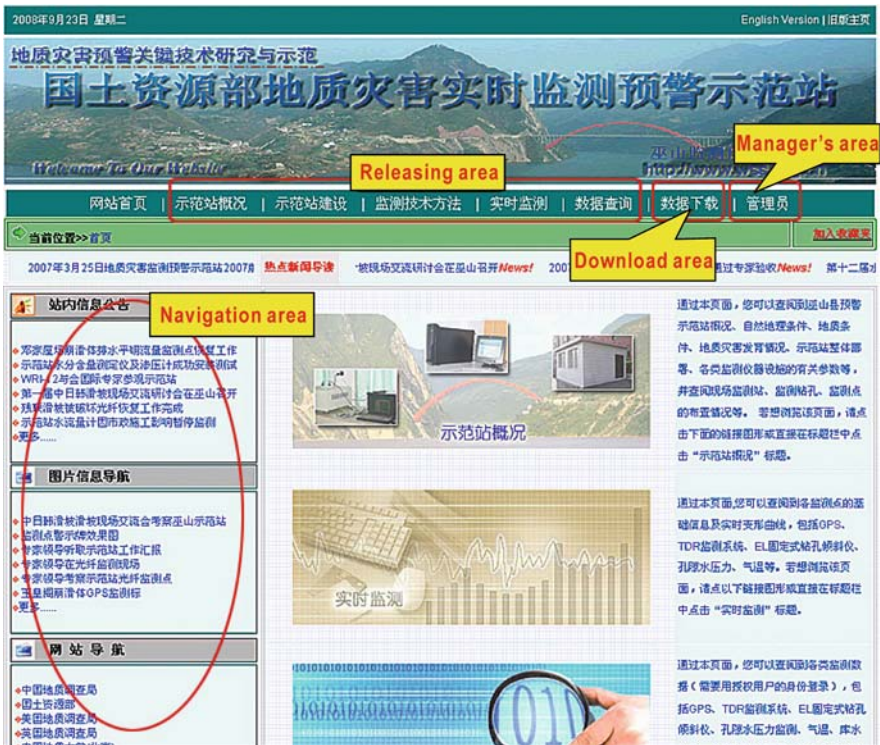
Fig. 24.12 Information issue homepage of the Wushan Demonstration Station

area for the connection between the remote user and administrator (shown in Fig. 24.12). Among them, the core contents are RTM and Data Query in the releasing area. RTM is used to display all types of real-time monitoring curves, and data query is used to download various types of monitoring data.

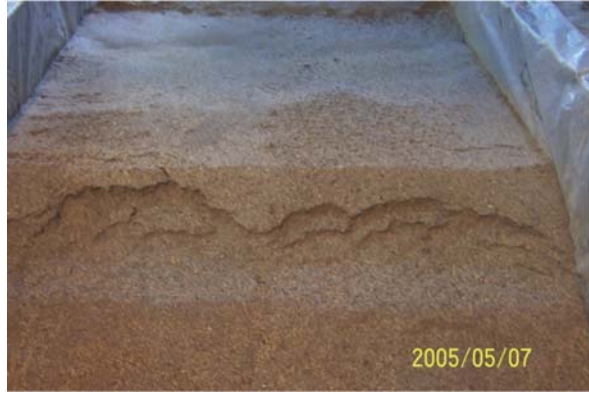
Fig. 27.7 Bank collapse for the erosion type

1. *Erosion type*: This can be described as the soil on the banks being carried away by erosion and washing out of the reservoir water, waves, and rainfall. At this point the bank collapses and moves backward. By the test, it can be found that when the slope angle is small or the c , ϕ in sand property is small, and the intensity of rainfall is small, the main type of bank collapse is the erosion type. This kind of bank collapse has the characteristics of being slow, long-lasting, and small in scale. Figures 27.7 and 27.8 show this type of bank collapse.

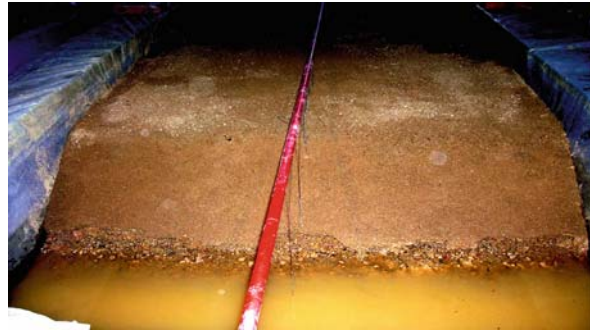
Fig. 27.15 Steep terrace formed by shallow erosion

1. *Surface erosion*: Waves destroyed the bank by carrying the intensely weathered materials away (Fig. 27.11). A discharge was formed on the slope toe area, and an exception occurred when the slope angle was too big or the water level was too deep. A steep terrace formed on the top of the erosion belt, see Fig. 27.15.

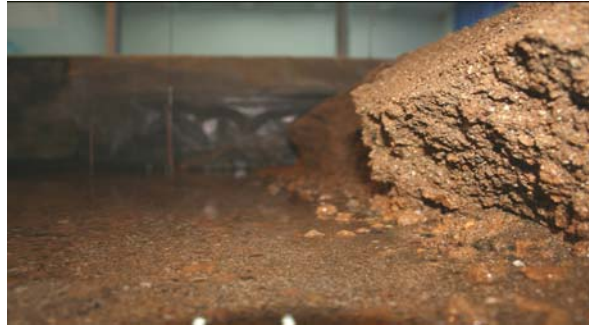
Fig. 27.16 The niche eroded by wave action on the back of the slope

2. *Shallow erosion*: Due to a tighter structure than that of the materials on the surface, the materials on the shallow part of slopes are not easily washed away. The velocity of erosion decreased. However, when time passed, the collapse also occurred due to the effect of gravity on the upper slopes. Several niches formed on part of the banks (Fig. 27.16).

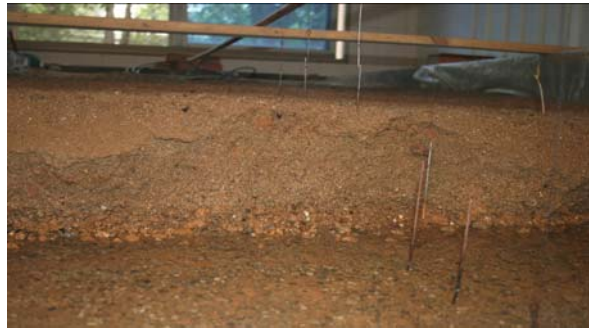
Fig. 27.17 The perpendicular wall after the collapse

3. *Deep erosion*: Due to niches and the width of the erosion belts that continued to enlarge, the effect of waves becomes smaller. With niches enlarging continually, the upper part of the slopes would collapse on a large scale, and would occur suddenly (see Fig. 27.17). Because of such a large amount of collapsed materials they cannot be carried away quickly, and the slope angle underwater would increase afterwards.
