# Chapter 3

## Research on the Characteristics and Slope Deformation Regularity of the Badong Formation in the Three Gorges Reservoir Area

**Abstract** The Three Gorges reservoir area is characterized by widely distributed strata of the Badong formation, in which large-size landslides and deep-reaching loosely consolidated formations are likely to occur. Therefore, it is significant to reveal the mechanism and patterns of the large-size landslides that occur in the Badong formation for a better understanding of the development of the nature of deformation and process of formation of the deep-trending loose-slope stratum in the Wushan, Fengjie, and Badong renewal city zones. In this chapter, the geological characteristics of the rock mass of the Badong formation are analyzed on the basis of a systematic explanation of the rock mass strata, space variation of the lithological combinations as well as the space variation of stratum thickness, and structural deformation of the Badong formation. To demonstrate the basic law of long-term deformation of the Badong formation slopes and the patterns of later stage reformation and landslide evolution, the authors use the Huangtupo landslide

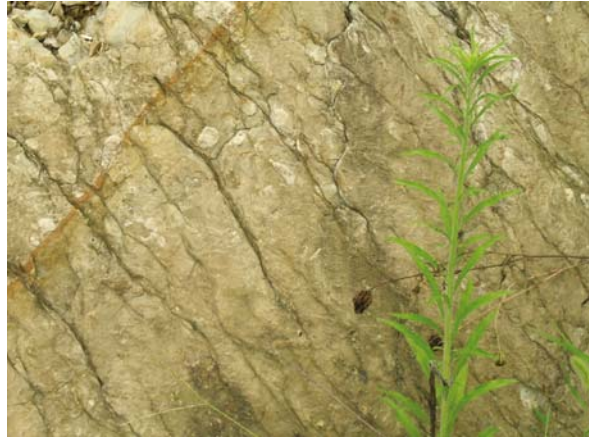
**Fig. 3.3** Cleavage of muddy pelmicrite of the 3rd section of Badong formation

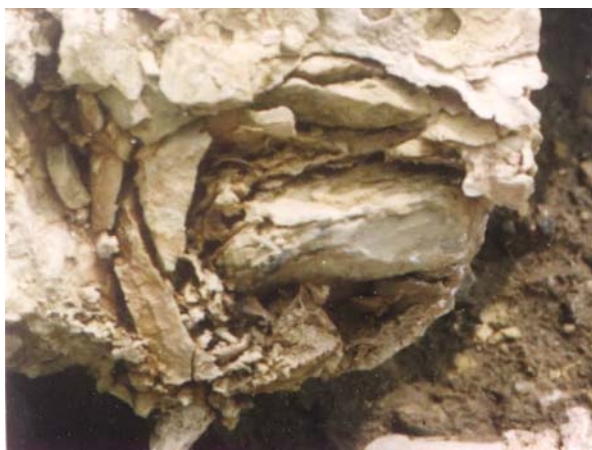
**Fig. 3.17** Breccias at the shearing outlet in the front edge of the Huangtupo landslide, a shredded cabbage pattern occurs as a result of strong pressure, in the riverfront, 300 m to the east of Sidaogou

The breccias are subject to strong pressure, with individual ones in the form of shredded cabbage as a result of strong pressure and friction as well as released stress, which rebounds and causes surface peeling. The breccias are in the form of calcareous half cementation. The pattern of the breccias zone is  $168^\circ \angle 36^\circ$ , with the underlying terrain reverses; as per the conclusion of the pattern variation, the upper terrain of breccias zone slides horizontally northward (Figs. 3.16a and 3.17).

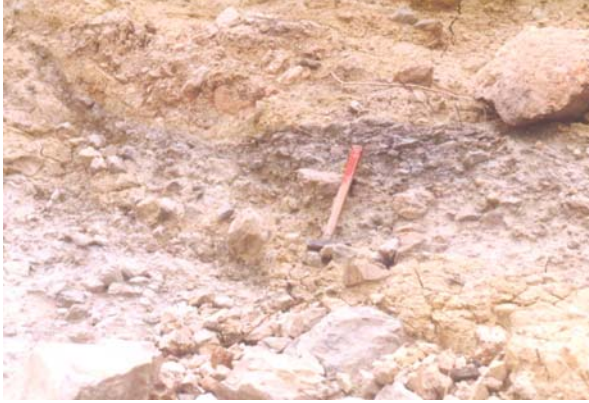
**Fig. 3.18** Landslide zone in the front flank of the Huangtupo landslide, in the riverfront, 200 m to the west of Erdaogou

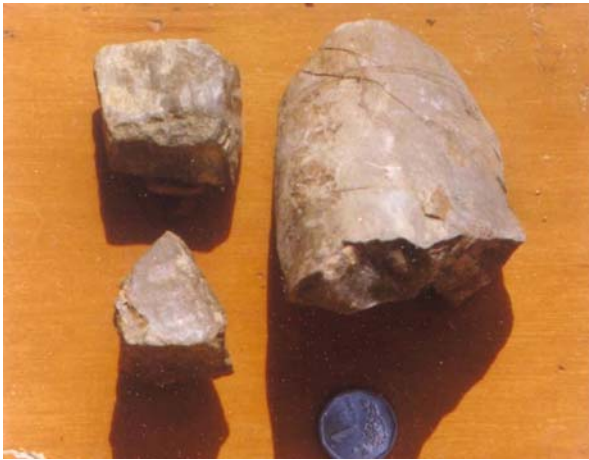
**Fig. 3.19** Rounding and polish of breccias in the front flank landslide of the Huangtupo landslide, on the riverfront, 200 m to the west of Erdaogou
