Chapter 8

Mechanism for the Rapid Motion of the Reactivated Qianjiangping Landslide in Three Gorges Dam Reservoir, China

Fawu Wang, Yeming Zhang, Zhitao Huo, and Xuanming Peng

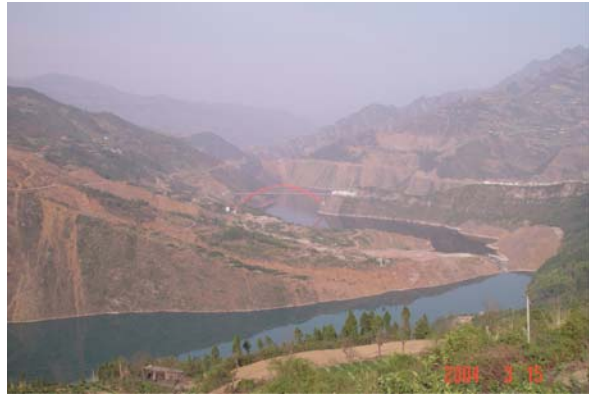
Fig. 8.2 View of the Qianjiangping landslide from the upstream side of Qinggan-he River (taken by F.W. Wang, March 15, 2004)

move so rapidly. It was the wave caused by the rapid sliding that killed the fishermen on their boats. A water trace left on the red bridge (shown in Fig. 8.2) detected after the landslide indicated that the highest level of the wave was about 30 m above the water level of 135 m.

Figures 8.2 and 8.3 are photographs of the landslide taken from the upstream side and front of the landslide, respectively. The landslide had a tongue-shaped plan, with a length of 1,200 m and a width of 1,000 m. It moved about 250 m in the main sliding direction of S45°E. The average thickness of the sliding mass was about 20 m, thinner in the upper part and thicker at the lower part. The total volume was estimated to be more than 20 million m³. The elevation of the main scarp was 450 m, and the elevation of the Qinggan-he River water level was 135 m when the

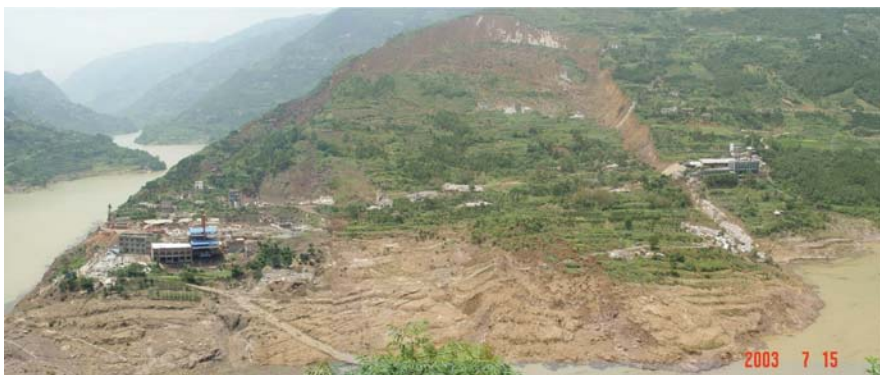
Fig. 8.3 Front-on view of the Qianjiangping landslide (taken by Y.M. Zhang, July 15, 2003)

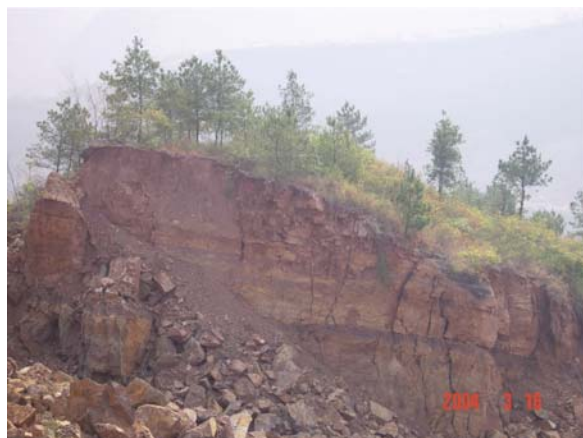
Fig. 8.4 View of the unrotated trees on the sliding mass in the middle of the Qianjiangping landslide

landslide occurred. The landslide release surface was along a bedding plane in the bedrock (Fig. 8.2). Factory buildings on the sliding mass still remained standing after sliding for about 250 m (Fig. 8.3). However, because serious cracks developed in the buildings, they could not be used again and were demolished and the building materials were recycled (compare with Fig. 8.2). Standing trees on the sliding mass in the middle of the landslide (Fig. 8.4) indicate that the angle of the sliding surface remained constant and no rotation occurred. The exposed sliding surface at the upper part was very planar and subparallel to the sandstone bedrock strata (Fig. 8.5). All of these phenomena show that the sliding mass slid along a planar sliding surface. When the sliding mass entered Qinggan-he River, the dip direction of the strata was changed to N45°W, which is opposite to the original dip direction of S45°E. The dip angle is about 5° in the bed of Qinggan-he River (Fig. 8.6). The deposits at

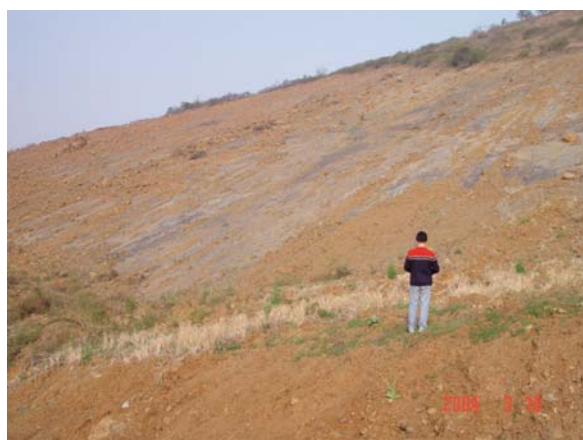
Fig. 8.5 The exposed planar sliding surface, which is also a sandstone bedding plane (there is a damaged rice paddy in front of the person)

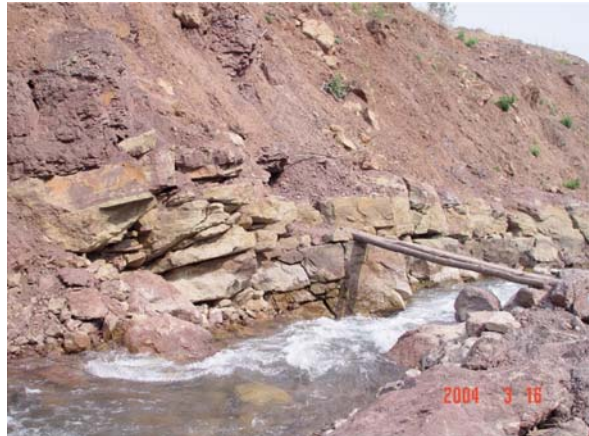
Fig. 8.6 View of the reversed dip direction of the sandstone beside Qinggan-he River (taken by F.W. Wang, March 16, 2004)

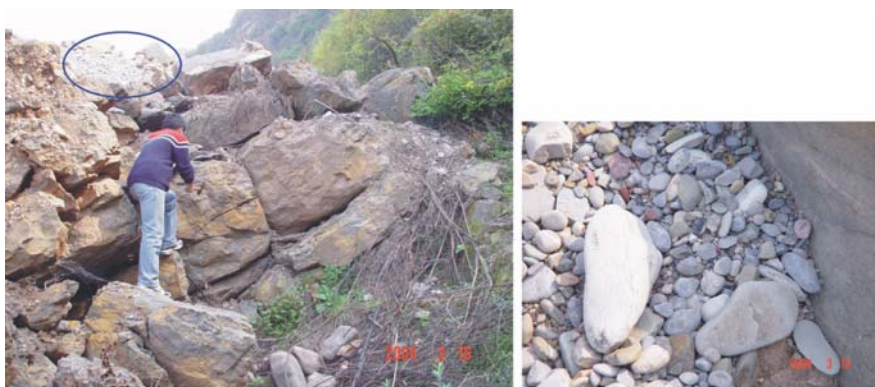
Fig. 8.7 Gravels displaced from the bed of Qinggan-he River and deposited in the toe of the landslide deposit (circled in photograph). Note that the sandstone dip direction is reversed and the dip angle has become steeper compared with Figs. 8.4 and 8.5)

the distal landslide margin contain white gravel with clasts up to 100 mm or so in diameter. The dip angle of the sandstone bedding at the distal margin is steeper than 30° (Fig. 8.7).

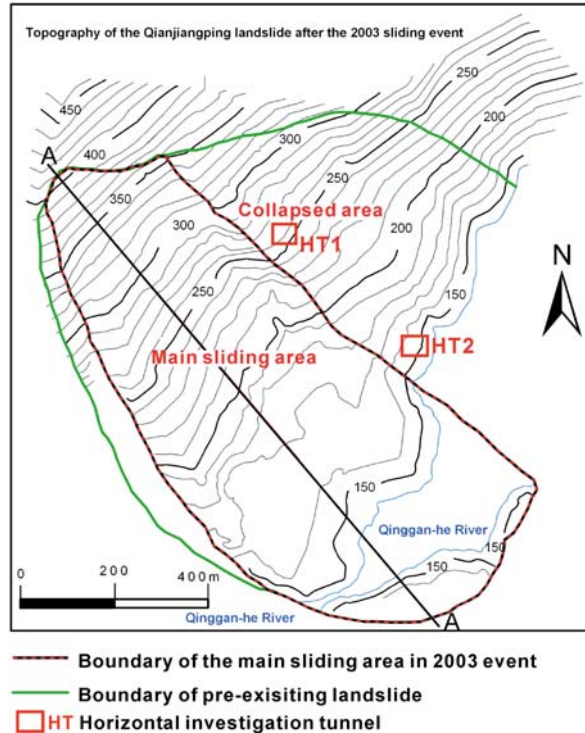
Fig. 8.8 Topography of the Qianjiangping landslide after the 2003 sliding event (modified from Wu et al. 2006)

Figure 8.8 is a topographic map of the Qianjiangping landslide prepared after the 2003 event (modified from Wu et al. 2006). The water level of the Qinggan-he River changed from 95 to 135 m when the first impoundment of the Three Gorges Dam reservoir was conducted. The Qinggan-he River made a big curve in front of the Qianjiangping slope, and erosion by the river at the toe of the slope probably had a negative effect on the stability of the slope. The highest elevation of the main scarp is about 420 m. The landslide has a tongue-like shape in plan view, with a length of 1,200 m and a width of 1,000 m. It moved about 250 m in the main sliding direction

In order to investigate the sliding zone of the 2003 landslide in more detail, two horizontal investigation tunnels (HT1 and HT2) were excavated by China Three Gorges University in the collapsed area to check the properties of the sliding zone as they existed before the 2003 event. The locations of the two tunnels are plotted in Fig. 8.8.

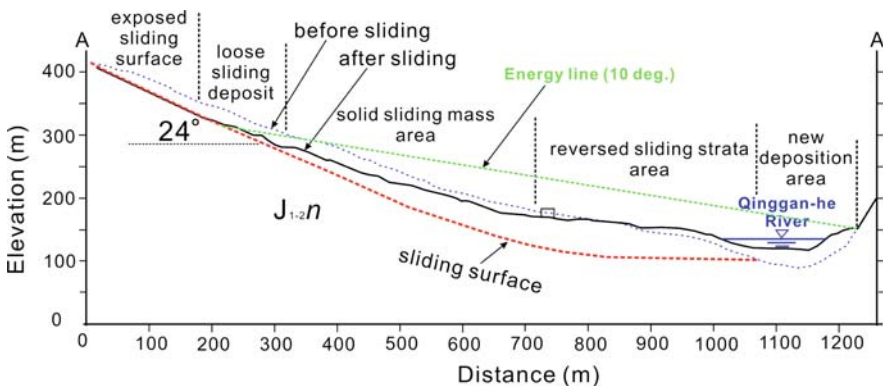
Fig. 8.9 Central longitudinal section of the Qianjiangping landslide

Figure 8.9 is a longitudinal section of the main sliding block of the Qianjiangping landslide. The bedrock in the landslide area is feldspathic quartz sandstone, fine sandstone with carbonaceous siltstone, siltstone with mudstone, and silty mudstone of the Lower Jurassic Niejiashan formation (J_{1-2n}). The dip direction of the strata is reversed near the Qinggan-he River. The average slope angle of the slide plane in the upper part is 24° . An energy line connecting the top and toe of the sliding mass is inclined at 10° , which is the apparent friction angle of the landslide. The 10° value indicates a highly mobile landslide.

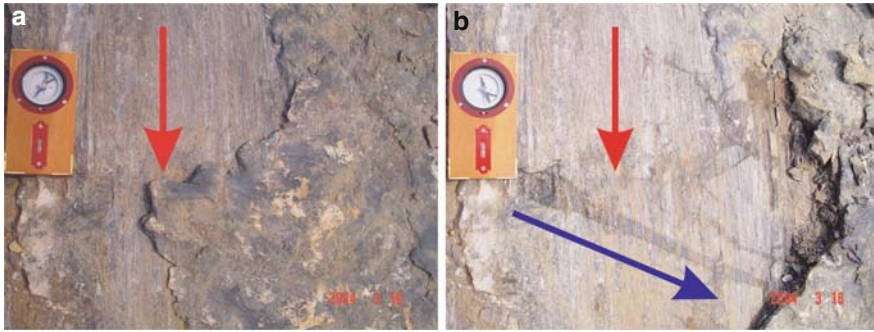
Fig. 8.10 A pair of photographs at the same site showing the pre-existing scratches that underlie the sliding surface of the July 2003 event (*blue arrow* shows the sliding direction, *red arrows* show the strike direction of the pre-existing scratches). The scratches are inferred to be slickensides formed by bedding-plane shear during folding of the rocks in the Cretaceous period

Figure 8.10 shows a sequence of two photographs of scratches on the sliding surface at the upper part of the landslide. Figure 8.10a shows the original situation, while in Fig. 8.10b a slice of sandstone has been stripped away from the plane to reveal more scratches. This shows that the scratches were present beneath the landslide sliding surface before the landslide occurred. The scratch strike direction is $S15^\circ W$ (red arrow). The sliding direction ($S45^\circ E$) of the July 2003 event (blue arrow) is also shown by the water dribble trace in Fig. 8.10b. The angle between the sliding direction and the scratches is about 60° . Comparison of the two photographs shows that the scratches were not formed by the event of July 2003. They must have

formed earlier, probably in a much older geological event, because calcite veinstone is widely distributed along them. This site lies between the Zigui syncline and Baifulai-Liulaiguan anticline that were folded during the Cretaceous period (Wang et al. 2002) and so the scratches can be interpreted as slickensides along bedding-plane shears.

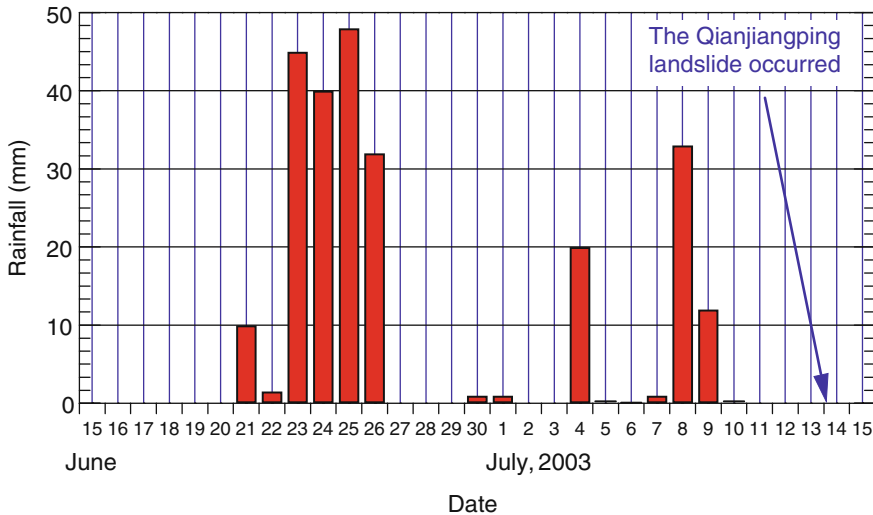
Fig. 8.11 Precipitation data monitored in Yichang city, 70 km from the landslide

Precipitation is monitored in Yichang city (Fig. 8.1), about 70 km from the landslide site. Intense rain from June 21 to June 26 and rain from July 4 to July 9, 2003 (Fig. 8.11) may have saturated the sliding mass and increased its unit weight. However, considering the high permeability of the slickensided sandstone and the transverse cracks crossing the sliding mass, it is not likely that high pore pressure would have resulted.

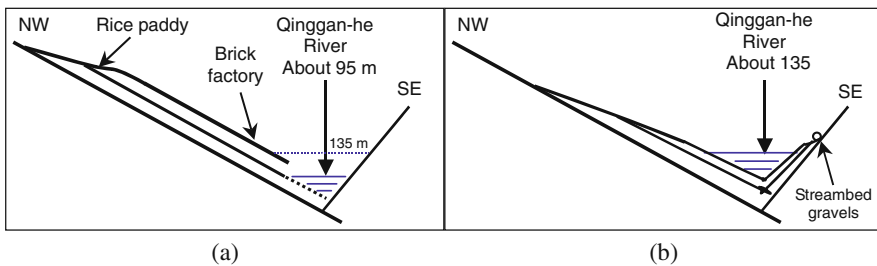
Fig. 8.12 (a) Structural model of the Qianjiangping slope and (b) a sketch of the landslide after failure

The landslide toe had been eroded by the Qinggan-he River long ago and offered little resistance to sliding. Only the left lateral boundary offered side friction and tension resistance from the neighboring rock mass. For such a huge landslide, the mechanical model can be simplified as a two-dimensional longitudinal section as shown in Fig. 8.12a. The situation of the landslide after failure is sketched in Fig. 8.12b.

With the slope in a critical state (Fig. 8.12a), an increase in water level in the river would decrease the effective normal stress in the toe of the slope, and the shear resistance would decrease at the same time. These changes in the mechanical balance resulted in the slope failure.

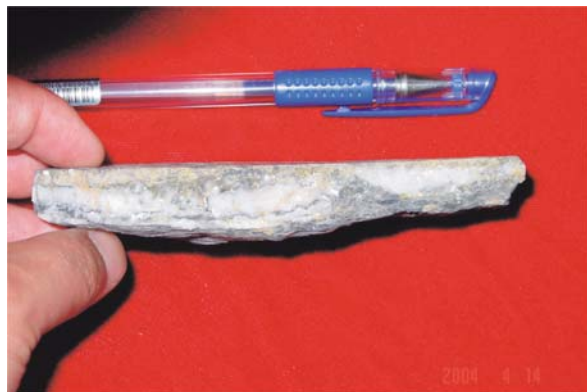
Fig. 8.13 Photograph of a crystalline calcite sample taken from the sliding surface at the upper part (The white color is crystalline calcite)

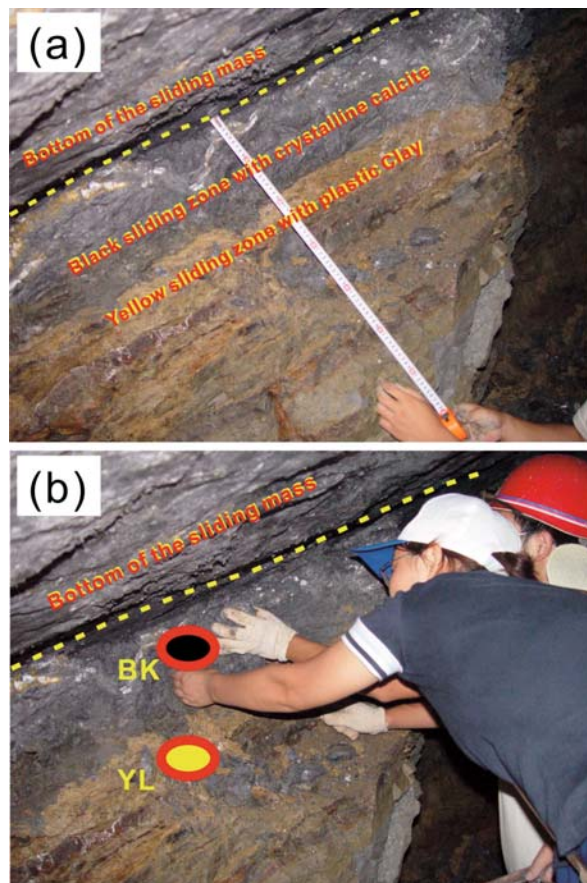
Fig. 8.14 Photograph of the sliding zone in a horizontal investigation tunnel. (a) Under the bottom of the sliding mass, the sliding zone can be observed to consist of two layers. The upper layer is black and includes crystallized calcite, and the lower layer is yellow plastic clay with a high water content. (b) Sampling from the black silt (BK sample) and yellow clay (YL sample) layers of the sliding zone

Observation and sampling were conducted in tunnel HT1. Figure 8.14 shows two photographs taken in the tunnel that face the sliding direction and show the sliding zone. In the investigation tunnel, two layers were observed in the sliding zone. The upper layer is a black clay layer with calcite blocks, while the lower layer is yellow clay. Both layers were water saturated with a thickness of 200 mm and were in a plastic state.

In situ observations reveal that the yellow clay layer may be the old sliding plane because the percentage of fine-grained particles was higher in the yellow layer than in the black layer. It is likely that the black layer formed in the 2003 event. Numerous

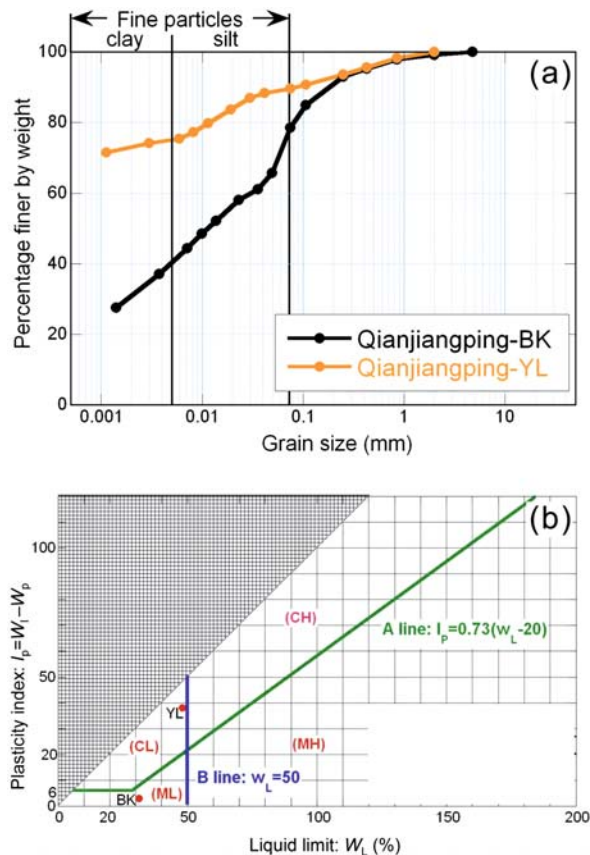
Fig. 8.15 Properties of the samples taken from the slide zone. (a) Grain size distribution of the samples. (b) Soil classification in the I_p - W_L chart. The black silt sample is labeled BK, and the yellow clay sample is labeled YL

To clarify the basic properties of the two samples, grain size analyses, Atterberg limit measurements, and X-ray diffraction analyses were conducted on the two samples. Figure 8.15 shows the grain size distributions (Fig. 8.15a) and soil classification (Fig. 8.15b) of the two samples. It is clear that the YL sample has more fine particles than the BK sample. In the I_p - W_L chart, the YL sample is classified as CL (clay with a low liquid limit), while the BK sample BK is classified as ML (silt with a low liquid limit).

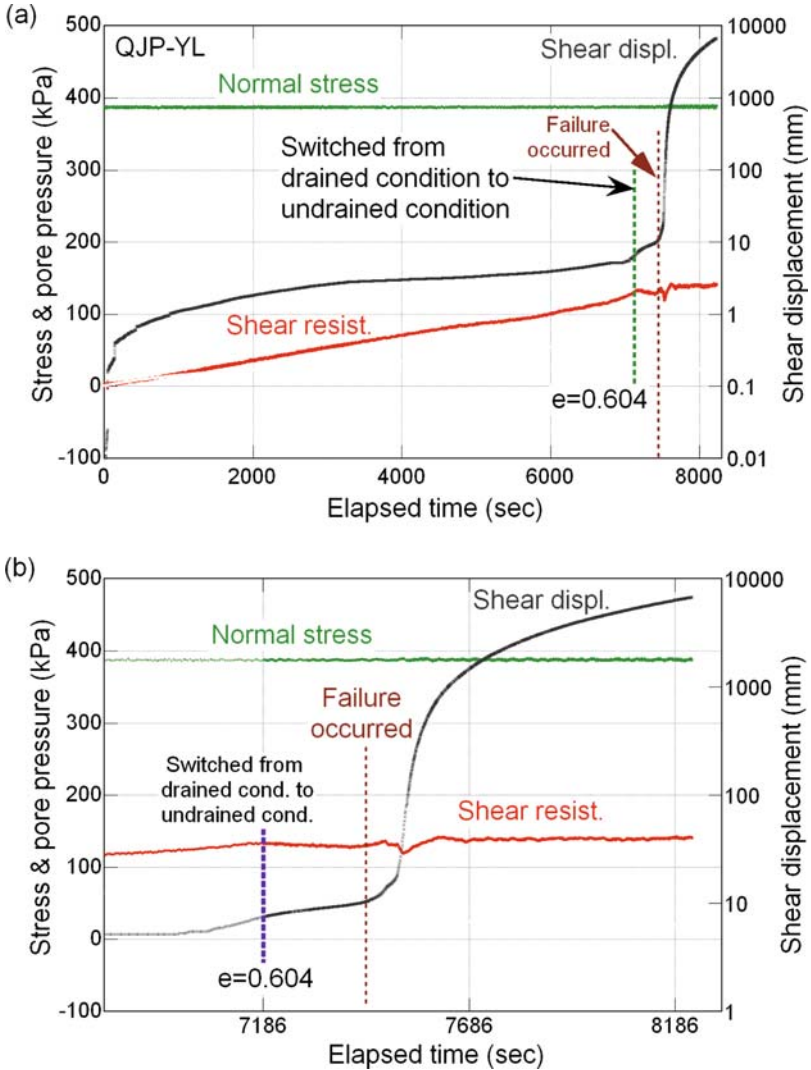
Fig. 8.19 Shear torque ring test results for the yellow clay sample (YL sample) from the Qianjiangping landslide. (a) Time series data for the whole test. (b) Close-up of the data near failure

The test results for the BK sample and the YL sample are shown in Figs. 8.18 and 8.19; they indicate that the two samples behaved differently. For the BK sample, shear resistance decreased quickly when the sample failed at a low residual shear resistance. Meanwhile, for the YL sample, shear resistance showed only a very small decrease and recovered quickly to the post-failure value.

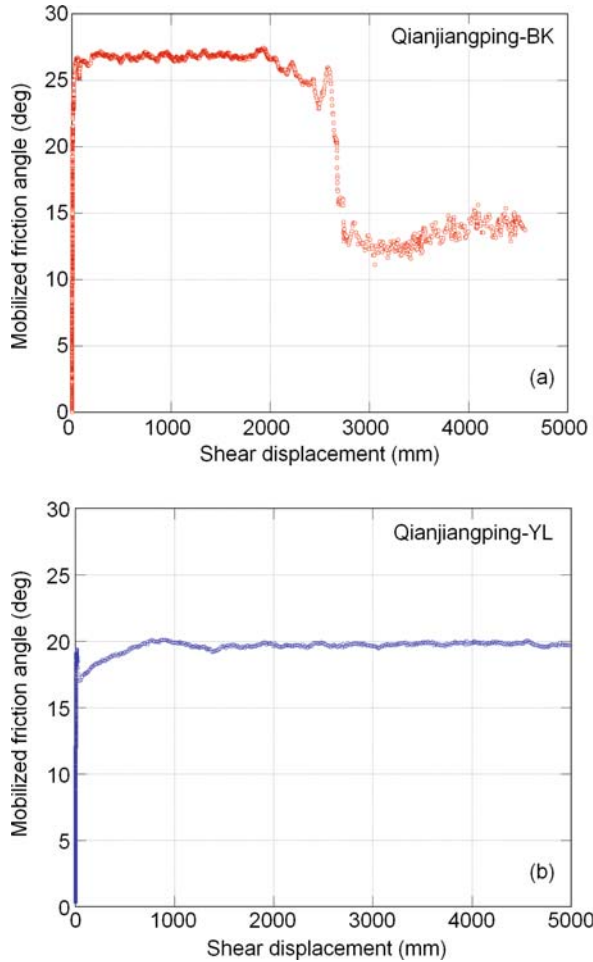
Fig. 8.20 Mobilized friction angle from the creep simulation test for the black silt sample (a) and the yellow clay sample (b) from the Qianjiangping landslide

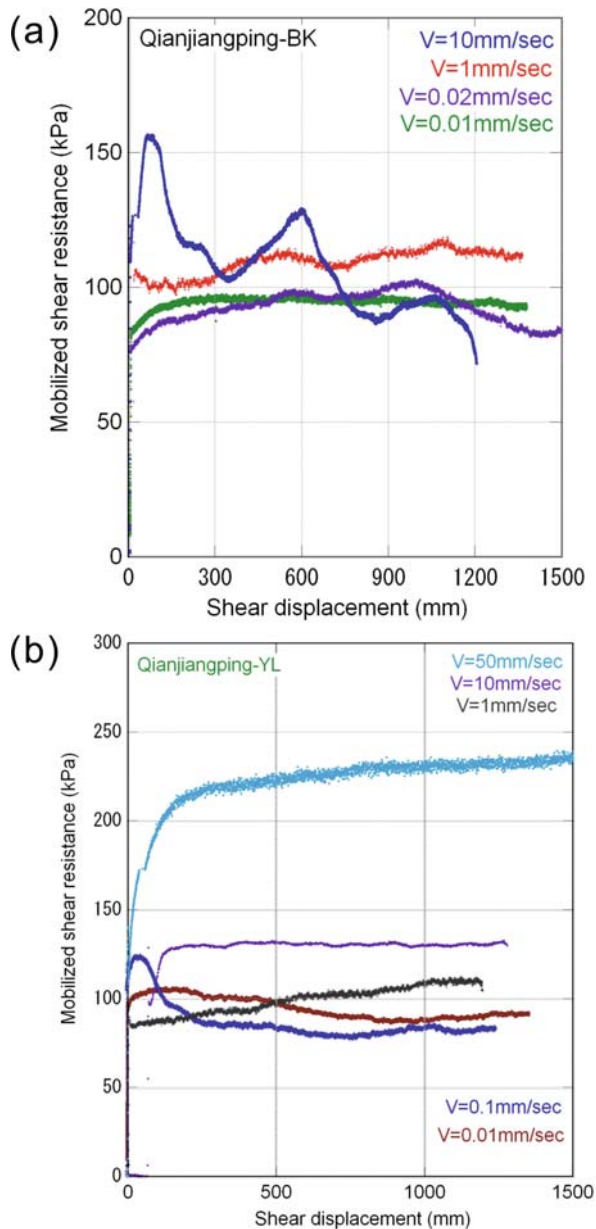
Fig. 8.21 The relationship between mobilized shear resistance and shear displacement at different shear velocities in the shear velocity ring test. Results for the black silt sample (a) and the yellow clay sample (b) from the Qianjiangping landslide

Figure 8.21 shows the relationship of the mobilized shear resistance with shear displacement of the two samples at different shear velocities. It is clear that for the BK sample, the shear resistance does not depend on the shear velocity when the shearing velocity is small (Fig. 8.21a). At shear velocities of 0.01 and 1 mm/s, the shear resistance did not show any obvious change, whereas at a shear velocity of

10 mm/s, the shear resistance became smaller than those produced at lower velocities when the shear displacement exceeded 750 mm. This result would mean that for the BK sample, shear resistance became lower when movement occurred at high velocity, while, for the YL sample, the mobilized shear resistance became higher at higher shear velocity (Fig. 8.21b).

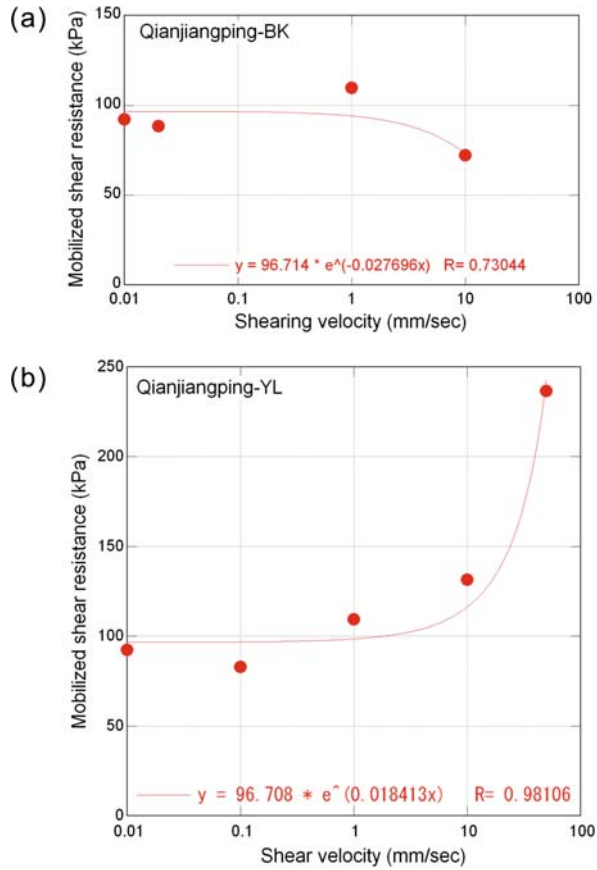
Fig. 8.22 The relationship between mobilized shear resistance and shear velocity for the black silt sample (a) and the yellow clay sample (b) from the Qianjiangping landslide

Figure 8.22 was obtained by plotting the mobilized shear resistance with shearing velocity for the two samples. Through comparison of the results, differences in the change of mobilized shear resistance with shear velocity can be examined. For the BK sample, the shear resistance became slightly smaller when the shear velocity increased, while for the YL sample, the shear resistance became much greater when the shear velocity increased. For the YL sample, the shear resistance shows a positive relationship with the shear velocity. When the shear velocity becomes higher, the shear resistance becomes higher.
