Digital Image Processing in Weathering Damage Analysis and Recovery Treatments Monitoring

Fulvio Zezza

Faculty of Architecture, University IUAV of Venice,
Convento delle Terese - Dorsoduro 2206, Venice, Italy
fulvio.zezza@iuav.it

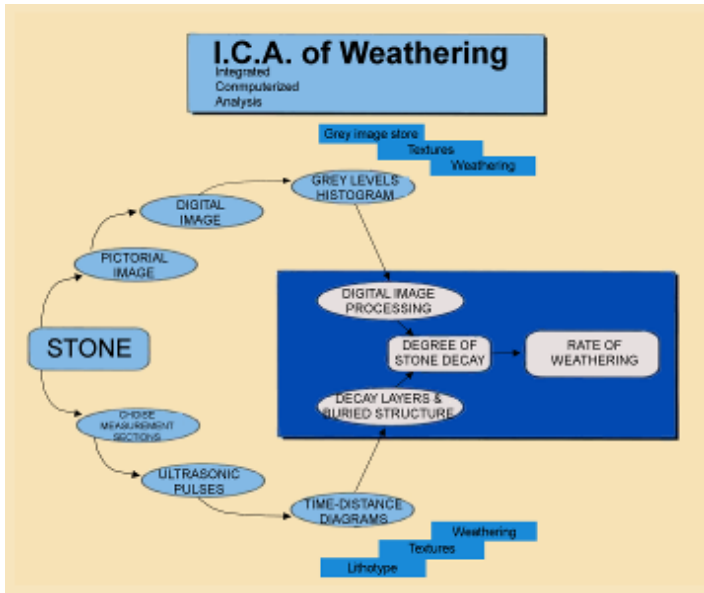
Fig. 1. ICAW technique: analytical approach to detect the rate of weathering (from F.Zezza 1996)

The process to determine the weathering forms and the thickness of the decayed layer consists in the transformation of the pictorial images into digital images and in the employment of ultrasonic pulses (Fig.1).

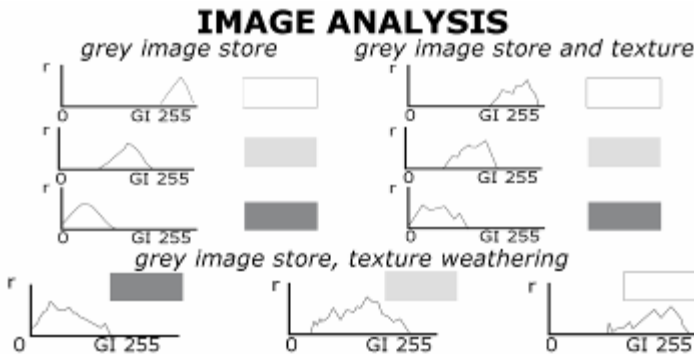
Fig. 2. The grey levels histograms allow to identify chromatic variations, textural characteristics and weathering degree of building material (from F.Zezza 1989)

With reference to the exposed surfaces, the quality of the image must allow to perceive the properties of the object. In digital image processing a black and white image (pictorial image) may be considered as a continuous dimensional function in two variable planes x and y able to supply a representative value of the luminosity for every pair of coordinates. This $f(x,y)$ function is representative of a certain distribution of luminosity in a planar domain internally connected and without singularity. Each image pixel will contribute through a different level of grey with which it is associated, to the formation of a digital image, these individual spatial samples (pixels) are represented by a value (L_g) indicating the level of luminosity relative to an appropriate scale. As regards the tonal range associated to images processed in false colour, the 256 gradations allowed for each of the three basic colours used (red, blue and green), practically a limitless number of combinations. As fig 2 shows in schematic form, the grey levels histograms reflect both the restitution of light energy determined by the chromatic variations of the rock (fig.2) and the textural and structural properties of the stone (exfoliation, lamination, fossils, fissuring, graded bedding etc.). The stone decay, as degree, is showed in abscissa by the interval of grey levels which tend towards 0 increasing in width.

Considering the variations of luminosity recorded in a series of images of rock of different colour and composition as well as different states of conservation, and supplying histograms from freshly quarried rock to severely damaged stone, it is possible to make the following observations: a) the gradual move towards the start of the abscissa, or rather towards the dark shades of grey, of the intervals relative to images of fresh of weathered stone; b) the dispersion of luminosity levels due to the presence of structures of organic or inorganic origin; c) the increase of the dispersion of these levels accompanied by a wider interval of the grey levels in which are included those of severely weathered stone and those of the fresh one.

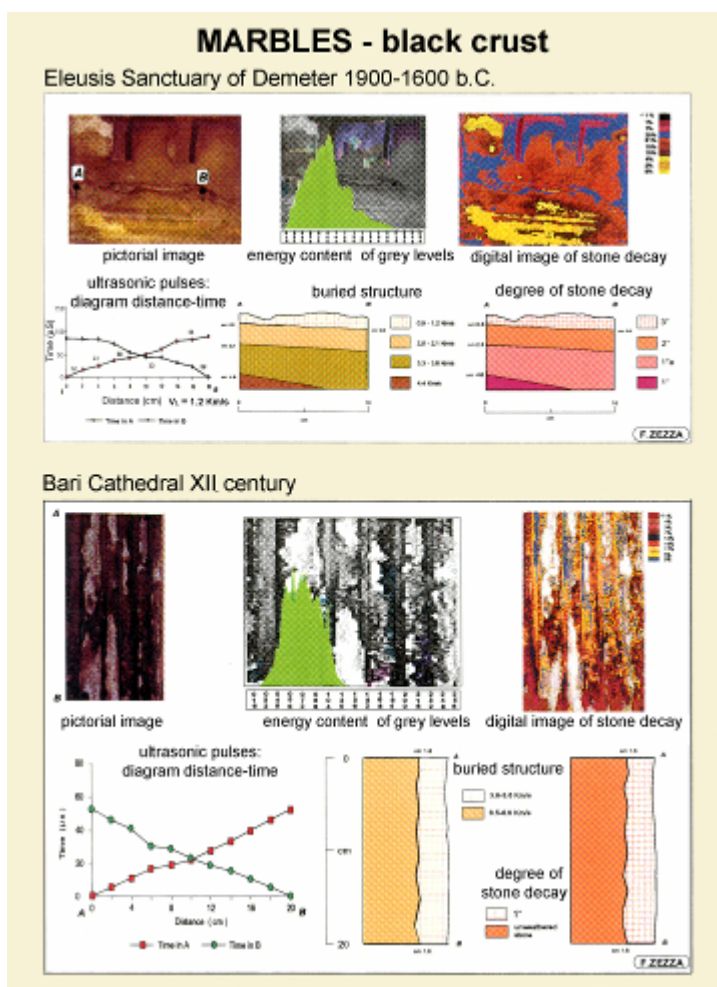
In fig.3 is assessed the deterioration degree and the thickness of the weathered layer of the marble portal (Cathedral of San Nicola, Bari) built in XII century. For the ancient marbles the ultrasonic measurements show the overlap of different weathered layers as the reproduced example (fig.3), referred to the marble of the Temple of

Eleusis dated between 1900-1600 B.C., indicates. The quantitative evaluation of stone decay degree depends by the damage indexes that express the rating of the weathering: their calculation is related to ultrasonic velocities which in turn mark the strength classification and the values of indexes as compactness, porosity and imbibitions of the building material (F.Zezza, 1996).

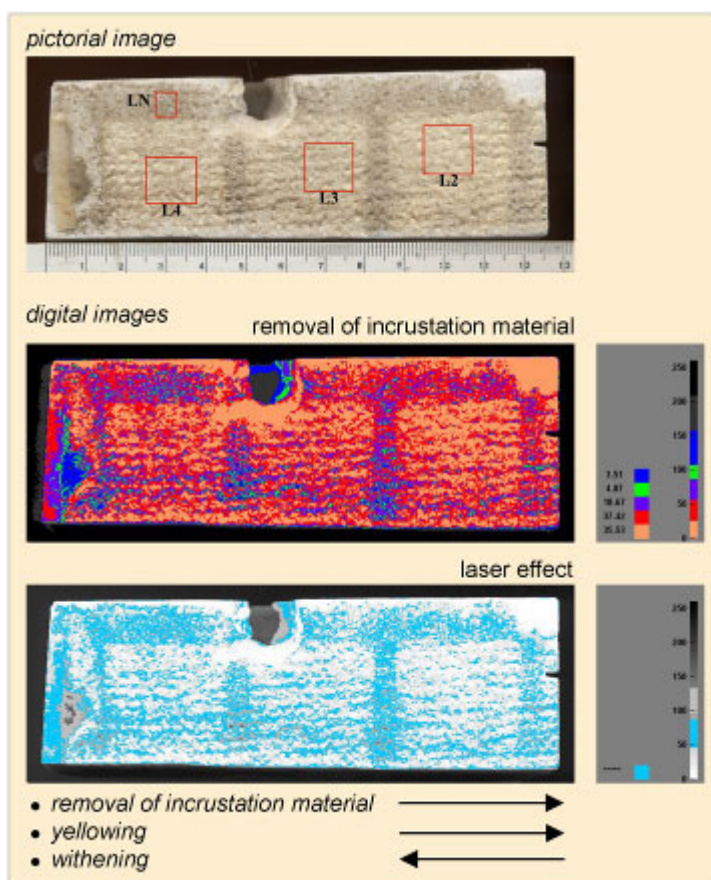
Fig. 8. Digital image analysis: chromatic variations of a Penthelic marble sample, after removal of incrustation material, treated with different infrared (IR) and ultraviolet (UV) radiation combination at relatively low energy fluencies

Three cleaned areas (L2, L3, L4, fig.8) have been interested by a simultaneous action of two discrete laser – based removal mechanism, characterized by different parameters as: i) the infrared (IR) and ultraviolet (UV) radiation combination at relatively low energy fluencies, ii) the number of pulses and iii) energy density (P.Pouli, V. Zafirooulos, 2003). The digital images analysis regarding the effects of removal of the incrustations (fig.8) clearly shows that the selected area L3 is located between two opposite conditions, the former (area L4) characterized by lower removal of crust with whitening effects, the latter (area L2) with higher removal of crust and yellowing effects.

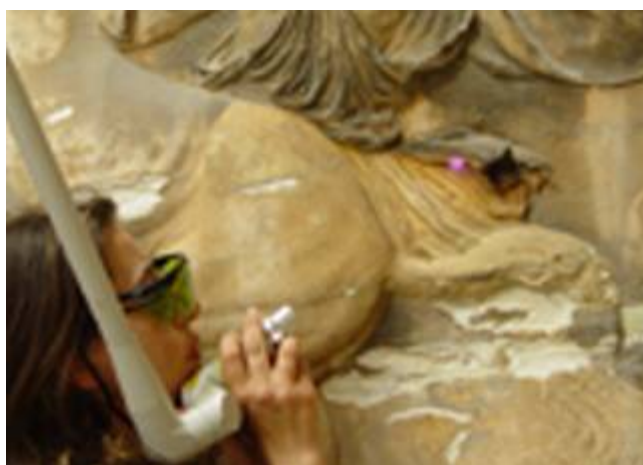
Fig. 10. Laser cleaning of the West Frieze Block - BVIII

The degree and the efficiency of the laser cleaning method (figg.9-10) have been tested taking into account the cases (E. Papakonstantinou, 2003) evaluating the points A, B and C outlined in Tab.1:

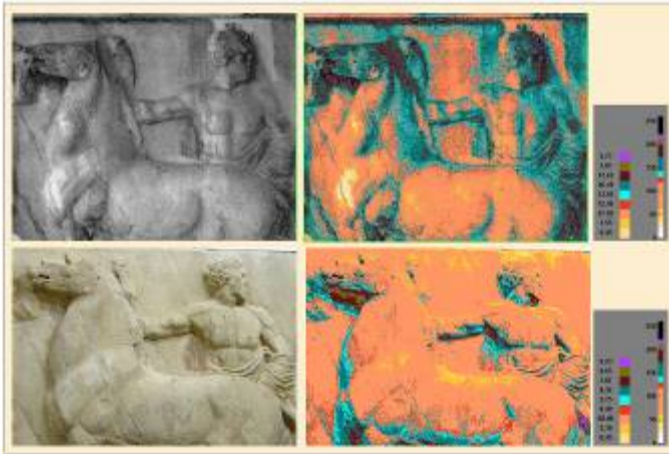
Fig. 11. Pictorial and digital images of the West Frieze - Block III before and after laser cleaning treatment

The comparisons of the pictorial and digital images certificate the homogeneity of the treatment which has preserved the monochromatic surface layers, verifying the good effectiveness of the cleaning process (fig.11). The black crusts have been removed as well as the loose deposits. The homogeneity of the orange colour indicates that the block surface has not suffered, in this case, chromatic variations, indicating the good cleaning result obtained by operators. The presence of the yellow colour is linked with washed zones during the exposition of the marble to the weathering and the blue-red colour indicates traces of monochromatic layers or primary and secondary structural characteristics (i.e. veins, cracks) of the Penthellic marble.
