Progress of Geo-Disaster Mitigation Technology in Asia

Environmental Science and Engineering

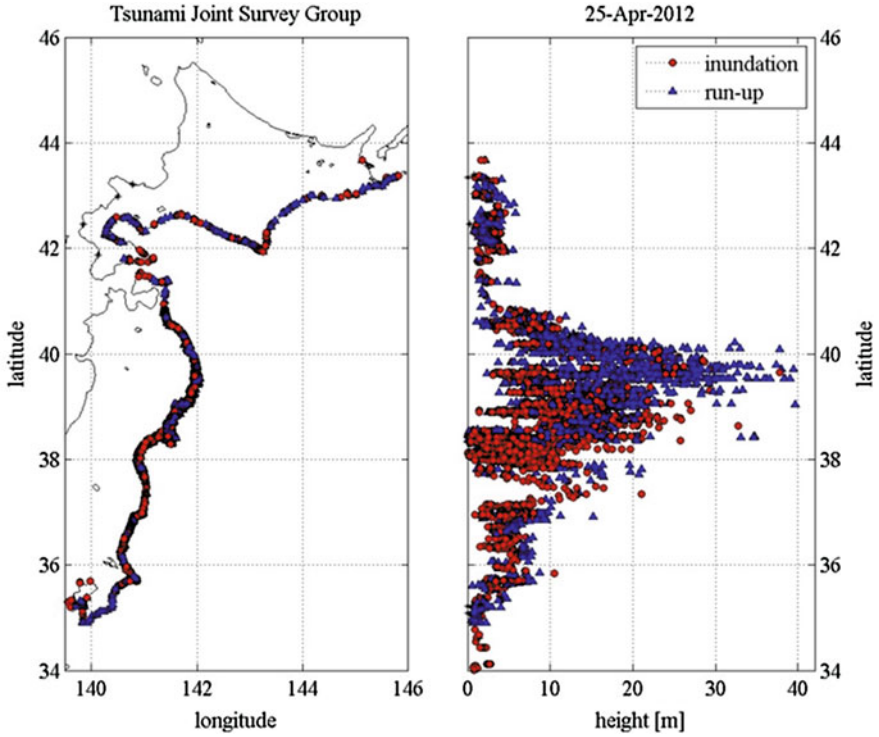
Fig. 6 Distribution map of inundation and run-up heights (The 2011 Tohoku Earthquake Tsunami Joint Survey Group: <http://www.coastal.jp/tsunami2011/>)

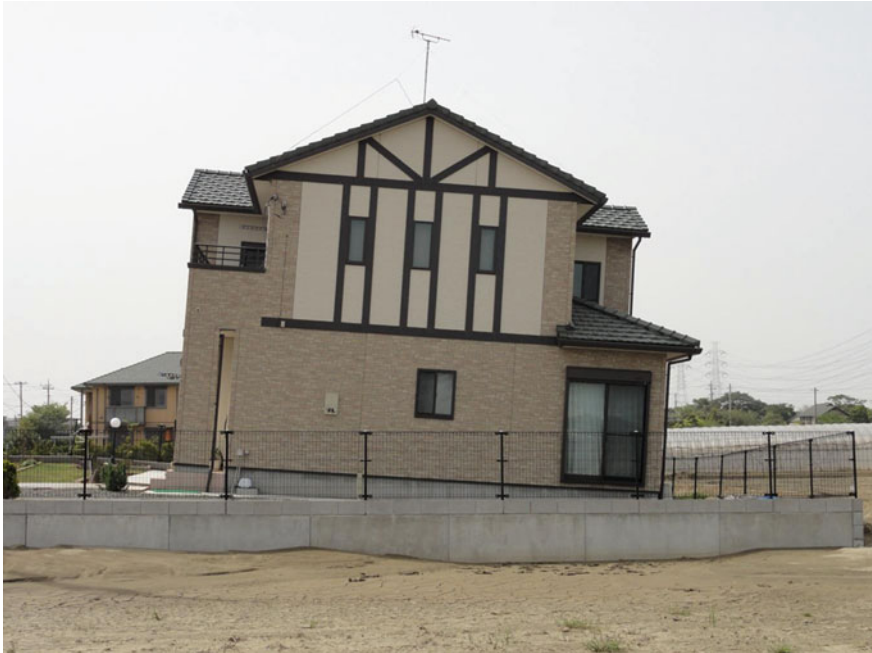
Photo 1 Damage to house by soil liquefaction

The completely collapsed houses numbered 118,480 (As of October 4, 2011, Japanese Government). Figure 7 shows number of damage to houses in each prefecture of the affected areas in comparison of damage in inland and coastal areas (BRI 2011) This figure indicates that most of the damage were caused by tsunami. The soil liquefaction occurred from Tohoku to Kanto regions, and severe damages such as an inclination of houses (Photo 1) and suspension of water supply occurred. Especially, reclaimed land in Urayasu city of Chiba prefecture was severely liquefied and many houses were damaged.

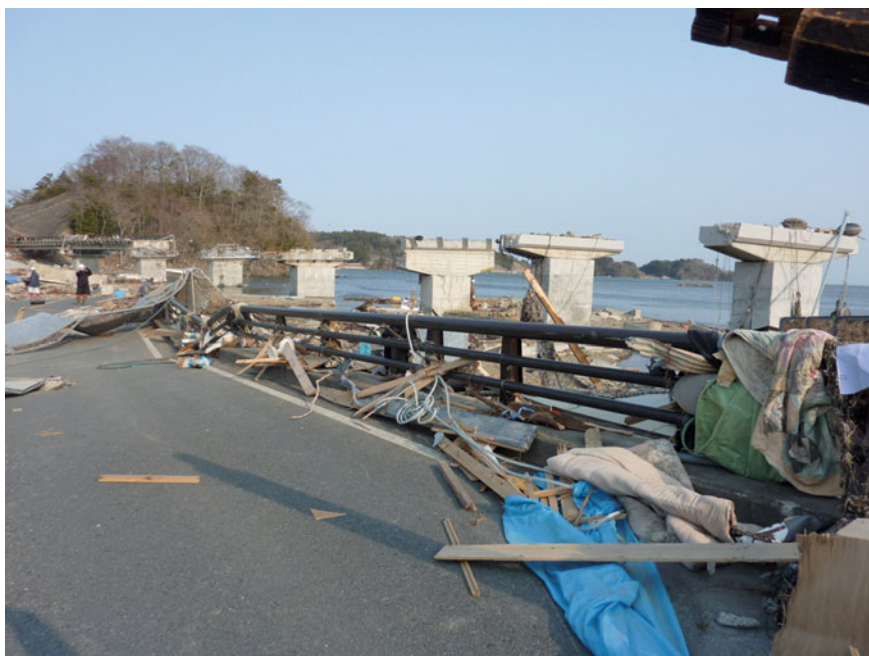
Photo 2 Damage to bridge by tsunami

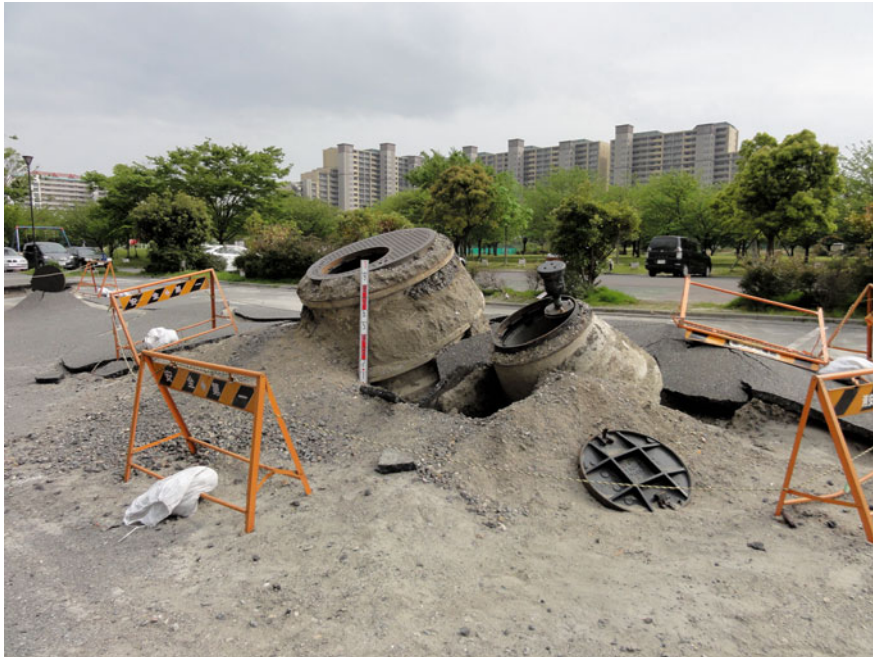
Photo 4 Uplift of underground water tank

The damage caused by the earthquake and tsunami seems to be classified into five categories. Firstly the causes of damage are divided by earthquake and tsunami. Causes of damage by earthquake are classified into ground shaking itself and ground failure such as liquefaction, slope failure and etc. Photo 5 shows damage to expansion joint of steel pipe with 2400 mm diameter. This damage seems to be caused by ground shaking and/or ground deformation. Photo 6 shows an uplift of underground water tank induced by liquefaction.

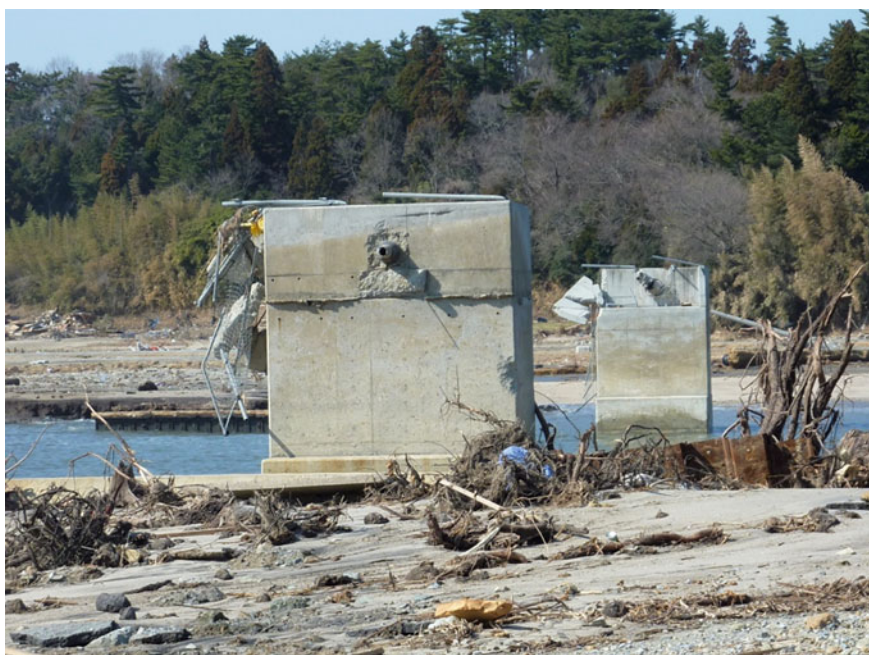
Photo 5 Damage to water pipe bridge

tsunami. The water pipe bridge was completely washed away. Photo 4 shows damage to a buried pipeline. The pipeline appeared above ground after tsunami because of scouring caused by tsunami. The mechanism of damage to pipeline, that is, how much force acts on a pipeline is not sure. The mechanism of this kind of damage must be clarified in the future (Photos 5, 6).

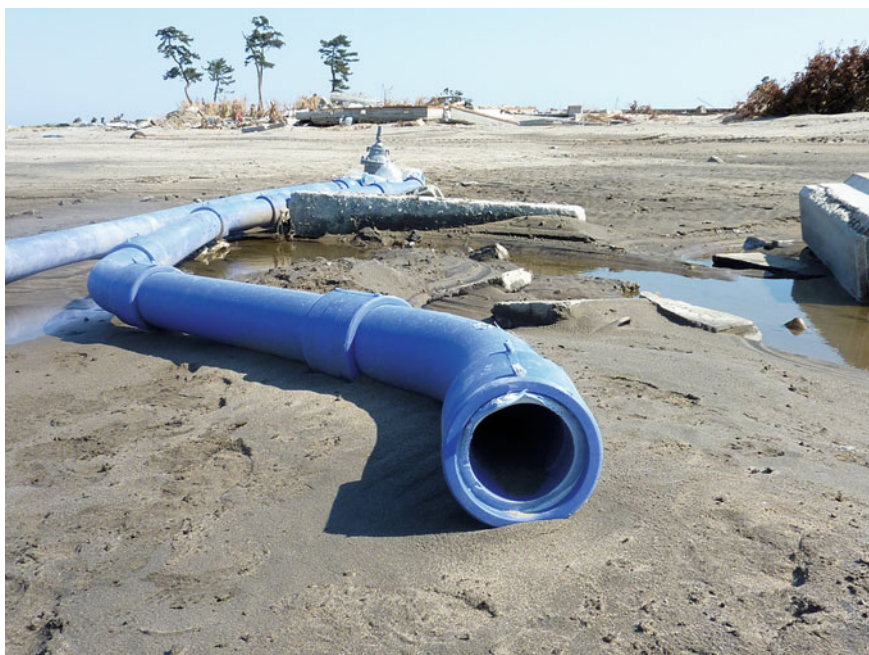
Photo 6 Damage to pipe by scouring of tsunami

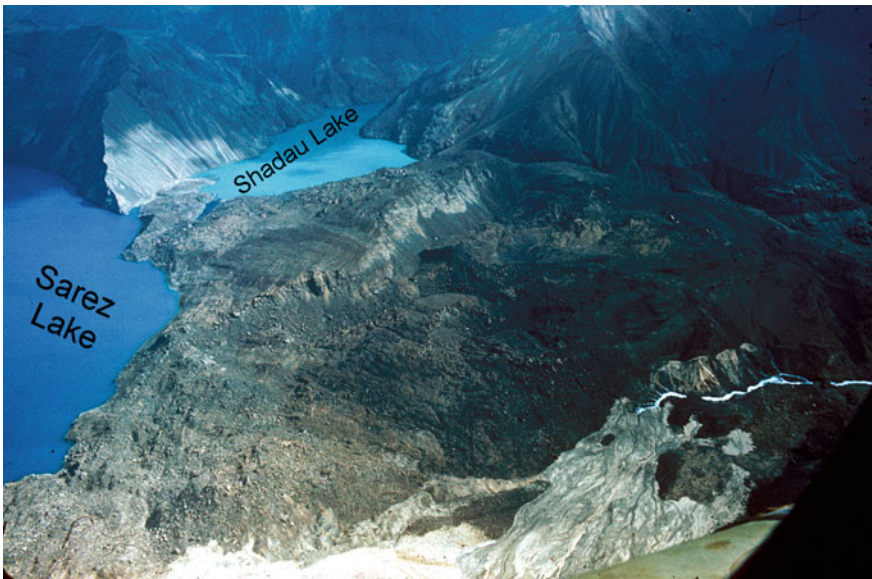
Fig. 3 The Usoi natural dam. Helicopter view from north. Giant block retaining original structure is visible on top of the dam in front of the Shadau Lake. Seeping water forms springs at the left bank of the erosion canyon. Whitish flat area above the canyon—deposits of debris flows that came in this direction before their diversion towards the Lake in 1947. Steep scarp that crosses the dam body indicate its transverse spreading likely due to impact over the steep opposite slope of the Murgab River valley

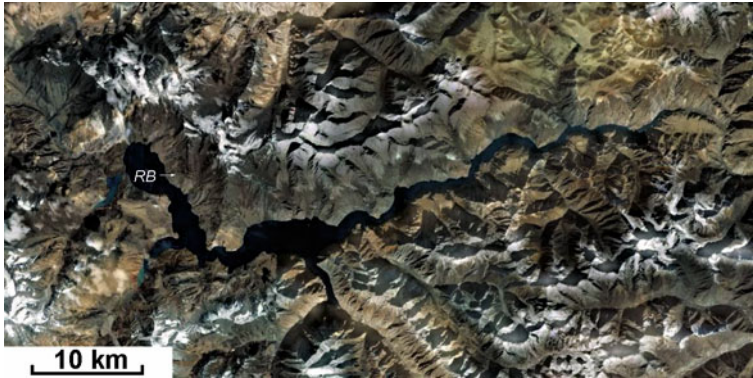
Fig. 4 The Sarez Lake. Google Earth space image. *RB*—location of the assumed Right-Bank landslide

The 500-m deep and 60-km long lake containing almost 17 km^3 of water (Fig. 4) was named after the Sarez village that was submerged along with several other minor settlements. Such inundation represents secondary disastrous effect of landslide river damming, which, though being not sudden and, thus, *sensu stricto*, not “catastrophic”, produced complete damage not only of the local people property, but of the entire inhabited environment, forcing people to resettle to other kishlaks (villages) in the Bartang River valley and in the Gunt River valley, passing south from the Rushan Range. In high mountains economic and social losses due to such secondary effects could be much higher than that of the landslide itself. All these however, are negligible in comparison with what could happen if the Usoi dam will be breached and water stored in the lake released.

In 1960s it was hypothesized that large-scale slope failure might occur on the lakes' right bank, 4–5 km from the blockage (RB on Fig. 4), which would cause the huge displacement wave that can gash over the dam at its lowermost section resulting in the dam's partial or complete breach (Sheko 1968; Sheko and Lekhatinov 1970; Fedorenko 1988), as it occurred, for example, in the Las Conchas valley (Argentina) in the prehistoric times (Hermanns et al. 2004). Different researchers estimated volume of this "Right-bank landslide" from 0.3 to 2.0 km³. However, possibility of such a large-scale failure, its volume and rate estimates are still controversial and require more studies (Alford and Schuster 2000; Ischuk 2011; Strom 2012c). Additional uncertainty of the Lake banks stability assessment is associated with high seismic activity of Central Pamirs. It should be mentioned that none of several gigantic past rockslides that had blocked the Murgab River valley close to the Usoi dam (Fedorenko 1988) remain intact, proving the assumption that long-term stability of the dam and lake can not be guaranteed without special security arrangements.

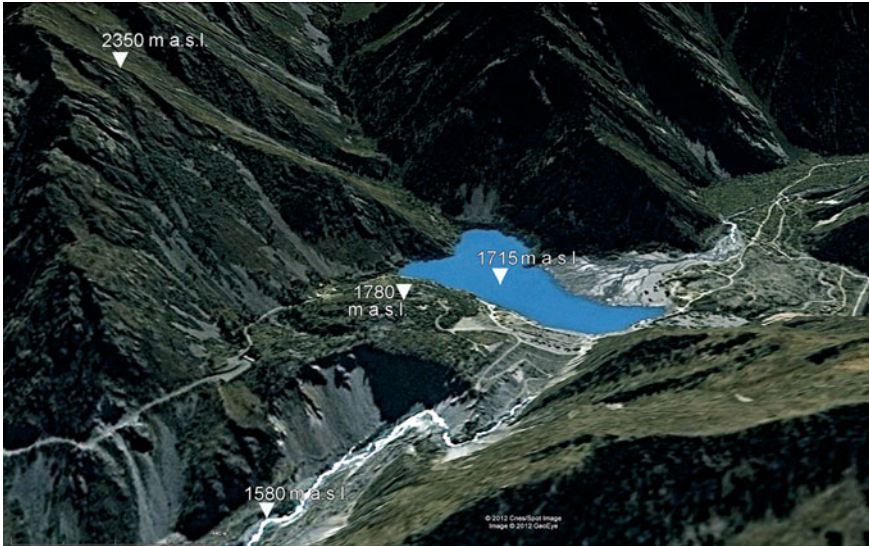
Fig. 5 The Issyk dam and Lake after restoration of the dam. The rockslide headscarp is on the left. Large alluvial fan was formed by debris flow that caused the dam's breach in 1963. 3D Google Earth view

The prehistoric landslide dam about 0.6 km^2 in size and up to 200 m high (about 50 Mm^3 in volume), composed of diorite blocks (on top) and same rock crushed at a high extent in the dams' interior (Eugen Gaspirovich, personal communication), was breached by overtopping caused by debris flow that originated in the upper reaches of the catchment due to the Jarsai glacial lake breach. Up to 6–7 million m^3 of debris was brought into the Issyk Lake within 3–4 h resulting in rapid increase of the lake level and creation of waves that destroyed the upper part of the blockage. Water stored in the lake rushed downstream eroding the dam body as well as river banks and valley bottom (Gerasimov 1965). Peak discharge recorded about 10 km downstream, close to the Issyk town, was $745 \text{ m}^3/\text{s}$, while mean discharge of the river at this site is $4,96 \text{ m}^3/\text{s}$ (from (State Water Inventory 1964–1981). Only small remnant lake has remained after the disaster. Later on an artificial dike was built in the eroded canyon to protect downstream valley and the Issyk town from new debris flows and to renew this beautiful touristic site (Fig. 5).

Fig. 5) where waves generated by debris flow entering in the lake removed blocky carapace armoring the blockage surface. Subsequent dam breach was quite rapid (Gerasimov 1965). Presence of large amount of intensively fragmented bedrock debris, which is entrained in the water flow leads to its immediate transformation in the rapidly moving debris flow, which was observed during the 1985 Bairaman dam breach in Papua New Guinea (King et al. 1989) and was described above in the Lower Aral landslide case (see Fig. 21). Such debris flows, besides extremely hazardous direct effects on the population and infrastructure, result in significant flood plane aggradation.

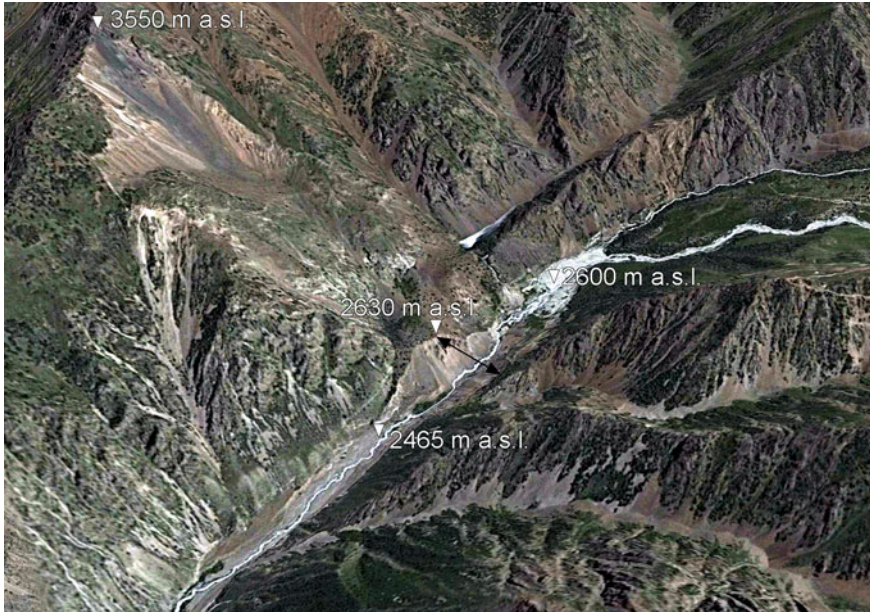
Fig. 7 The Yashinkul dam breached in 1966. Note large difference of the benchmarks elevations upstream and downstream from the dam resulting from the significant sedimentation of the 300-years old lake (compare with the Aini landslide dam on Fig. 6). Just downstream from the dam evidence of valley aggradation are still visible. 3D Google Earth view

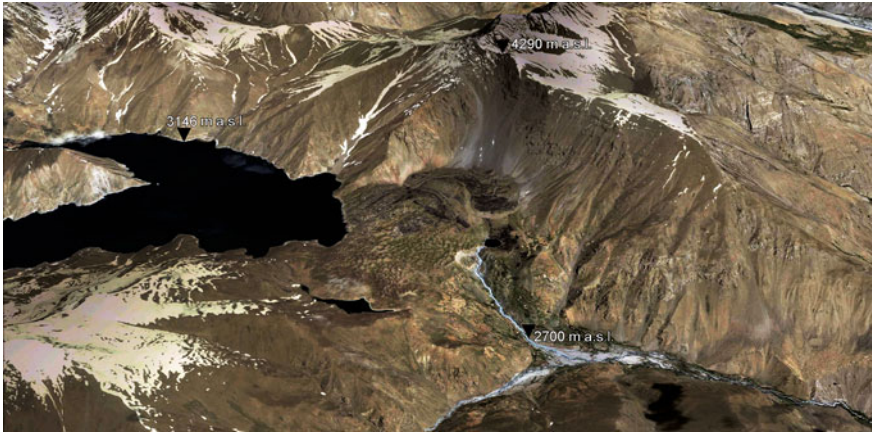
Fig. 9 Rockslide dam of the Shiva Lake in the Afghan Badakhshan at $37^{\circ}23' N$, $71^{\circ}24' E$ (6 on Fig. 1). It is clearly visible that the headscarp is a unique feature which relief is much younger than that of other parts of the valley slope. 3D Google Earth view

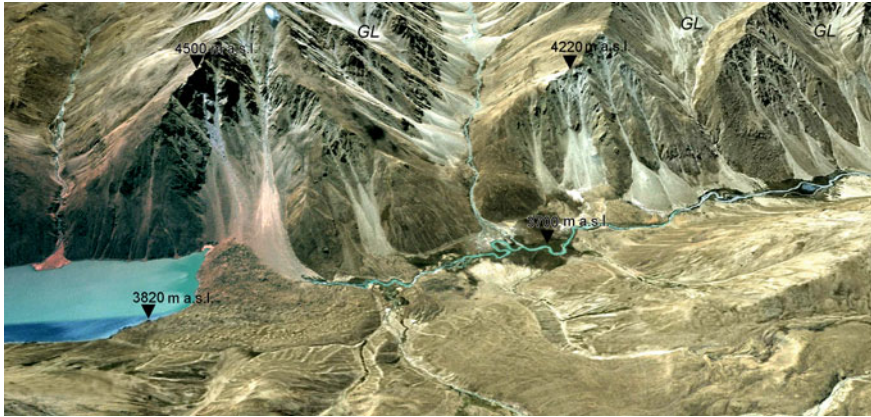
Fig. 10 The Rivakkul Lake dam in the Gunt River basin at $37^{\circ}37' N$, $72^{\circ}03.5' E$ (7 on Fig. 1). One more smaller blockage can be seen immediately downstream from the dam and one more—downstream from the small green plane at 3700 m a.s.l., which is the bottom of the small emptied lake. *GL*—modern glacier deposits contemporary with the damming features develop much higher than rockslides that blocked the valley. 3D Google Earth view

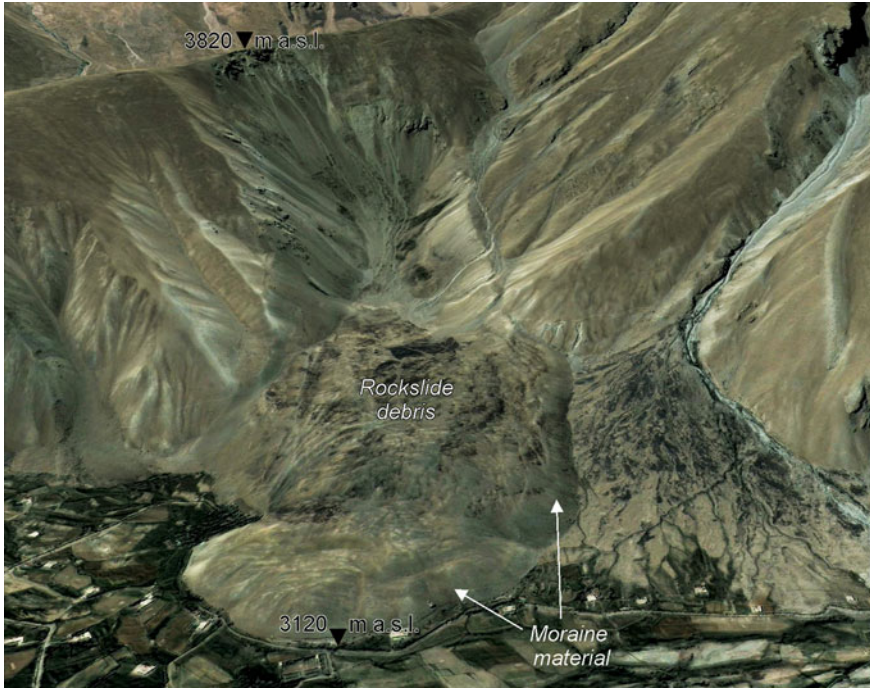
Fig. 11 The Imom rockslide at the left bank of the Gunt River valley. Frontal and flank parts of its body are composed of moraine material resting at the slope base that had been bulldozed by moving rockslide debris. 3D Google Earth view

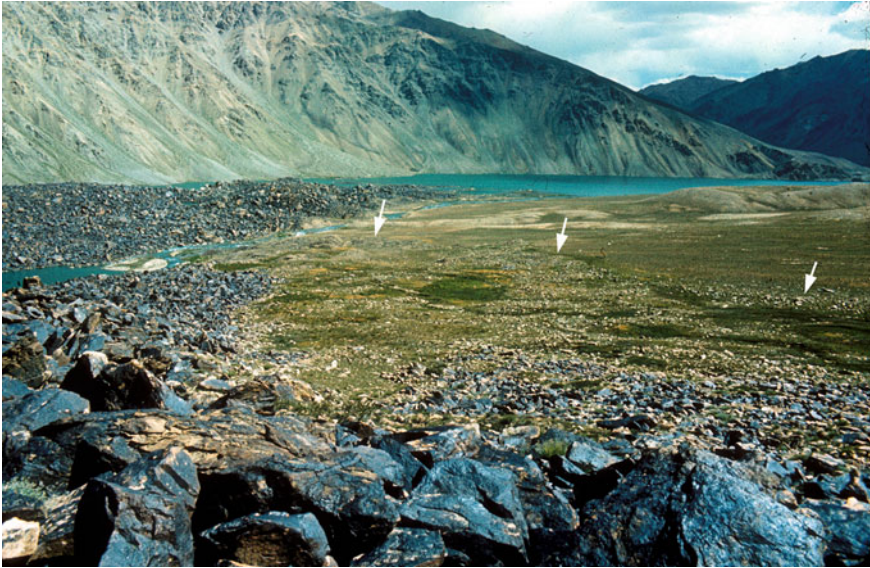
Fig. 14 Wide thin stripe of moraine material bounding central part of the Yashilkul rock avalanche debris composed of gneiss blocks. Its microrelief differs significantly from old moraine material (outer limit of rock avalanche is marked by *arrows*). Photograph was made in 1980s before the construction of the spillway visible on Fig. 13

part of the latter spread outside the limits of the blocky gneiss zone forming microrelief that differs significantly from the intact terrain outside (Figs. 13, 14). Besides, here we can also see that the headscarp is a unique feature at this slope within its elevations range, which indicate non-climatic cause of its origin.

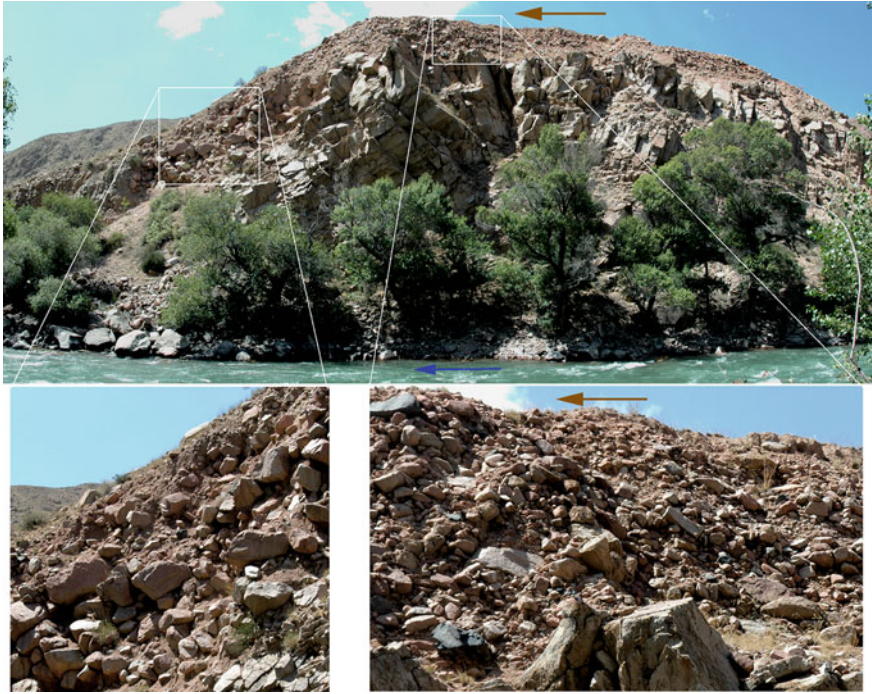
Fig. 21 Debris left by outburst flood after breach of the Lower Aral Holocene landslide dam on the isolated ~ 10 m high cliff about 2 km downstream from the breached dam. *Dark blue arrow* shows river flow direction. *Left inset*—large angular blocks of granite up to 1 m in size carried by the first, most powerful surge of the debris flow formed by outburst and deposited immediately downstream from the cliff in its ‘shadow’. This material was, likely, eroded from the dams’ outer part. *Right inset*—cliff is covered by stony angular granite debris left by the following part of the debris flow enriched by smaller fragments, likely from the internal part of the dams’ body. Orientation of flattened fragments clearly indicates direction of debris flow motion (*brown arrows*). Note that debris flow was thick enough to leave about 2-m thick debris 10 m above the river level

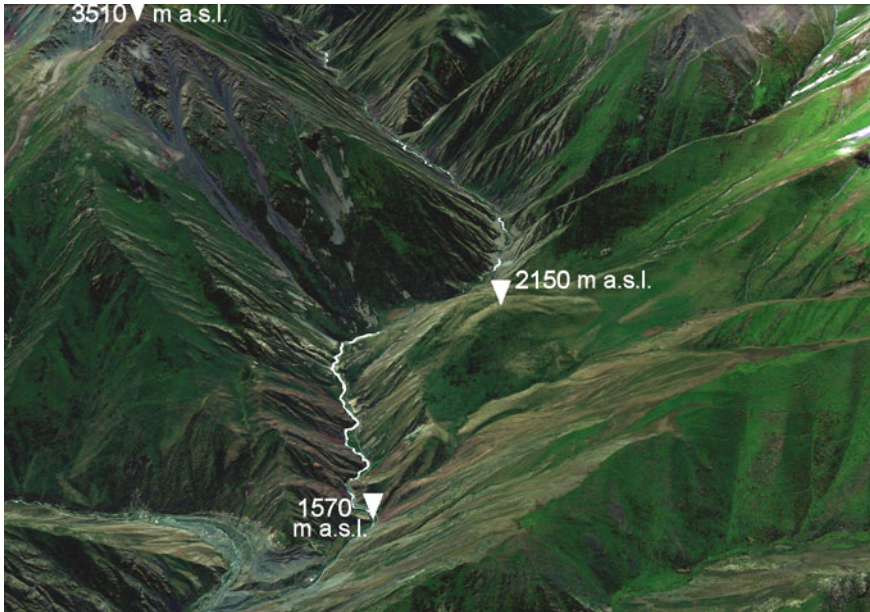
Fig. 22 Breached Aksu dam in the Aksu River valley at the northern slope of the Kyrgyz Range. Remaining part of the dam's body is the smooth hill with top mark at 2150 m a.s.l. 3D Google Earth view

The giant Aksu dam more than 400 m high (it is a minimal—effective dams' height) and about 1.5 km^3 in volume (Fig. 22) that had blocked rather small river demonstrates opposite behavior. With $DBI = 1.94$ this feature should be in the stability domain, which upper limit is 2.75 (Ermini and Casagli 2003). Nevertheless the dam was breached and, judging from the absence of lake sediments in the valley upstream, soon after its formation. Most likely that after overtopping rapid turbulent flow at the downstream slope of this very compact dam with along-stream length of 2.5 km only (compare with ~ 4 km long Usoi and ~ 3.5 km long Shiva dams of the same order of size) had eroded its proximal lower part very fast.

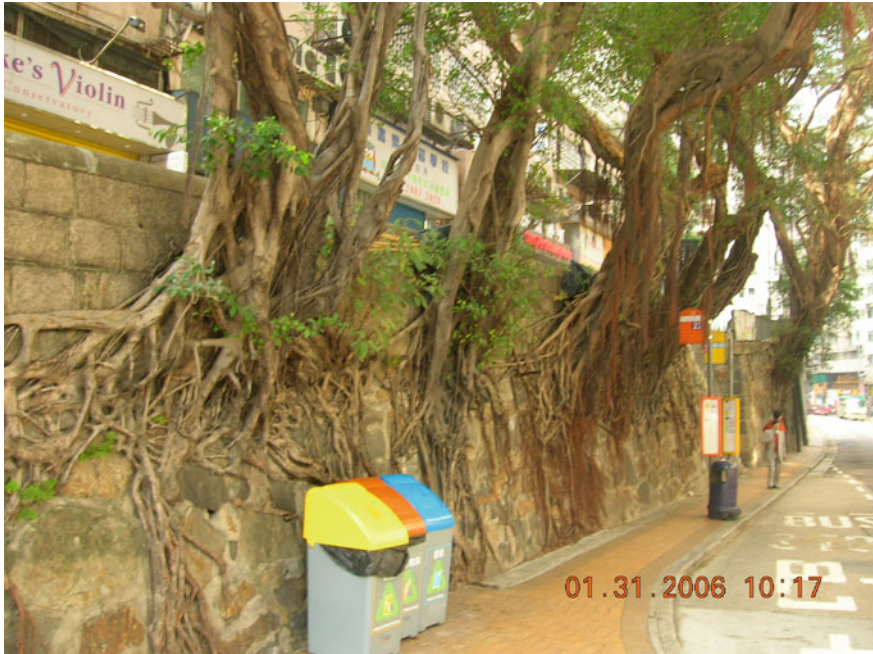
Fig. 4 Large banyan trees growing out of old masonry retaining walls on Bonham Road, Hong Kong Island

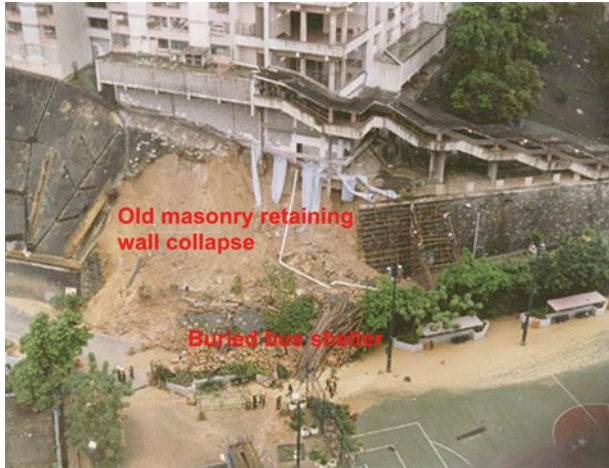
Fig. 8 Collapse of Kwun Long Lau old masonry retaining wall in 1994 (modified after GEO)

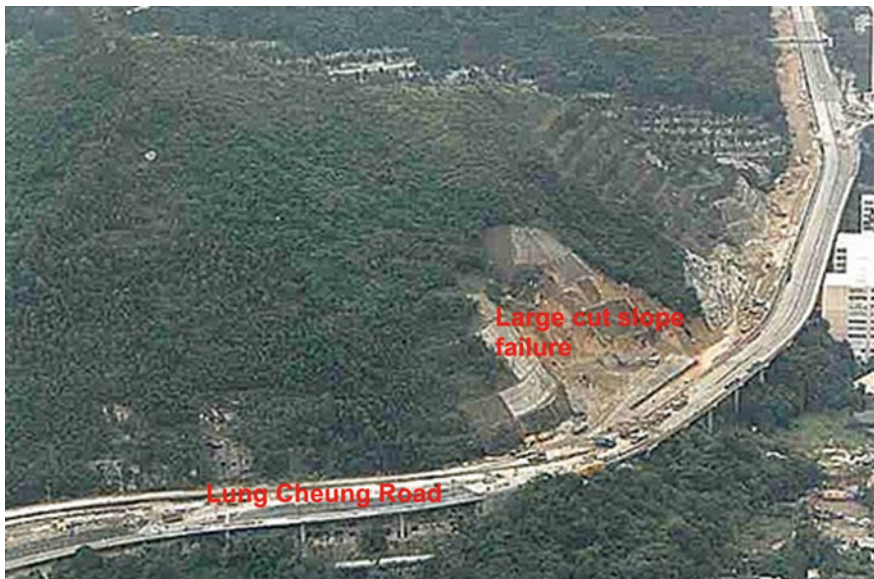
Fig. 10 Landslide in a cut slope above Lung Cheung Road in 1997 (modified after GEO)

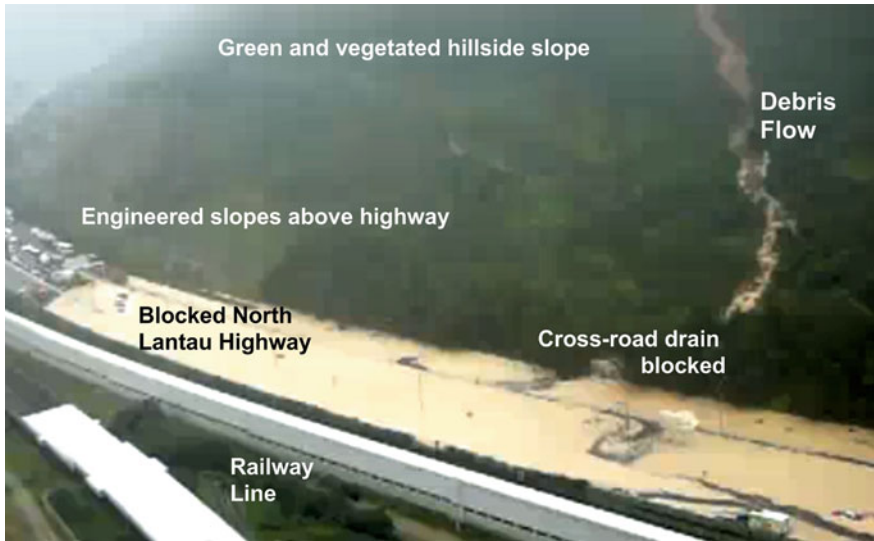
Fig. 11 Blockage of newly constructed North Lantau Express by channelized debris flow on streams from above mountain on June 7, 2008 (modified after web video)

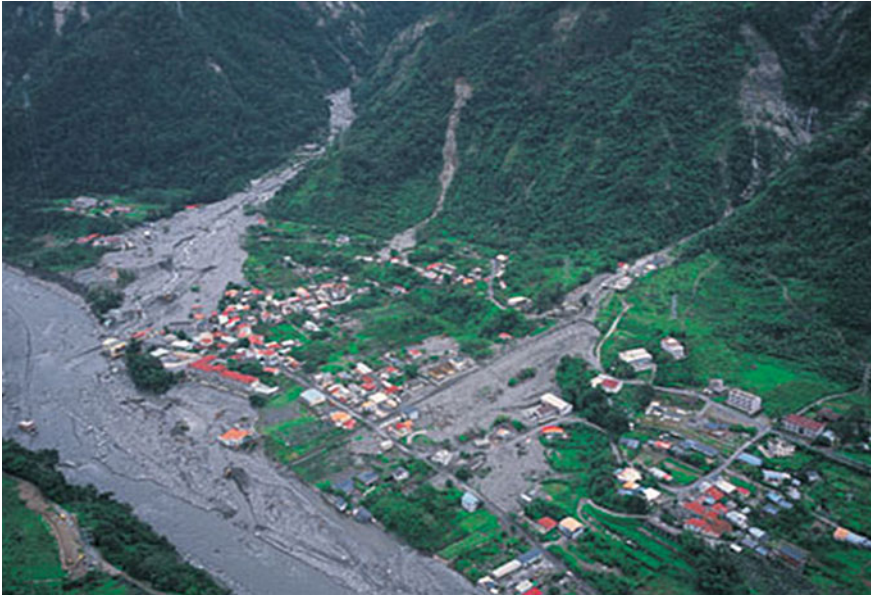
Fig. 1 Debris flow disaster at Song-Her village in central Taiwan. The village is partially buried by debris flows and an original small stream outbursts into debris flow river of more than 30 m wide. This scenario is typical in Taiwan

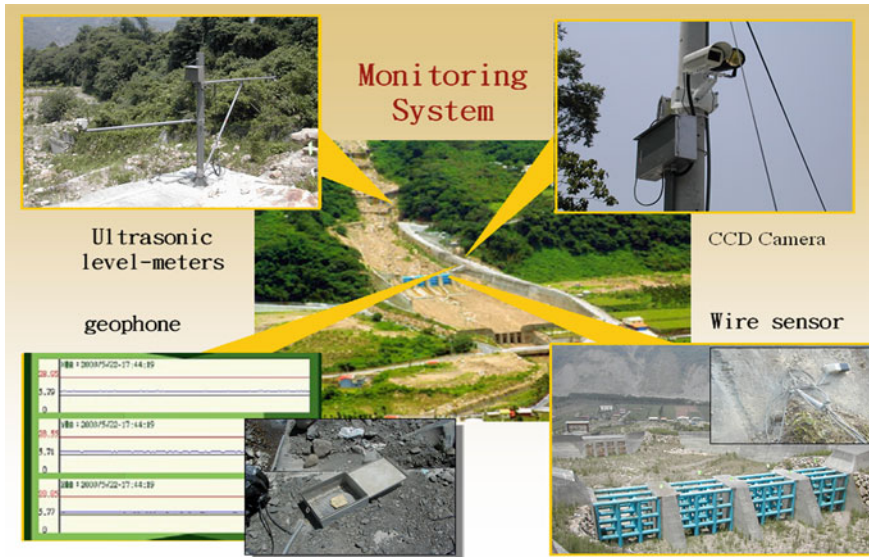
Fig. 6 Standard SWCB monitoring system. Equipments include CCD camera, geophone, wire sensor and ultrasonic level-meter, installed at Fengqiu debris-flow potential stream in the Chenyoulan stream watershed,Taiwan

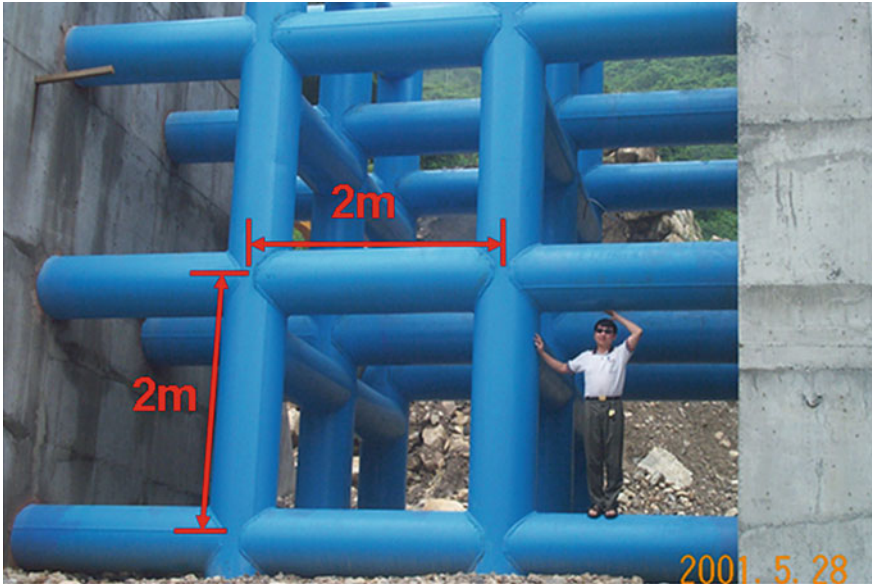
Fig. 11 Typical dimension of open-type sabo dams: steel slit dam

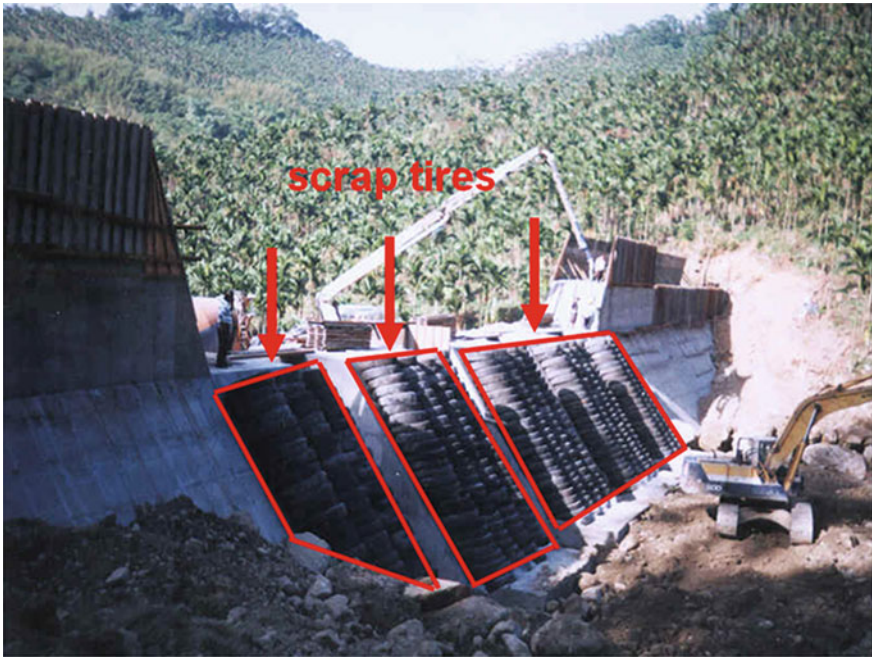
Fig. 12 Slit dam with scrap tires installed to reduce debris flow impact. Huashan River at Kukeng Township of Yunlin County, Taiwan

Fig. 13 The installation of accelerometers in the slit dam

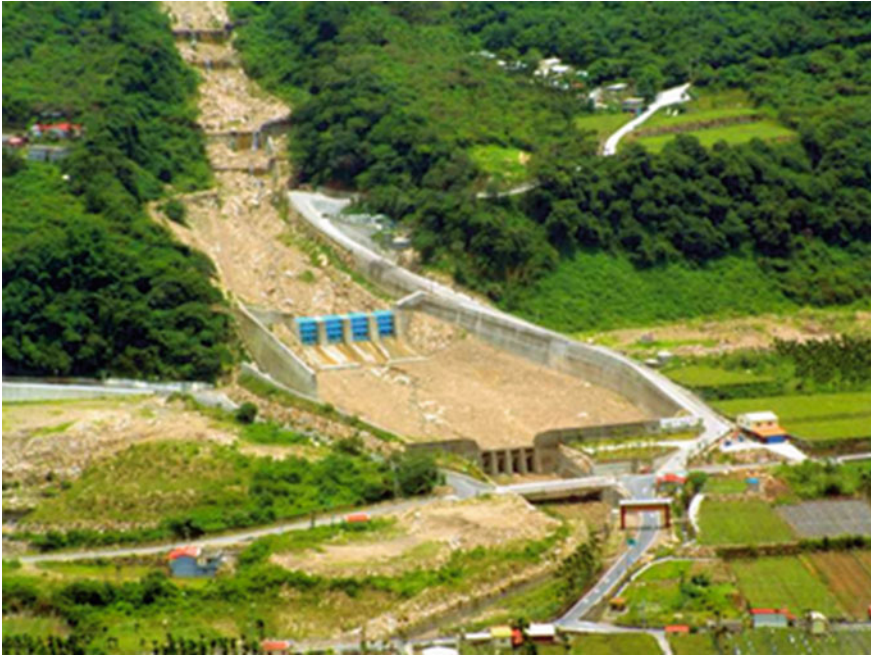
Fig. 15 Debris-flow control structures, such as Sabo dams, debris barriers, and debris basins, at Fengqiu in the Chenyoulun Stream watershed (Jan and Chen 2005)

In view of the ability to withstand the impact force while maintaining ecological balance, it is indeed a versatile method of conserving the environment. Because of these benefits, open-type dam has become the most often seen in Taiwan nowadays. However the design of open-type dam is always composed of a series of different types of dames (Fig. 15). So the design can be safe and satisfy different requirements of residents.

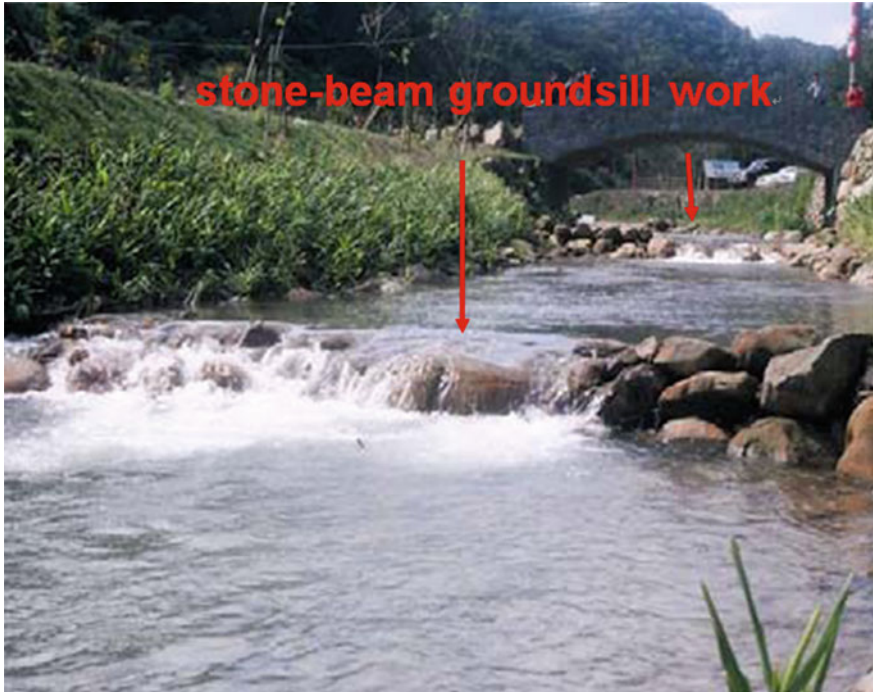
Fig. 16 Continuous stone-beam ground sill work (Hsieh 2008)

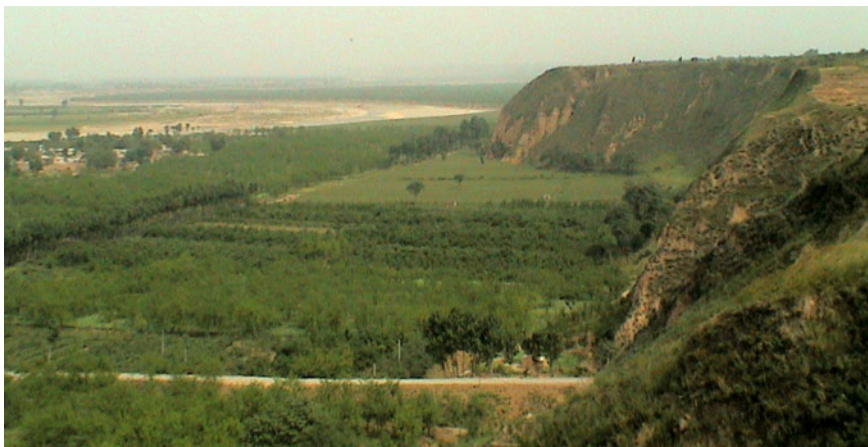
Fig. 11 A typical topography preferring for the rapid long run-out landslide, the side slope of a loess platform to the south bank of the Jinghe river

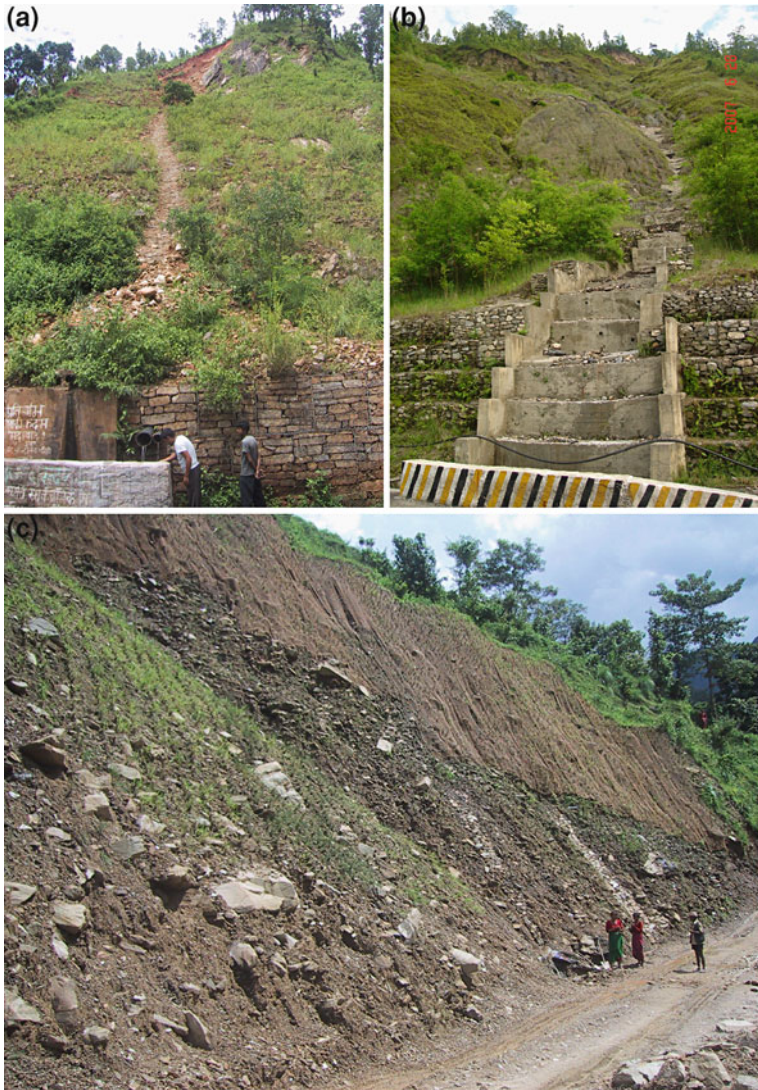
Fig. 21 Bioengineering works to mitigate landslide disaster and applied to various roadside slopes of highways and roads, **a** French drain and grass plantation in a landslide site of the Arniko Highway, **b** Drainage measure and tree grass plantation in Krishnabhir landslide (Photo courtesy: Anjan Kumar Dahal), **c** Coir netting and grass plantation in roadside slope of a rural road

work was extended further to other major highways such as Prithivi Highway and Pokhara-Baglung roads (see Fig. 3 for location). The projects succeeded in controlling slope failures and erosion. A problematic landslides of Prithivi Highway (Krishnabhir landslide, Fig. 21) was also managed by bioengineering works in conjunction with civil engineering structures. Many on-going road projects are also extensively using bioengineering in combination with engineering structures to control cut slope failures and soil erosion. Bioengineering works, which are generally found to be applied in roadside slopes of Nepal as low cost mitigation measures, are presented in Table 3. Some examples of bioengineering in roadside slopes can be seen on Fig. 21. Figure 22a illustrates a successful case of community based river training work with bioengineering systems for flood protection in Terai. The community used local materials to prepare this embankment for river training work. Not only roadside slopes, but problematic slope in a settlement area is also successfully protected by bioengineering work and Fig. 22b illustrates a case of a village (Patleket) situated in eastern part of Kathmandu.

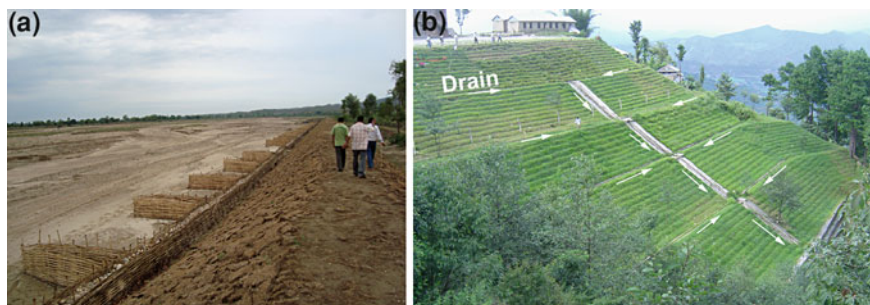
Fig. 22 **a** Community based river training work with bioengineering systems for flood protection in Terai and **b** Bioengineering work for the protection of problematic slope in a settlement area, east of Kathmandu

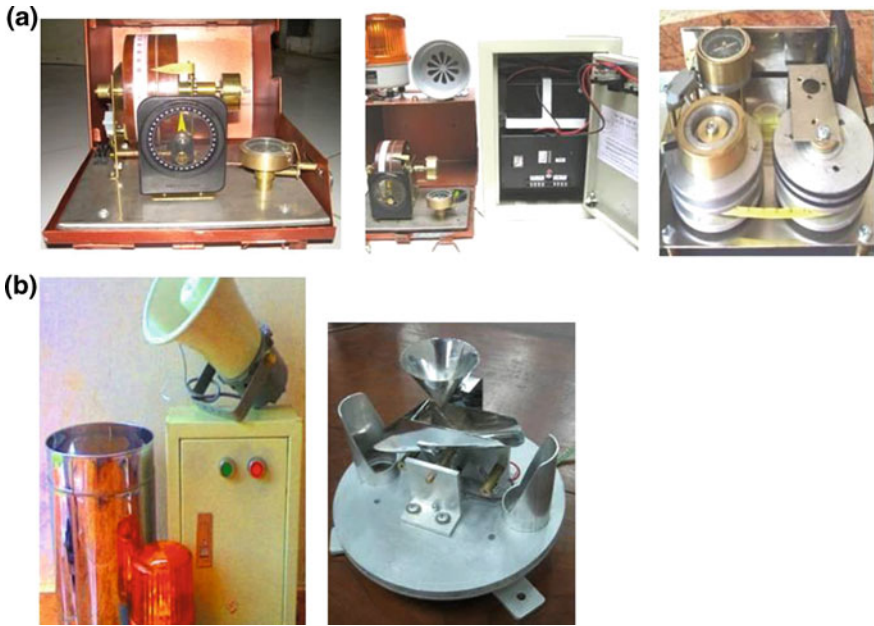
Fig. 3 a Above, the manual extensometer (generation 1 on the left and generation 2 on the right), connected with alarm system in the middle, and b below, the rain gauge with the alarm system (Fathani et al. 2008; Fathani and Karnawati 2009)

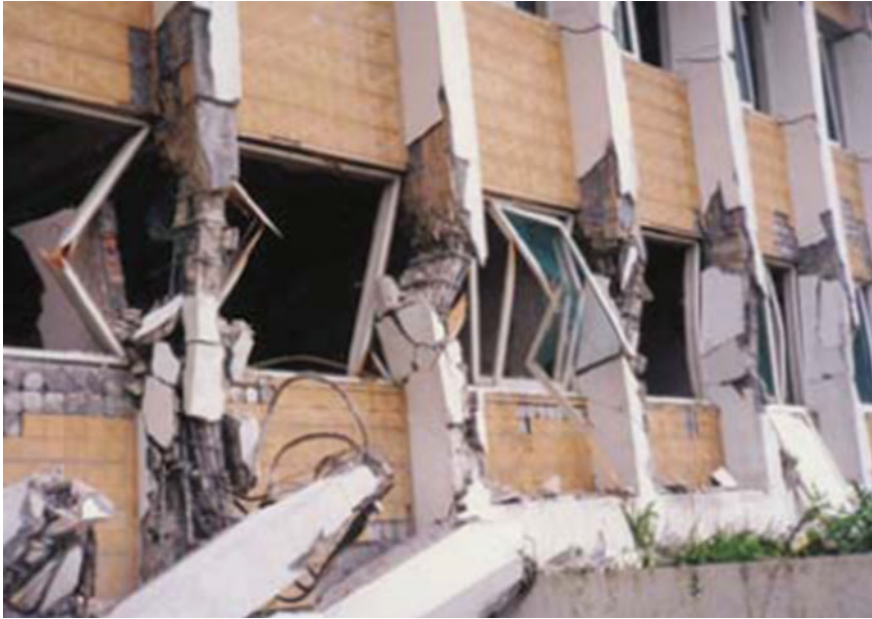
Fig. 3 Short-column effect

This resulting high damage rate of structures is from a large percentage of buildings that collapsed were one-to-three story reinforced concrete frame structures constructed with brick infill partitions and exterior walls. Many of them had pedestrian corridors and open front at the ground floor. More than two dozen modern high-rise apartment buildings overturned or collapsed because of inadequate design. Some of the buildings collapsed because of the so-called “short-column effect” as the spaces between columns were partly filled by windowsills (Fig. 3). These windowsills trap the columns preventing the development of their normal flexural behavior over their height and allowing them to only deform over their free-height, i.e., the length of the column not surrounded by windowsills. As a result, although the shorter length of the trapped column would make it possible to resist higher lateral forces before the flexural strength of the column is reached, the ultimate shear strength of a short column is thus first reached and typical non-ductile shear failures ensue.

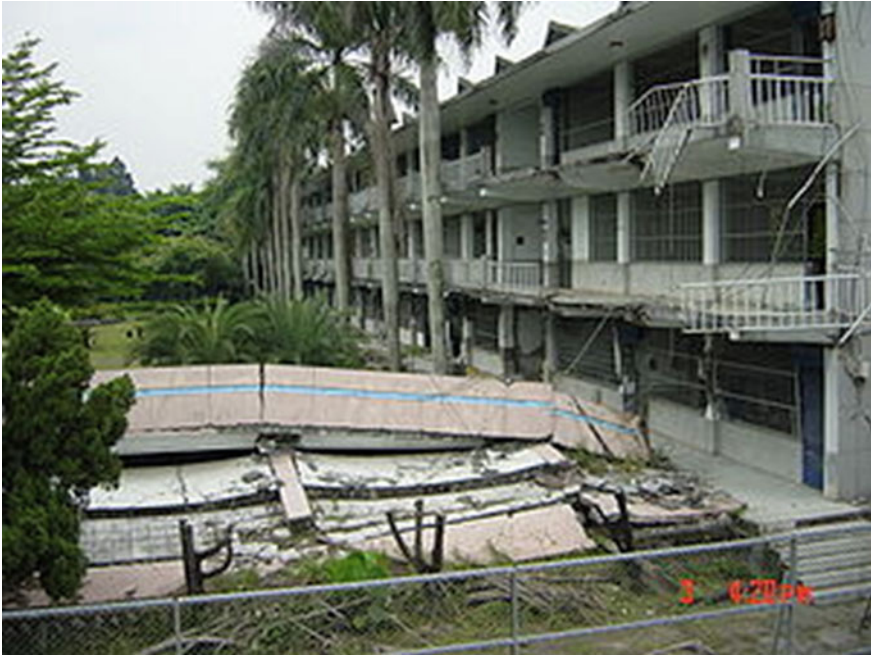
Fig. 4 Heavily damaged Guangfu elementary school in Wufeng (wikipedia: 921 earthquake)

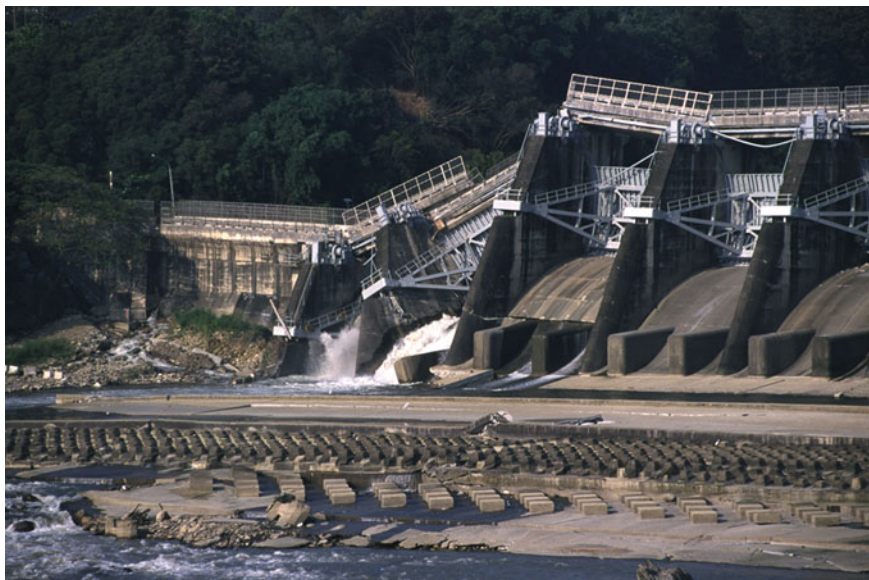
Fig. 5 Damage to Shih-Kang dam

No human-made structures were able to sustain such rupture, and Shih-Kang Dam (Fig. 5), located close to the north end of the rupture, was the one suffered the most. It is a gravity dam, about 25 m high, and has about 18 gated bays that serve as a spillway. The dam was directly intersected by fault rupture, with a differential movement of about 9 m vertically and 2 m horizontally under bays 16–18. The fault had not been mapped at the site prior to the earthquake. Bays not affected by the fault rupture survived essentially undamaged. A peak ground acceleration (PGA) of 0.56 g was recorded in a town nearby.

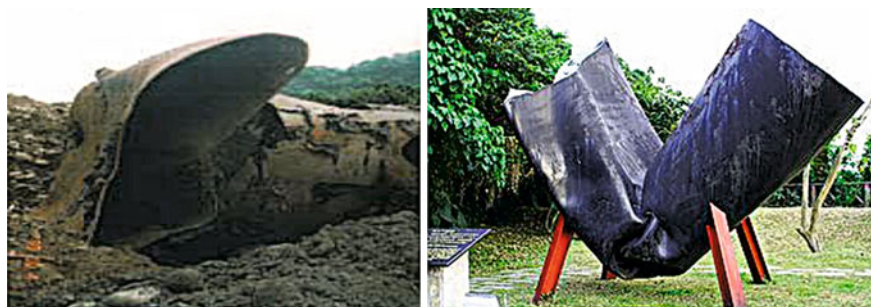
Fig. 6 The distorted 2000 mm steel pipe in Fengyuan (*left*) is now exhibited at the museum of drinking water, Taipei (*right*)

It is noted that the fault rupture also passed by about 20 m from the easternmost end of the Fengyuan Water Treatment Plant described above. At this location the faults run nominally in the north–south direction. The vertical offset at the fault trace was about 4 m (east portion moving up with respect to the west portion) and the horizontal offset was between 1–2 m (left lateral offset). These offsets were large enough to sever four steel pipelines with diameters of 400, 1100, 1500, and 2000 mm which traversed the fault and ran nominally in a NW–SE direction. Figure 6 show the distorted 2000 mm steel pipe, and a remnant of it is now exhibited in Taipei.

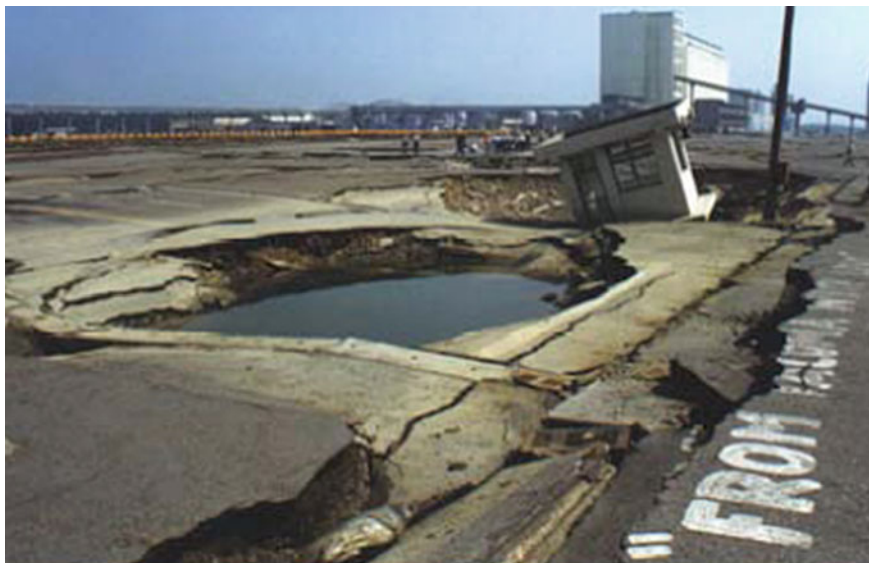
Fig. 9 Damage of Taichung port by liquefaction
